**TL 214 CONDITION ASSESSMENT AND
RECOMMENDATIONS FOR
UPGRADING**

September 9, 2002

TRO – Engineering

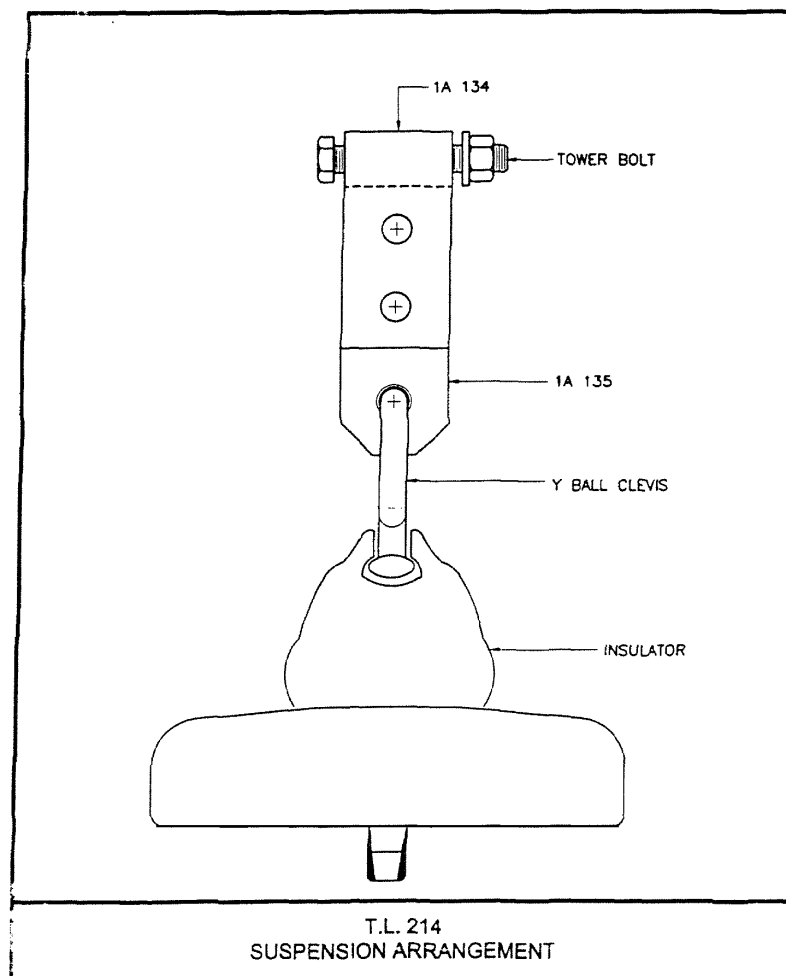
Figure 6.1 1A 134/135 Plates

In summary, the assessment indicated that the line is in good condition, with the one exception being the worn attachment plates (1A 135 plates), which currently are being replaced through regular maintenance in 2002.

The 1A 135 plates connect to the Y-Ball clevis, which holds the insulator string. This arrangement is connected to the tower by the connection plate (1A 134 plate), see figure 6.1. While replacing the 1A 135 plates it was found that the 1A 134 plates were also worn, which could not be determined from the initial assessment. Several locations have had the plates replaced and it is recommended that all plates identified as wearing be replaced. These plates primarily require replacement on Structures 275 to 355, which is the area identified as experiencing high wind conditions.
