NEWFOUNDLAND & LABRADOR HYDRO

Snook's Arm Wood Stave Penstock

Evaluation, Recommendation and Estimated Cost for Replacement

January 26, 2004

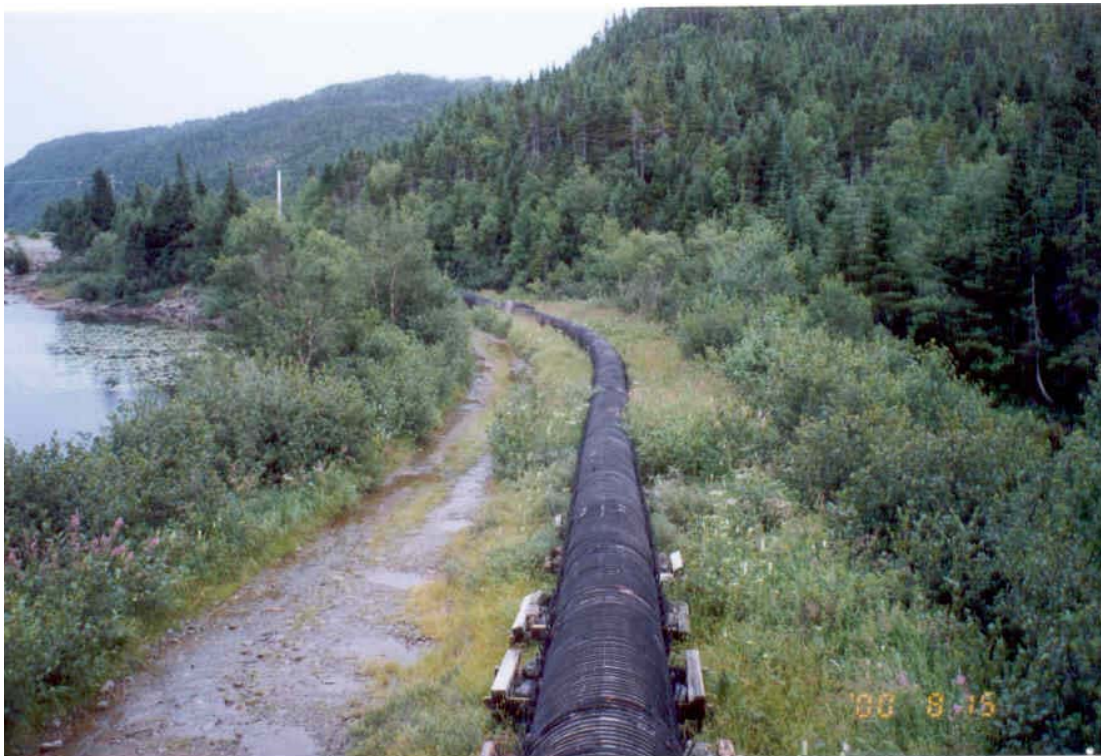
The penstock profile has several flat sections and one reverse section in the mid to upper half of the penstock, see photos #1 & #2. The reverse grade increases the probability of the penstock collapse during operation, when the Plant is fully loaded. The only protection from collapse is a vacuum breaker valve located at the mid-point of the line. This valve is designed to break any vacuum that may cause a collapse. It is critical that this valve is kept in good working condition to ensure that it will operate as required. Recent problems experienced include a fire in the valve enclosure and a malfunction of the valve.

Photo #1: View of penstock, August 2000.

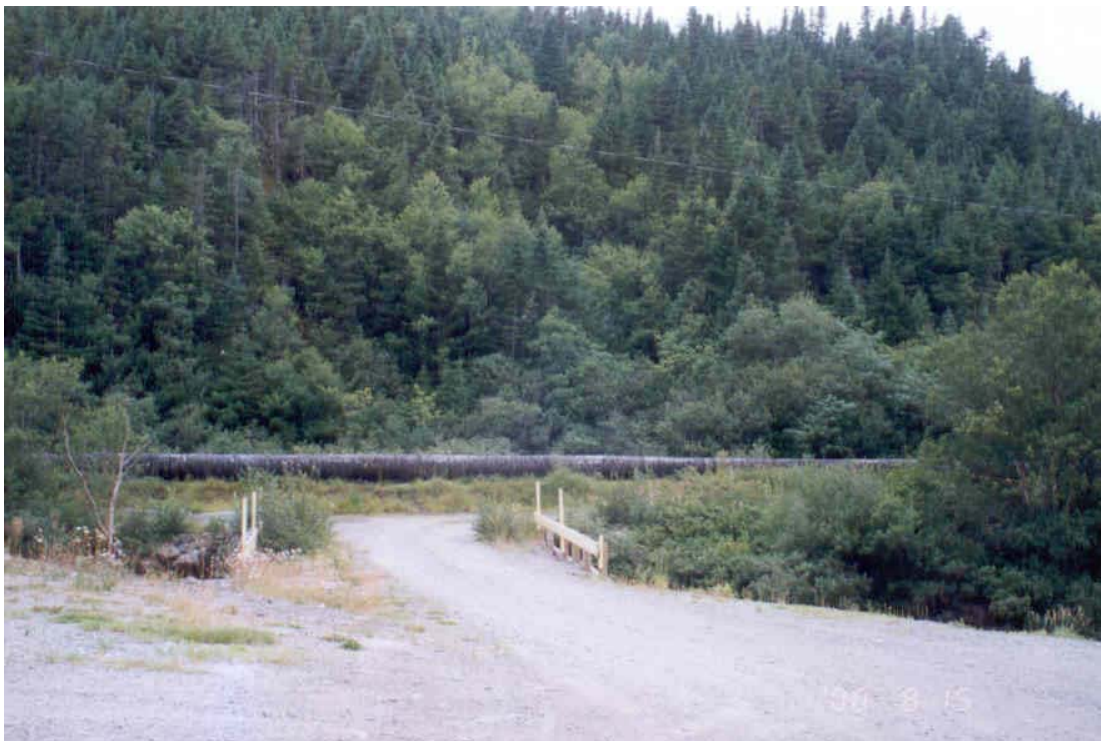
Photo #2: View of flat and reverse section of penstock, August 2000.

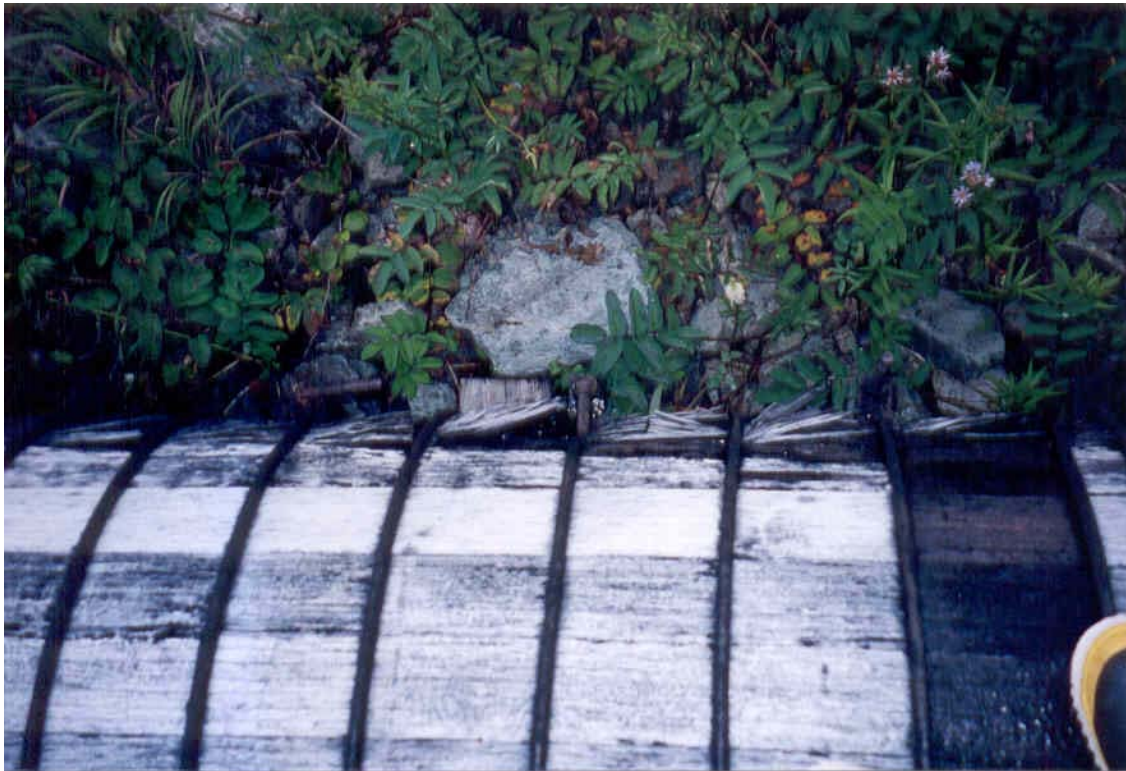
Various inspections of the penstock have indicated that there is joint leakage between the staves, brooming at stave ends and between steel bands and crushing of the staves along the spring line or top of the penstock. The brooming and crushing is worse at the lower end of the penstock, which is subject to higher pressures. The crushing and brooming indicates delamination between the wood fibers and deterioration of wood, see photos #3 & #4. The rate and areas of deterioration continues to grow with the age of the structures.

Photo #3: View of brooming between metal bands, August 2000.

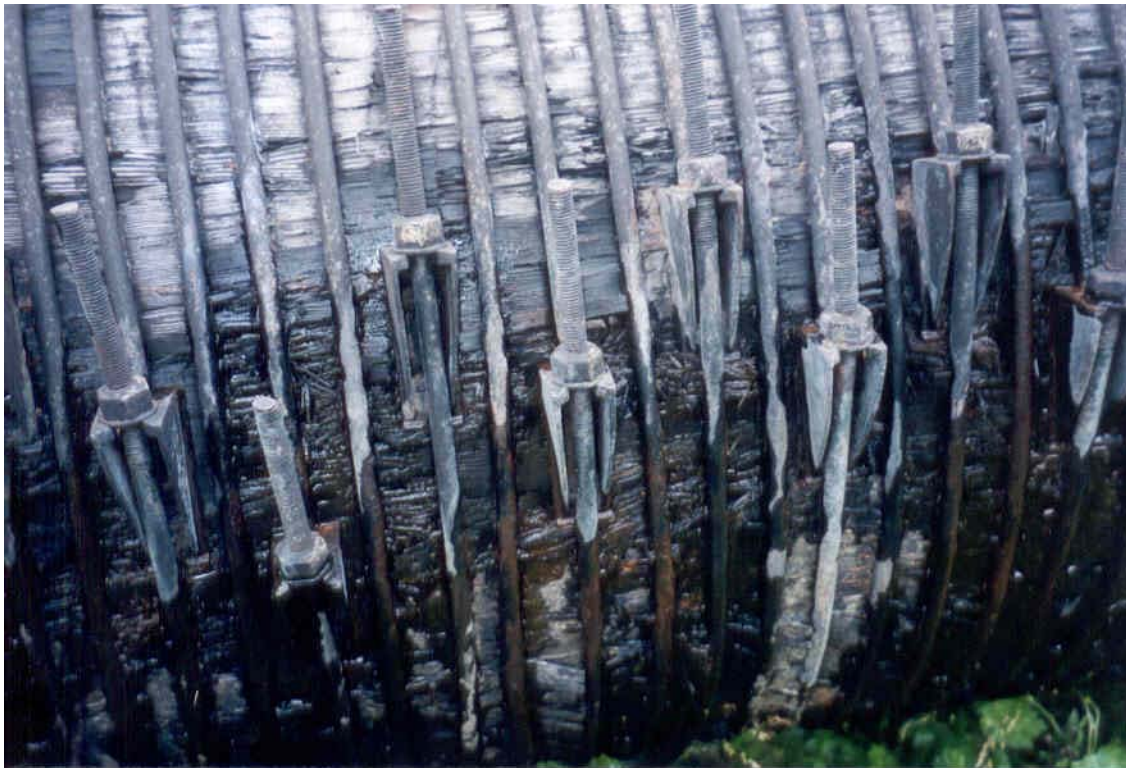
Photo #4: View of crushing and brooming of wooden staves, August 2000.

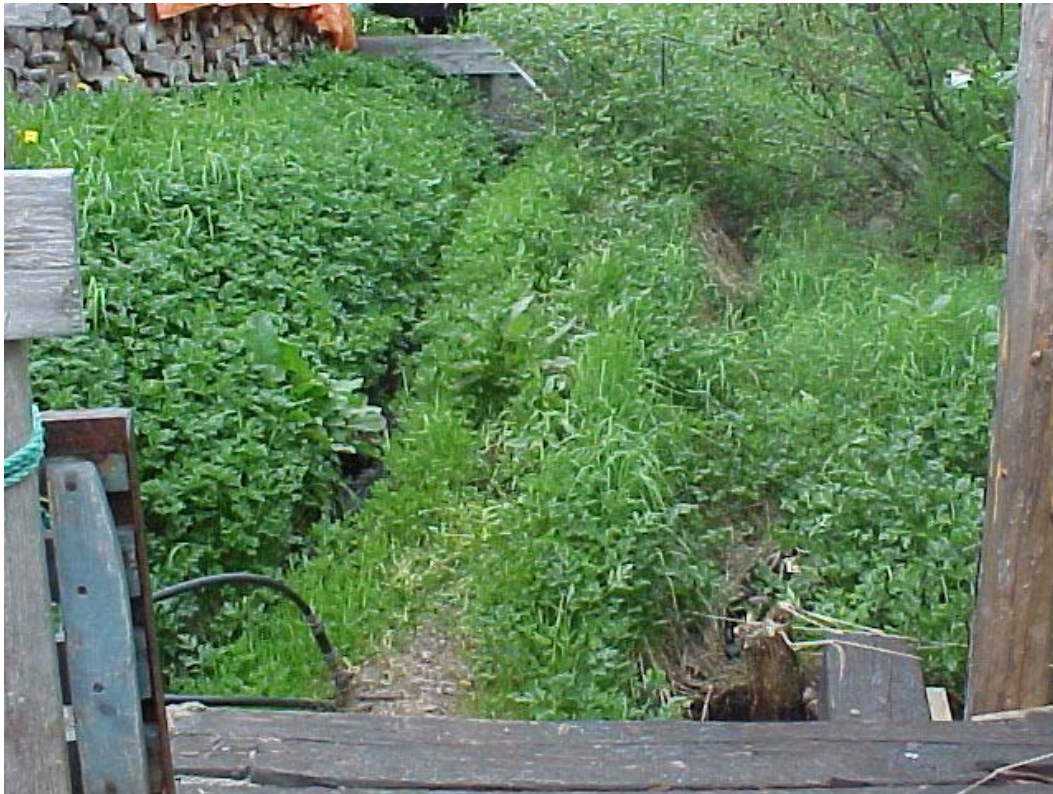
Also along the length of the penstock, areas of moss and other vegetation are growing directly on the penstock; see photos #5 & #6. Vegetation growth typically retains moisture and cause stave deterioration. In some cases the vegetation can be parasitic to the wood stave. Vegetation thrives because of continuous water supply leaking from the penstock. The cost of removing the vegetation continues to increase.

Photo #5: Vegetation growth around and on penstock, June 2001.

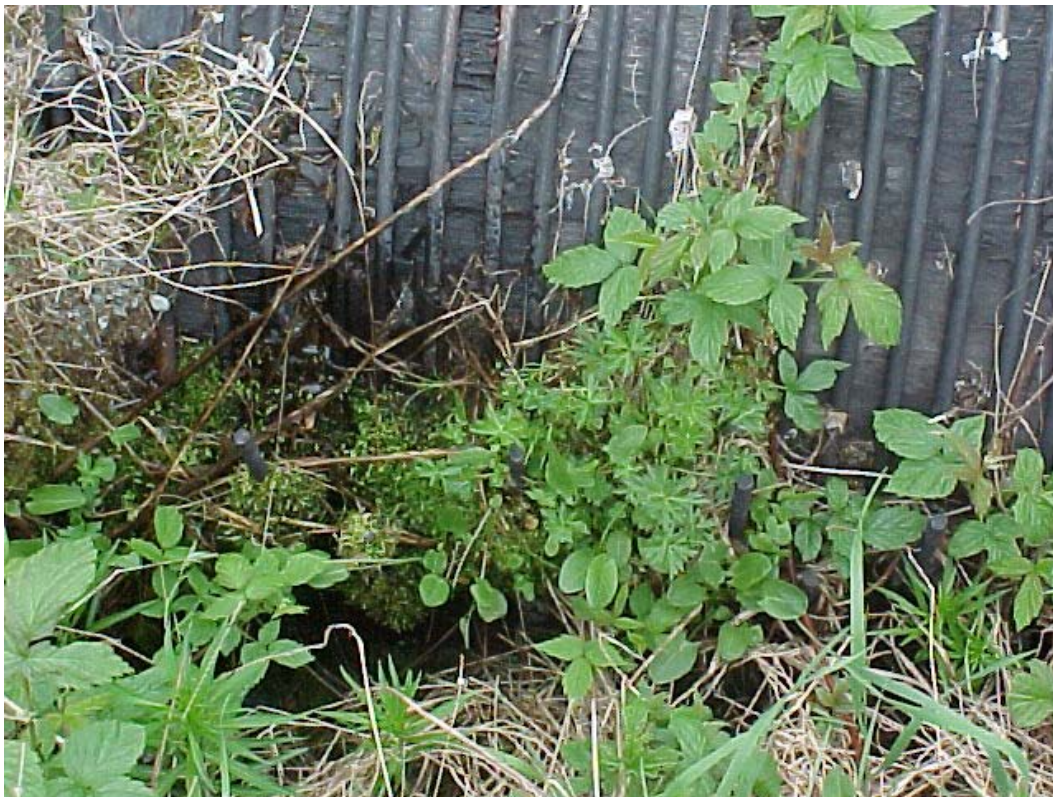
Photo #6: Moss and other vegetation growing directly on penstock, June 2001.

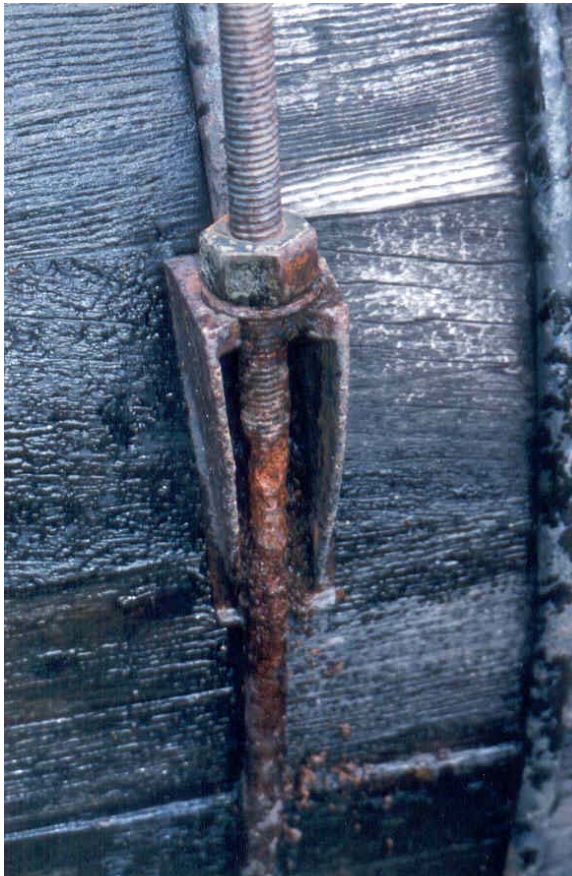
There are approximately 12,000 steel bands used to maintain the shape and integrity of the penstock. All of the bands show various signs of rusting, corrosion and deterioration. Also, in recent years some bands have been observed with significant corrosion below the threads on the band, see photos #7 & #8. These bands are required to be replaced or new ones installed adjacent to the old ones (where possible). In addition, there is bright, visible corrosion on the majority of the steel bands that do not receive direct sunlight. These areas include the penstock enclosure, buried section of the penstock and at the road crossings. In these same areas it is difficult if not impossible to replace the steel bands because of the limited access. Also, in several locations it is impossible to replace the bands unless the penstock is dewatered, because of the decreased band spacing and the higher pressure on the lower half of the penstock. However, frequent dewatering of the penstock is not recommended because of its aged and deteriorated condition.

Photo #7: View of corrosion below threads, August 2000.

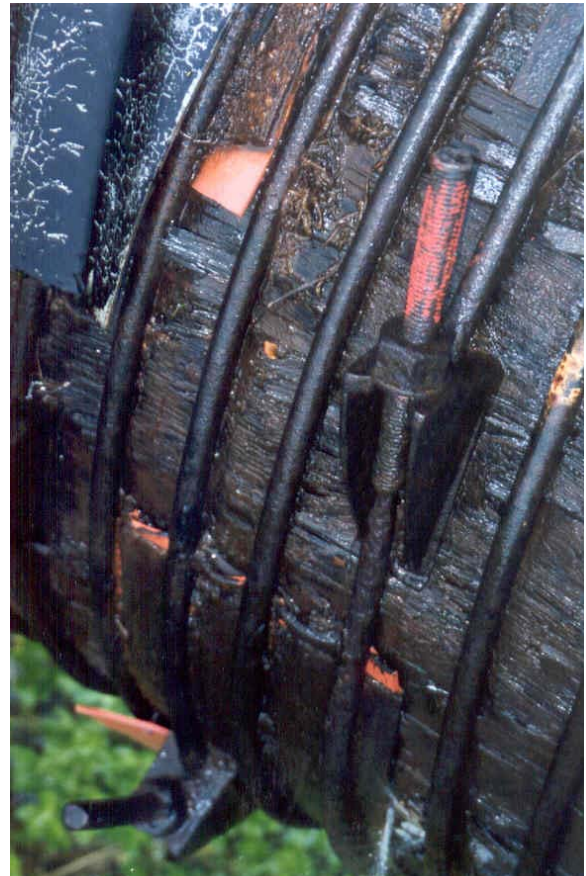
Photo #8: View of corrosion on metal bands, August 2000.

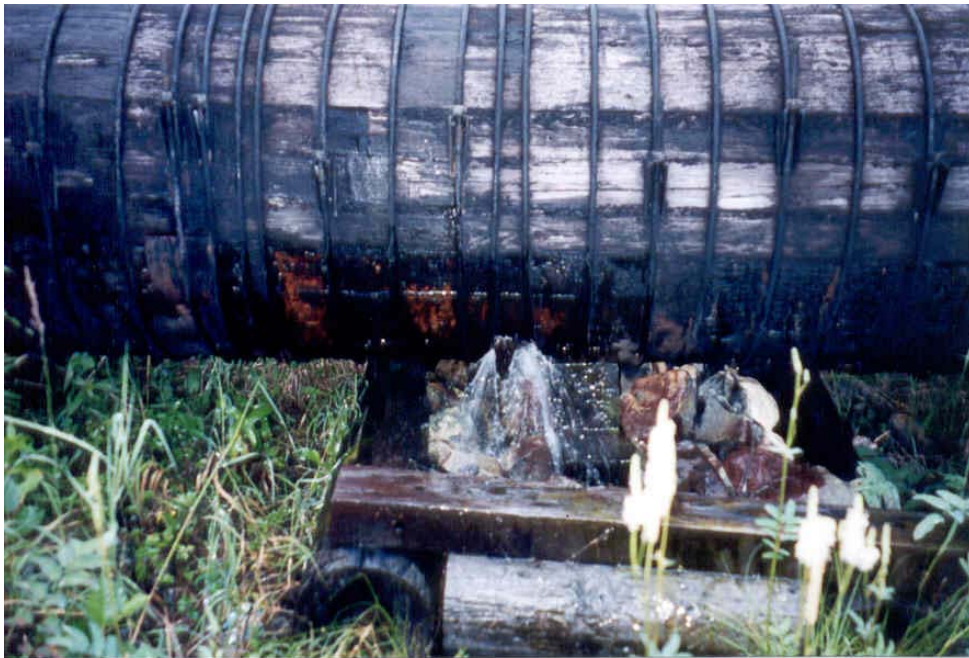
Leaking of the penstock joints have been observed since at least 1968, see photos #9, #10 & #11. The leaks were sometimes repaired by driving nails into the leaking area, this method however tends to promote deterioration of the wooden staves, see photo #12. The more common method of sealing the leaks involved the installation of small steel plates under the existing steel bands or by adding new bands between the existing ones in the area of the leak, see photo #13. The penstock has been dewatered approximately 4-5 times since 1989 to repair the leaks. During one event, the penstock was dewatered for approximately 5-6 days, which allowed the wood staves to dry out and shrink in size. When the penstock was watered up there were a significant number of additional leaks of various sizes, which required lengthy time and effort spent to correct and seal the new leaks. Based on this experience, the penstock has been dewatered and watered up during the same day to repair any leaks in the penstock. However, each time the penstock is dewatered, additional leaks appear when the penstock is watered up again. Overall, the dewatering of the penstock is a significant activity that creates just as many or more leaks than those that are repaired.

Photo #9: Water leaking from penstock, August 2000.

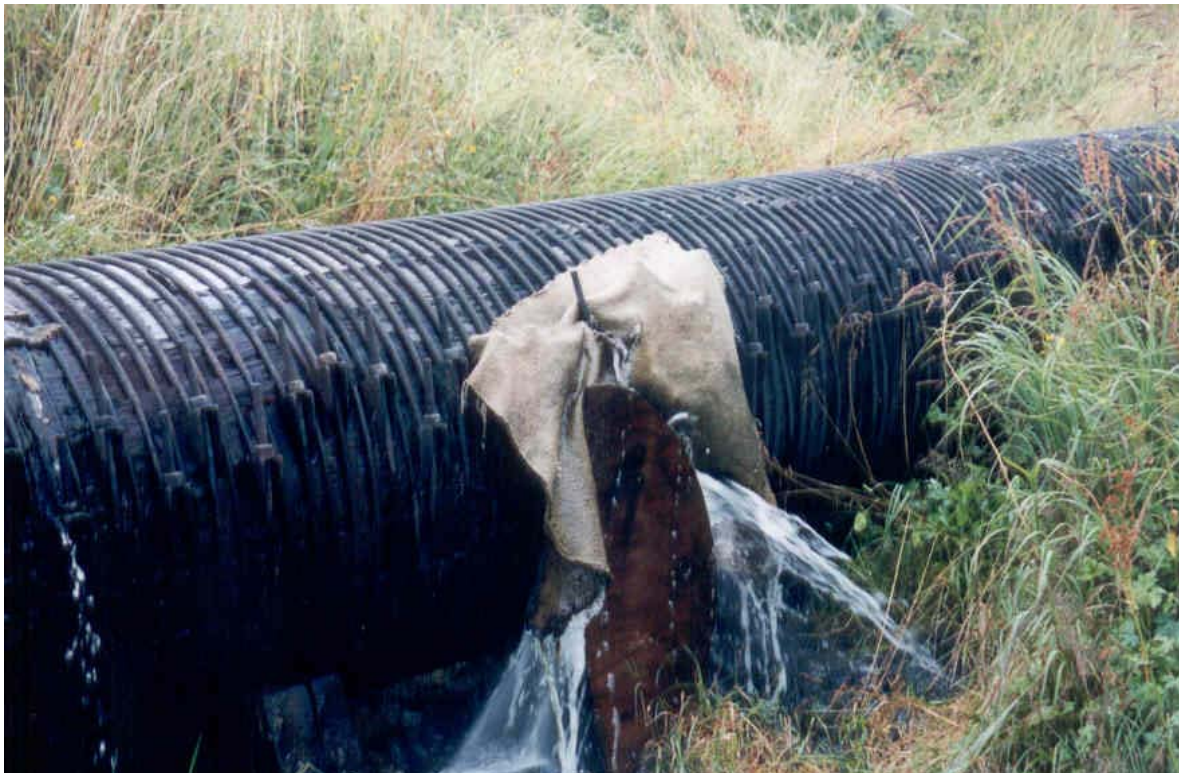
Photo #10: Water leaking from penstock, August 2000.

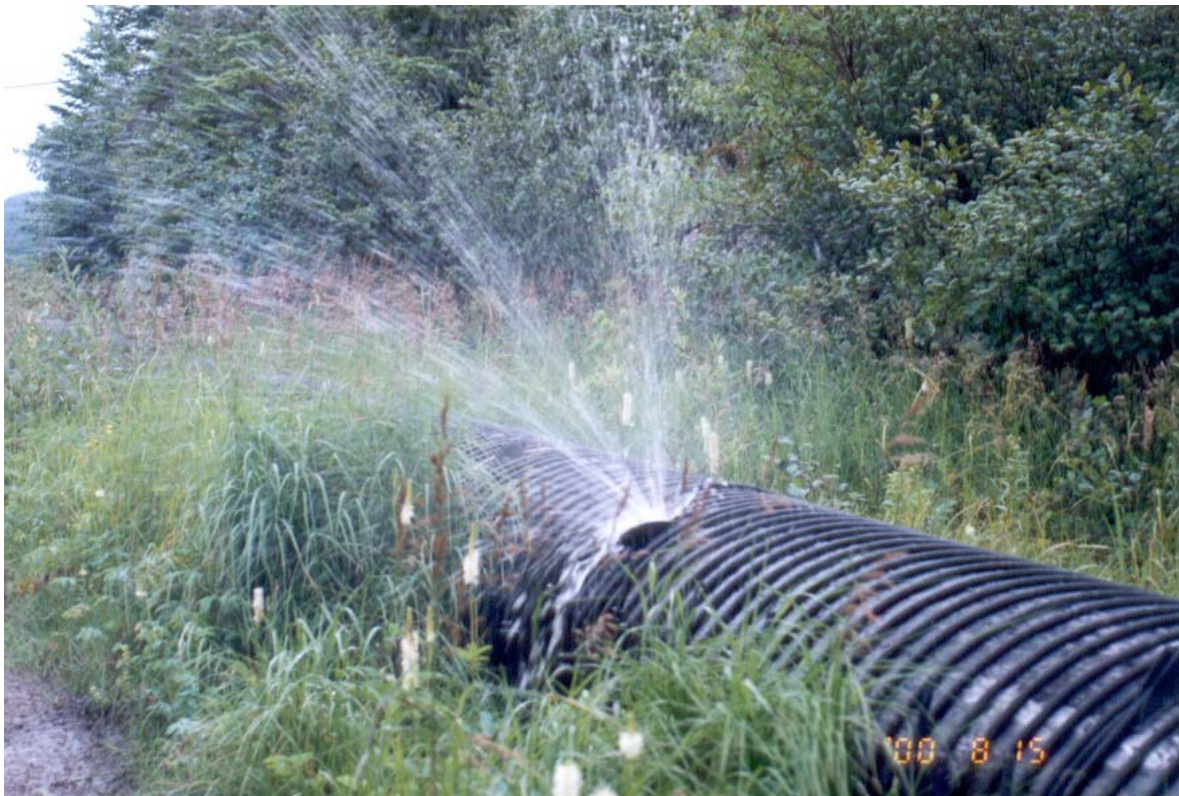
Photo 11: View of water leaking from penstock, August 2000.

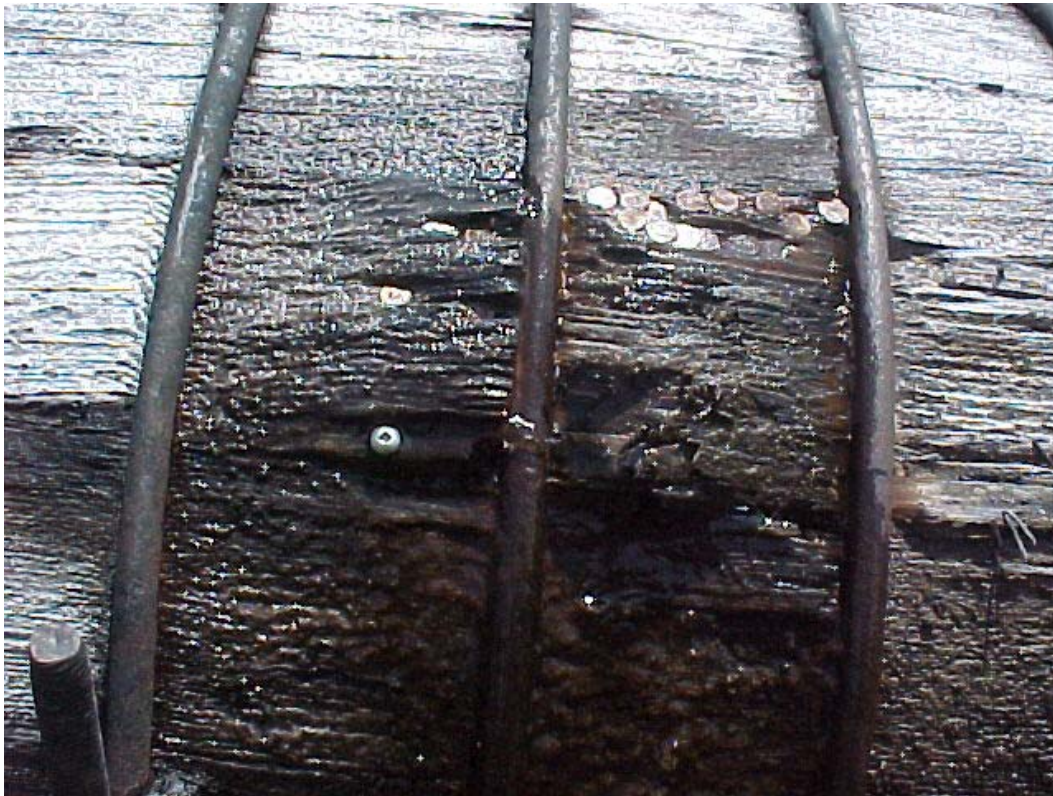
Photo #12: Nails driven into penstock to stop leaks, June 2001.

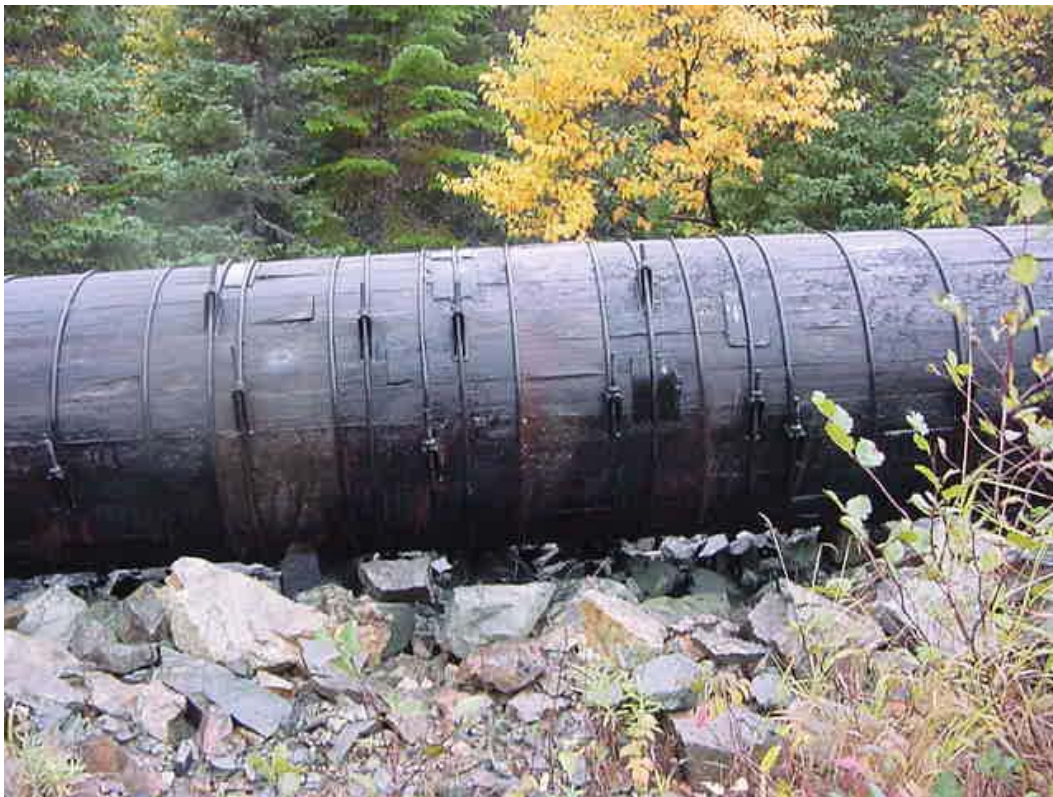
Photo #13: Metal patches placed under new bands to stop leaks, October 2003.

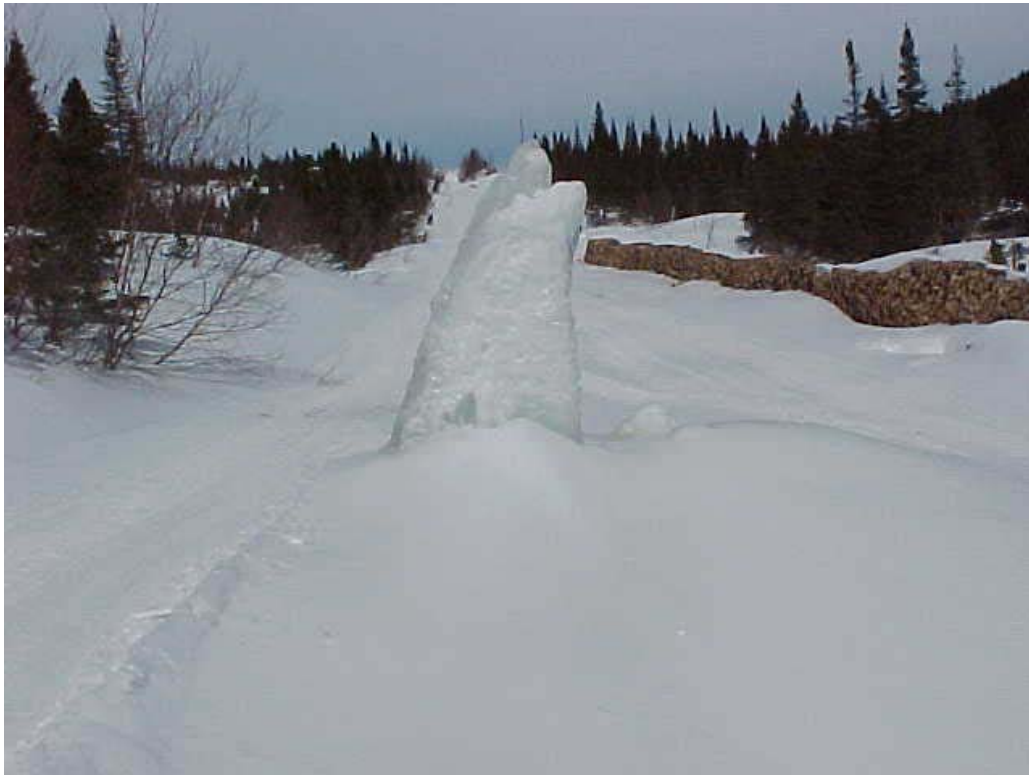
The formation of ice was investigated during the winter of 2001 and several observations were made. The ice formations were fed from the penstock by the constant flow of running (leaking) water. The ice formations extended down over the sides of the penstock to the ground. One ice formation observed was 8 ft high and 3 ft long at its base, the average ice formation was 5 – 6 ft in height, see photo #14. The danger caused by the ice formations is that the ice loads or large ice chunks could severely damage or rupture the weakened penstock. Another key area of ice formation was under the penstock enclosure. The leaking water causes large ice formations under the enclosure around the area of the access road, see photo #15. Besides adding a substantial load to the penstock and its support structure, it also interrupts local traffic (this sometimes leads to unsupervised demolition of the ice).

Photo 14: Ice formation above penstock, April 2001.

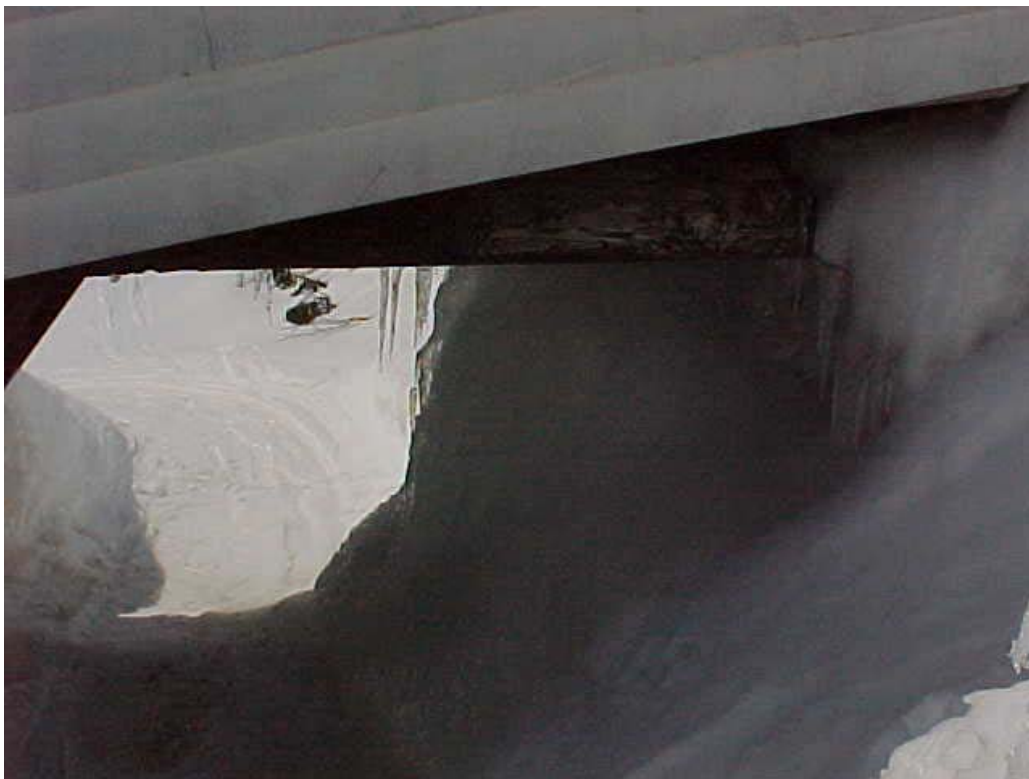
Photo 15: Ice formations under penstock enclosure, April 2001. For location of ice formation refer to Photo #18.

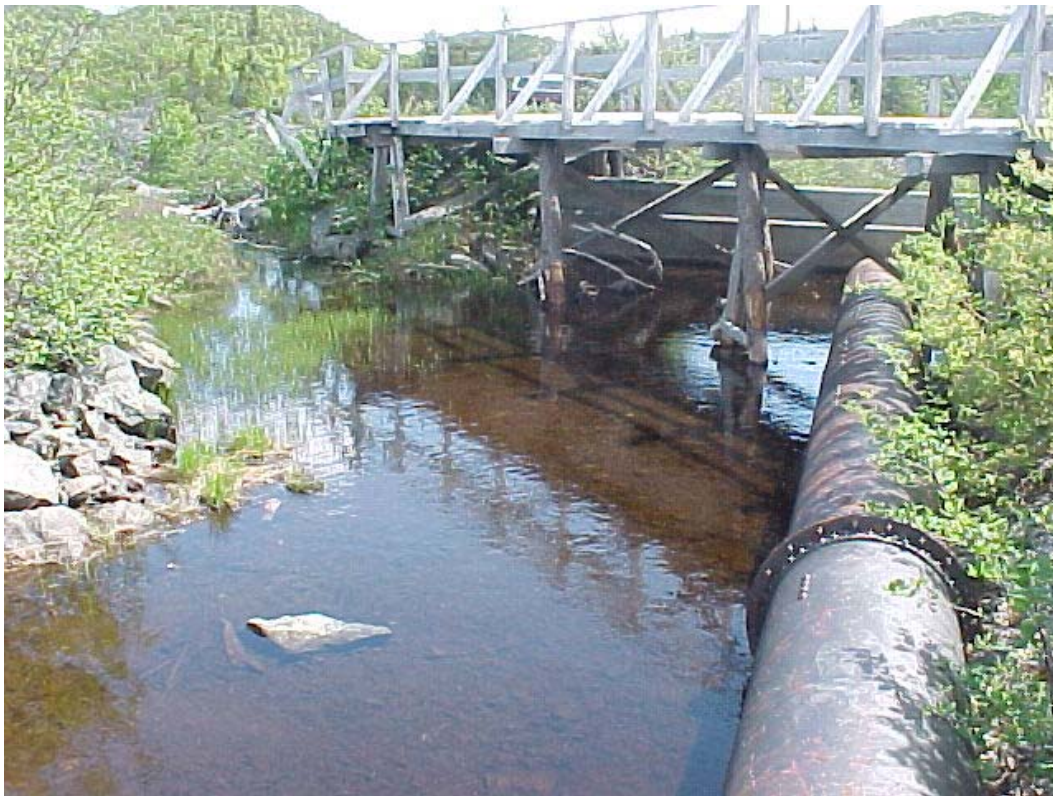
The first section of the penstock, from the intake to approximately 80 ft downstream, is fabricated from riveted steel plate; refer to location #1 on map SA-1 and photos #16 & #17. Because of the age of this steel section of penstock plus the fact that it has been partially or totally submerged for years, it continues to deteriorate. In addition, the concrete saddles for this section are also damaged. This section of penstock will likely be required to be replaced at the same time as the adjacent wooden penstock.

Photo #16: Accumulation of water behind concrete cut-off dam, June 2001.

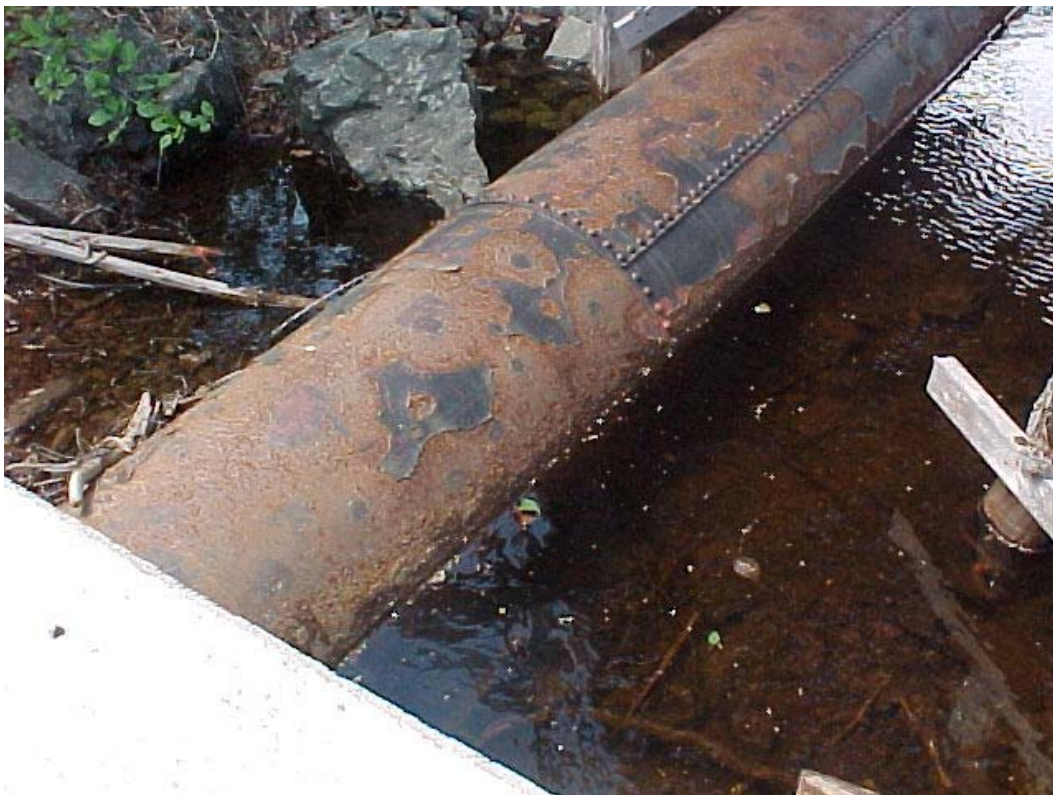
Photo #17: Steel section of penstock, partially submerged in water, June 2001.

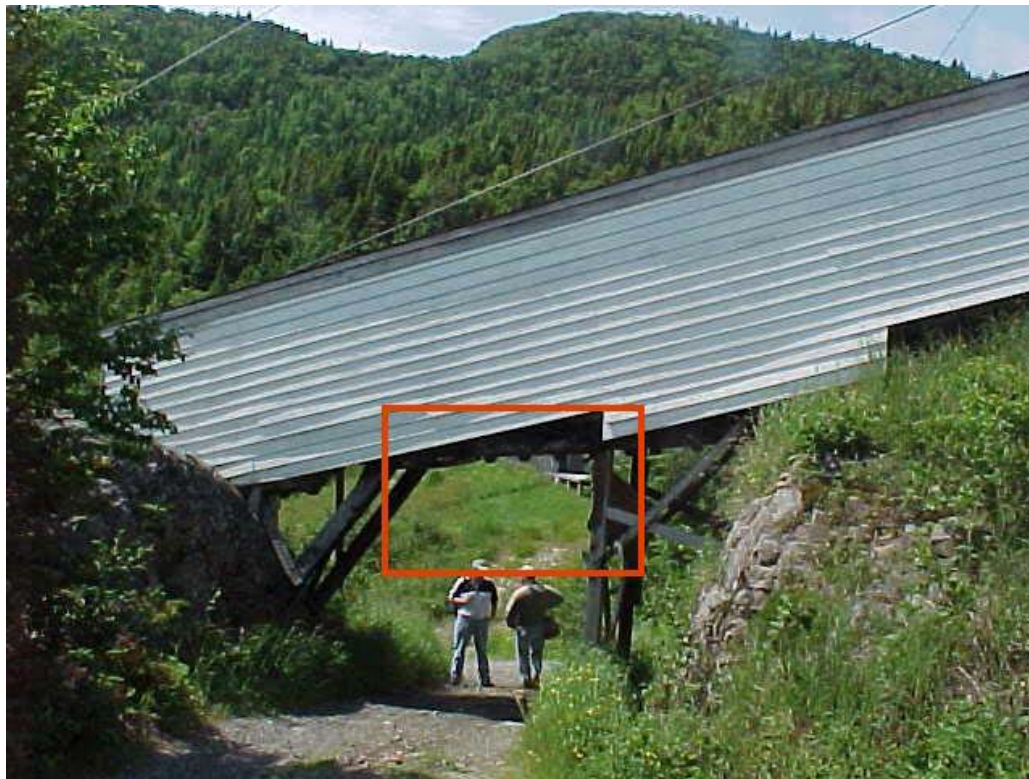
The penstock is enclosed for a length of 75 ft in the vicinity of the access road; the enclosure was built to reduce ice formation during the winter. The penstock invert was heat traced to reduce ice buildup inside of the structure; however, ice buildup inside and outside of the enclosure is still an ongoing problem. There are several concerns associated with this structure including the old and deteriorated condition of the enclosure, reliability of the heat tracing, and the limited access for inspection and maintenance of the penstock inside the enclosure. In general, the structure is becoming more of a safety concern as it ages.

Photo 18: Penstock enclosure over access road, July 2002. Highlighted area indicates location of ice formation shown in Photo #15.

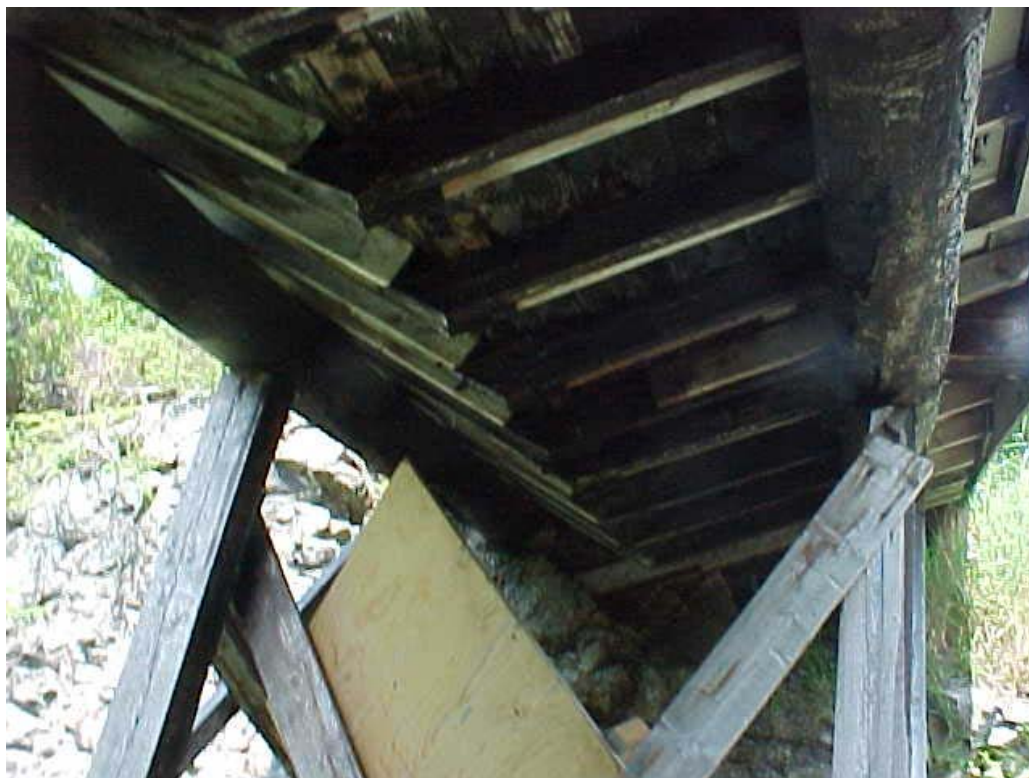
Photo 19: Support structure for penstock enclosure, July 2002.

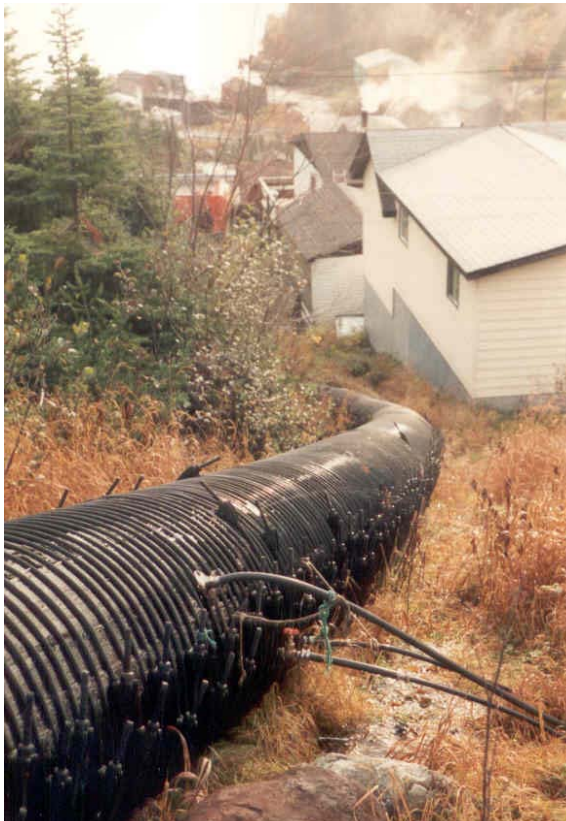
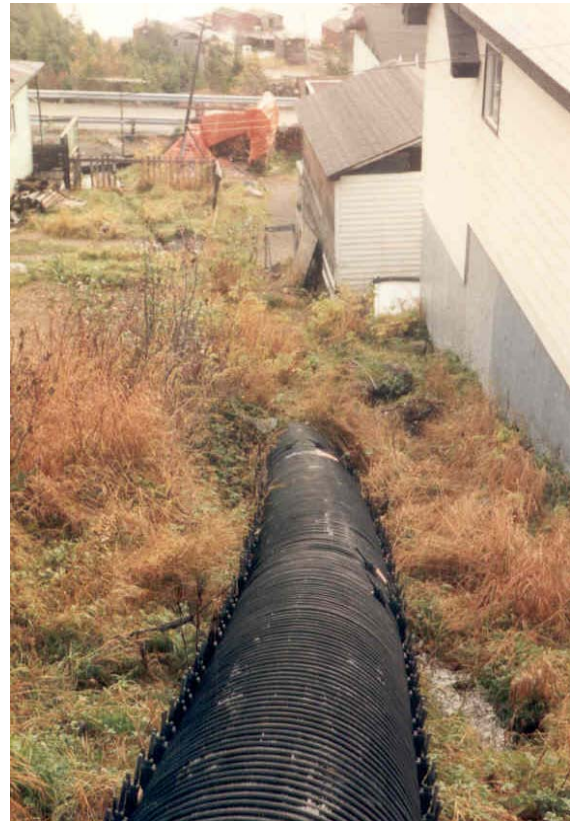
The penstock passes through the middle of the community and at times, is within a few feet of the adjacent houses; see photos #20 & #21. Also a considerable length of the penstock, approx. 200 ft is buried, refer to location #3 on map SA-2 and see photo #22. In 1998, a section of the buried penstock was excavated and it was observed that the penstock is supported on cradles, similar to the rest of the penstock. Buried penstocks are designed to be fully supported along their length, the discovery of cradles supporting the penstock in the buried section, suggests that the penstock was not designed to be buried. The burial of the penstock subjects it to additional loads from the overburden soil and live loads from vehicles, skidoos, woodpiles, etc. In addition, there is very poor drainage around the penstock causing the penstock to be submerged in water. The risk associated with this section of penstock is high because of additional loading, moist conditions and lack of maintenance; there is a high probability of failure of this section of the penstock.

Photos #20 & #21: View of penstock passing through community, October 1992.

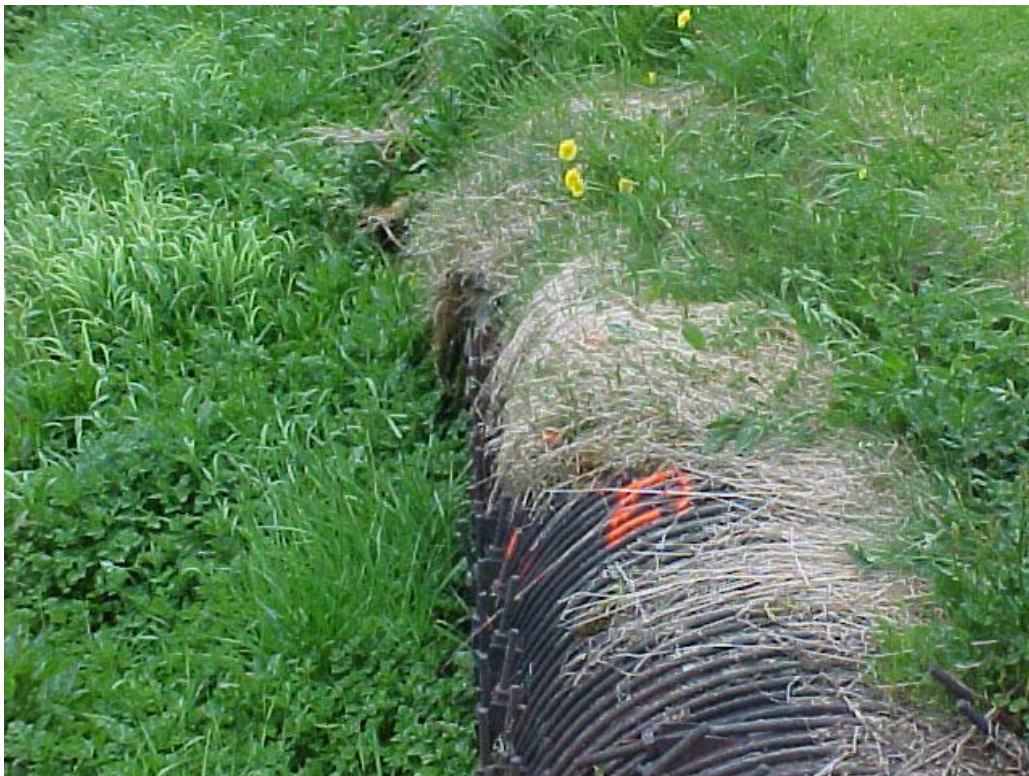
Photo #22 Buried section of penstock in community, June 2001.

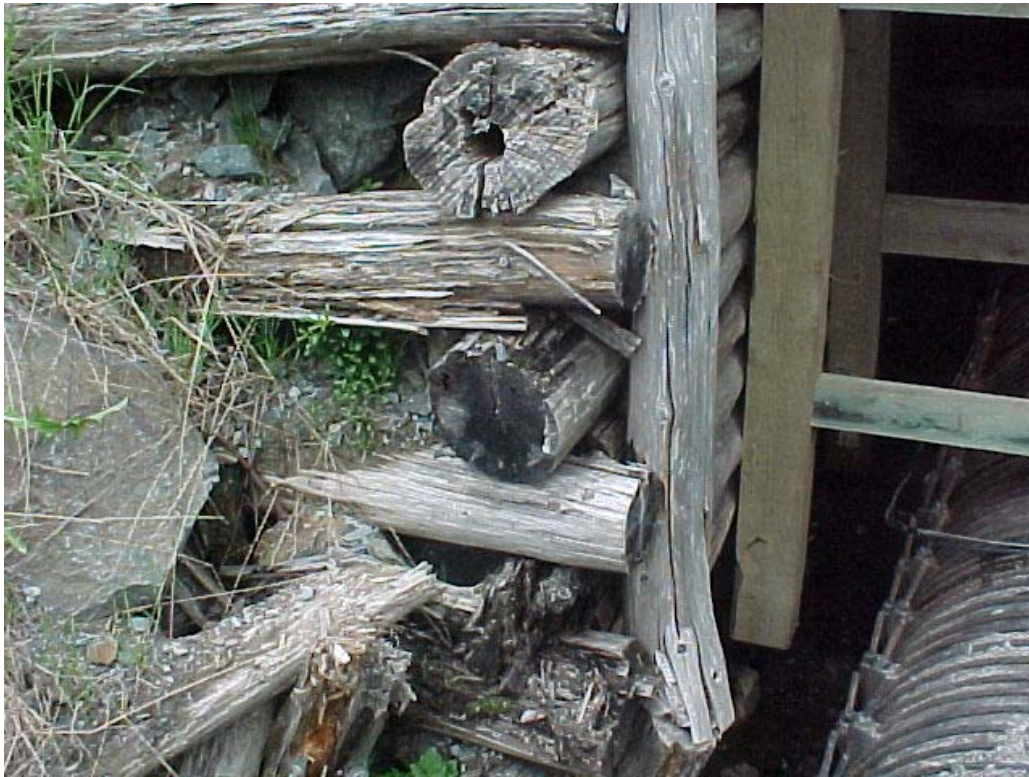
Some of the existing bridge components were constructed in 1971 and they are showing obvious signs of deterioration. The bottom section (approx. lower $\frac{3}{4}$) of the bridge abutments are constructed from local untreated timbers and they are deteriorating, see photo #23. It appears that the only thing keeping the abutments from collapsing is a framework of pressure treated timber braced between the existing abutments, which were installed several years ago, see photo #24. The department of Works, Services and Transportation have indicated that they have no plans to replace this structure in the near future.

Photo 23: View of bottom portion of bridge abutment, June 2001.

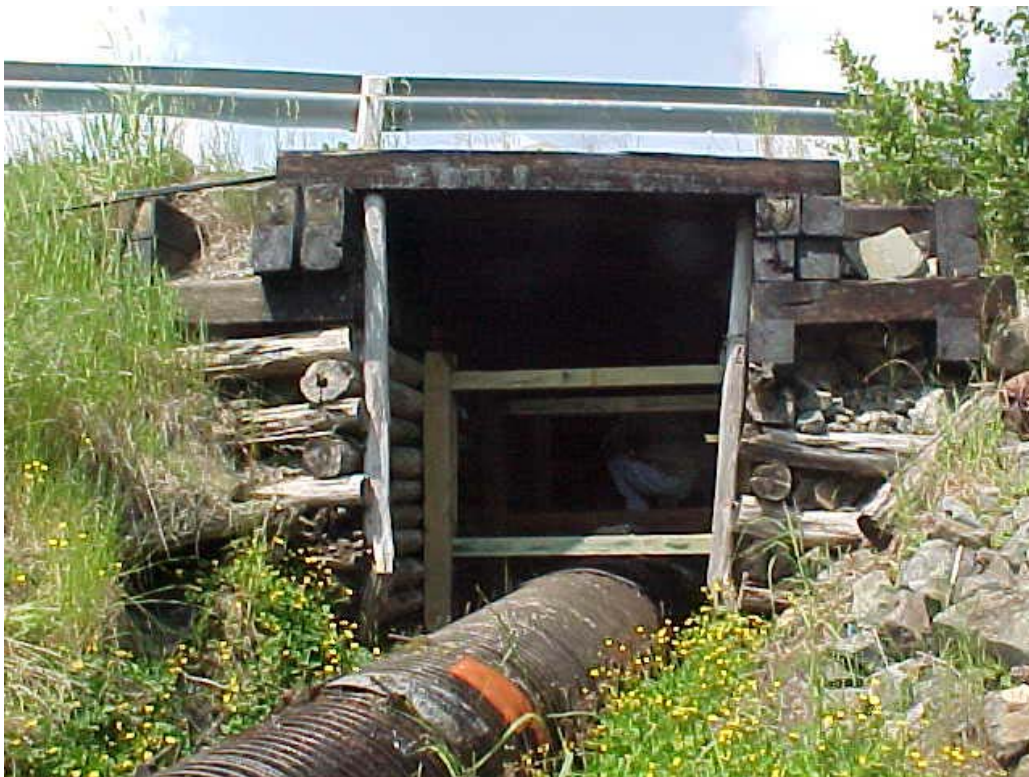
Photo 24: Road bridge over penstock, note timber reinforcement between abutments, July 2002.

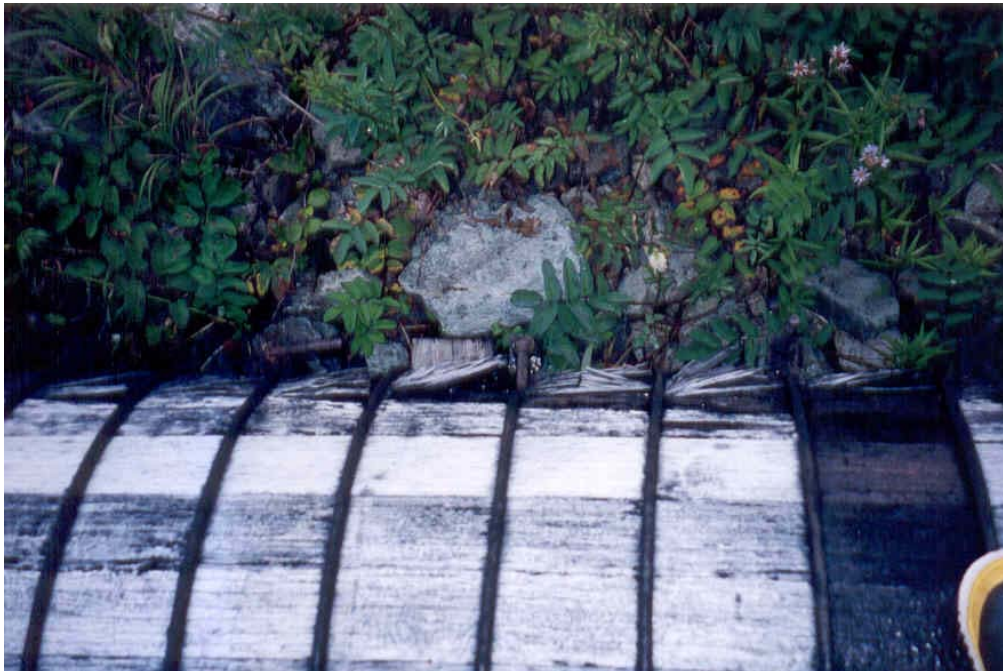
The original wooden penstock components were coated with creosote to provide protection from deterioration and sunlight. Typically a wood penstock would be recoated with creosote every 5-10 years to maintain the protective coating. This penstock has not been coated for at least 15 years (due to environmental restrictions on the use of creosote) and as a result the majority of the wooden penstock has no protection coating, especially along the top, see photo #25. The lack of protective coating has accelerated the deterioration of the wooden staves.

Photo #25: Loss of protective coating on penstock and bleaching of the wood, August 2000.
