NEWFOUNDLAND & LABRADOR HYDRO

Snook's Arm Wood Stave Penstock

Evaluation, Recommendation and Estimated Cost for Replacement

January 26, 2004

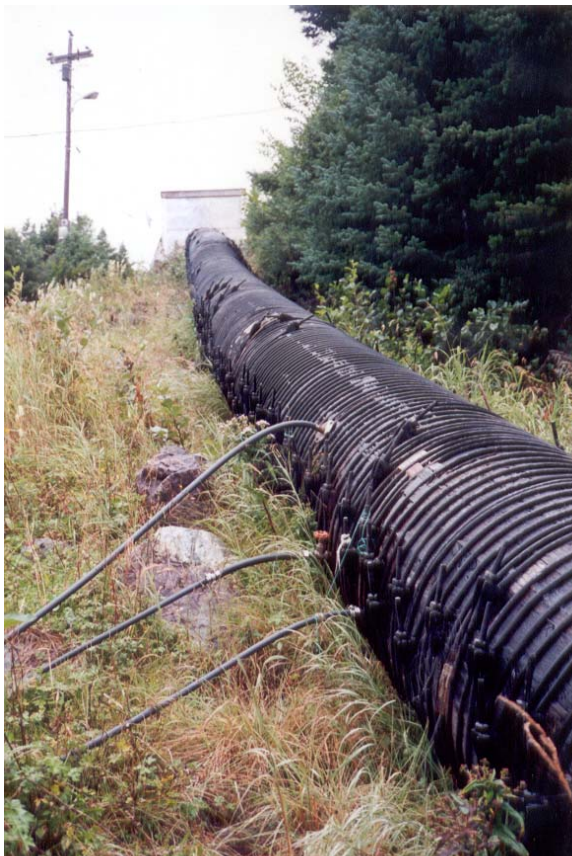
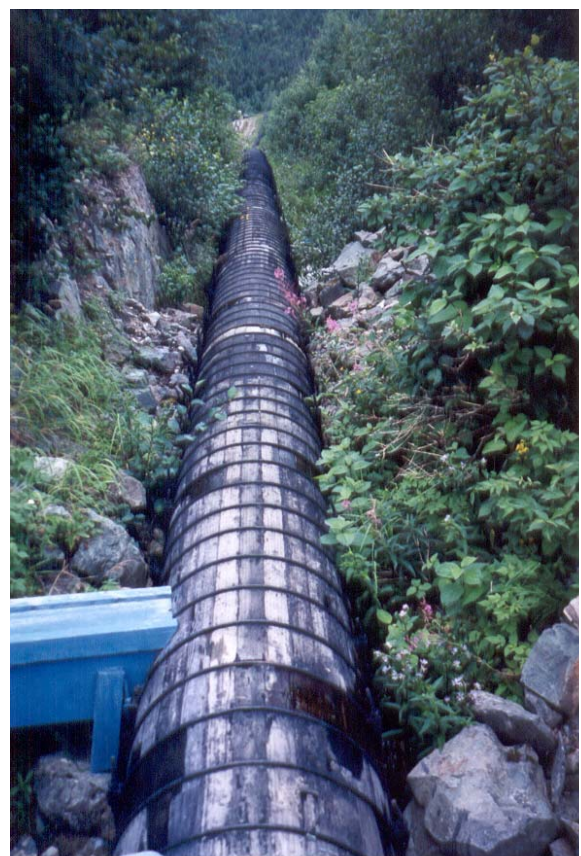
As indicated earlier, the penstock passes through the community and in several locations the penstock is within a few feet from homes and roadways. The proximity of the penstock to the homes has encouraged many residents to tap into the penstock for a source of water, see photos #26 & #27. These taps were constructed without any permission from Hydro and in several locations have been abandoned and leaking water, see photo #28. In addition, all terrain vehicles and skidoos travel over and under the penstock, which imposes additional loads and stresses on the penstock. In the upper half of the penstock, there is firewood stacked adjacent to the penstock, see photo #29, and in several places there are cuts in the penstock from chainsaws. The use

Photos #26 & #27: Water take-offs to adjacent homes (left) and Nugget Pond gold mine security building (right), August 2000.

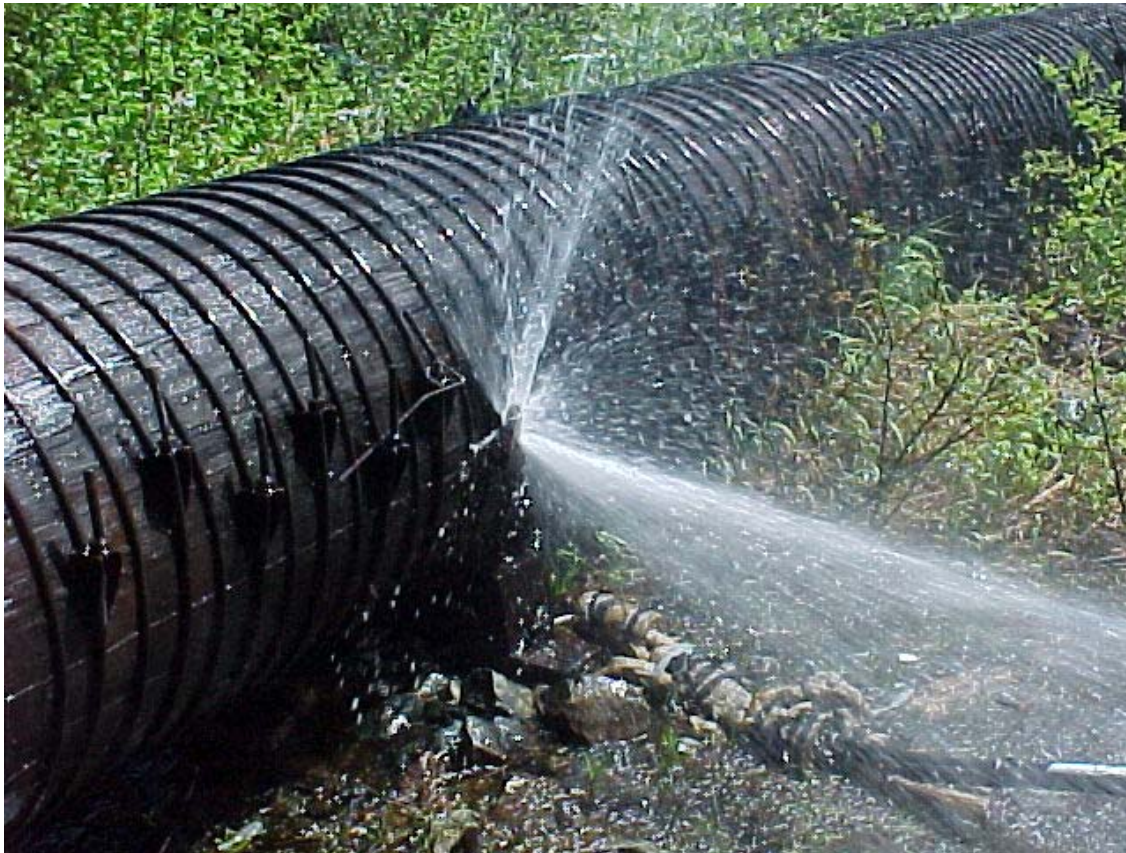
Photo #28: Location of abandoned water tap in penstock, June 2001.

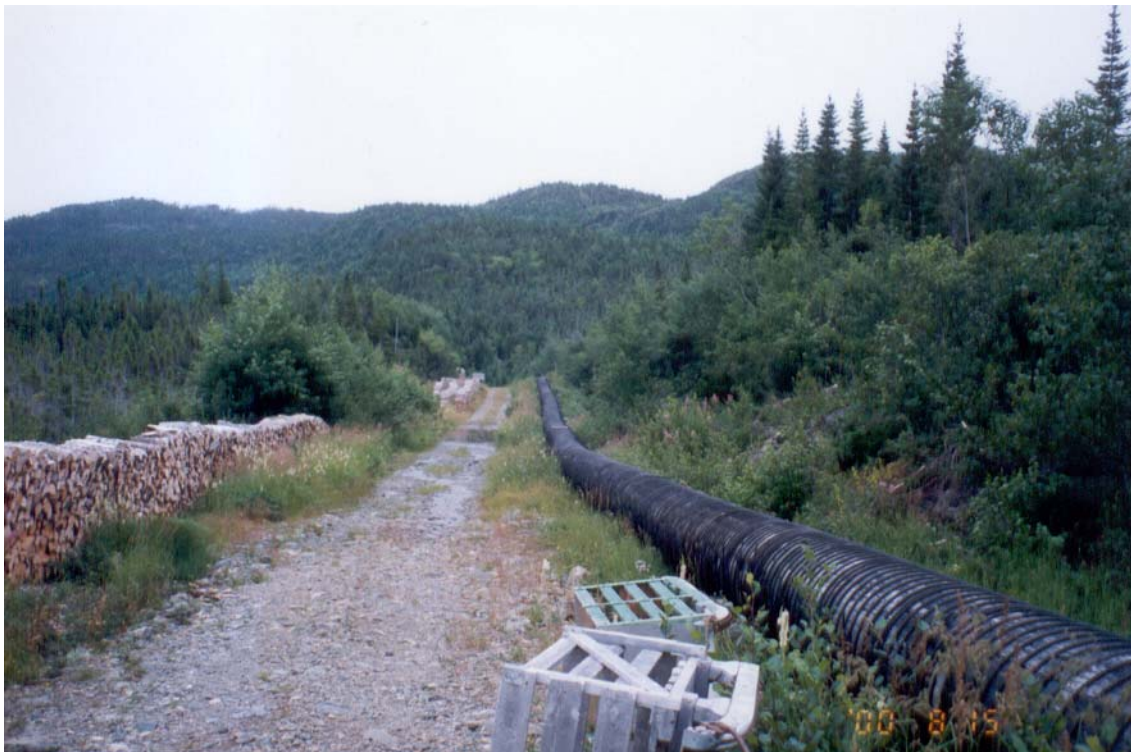
Photo #29: View of access road and firewood adjacent to penstock, August 2000.

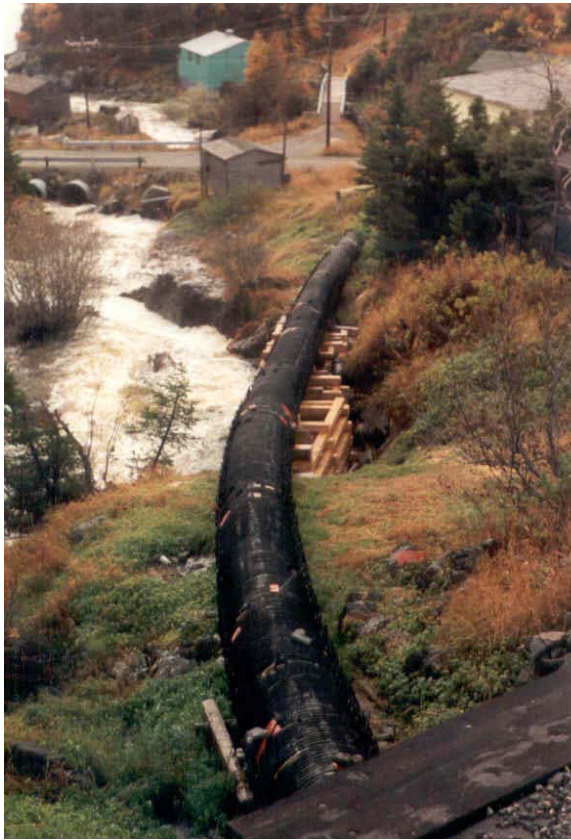
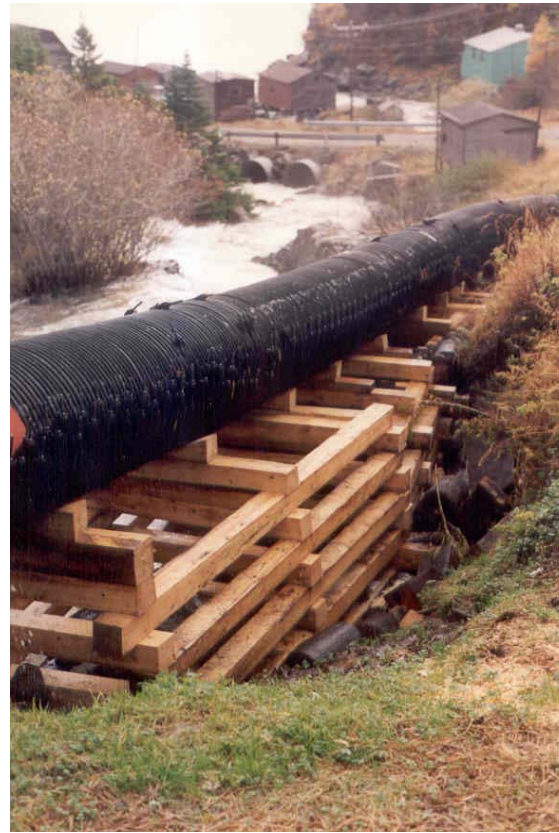
The lower section of the penstock passes under the main access road to the community and then proceeds along the side of a brook towards the powerhouse, refer to location #5 on map SA-2. In 1992 high water levels in the brook caused a section of the embankment under the penstock to erode. Untreated timber cribbing was installed along side of the brook to support the penstock, see photos #30 & #31. The timber support is 15 years old and is still subject to brook damage. The penstock has also developed a noticeable dip in elevation at this location resulting in more leaks.

Photos #30 & #31: Timber support added under penstock after erosion of embankment, October 1992.

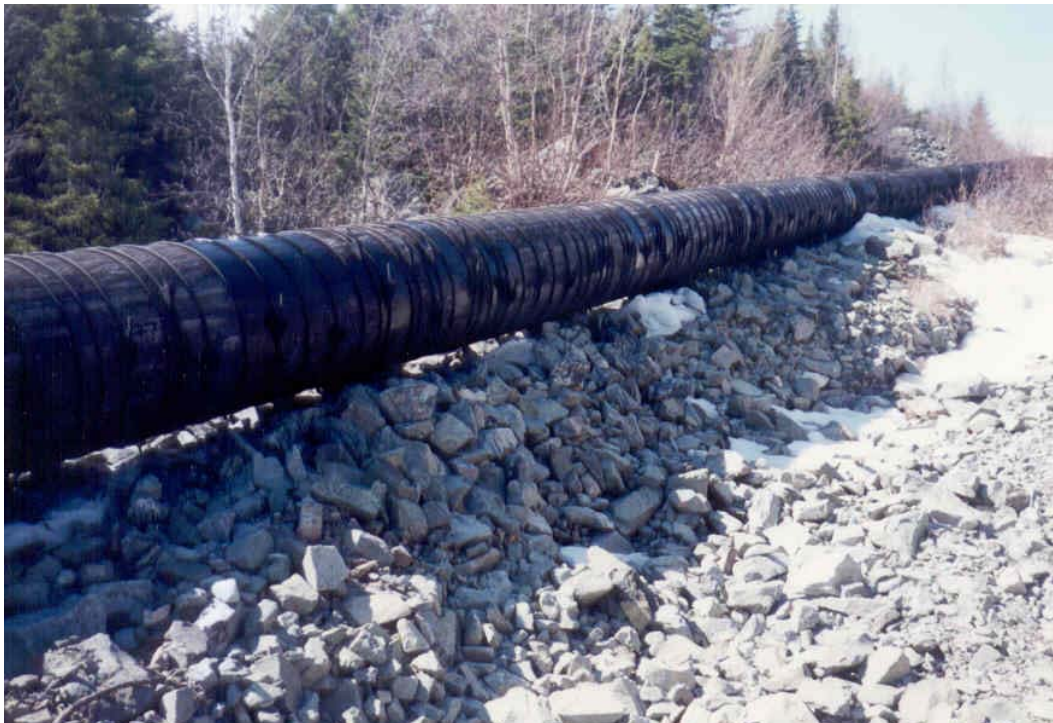
In 1996 water overtopped Snook's Arm main dam and caused flooding downstream. The flooding caused a 200 ft section of the access road to the Nugget Pond gold mine to be washed away. The flooding caused a significant amount of rock and debris to move downstream and adjacent to the penstock. Though, the majority of the rock debris was removed, however some of the rocks remain next to the penstock, see photos #32 & #33. This rock debris probably has and will continue to impose stresses on the penstock and, which over time, may displace the penstock transversely. Another similar event would likely have a major impact on this section of the aged and weakened penstock.

Photo #32: View of rocks and gravel washed up against penstock, April 1996.

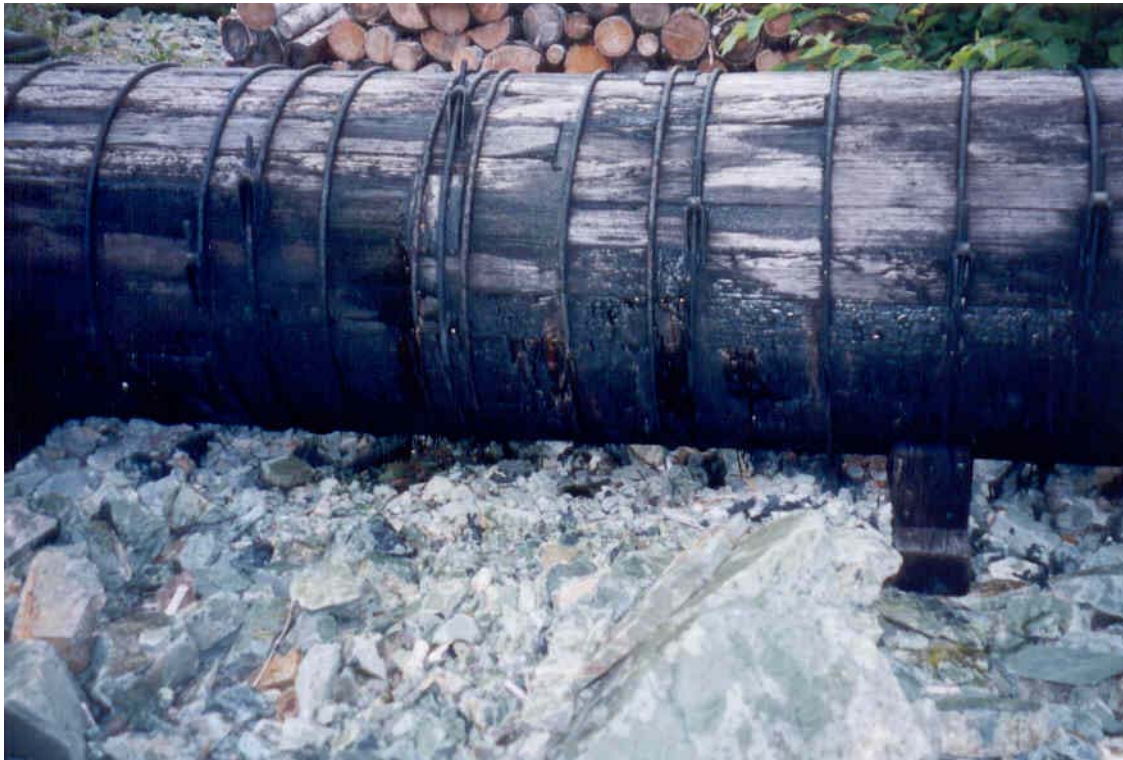
Photo #33: View of rocks and gravel under penstock, August 2000.

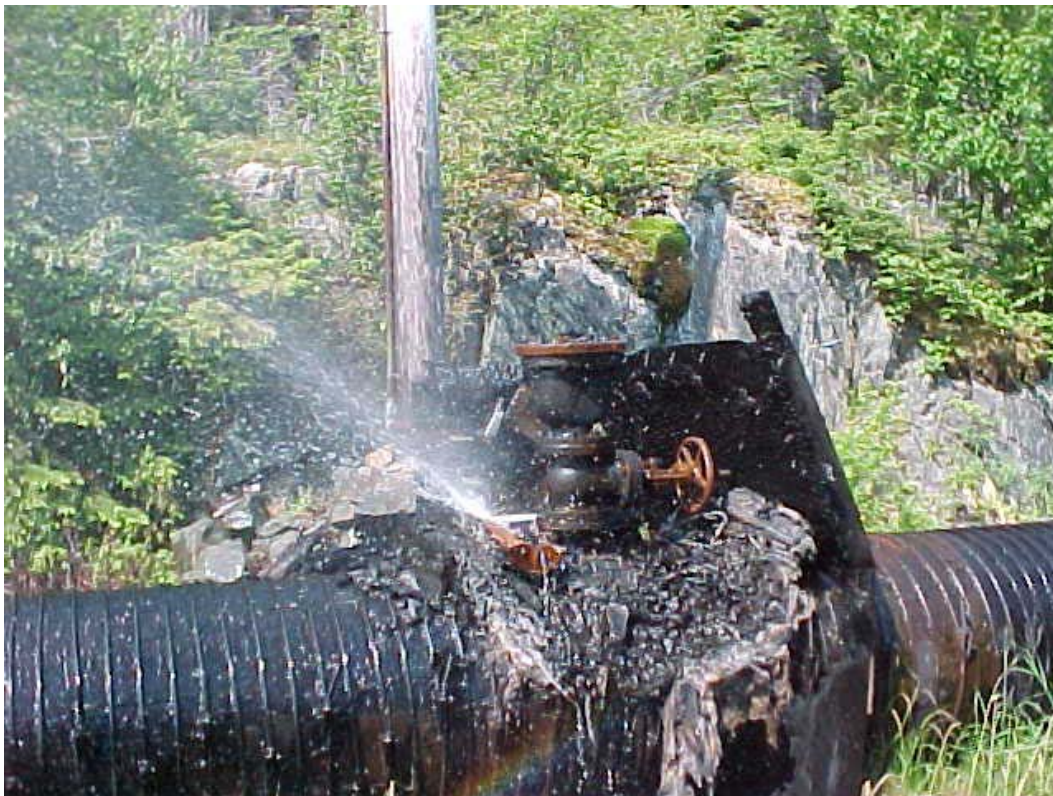
In 2002 a fire occurred in the valve enclosure around the vacuum breaker valve, see photos #34 & #35. The fire was caused by a malfunction of the heat tracing and caused the destruction of the valve enclosure and damage to the valve. Luckily, there was no apparent damage to the penstock. However, the vacuum breaker valve did require repair. And, as stated earlier, if this valve fails to operate when required, the penstock may collapse.

Photo 34: Fire damage to vacuum breaker valve enclosure, July 2002.

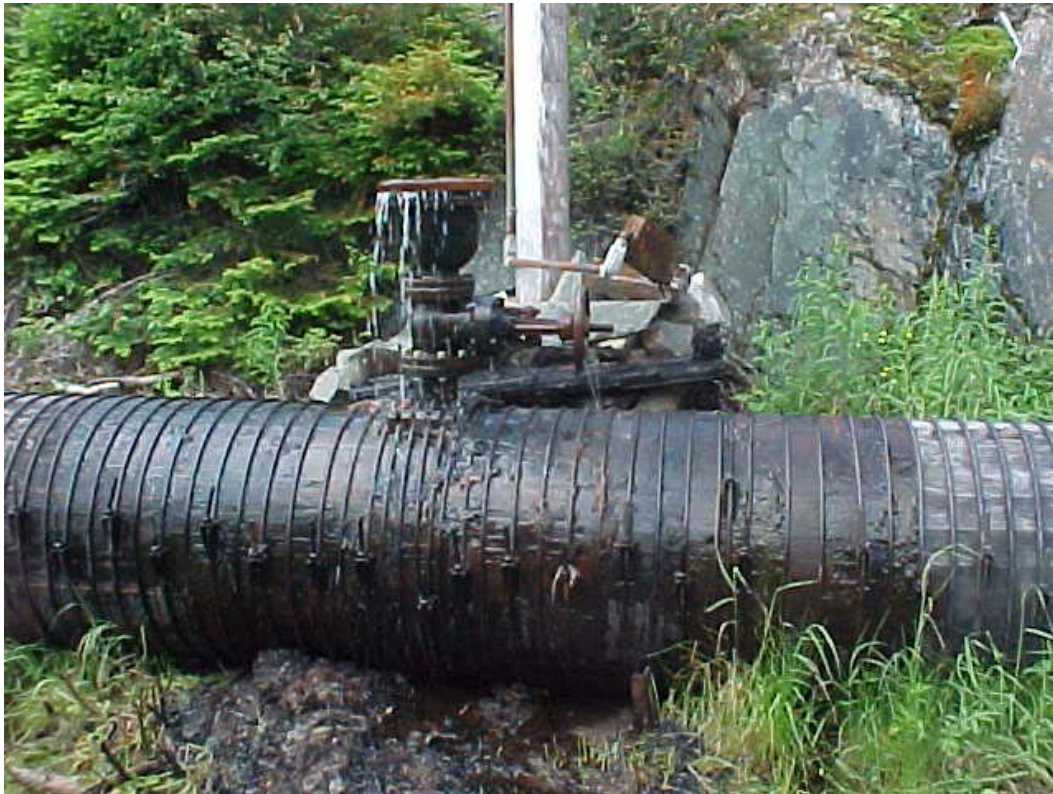
Photo 35: Vacuum breaker valve after fire, July 2002.
