Engineering Condition Assessment of the Corner Brook Frequency Converter

**Prepared by: Paul Nolan, P.Eng.
TRO Engineering Department
Newfoundland and Labrador Hydro
April 7, 2005**

ENGINEERING CONDITION ASSESSMENT

CORNER BROOK FREQUENCY CONVERTER

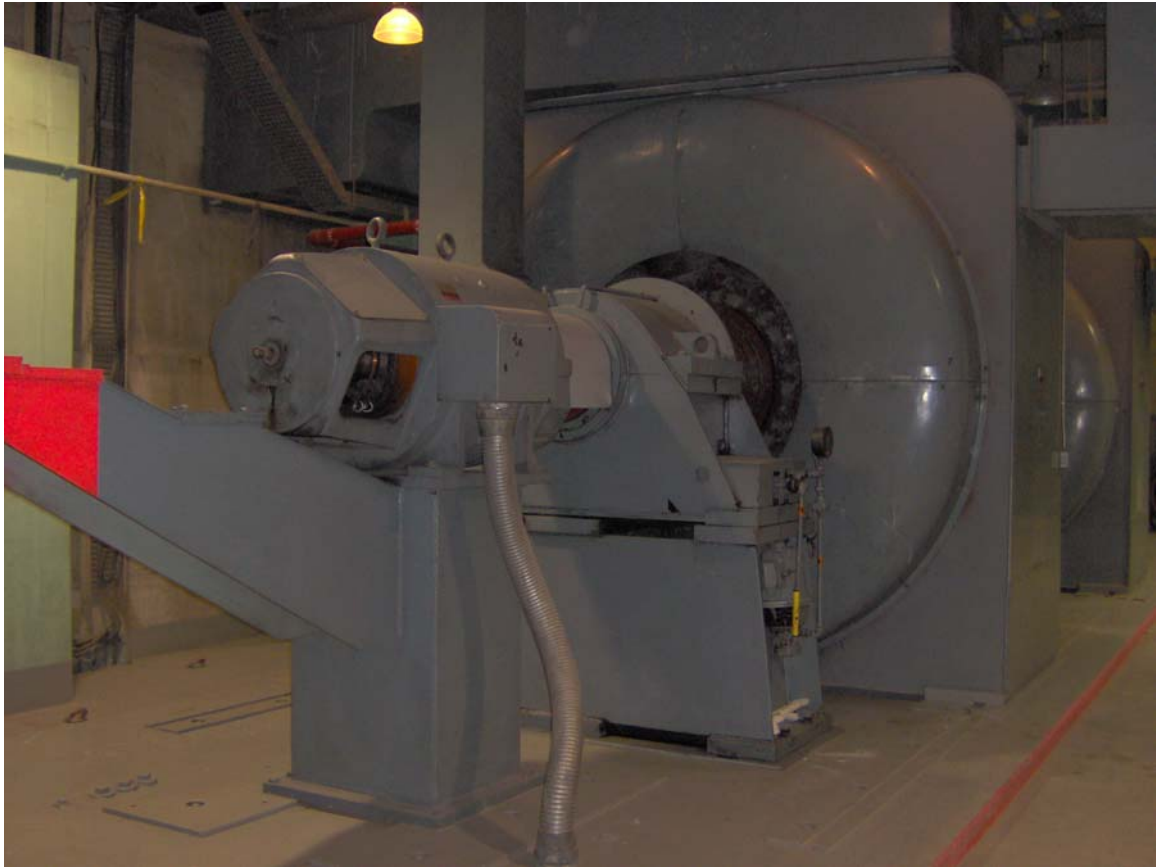
The insulation resistance value of the rotor windings is very low, in the order of 300 kohms. These low values are indicative of a failure within the next few years, but the failure could occur at any time. The rotors should therefore be rewound. Because the existing windings are asbestos insulated, the rewind will cost more than usual.

Figure 1 – 50 Hz Rotor (2005)

- The condition of the insulation of the rotors (especially the 50 Hz rotor) was identified by Acres as very low. This issue has not been addressed. The 50 Hz rotor should be rewound as soon as possible. (A thorough assessment of the Grand Falls unit should be performed in order to explore the option of rewinding this unit as a replacement to the Corner Brook unit. This would decrease the length of the outage.) During this rewind, a thorough assessment of the other rotating equipment should be conducted.

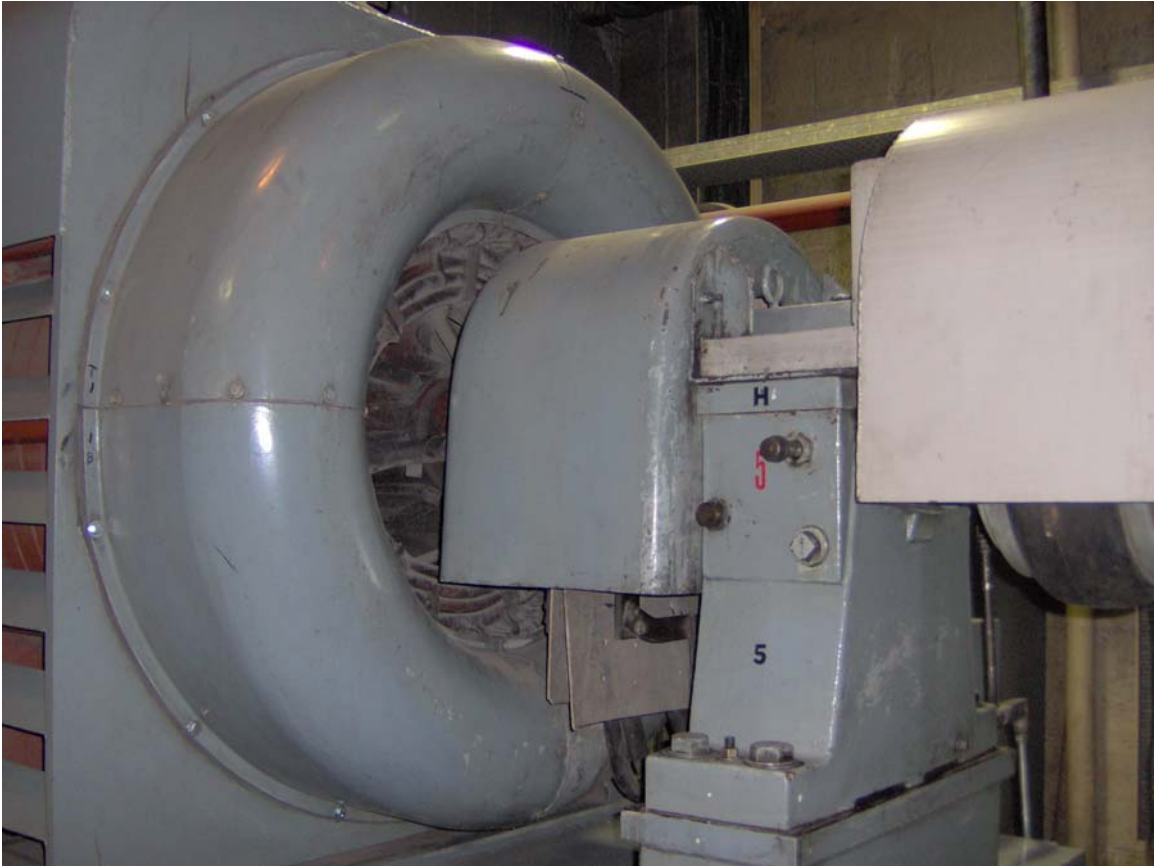
Figure 2 – 60 Hz Rotor (2005)

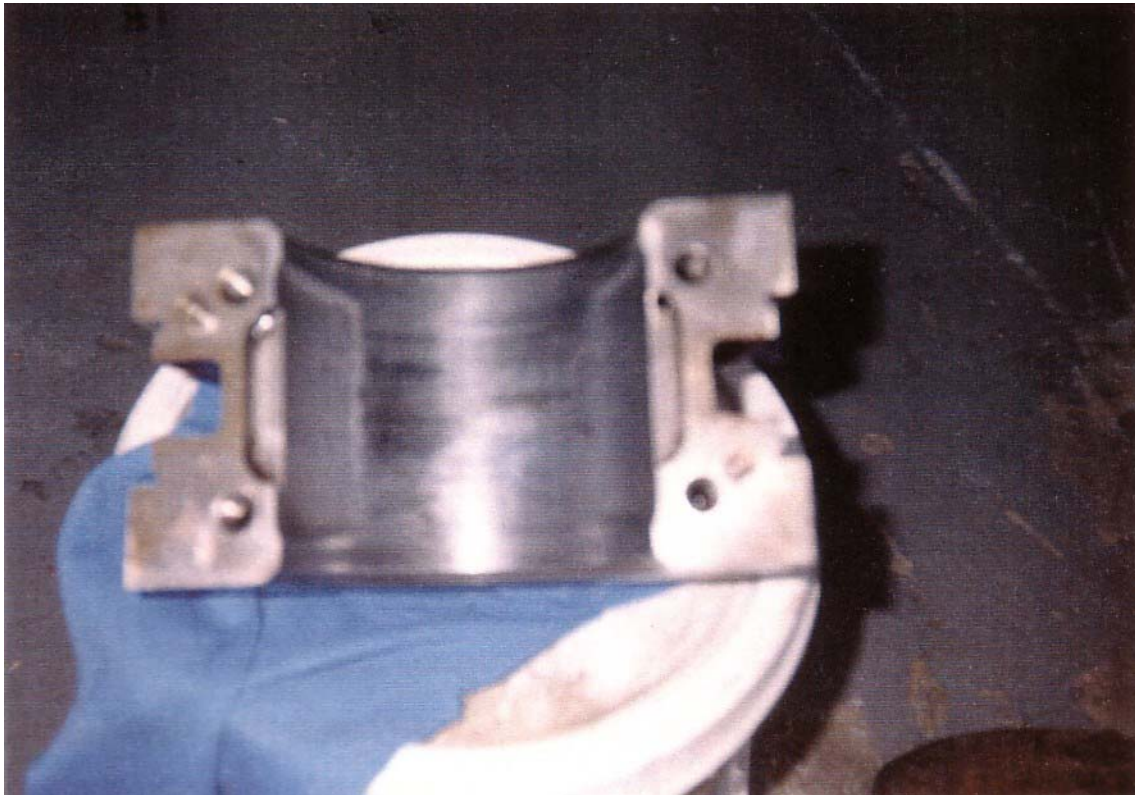
The pedestal bearing has been wiped and should be replaced.

It is incorrect to state that this bearing has been wiped. This bearing has been partially wiped. A wiped bearing would likely cause damage due to contact between the shaft and the bearing shell. A machine cannot be operated with a wiped bearing.

Figure 3 – Top Half of the Pedestal Bearing (1998)

The bearing should be replaced as soon as possible. It is running at higher than normal temperatures, as evidenced by the condition of the oil, and bearing failure is possible. This could cause shaft damage and a lengthy outage.

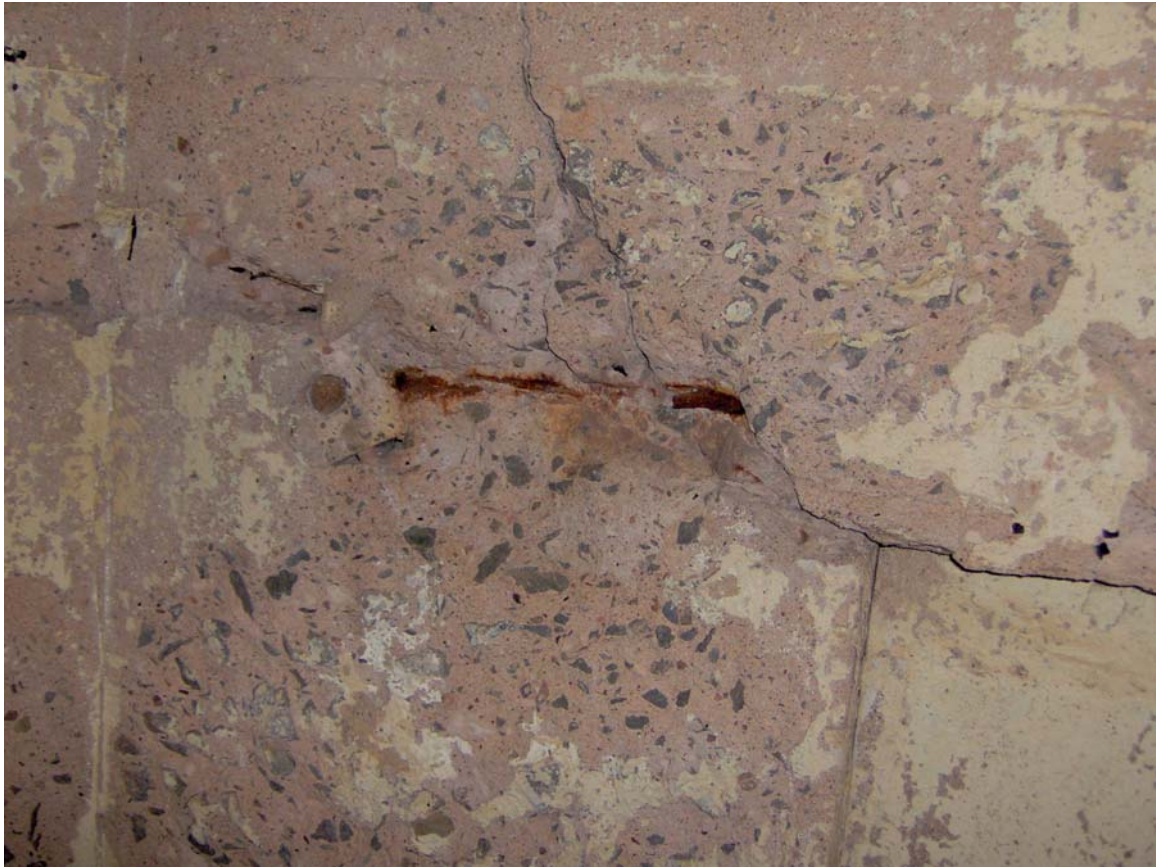
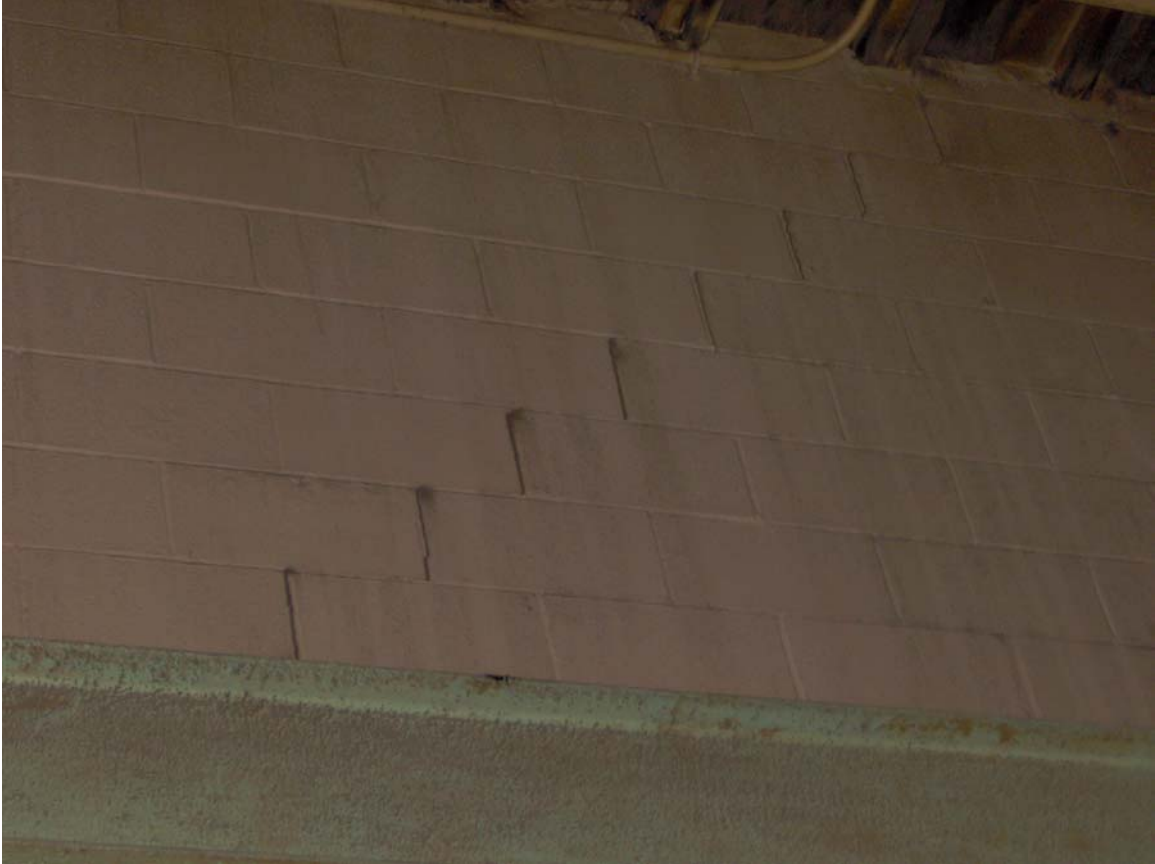
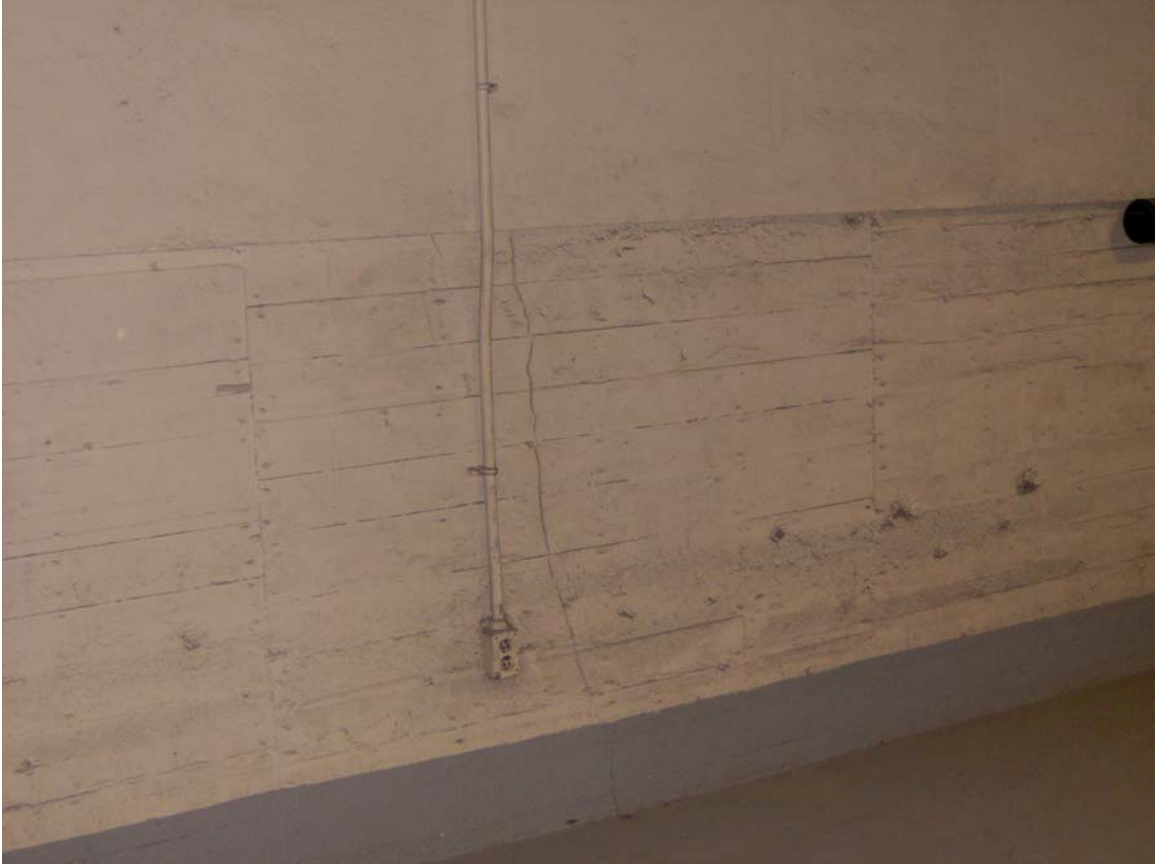
The building requires repair. Concrete and bricks have fallen from the roof and building sides and damaged the bushings and post insulators. Building cracks have allowed entrance of the wood debris associated with operation of the paper mill. The ceiling in the stairwell is temporarily repaired using a sheet of plywood. This should be permanently repaired.

Repairs have been made to the roof and stairwell ceiling. Caulking has been applied to building cracks when possible to decrease the ingress of dirt and dust. The overall condition of the building remains poor.

Figure 4 – Example of Crack in Wall (2005)

Figure 5 – Example of Crack in Wall (2005)

Figure 6 – Example of Crack in Wall (2005)

Repairs to the concrete and masonry (\$5,000 estimate) should be done as soon as possible.

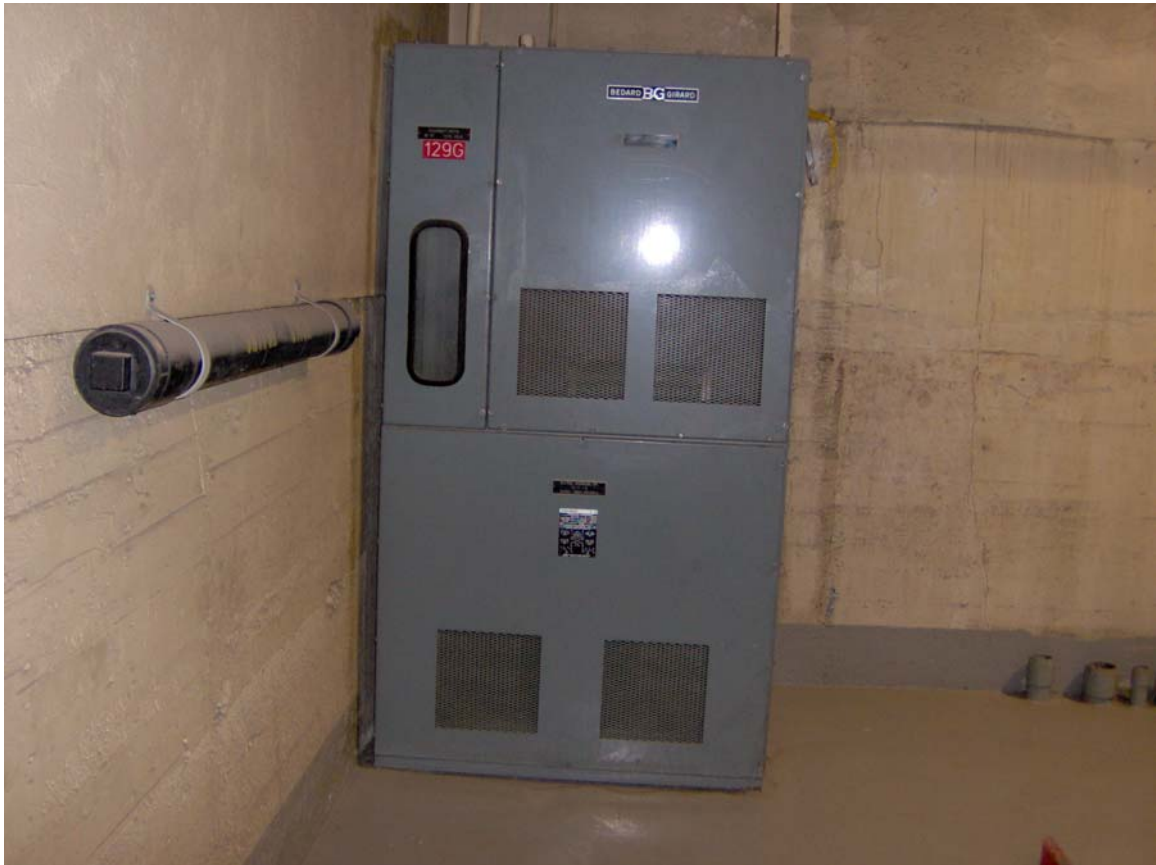
The neutral grounding transformers are oil insulated and should be replaced by dry type transformers.

This issue has not been addressed.

The risk of an oil leak from these transformers is small. A dry type transformer would be more susceptible to problems caused by the accumulation of dust and dirt.

Figure 7 – Neutral Grounding Transformer (2005)

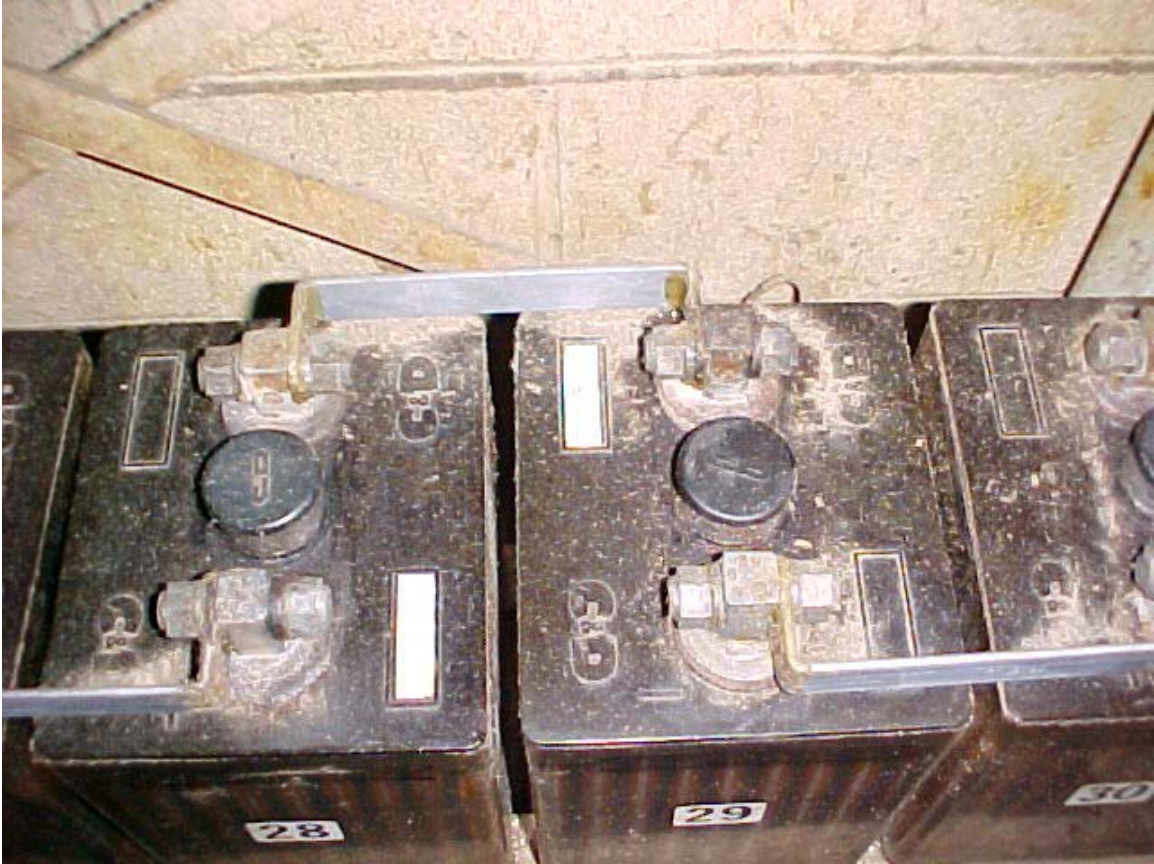
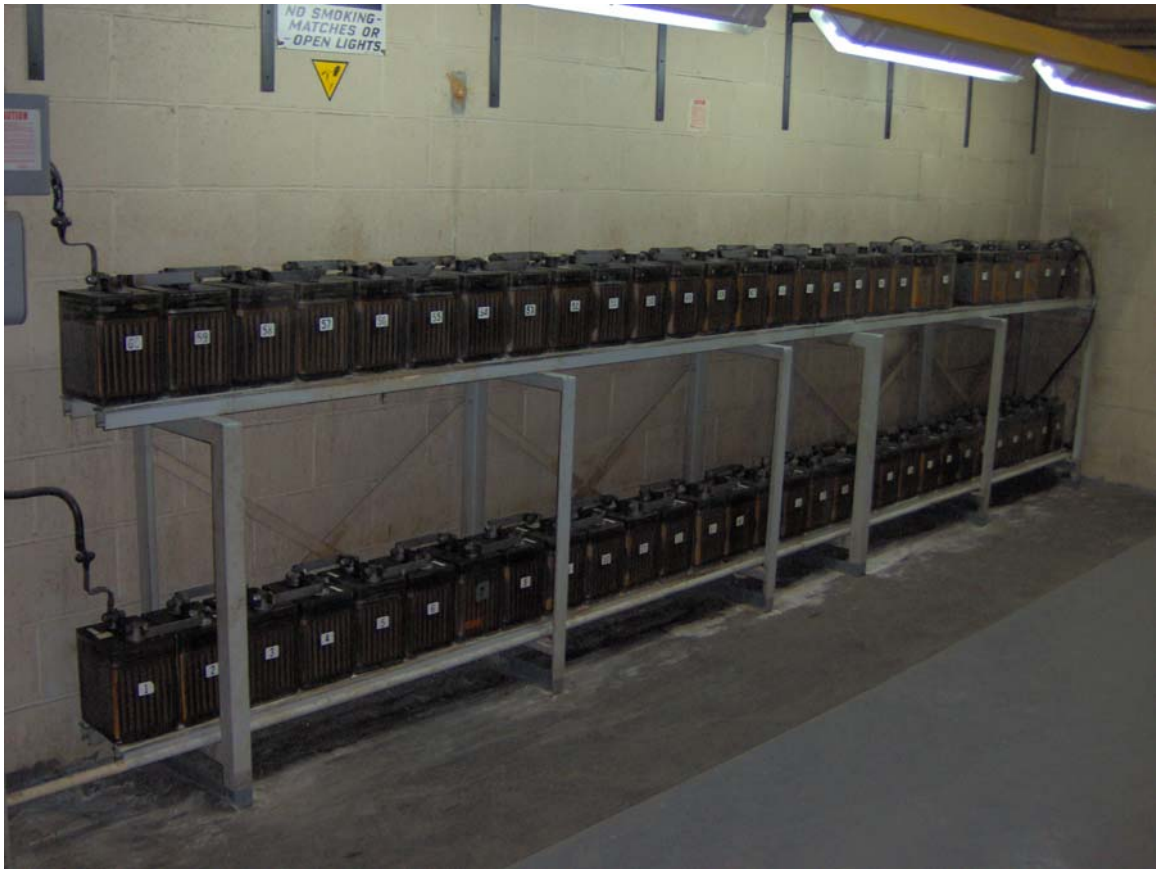
The batteries should be enclosed and measures taken to control and exhaust hydrogen gases.

An overhead shield and lighting has been installed. The hydrogen gases from the bank are not being exhausted. The battery bank is scheduled for replacement in 2005 under a capital project ("Replace Battery Banks – Various Stations and Lines"), which also includes the replacement of several other battery banks. The total project cost is \$165,700. The cost of replacing the Corner Brook frequency converter's battery bank is roughly \$40,000. The building's ventilation system, in addition to providing cooling air for the transformers and converter, exhausts hydrogen gases from the battery bank.

Figure 8 - Close-up of Battery Bank (2001)

Figure 10 – Battery Bank {Scheduled For Replacement} (2005)

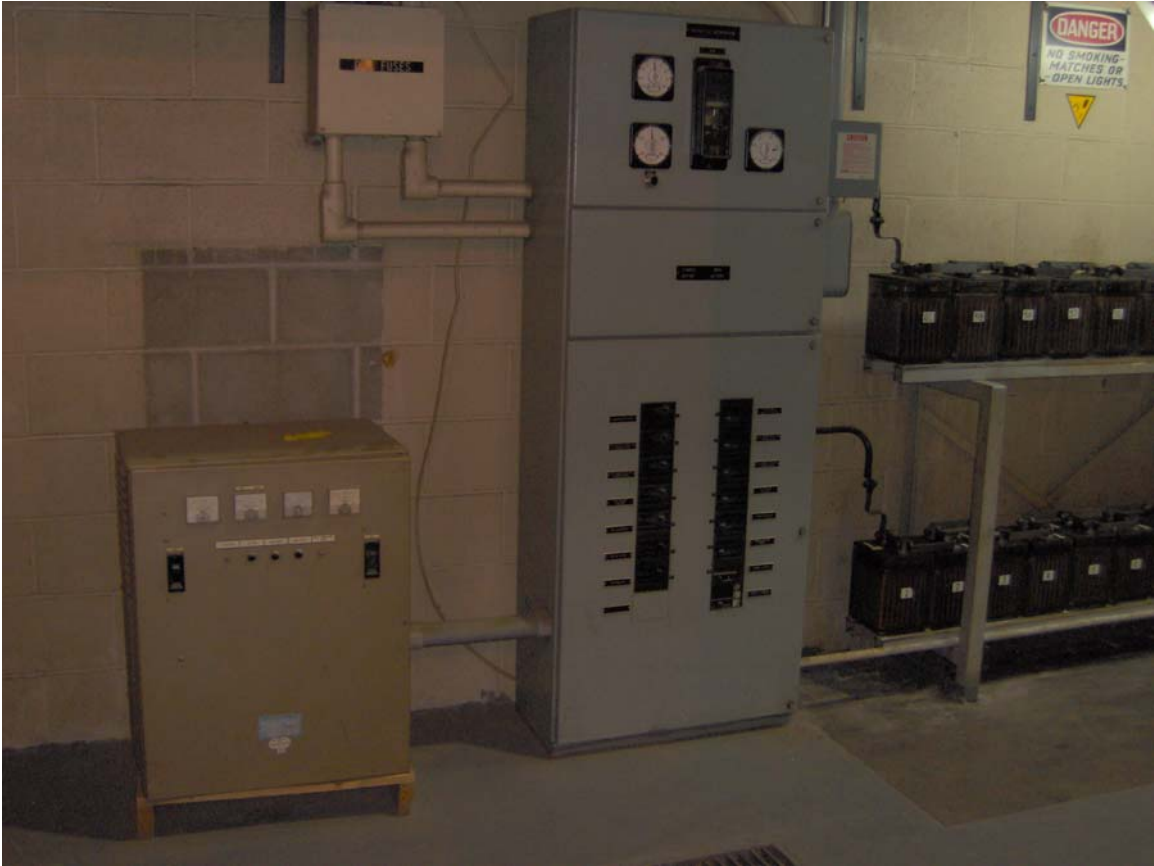
Figure 9 – Battery Charger & DC Panel (2005)

- The existing battery charger is nearing the end of its service life. The cost of replacing this unit is approximately \$10,000. This work should proceed, if justified.

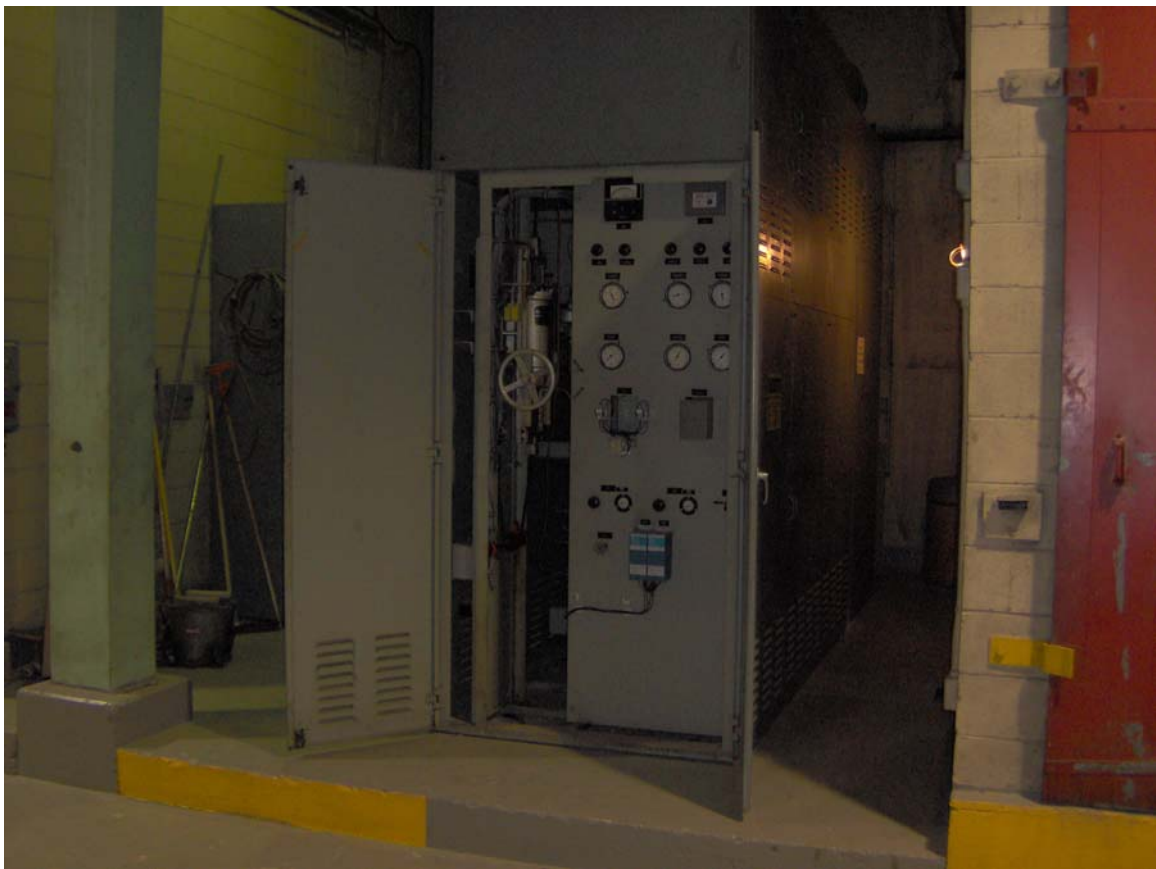
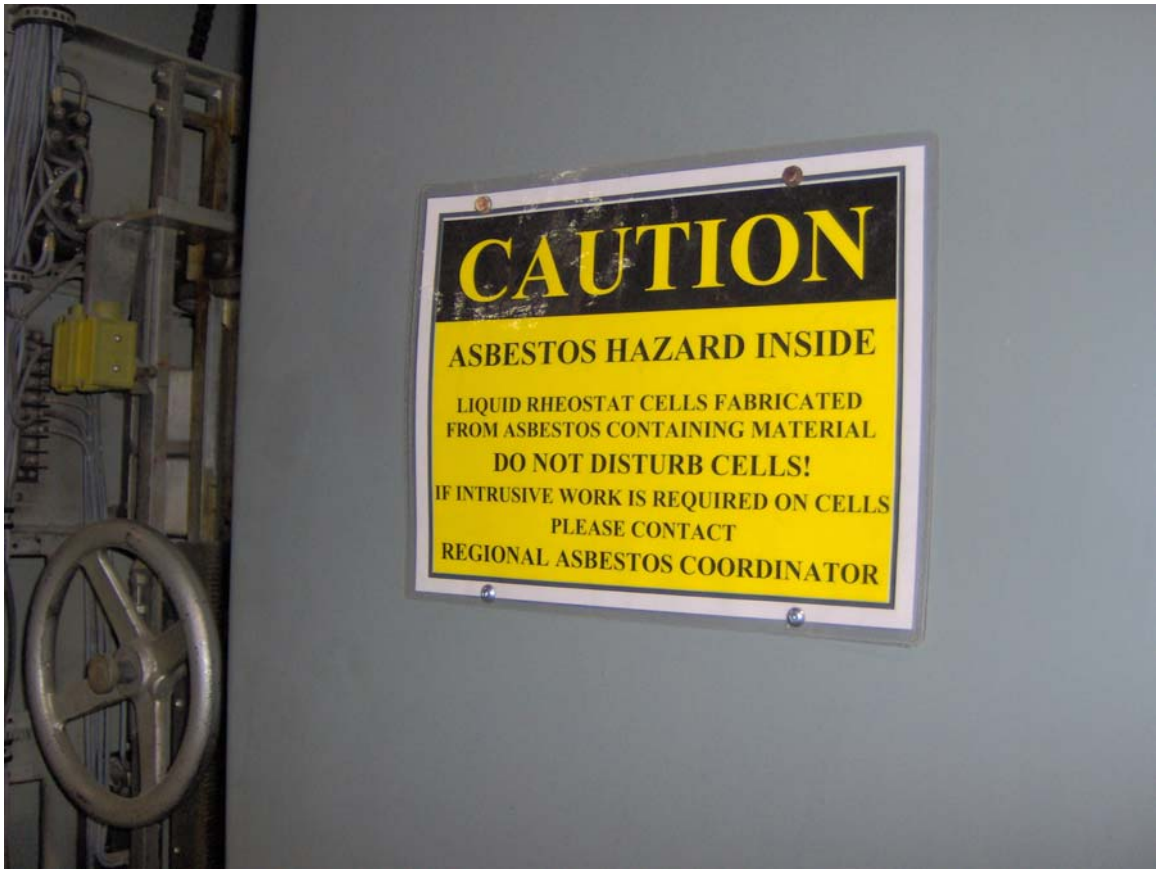
The building and piping asbestos insulation has been removed. The chamber of the liquid rheostat is asbestos lined and is still in service.

Figure 11 – Liquid Rheostat (2005)

Figure 12 – Liquid Rheostat Asbestos Warning Sign (2005)

This site has been identified under Hydro's Asbestos Abatement Program and is scheduled to be inspected this summer. The results of the inspection will determine the course of action required by Hydro.

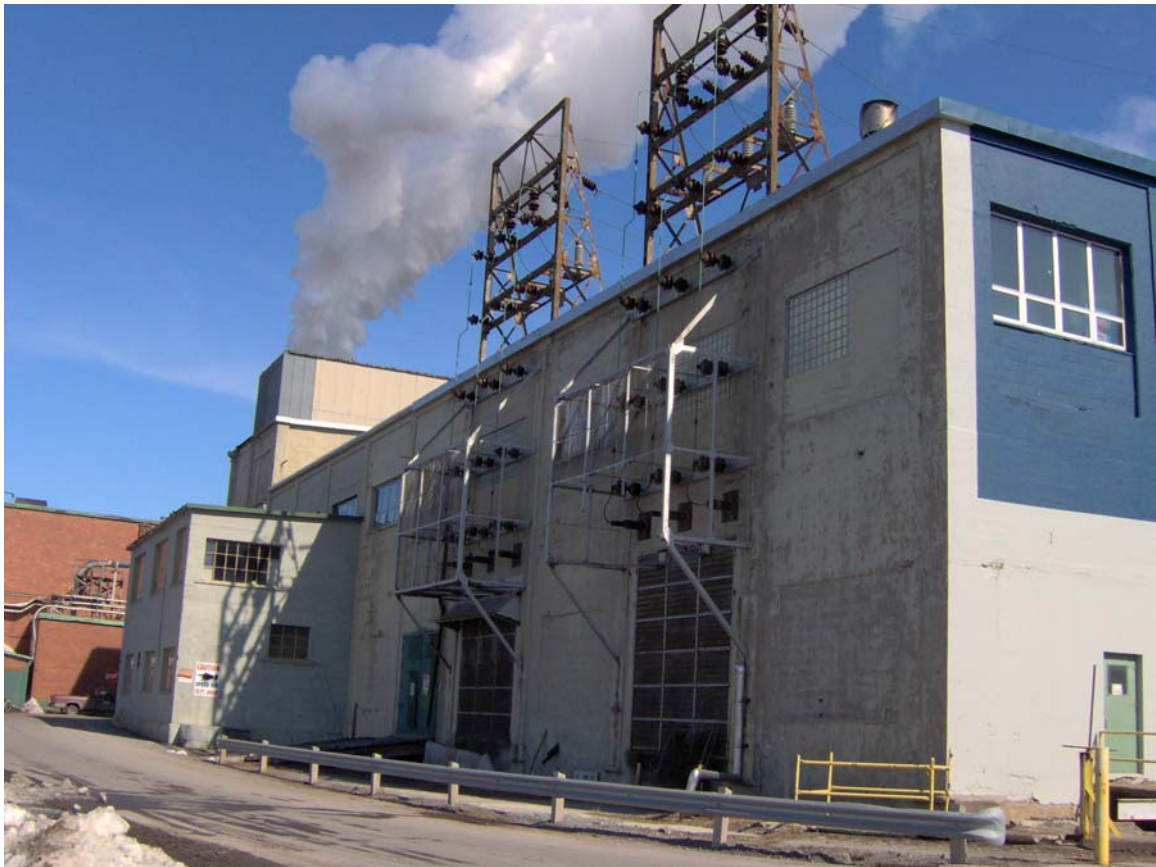
Operations are beginning to address the condition of the steel take-off towers and insulators this year. The take-off towers will be painted (cost estimate = \$6400) and the 66 kV pin cap and suspension insulators will be replaced (cost estimate = \$19,450).

The entrance bushings for the 500 mcm conductor to transformer T2 are damaged and should also be replaced (cost estimate = \$12,200 for each of the twelve bushings). These bushings are not scheduled for replacement this year.

Figure 13 – Towers and External 66 kV Bus (2005)

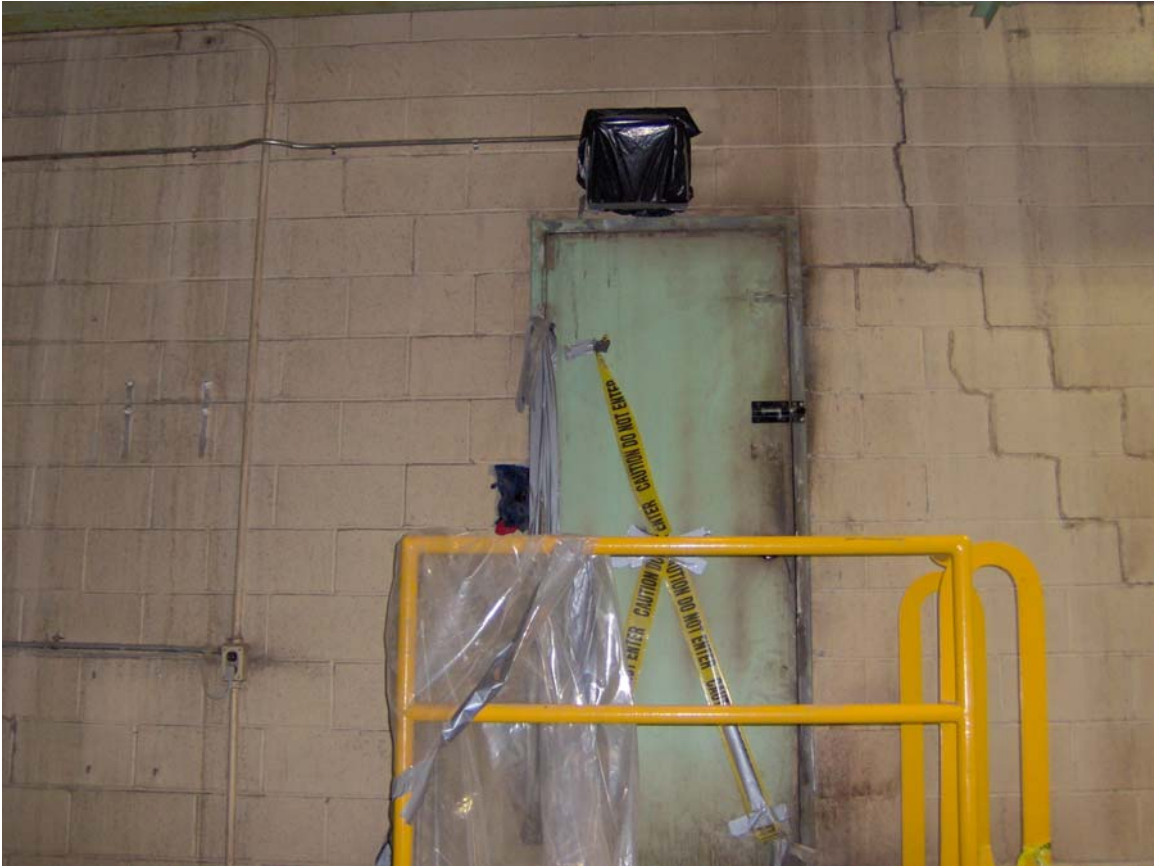
- The bearing on the starting motor has an oil leak. This should be investigated and replaced if necessary.
- The emergency exit door from the upstairs switchgear area was damaged during a fire and should be repaired.

Figure 14– Emergency Exit from Switchgear Floor (2005)

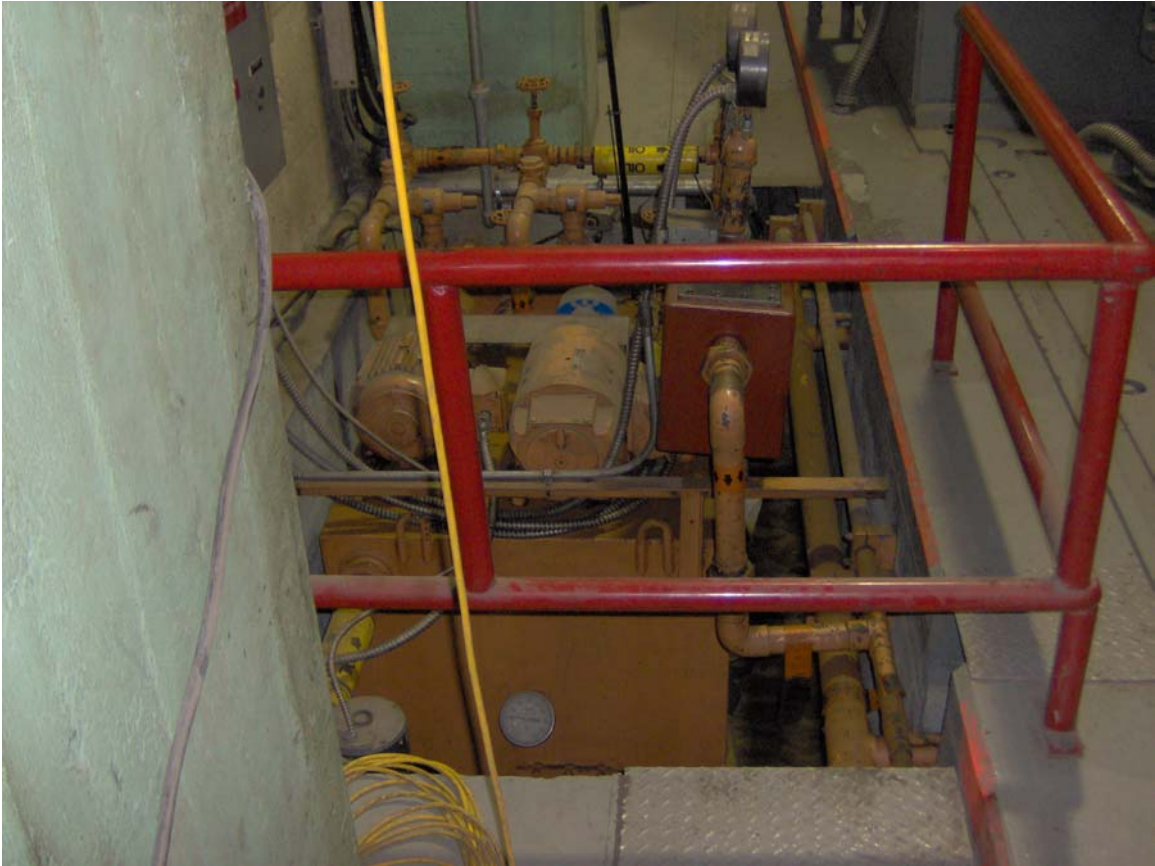
- The main lube oil pump is nearing the end of its service life. The cost of replacing this pump is estimated to be \$7,000. This work should be budgeted and completed within the next couple of years.

Figure 15– Main Lube Oil Pump (2005)

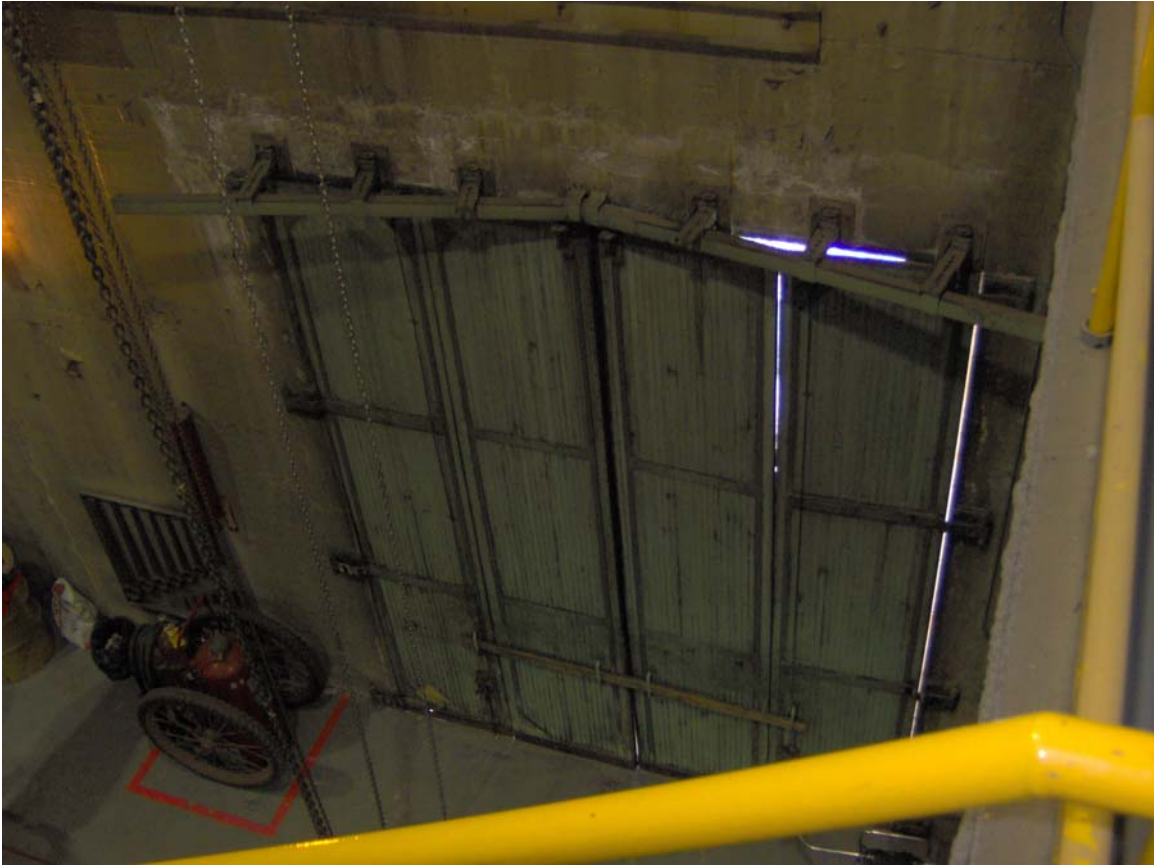
- The main door to the converter area is in poor condition and should be replaced (budget estimate is \$5,000). The four personnel doors are in poor condition and should also be replaced (budget estimate is \$4,000). The existing fireproof transformer doors require upgrading (budget estimate is \$2,000).

Figure 21 – Main Door To Converter Area (2005)

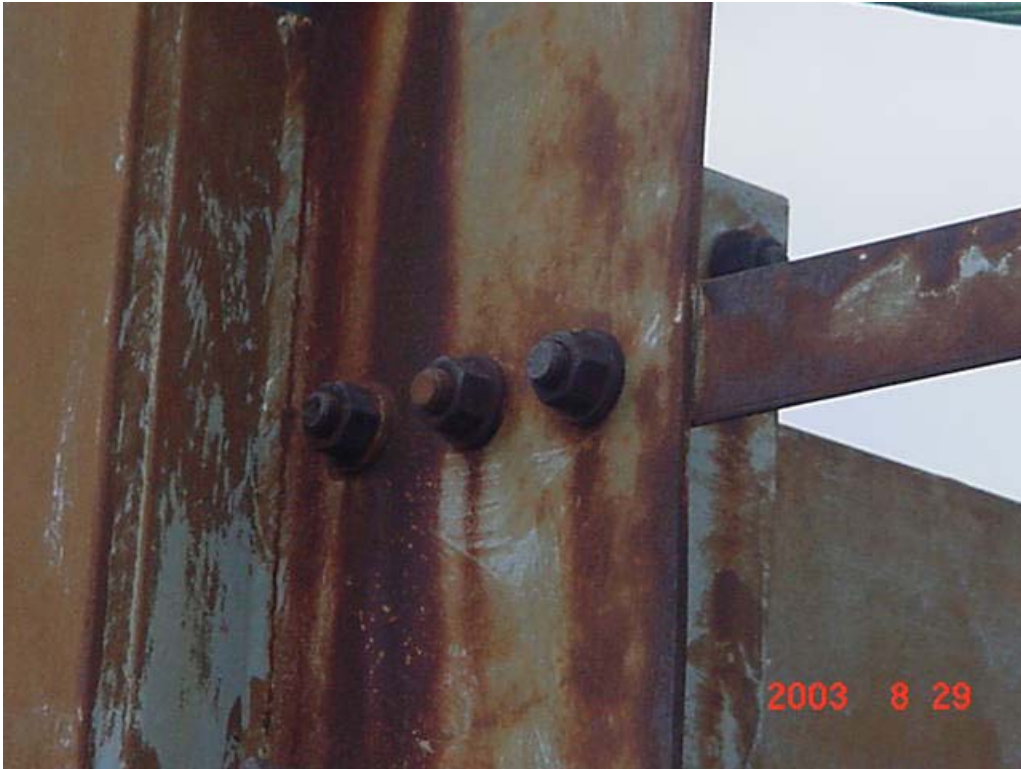
Both towers are in good condition, including the bolted connections and leg anchors. Approximately 80 percent of the surface area of both towers is lightly corroded with some signs of mild pitting. Although maintenance of these steel towers is not urgent, it is recommended that a protective coating be applied to prevent any further deterioration of the structural steel. A two to three year delay in carrying out this maintenance would be acceptable.

Take Off Tower for T1, bolted connection, leg to horizontal brace, light corrosion.

As a protective coating, it is recommended that a good quality zinc or aluminium rich self priming paint be used. Surface preparation shall be in accordance with the SSPC-SP-2 standard (hand tool cleaning). Hydro currently stocks a high quality product that would be suitable for use on the towers. This product is Galvacon GC-243 cold galvanizing compound, however, it is quite expensive at \$232.00 per gallon.

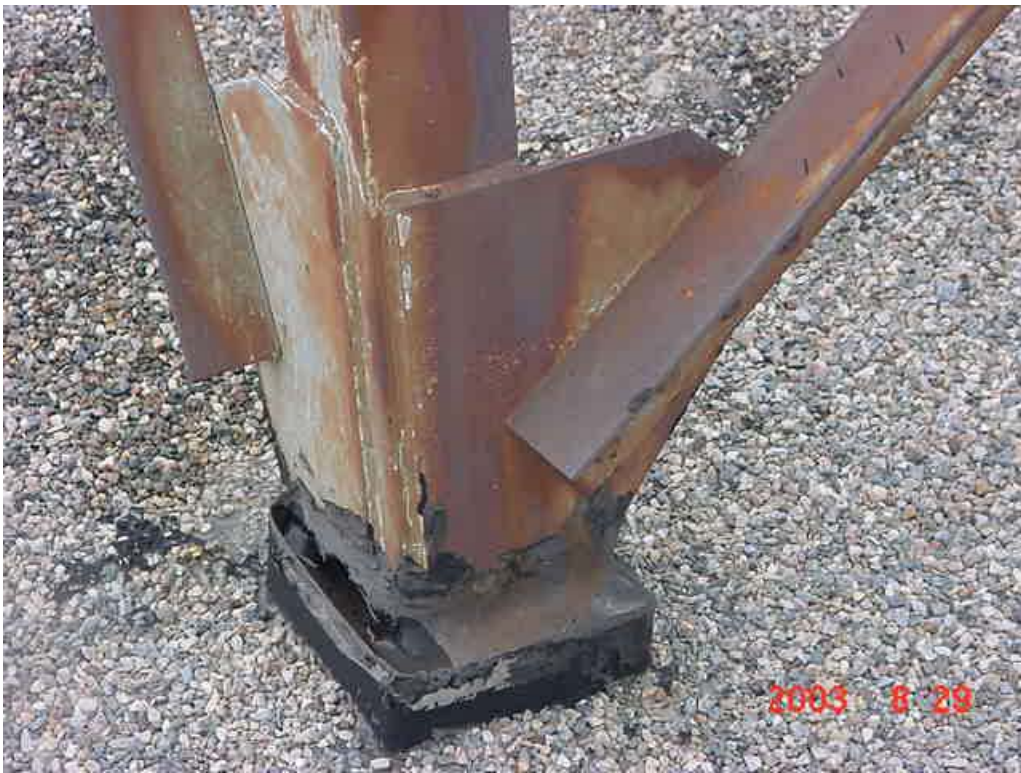
Take Off Tower for T2, leg anchor, light corrosion and mild pitting.

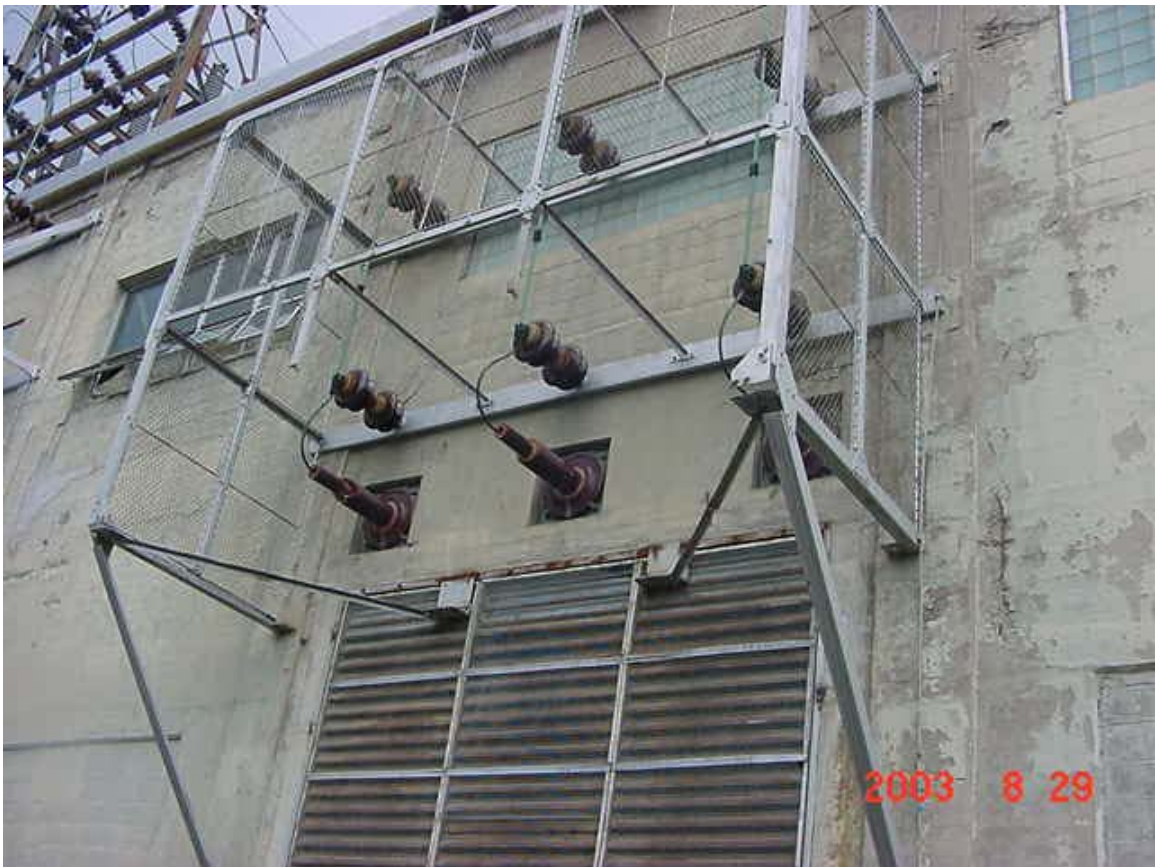
Last year, in order to facilitate the removal of T2 from the Frequency Converter Building, part of the protective structure that prevents the incidental contact between the 66 kv Bus and Mill Personnel/Equipment was removed. For safety reasons it is recommended that this structure be reinstated to its original condition as soon as possible. See drawing No. 401-S-16-Rev. 2.

Protective Structure for T2 External 66 kv Bus, steel frame and wire mesh removed.

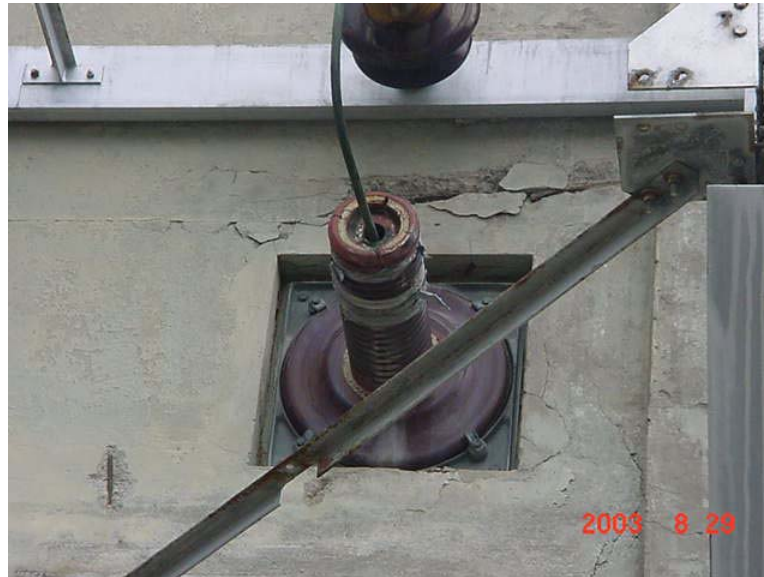
Both A and C phase entrance insulators for the 500 MCM Conductor leading to T2 have sustained considerable physical damage, resulting in reduced leakage distances and an increased probability of flashover. It is recommended that both A and C phase insulators be replaced as soon as a suitable substitute can be found. The existing insulators are vintage 1966, Canadian Porcelain, 69 kv, 350 BIL, catalogue No. 1216. Dave Hicks of TRO Engineering has been contacted for assistance in locating the replacement insulator.

Damaged A phase entrance insulator.

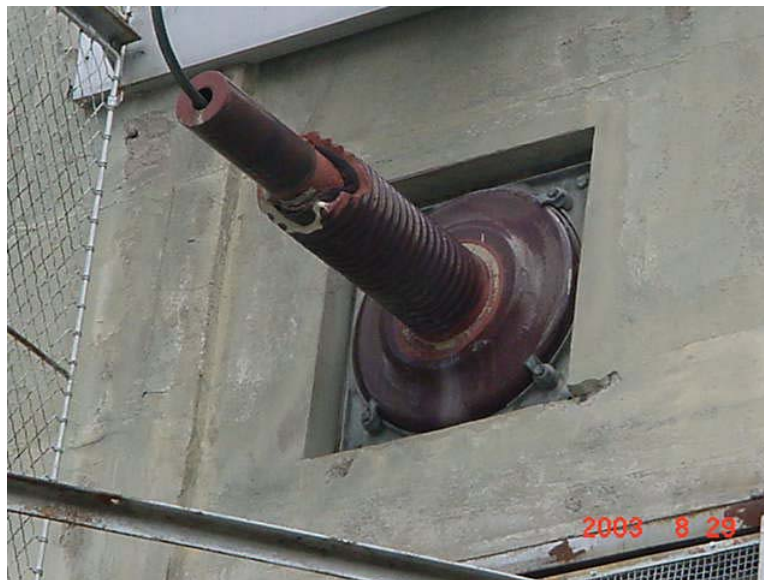
Damaged C phase entrance insulator.

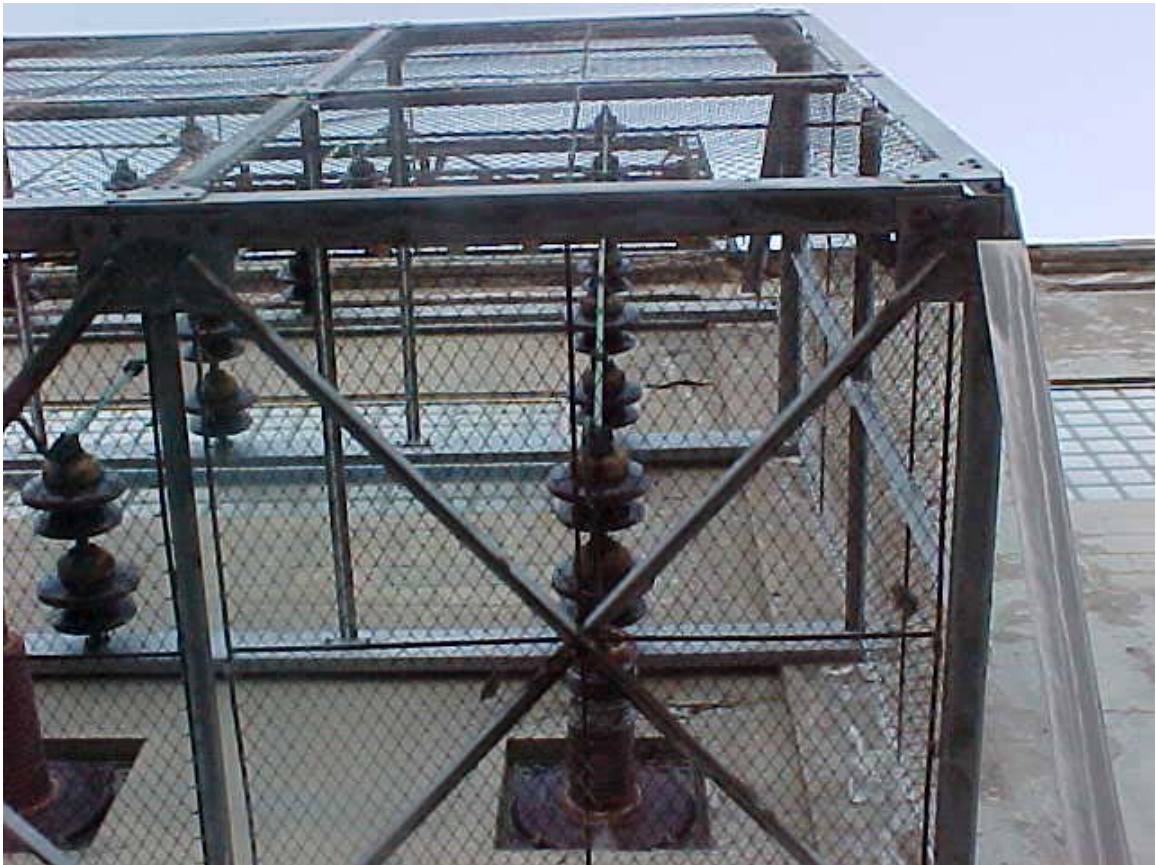
The current 66 kv Bus arrangement on the frequency converter building is supported by C.O.B. pincap and suspension insulators. These types and make of insulators have been failing at an ever increasing rate in many of our terminal stations, distribution, and transmission lines. Therefore, it would be prudent to consider changing out these insulators within the next several years. The pincap insulators are vintage 1966, C.O.B., catalogue No. 37769 (double units), 36 units would require replacement. The suspension insulators are vintage 1966, C.O.B., ball and socket type, catalogue No. 32436. 12 strings of 5 units would require replacement. Hydro currently stocks suitable station post and suspension type insulators for this work.

C.O.B. pincap insulators, 66 kv Bus CBPPL frequency converter building.
