Engineering Condition Assessment of the Corner Brook Frequency Converter

**Prepared by: Paul Nolan, P.Eng.
TRO Engineering Department
Newfoundland and Labrador Hydro
April 7, 2005**

ENGINEERING CONDITION ASSESSMENT

CORNER BROOK FREQUENCY CONVERTER

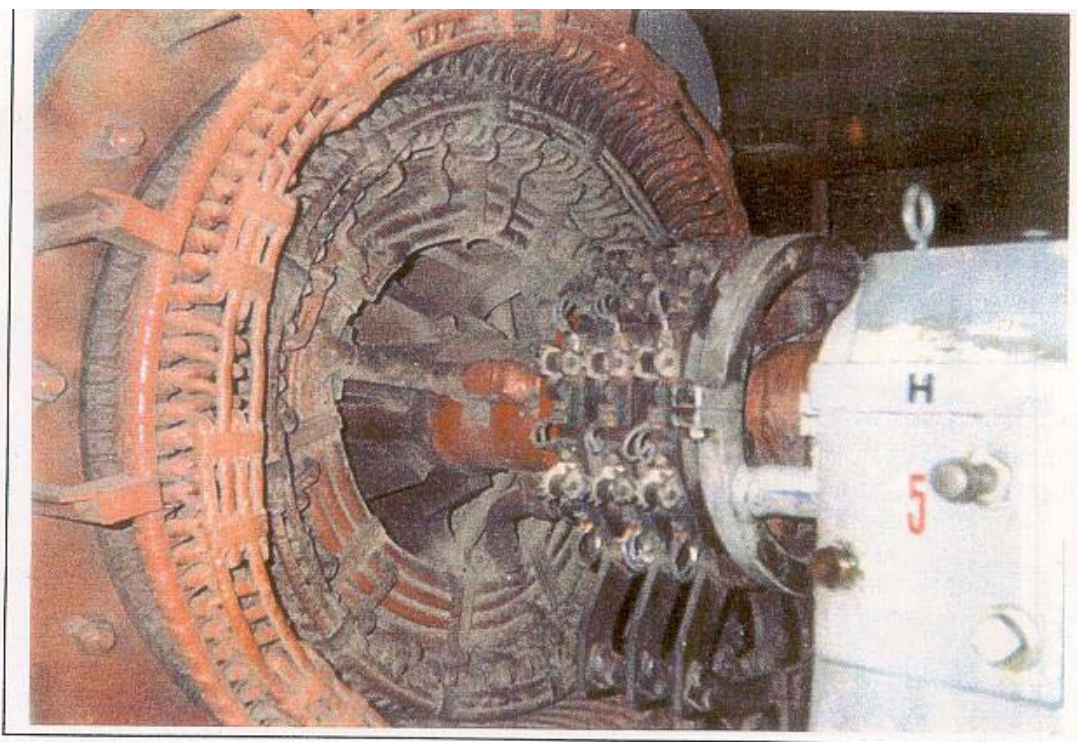
Photo 1: Dust and dirt on the machine windings and rotor - August 19, 1998

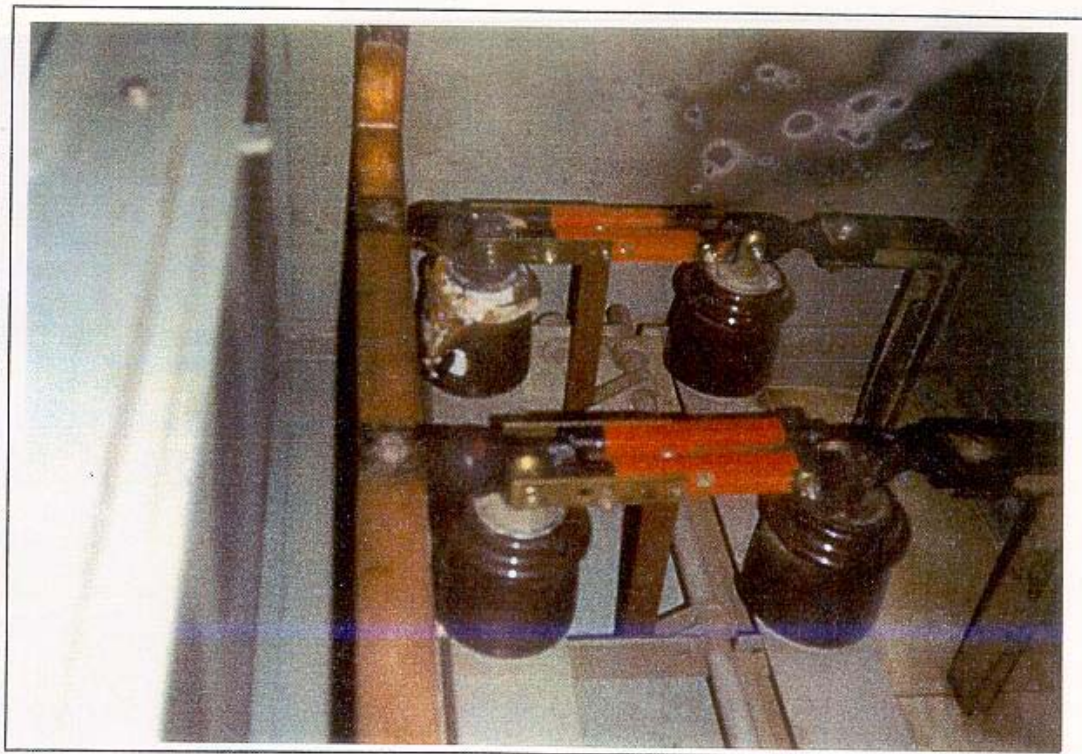
Photo 2: Arcing and burning found in cubicle - August 19, 1998

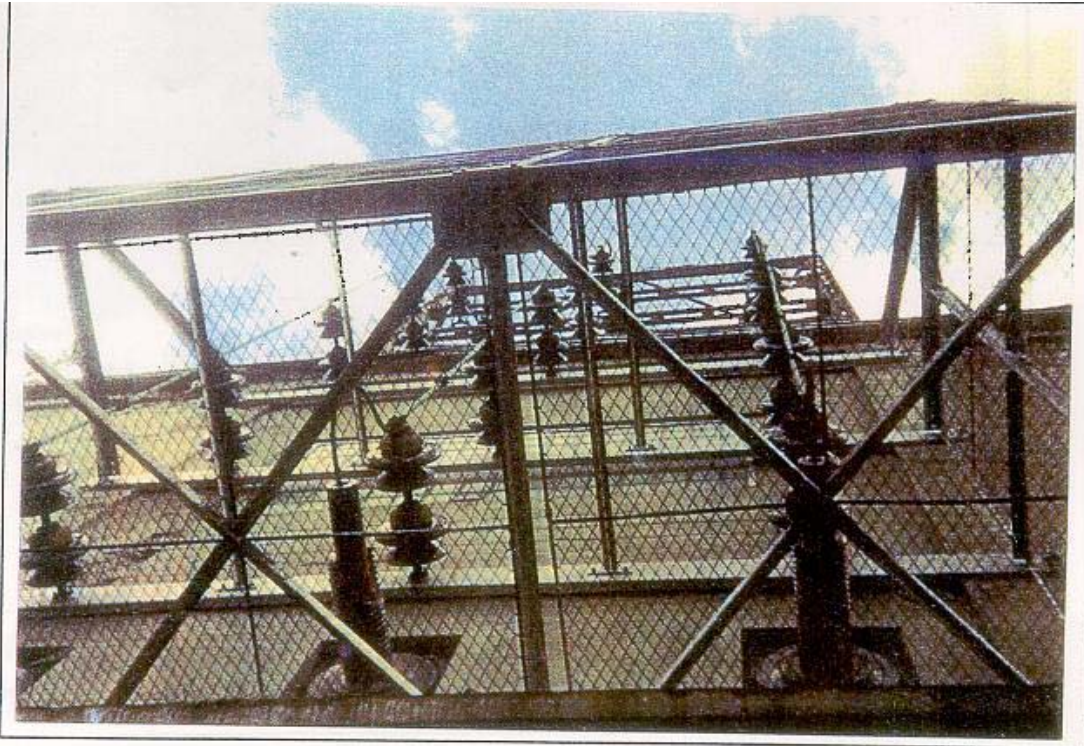
Photo 3: Damaged bushings outside the converter building - August 19, 1998

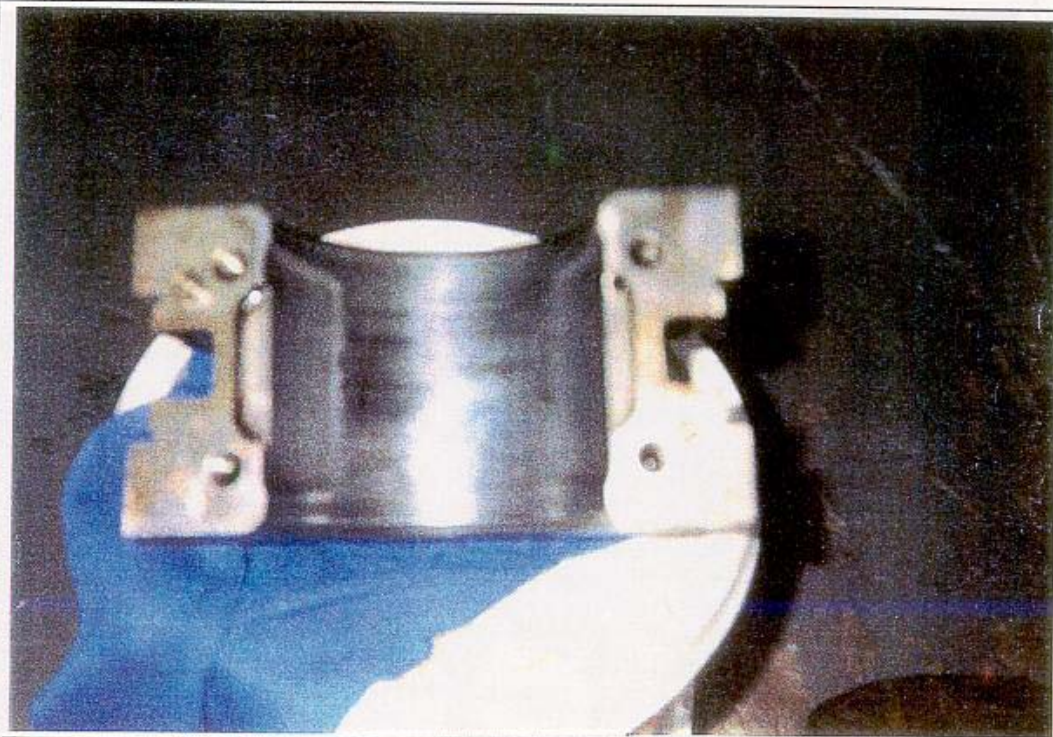
Photo 4: Shows scoring that has occurred on the pedestal bearing which has failed
- August 19, 1998

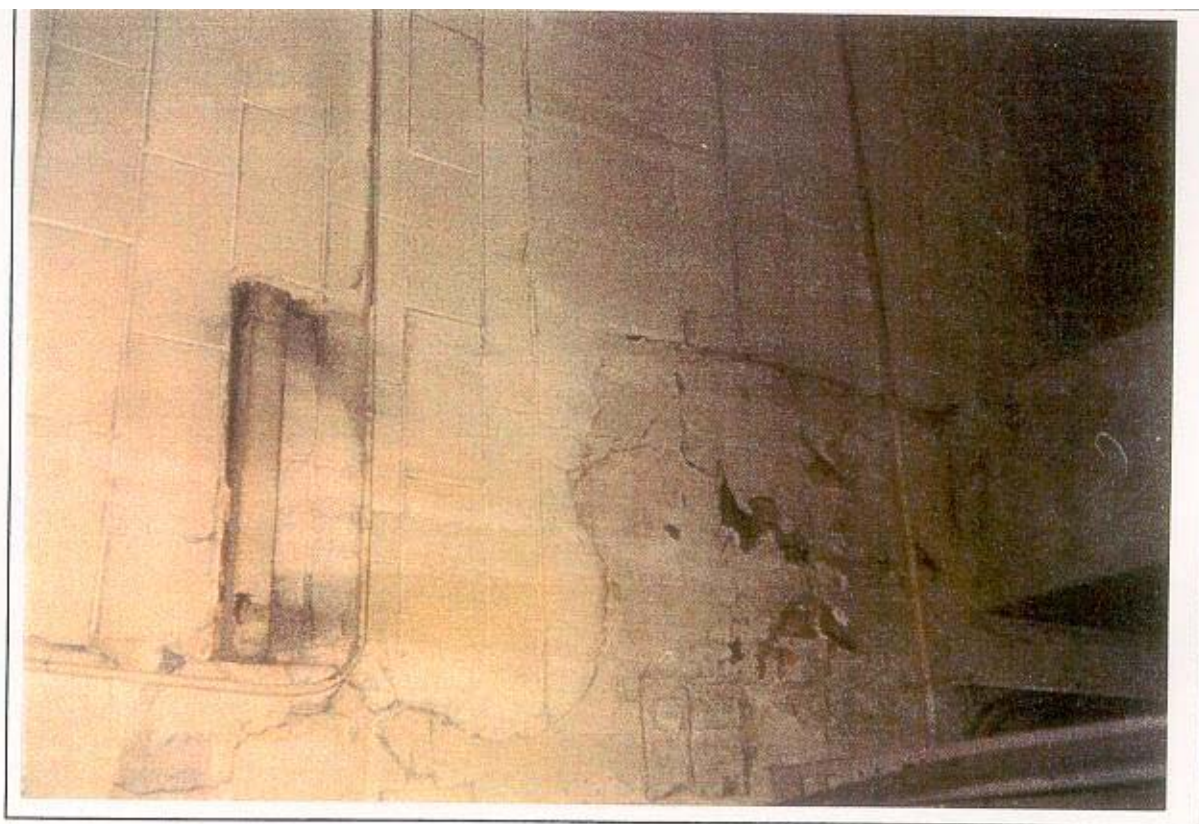
Photo 5: Type of structural deterioration in the building - August 19, 1998
