NEWFOUNDLAND & LABRADOR HYDRO

Upper Salmon Access Road

Condition Assessment

December 21, 2004

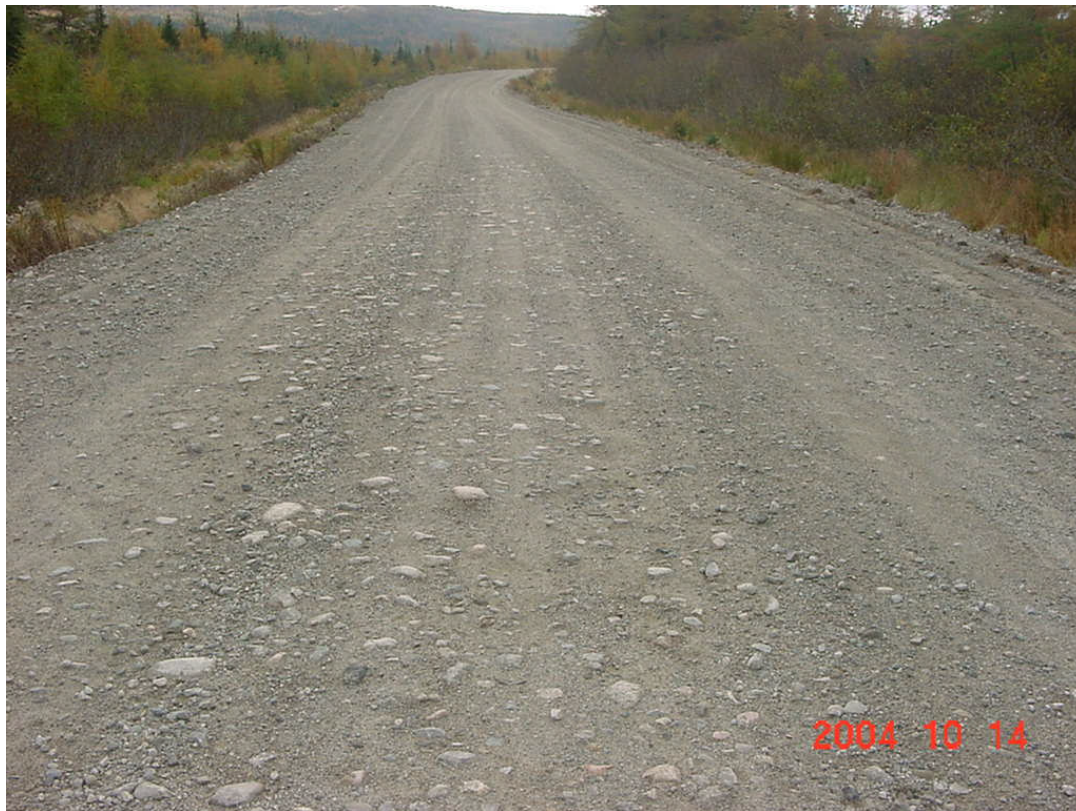
Even though the majority of road topping has been lost, the present road surface is in fair condition. There are few potholes due to the well draining type of material used in construction, however the surface is very rough, containing numerous cobble-sized rocks. Apart from causing a rough ride, this makes surface grading difficult and much slower than normal. With culvert maintenance and periodic grading of rougher areas (as they develop) the surface should not deteriorate further.

Photo #1: Average Road Condition, October 2004.

Replacement of the road topping should be scheduled for 2007.

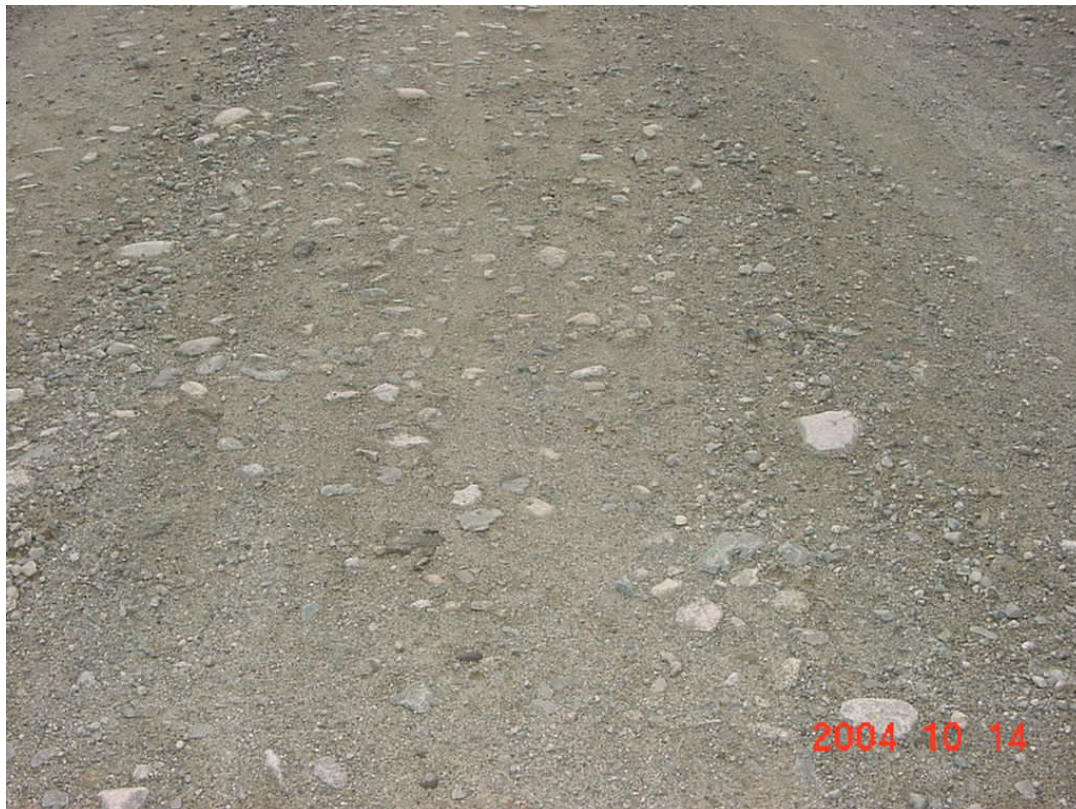
Photo #2: Average Road Condition (Close-up), October 2004.

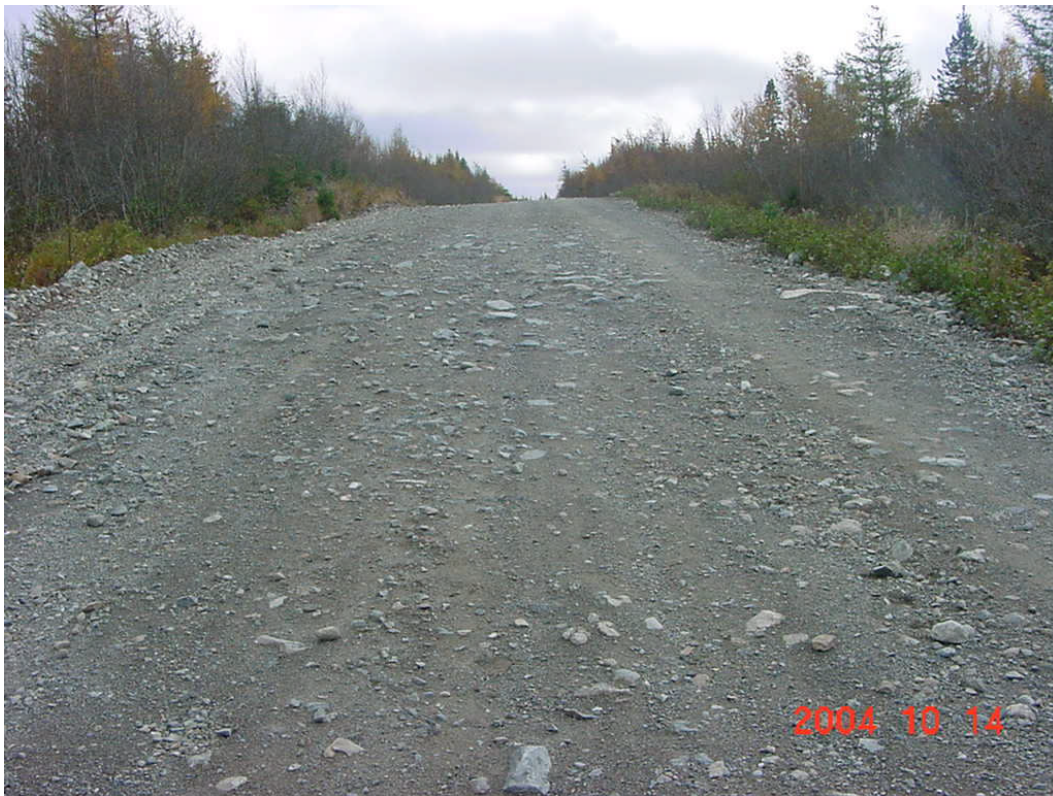
Photo #3: Typical Rough Area, October 2004.

Grading should continue in rougher areas as they develop and as required. Small amounts of topping can be imported to repair rougher areas where required.

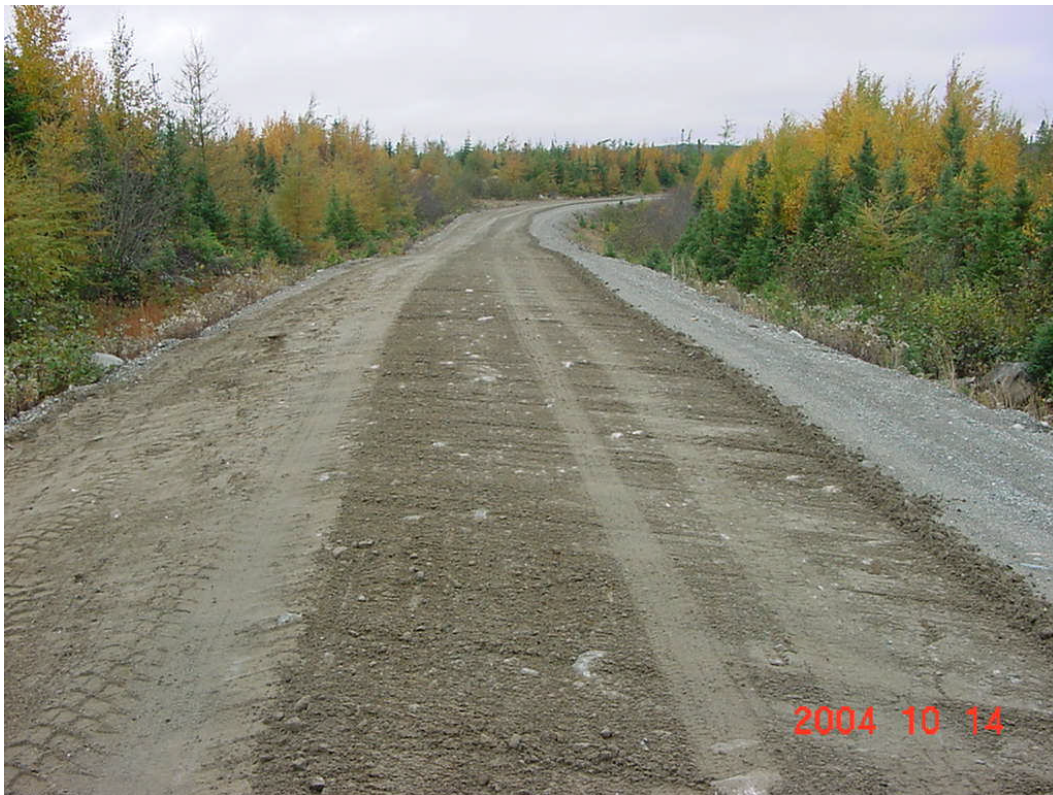
Photo #4: Road Surface after Grading, October 2004.
