1 **B-98 Microwave Site Refurbishing, \$364,000**

Post Construction Inspection Report

**EXISTING 387 ft. (118 m)
GUYED TOWER**

Mary March Hill, NF.

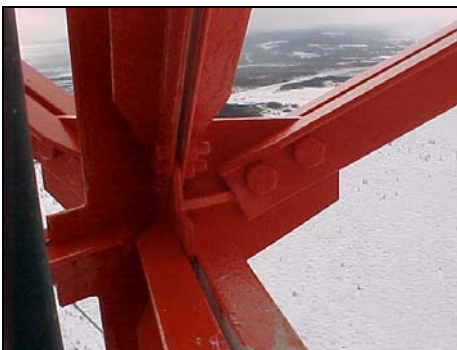
2.1.3 **Tower Paint refurbishment** - Only the top band of the tower has been completed.

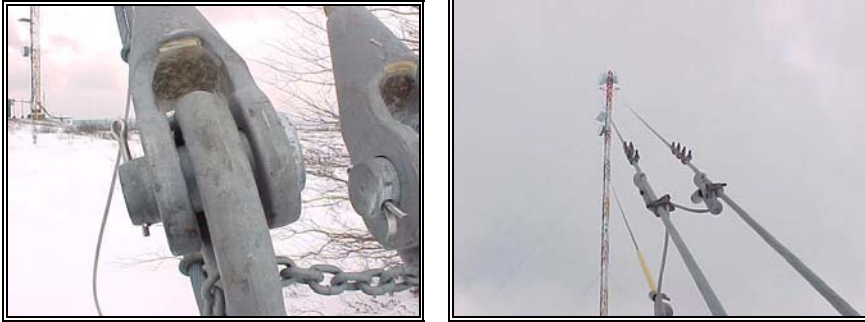
2.1.4.1 **Replacement of the guys at level 4 – 362 ft (110m).** – Complete with note.

Additional Ice Clips are required as per spec, three clips per guy are required.

Note that the Turnbuckles used are larger than the previous, this is considered to be acceptable.

Guy level 3 is considerably under tensioned.

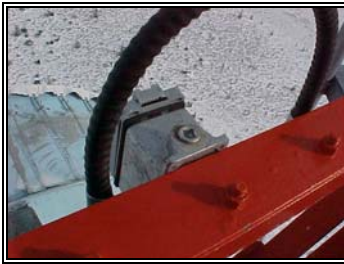
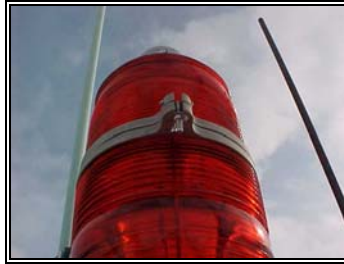
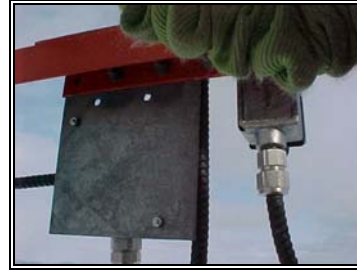
2.1.5 Replacement of the Complete Obstruction Lighting System On The tower - Complete

As was inspected in the tower and outside the building, all work appears to be complete and work is of good quality.

All connectors are stainless and receptacles have been installed as per specification.

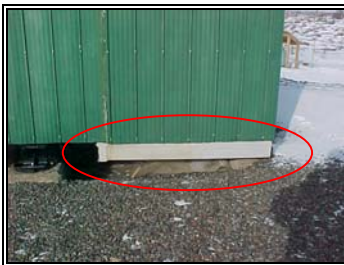
2.1.6 – Building Foundation Repair and Backfill – Complete with Note.

New frame material requires painting as per specification.

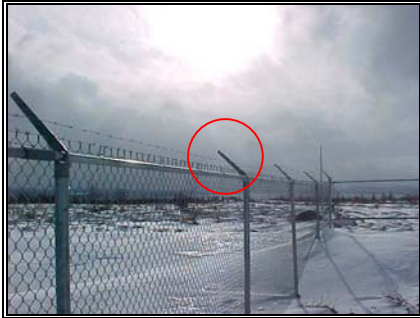
2.1.7 Replacement of Security Fence – Complete with Minor Note

Top row of barbwire needs to be reattached at various locations as it has come loose from the stanchions, recommend using tywraps to ensure barbwire remains in place.

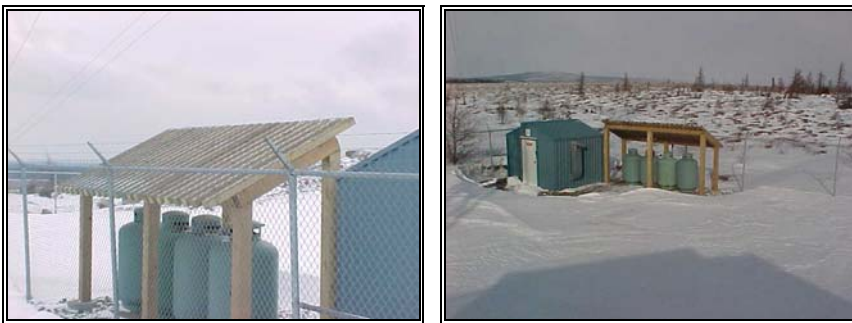
2.1.9 Installation of Ice Shield Over Propane Tanks – Complete
