1 **B-29 Reliability Upgrades-Frequency Converter, \$1,320,200**

Engineering Condition Assessment
of the
Corner Brook Frequency Converter

Prepared by: Paul Nolan, P.Eng.
TRO Engineering Department
Newfoundland and Labrador Hydro
April 7, 2005

APRIL 7, 2005

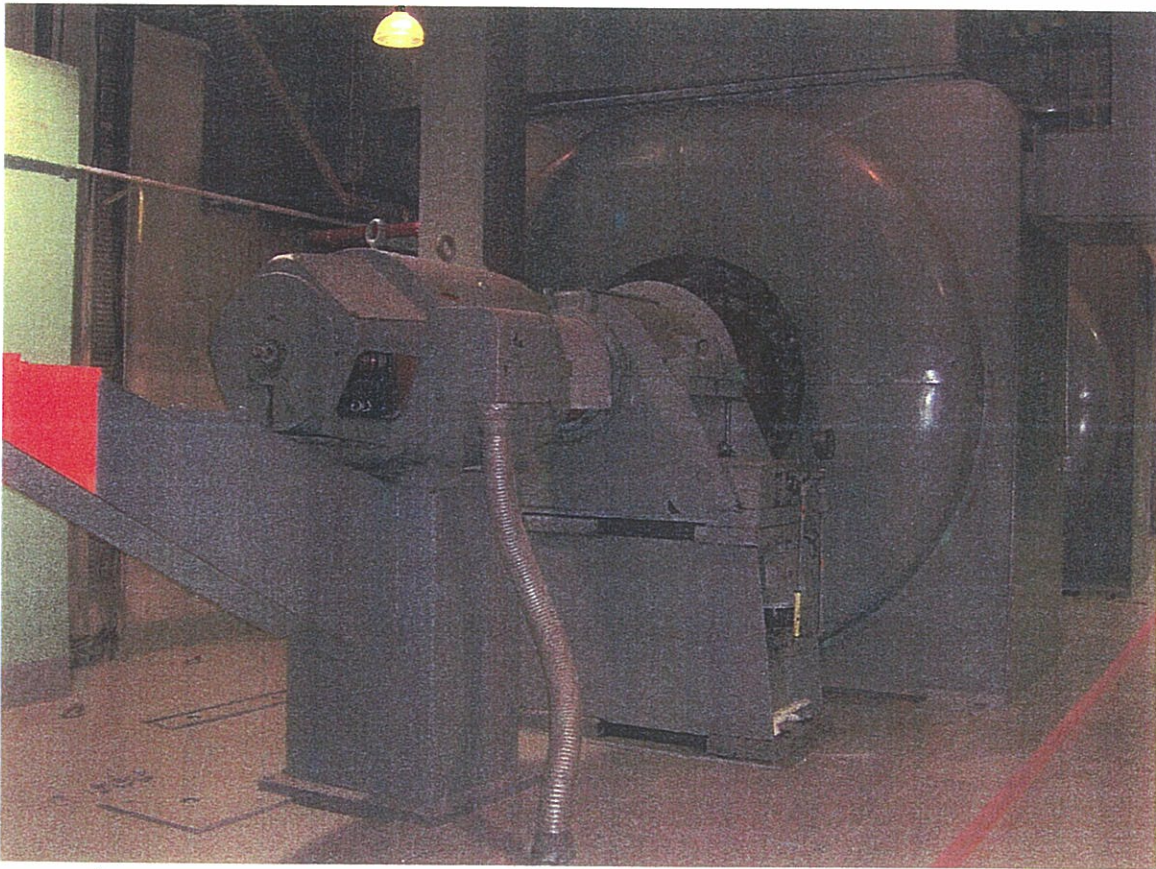
Figure 1 – 50 Hz Rotor (2005)

The insulation resistance value of the rotor windings is very low, in the order of 300 kohms. These low values are indicative of a failure within the next few years, but the failure could occur at any time. The rotors should therefore be rewound. Because the existing windings are asbestos insulated, the rewind will cost more than usual.

Readings of the insulation values of the 50 Hz rotor since 1998 remain very low (approximately 200 to 300 kohms.) The readings for the 60 Hz rotor, unlike the 50 Hz rotor, improved after cleaning.

- The condition of the insulation of the rotors (especially the 50 Hz rotor) was identified by Acres as very low. This issue has not been addressed. The 50 Hz rotor should be rewound as soon as possible. (A thorough assessment of the Grand Falls unit should be performed in order to explore the option of rewinding this unit as a replacement to the Corner Brook unit. This would decrease the length of the outage.) During this rewind, a thorough assessment of the other rotating equipment should be conducted.

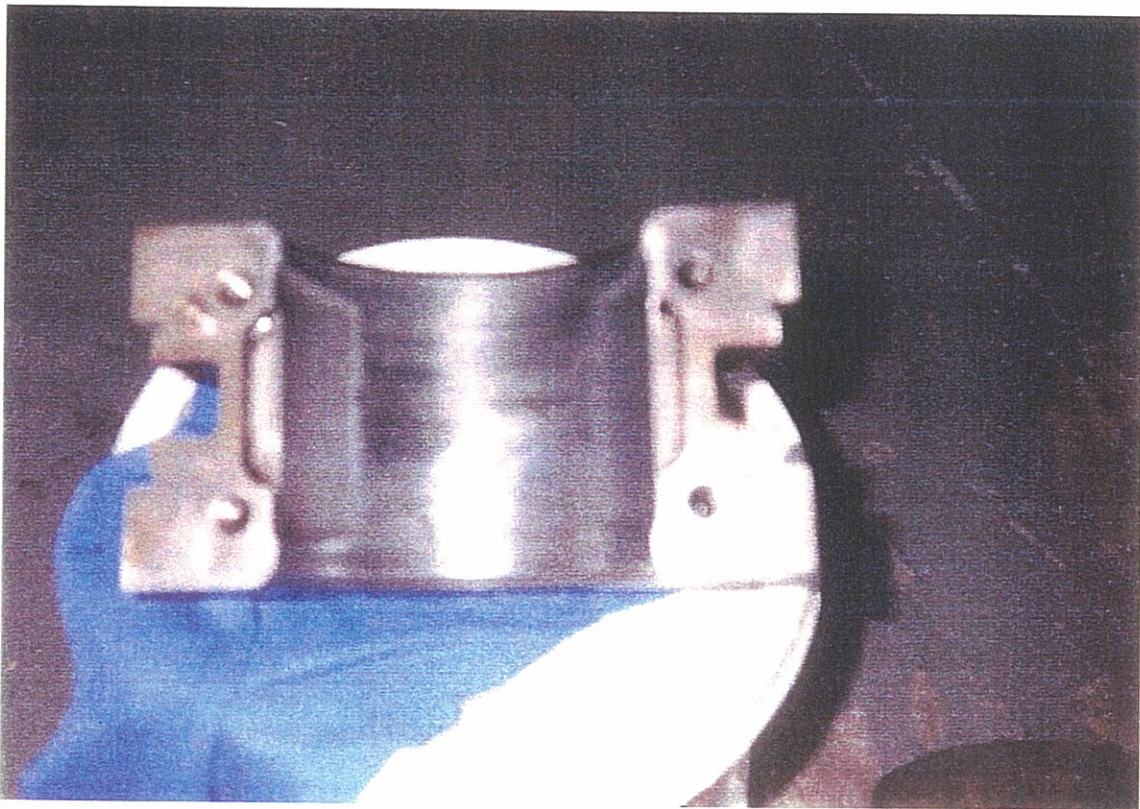
Figure 3 – Top Half of the Pedestal Bearing (1998)

The pedestal bearing has been wiped and should be replaced.

It is incorrect to state that this bearing has been wiped. This bearing has been partially wiped. A wiped bearing would likely cause damage due to contact between the shaft and the bearing shell. A machine cannot be operated with a wiped bearing.

The bearing should be replaced as soon as possible. It is running at higher than normal temperatures, as evidenced by the condition of the oil, and bearing failure is possible. This could cause shaft damage and a lengthy outage.

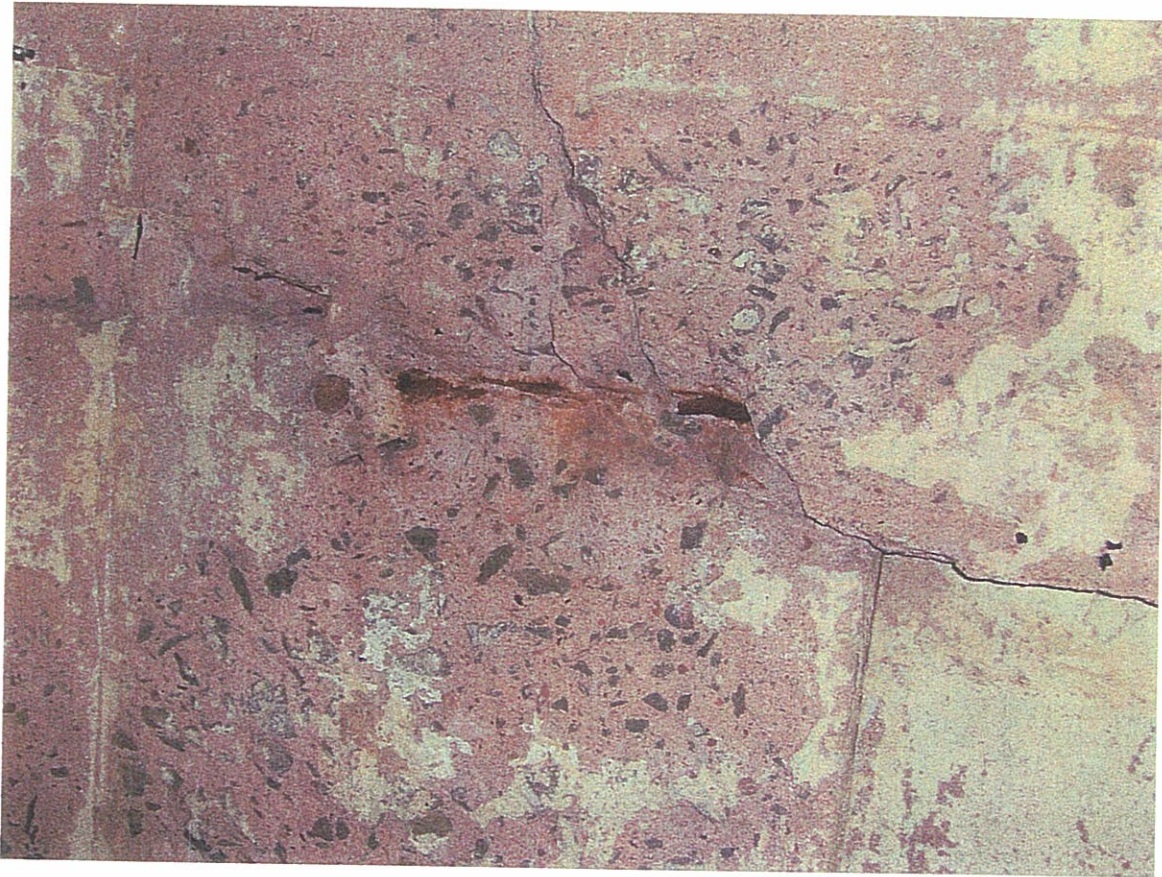
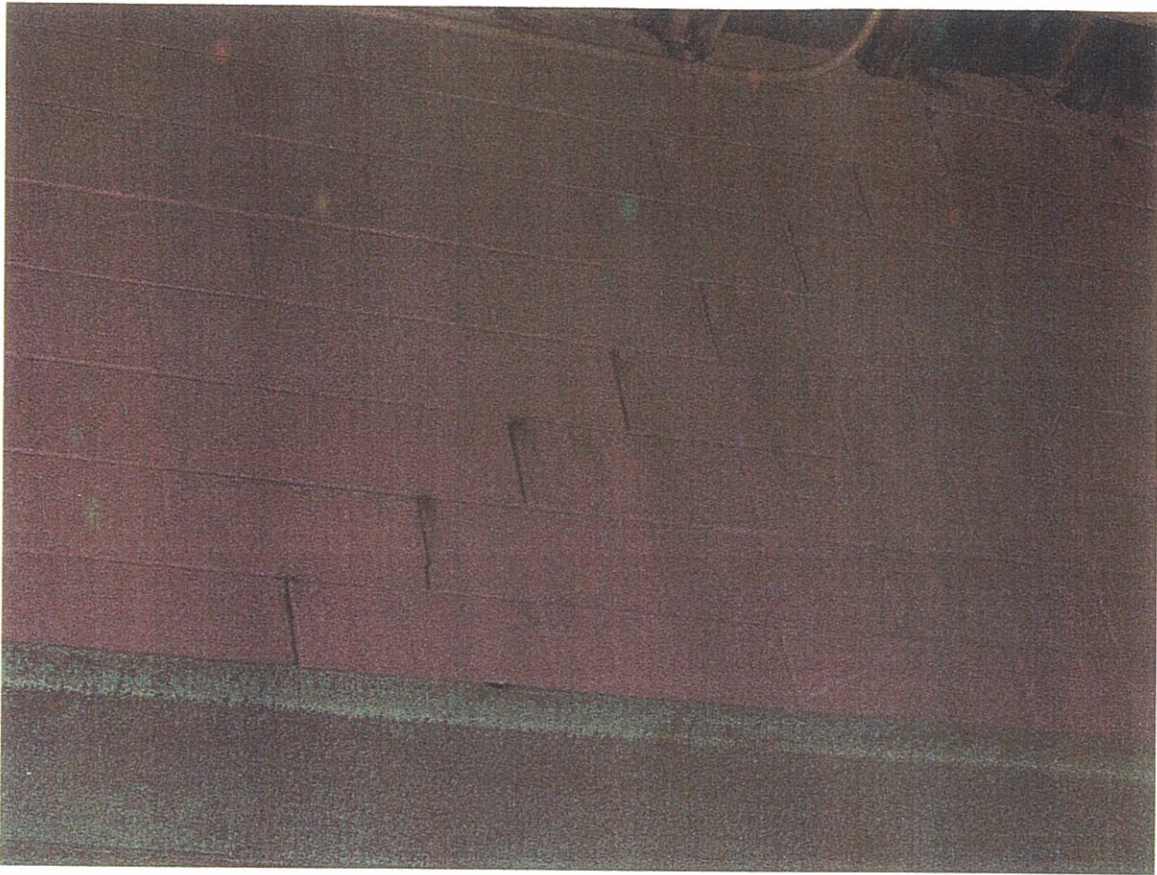
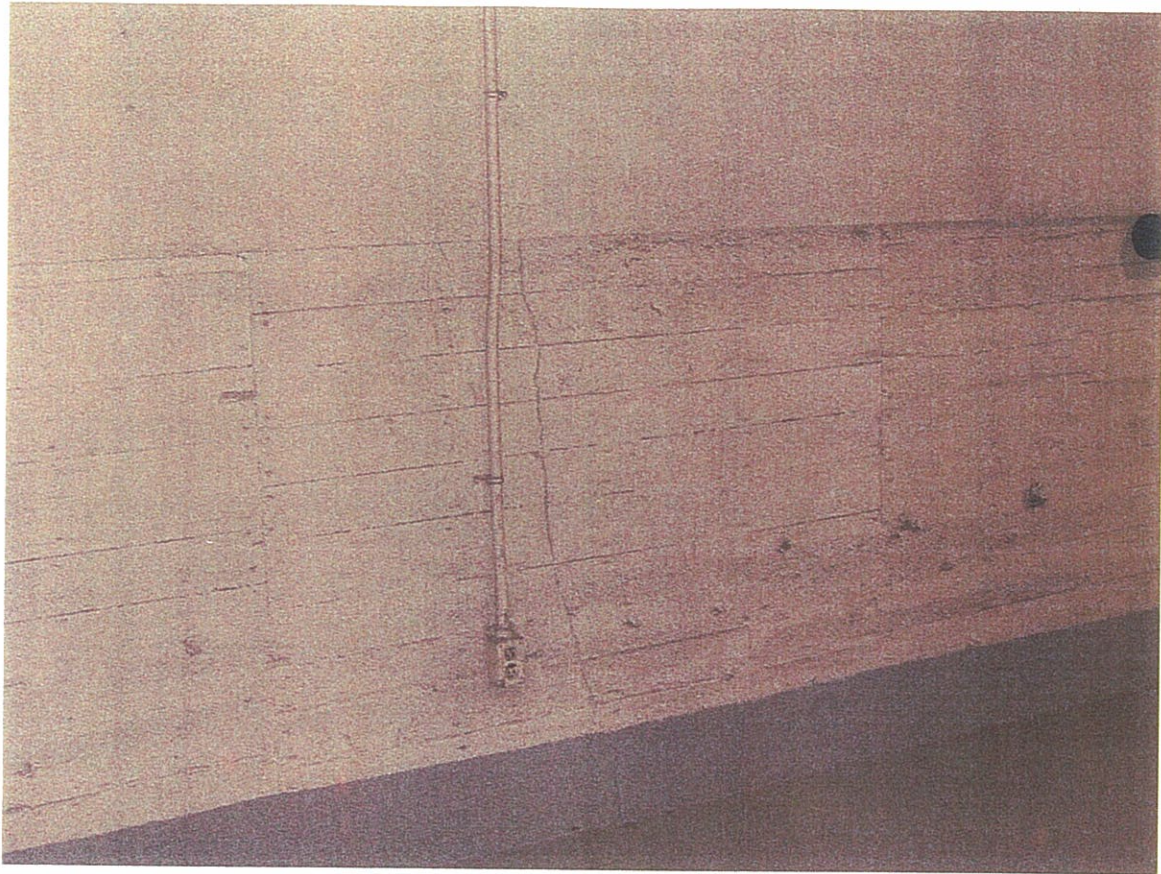
The building requires repair. Concrete and bricks have fallen from the roof and building sides and damaged the bushings and post insulators. Building cracks have allowed entrance of the wood debris associated with operation of the paper mill. The ceiling in the stairwell is temporarily repaired using a sheet of plywood. This should be permanently repaired.

Repairs have been made to the roof and stairwell ceiling. Caulking has been applied to building cracks when possible to decrease the ingress of dirt and dust. The overall condition of the building remains poor.

Figure 4 – Example of Crack in Wall (2005)

Figure 5 – Example of Crack in Wall (2005)

Figure 6 – Example of Crack in Wall (2005)

Repairs to the concrete and masonry (\$5,000 estimate) should be done as soon as possible.

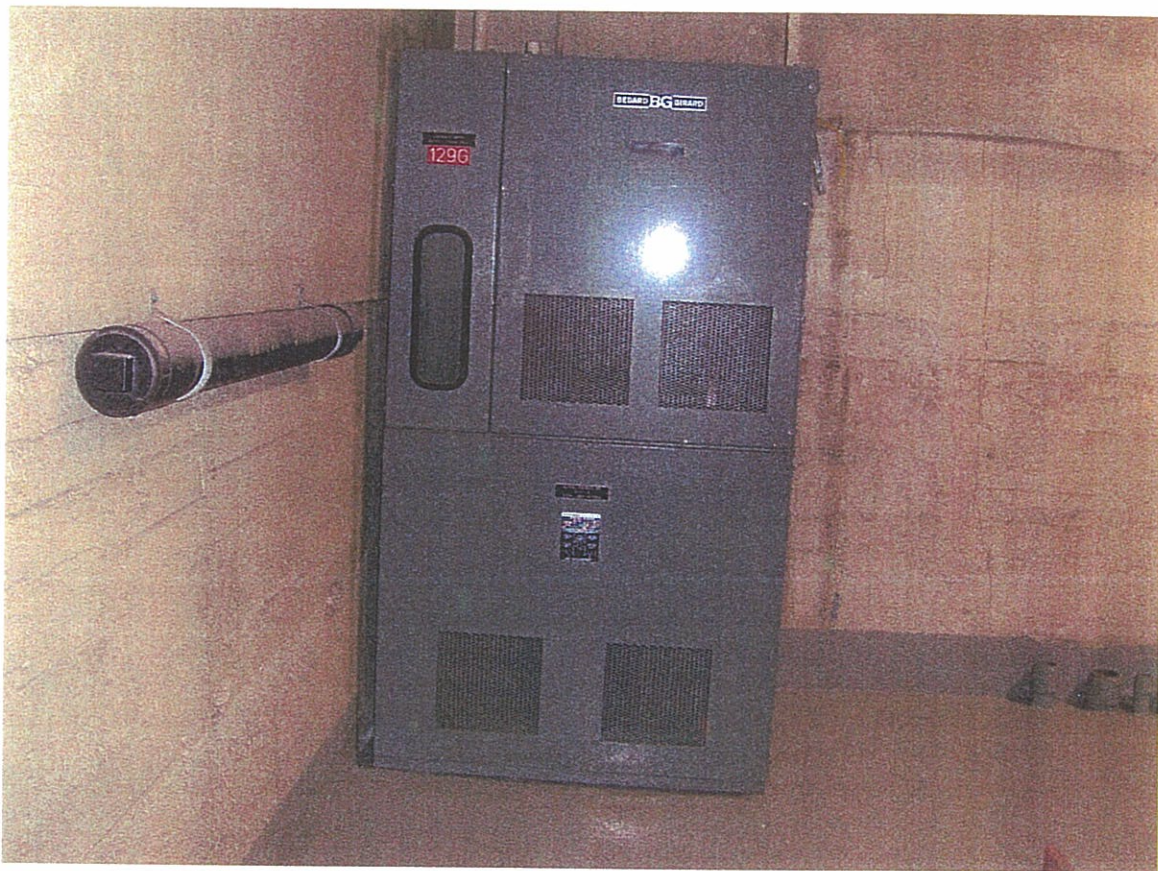
Figure 7 – Neutral Grounding Transformer (2005)

The neutral grounding transformers are oil insulated and should be replaced by dry type transformers.

This issue has not been addressed.

The risk of an oil leak from these transformers is small. A dry type transformer would be more susceptible to problems caused by the accumulation of dust and dirt.

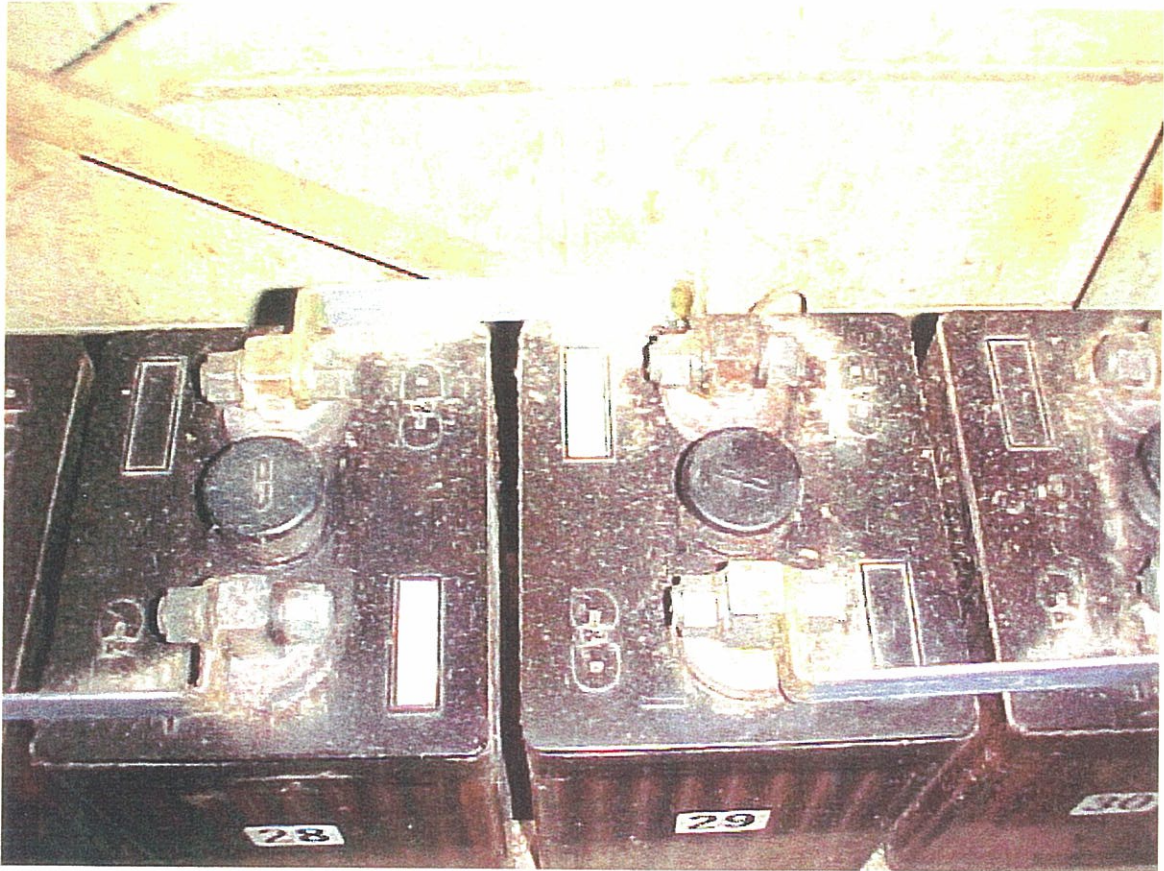
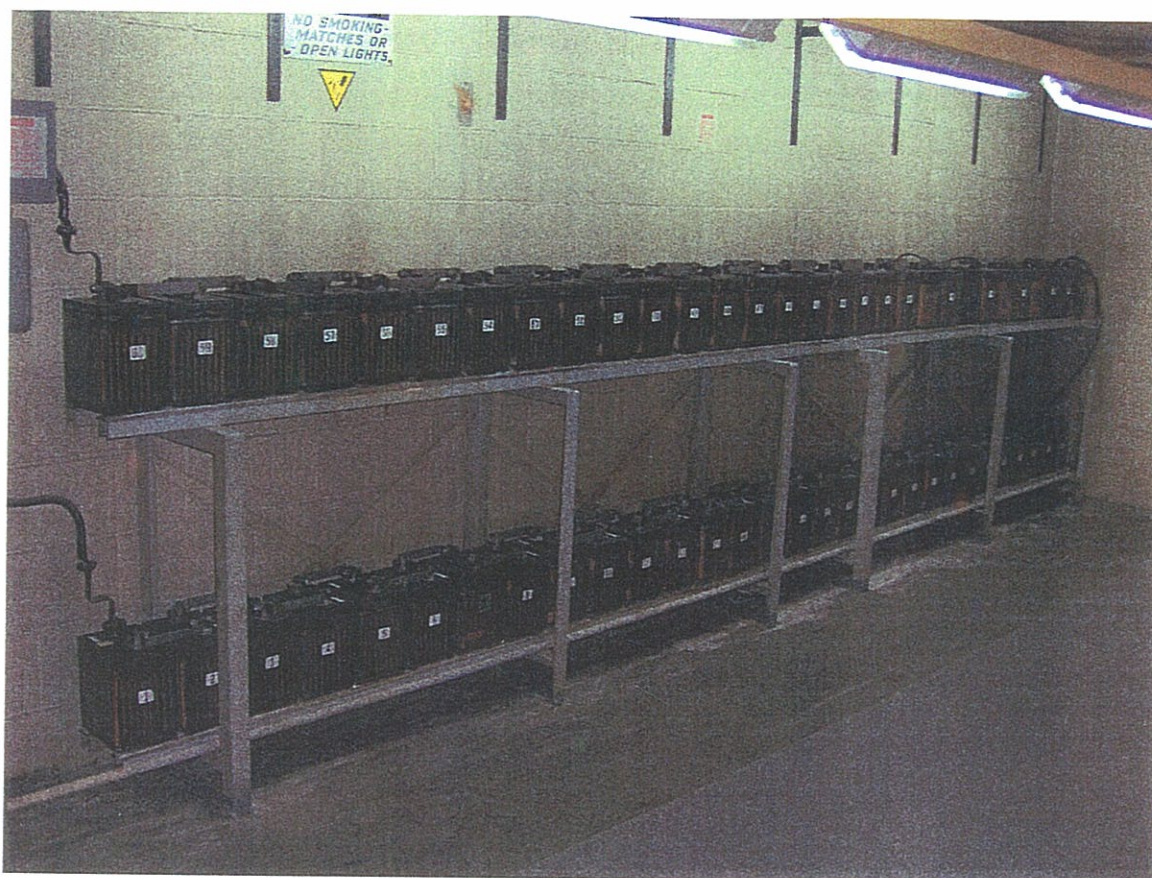
An overhead shield and lighting has been installed. The hydrogen gases from the bank are not being exhausted. The battery bank is scheduled for replacement in 2005 under a capital project ("Replace Battery Banks – Various Stations and Lines"), which also includes the replacement of several other battery banks. The total project cost is \$165,700. The cost of replacing the Corner Brook frequency converter's battery bank is roughly \$40,000. The building's ventilation system, in addition to providing cooling air for the transformers and converter, exhausts hydrogen gases from the battery bank.

Figure 8 - Close-up of Battery Bank (2001)

Figure 10 – Battery Bank {Scheduled For Replacement} (2005)

The batteries should be enclosed and measures taken to control and exhaust hydrogen gases.

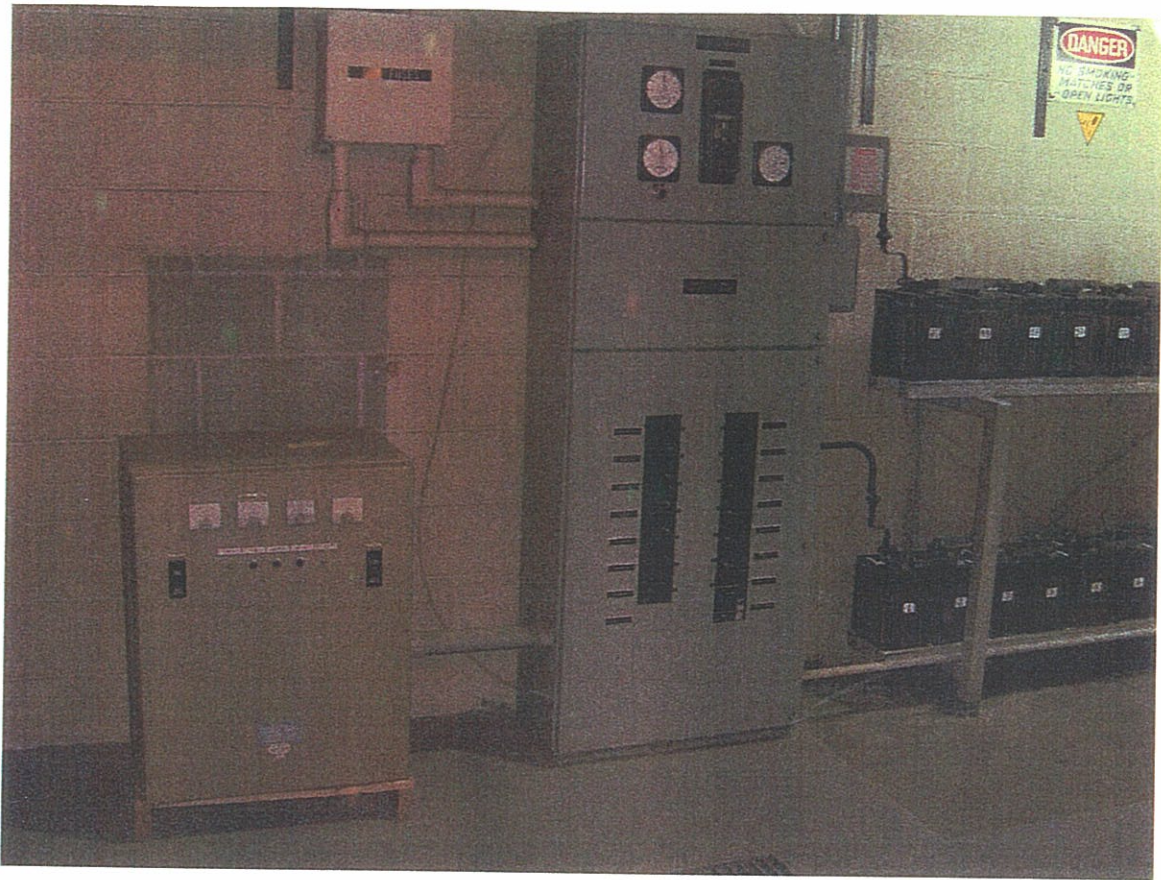
Figure 9 – Battery Charger & DC Panel (2005)

- The existing battery charger is nearing the end of its service life. The cost of replacing this unit is approximately \$10,000. This work should proceed, if justified.

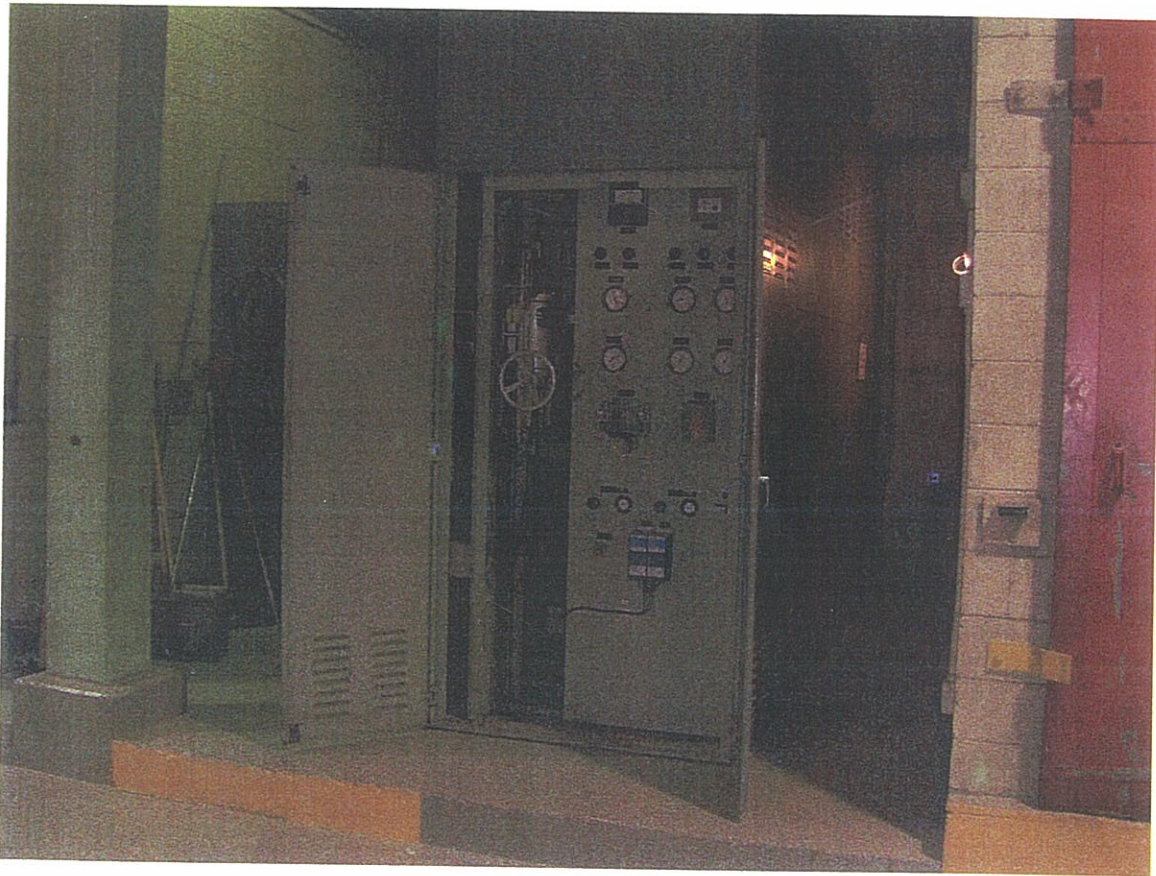
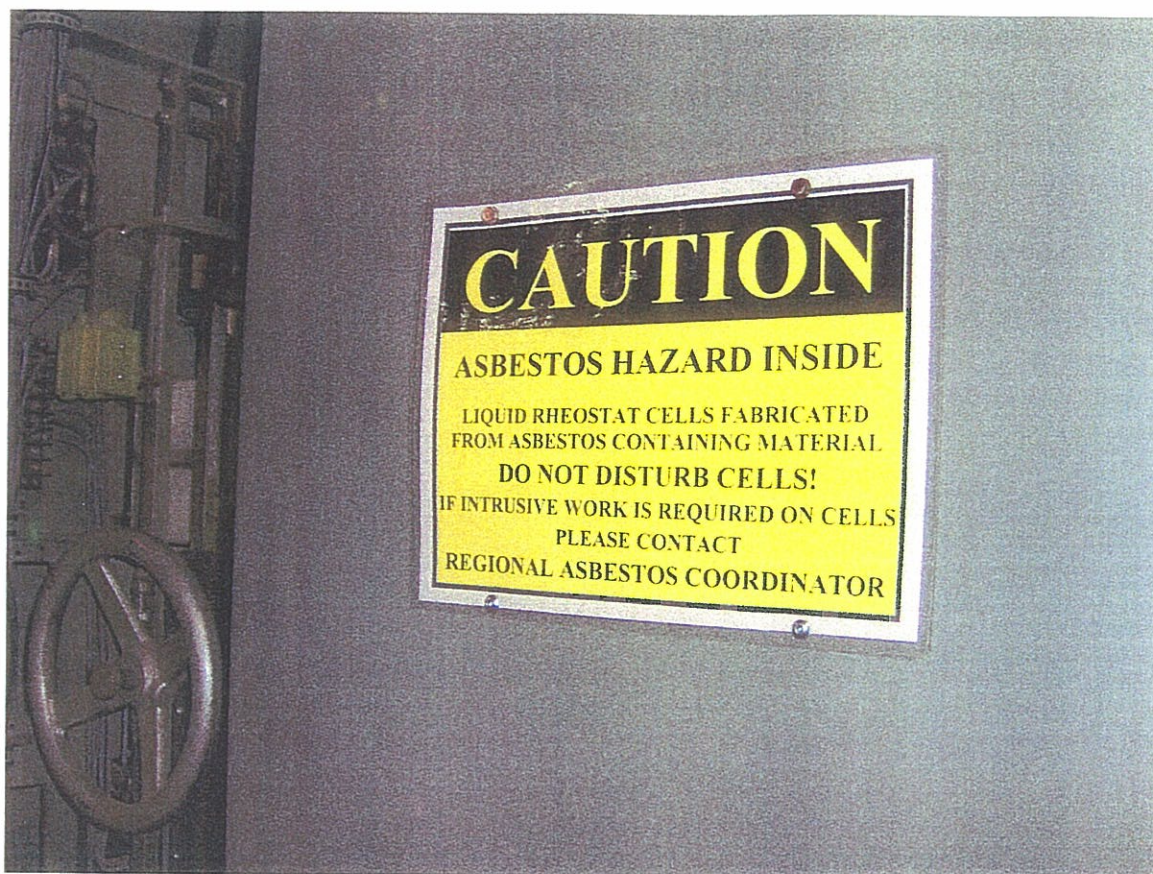
The building and piping asbestos insulation has been removed. The chamber of the liquid rheostat is asbestos lined and is still in service.

Figure 11 – Liquid Rheostat (2005)

Figure 12 – Liquid Rheostat Asbestos Warning Sign (2005)

This site has been identified under Hydro's Asbestos Abatement Program and is scheduled to be inspected this summer. The results of the inspection will determine the course of action required by Hydro.

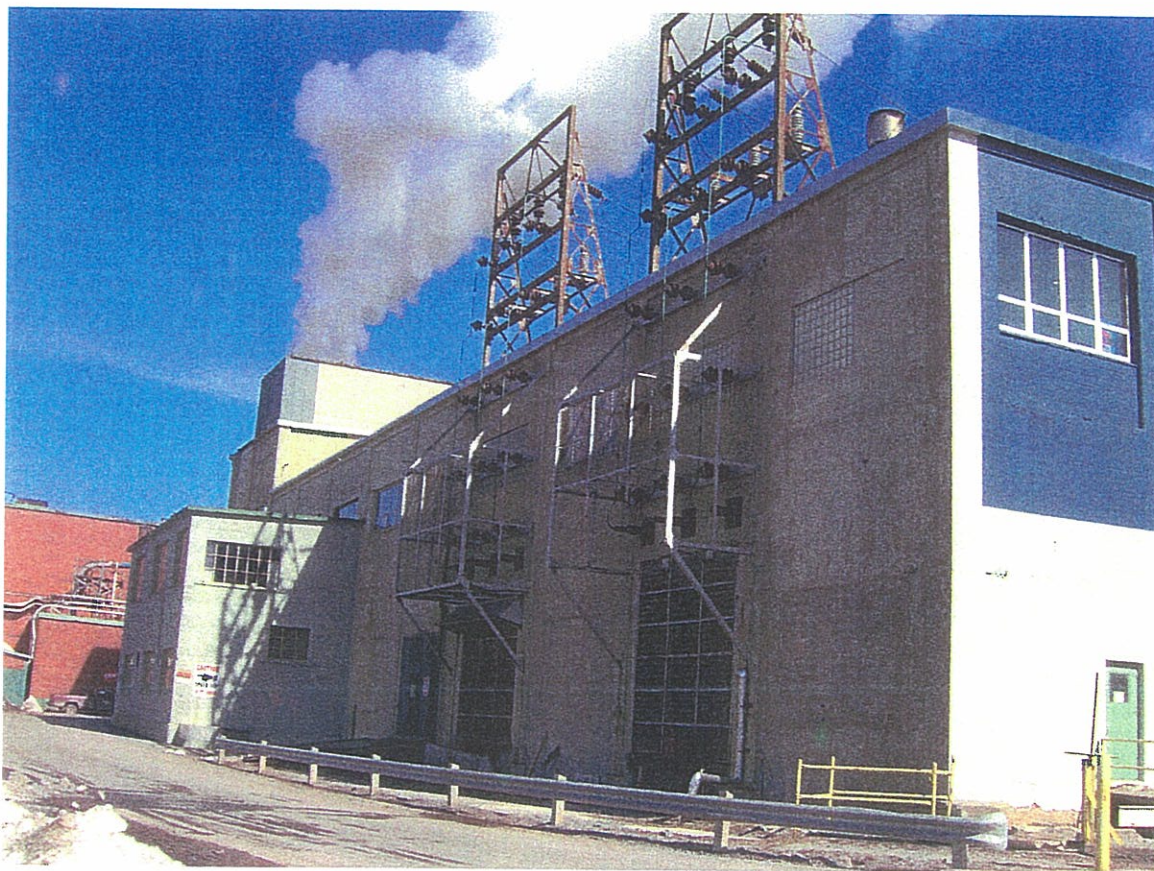
Figure 13 – Towers and External 66 kV Bus (2005)

The entrance bushings for the 500 mcm conductor to transformer T2 are damaged and should also be replaced (cost estimate = \$12,200 for each of the twelve bushings). These bushings are not scheduled for replacement this year.

Operations are beginning to address the condition of the steel take-off towers and insulators this year. The take-off towers will be painted (cost estimate = \$6400) and the 66 kV pin cap and suspension insulators will be replaced (cost estimate = \$19,450).

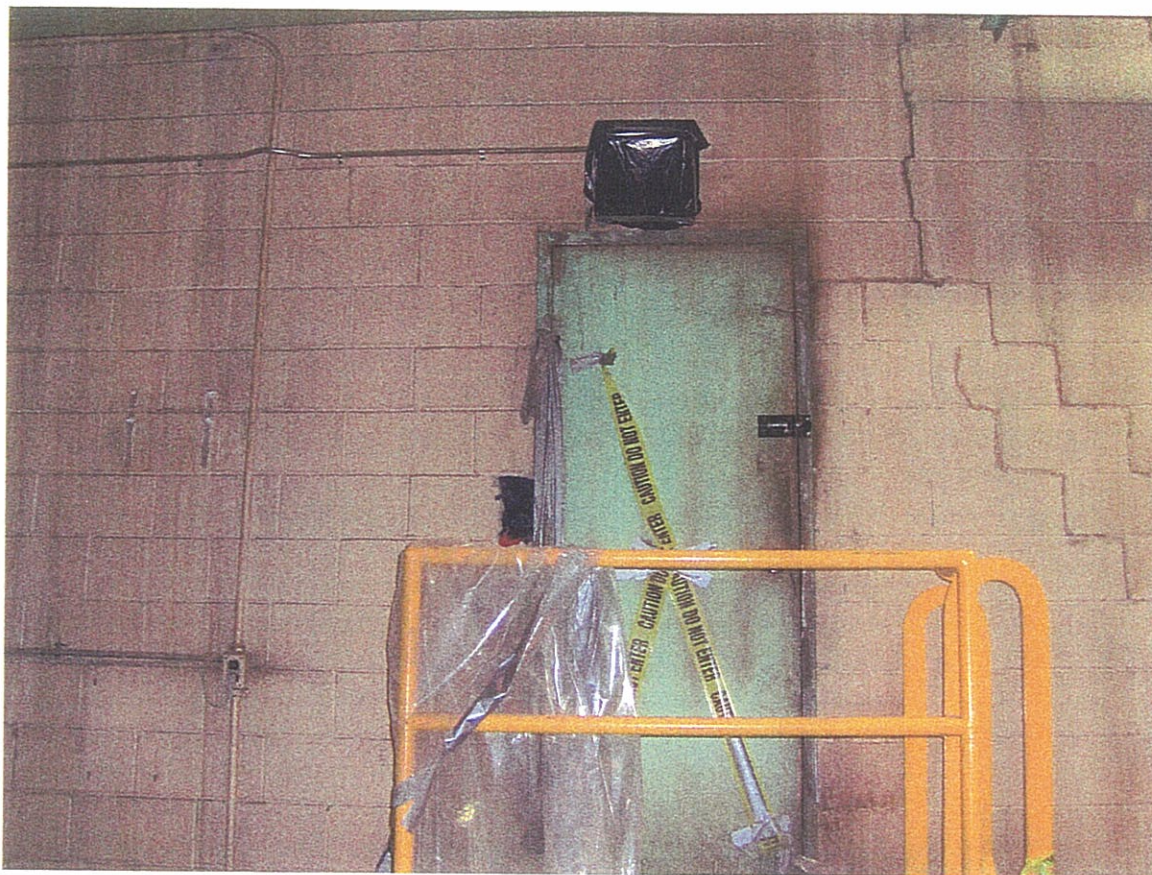
Figure 14– Emergency Exit from Switchgear Floor (2005)

- The bearing on the starting motor has an oil leak. This should be investigated and replaced if necessary.
- The emergency exit door from the upstairs switchgear area was damaged during a fire and should be repaired.

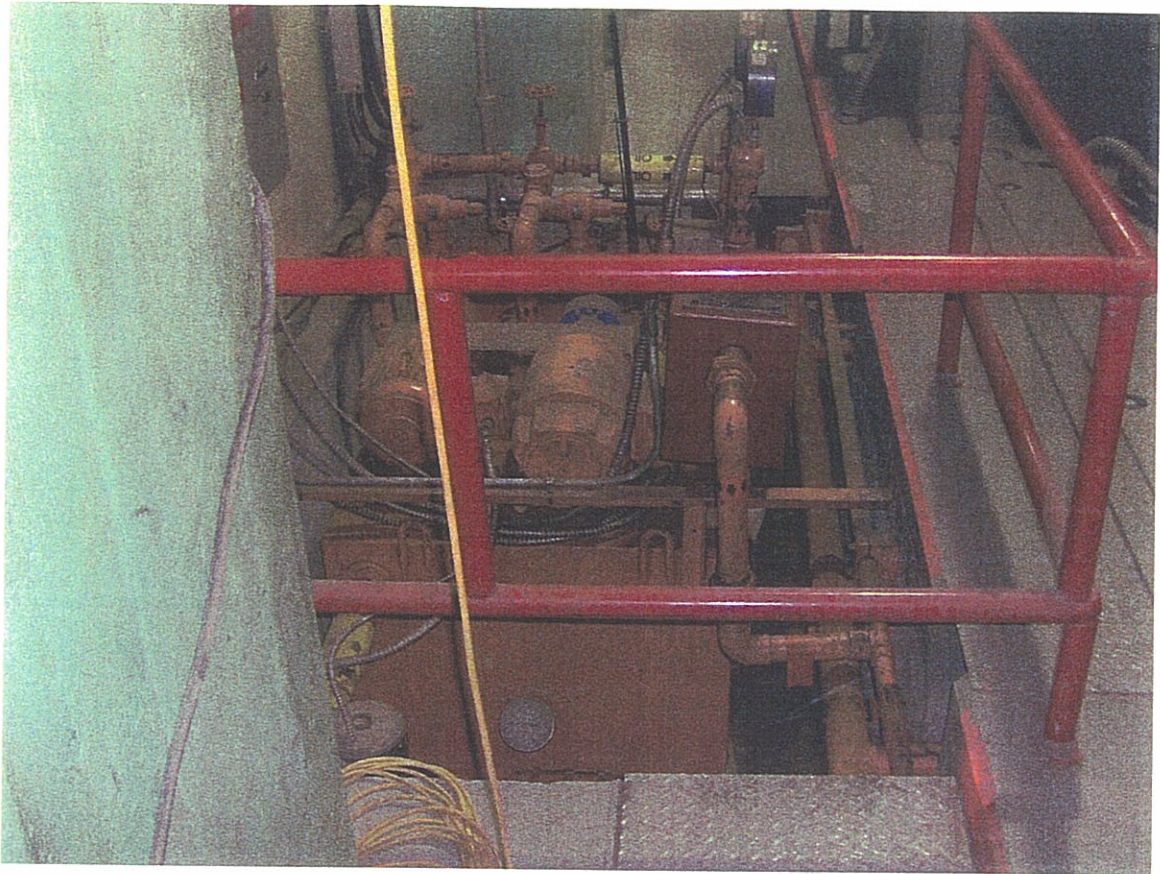
Figure 15– Main Lube Oil Pump (2005)

- The main lube oil pump is nearing the end of its service life. The cost of replacing this pump is estimated to be \$7,000. This work should be budgeted and completed within the next couple of years.

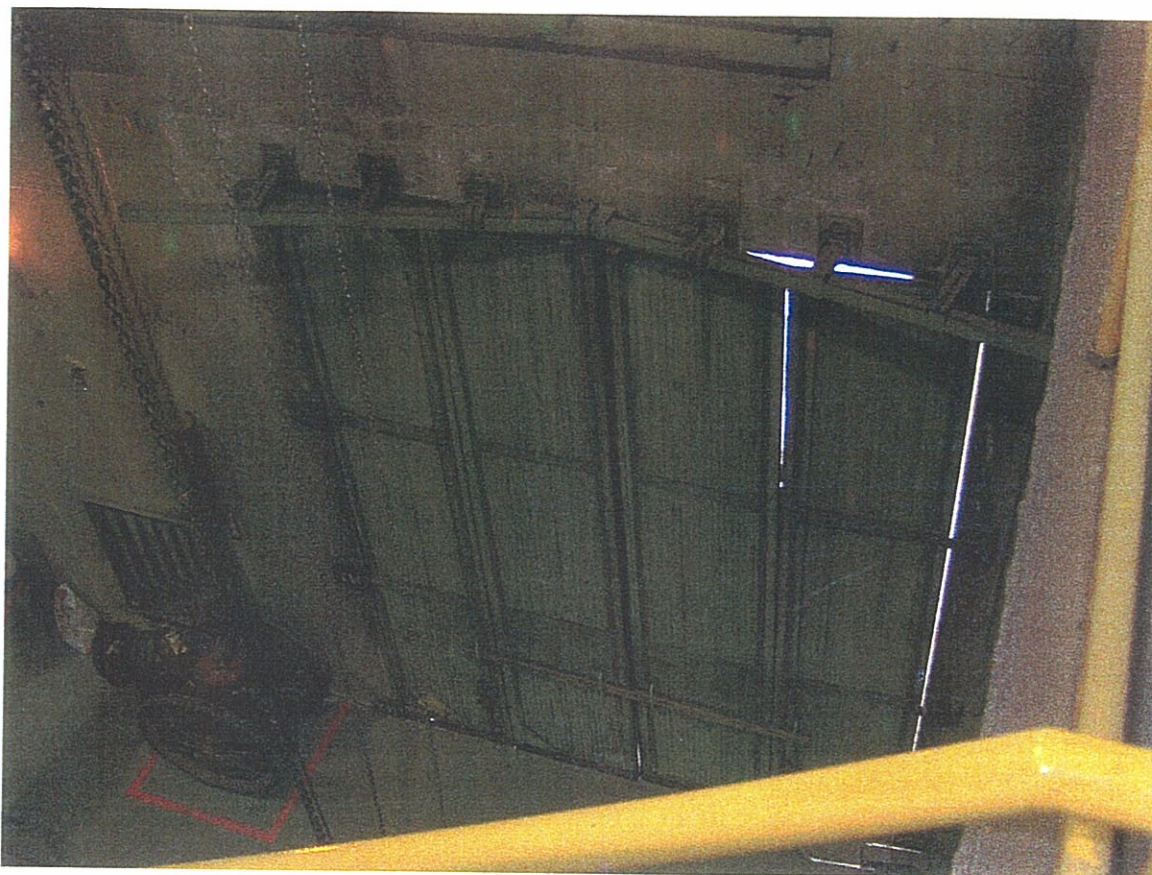
Figure 21 – Main Door To Converter Area (2005)

- The main door to the converter area is in poor condition and should be replaced (budget estimate is \$5,000). The four personnel doors are in poor condition and should also be replaced (budget estimate is \$4,000). The existing fireproof transformer doors require upgrading (budget estimate is \$2,000).

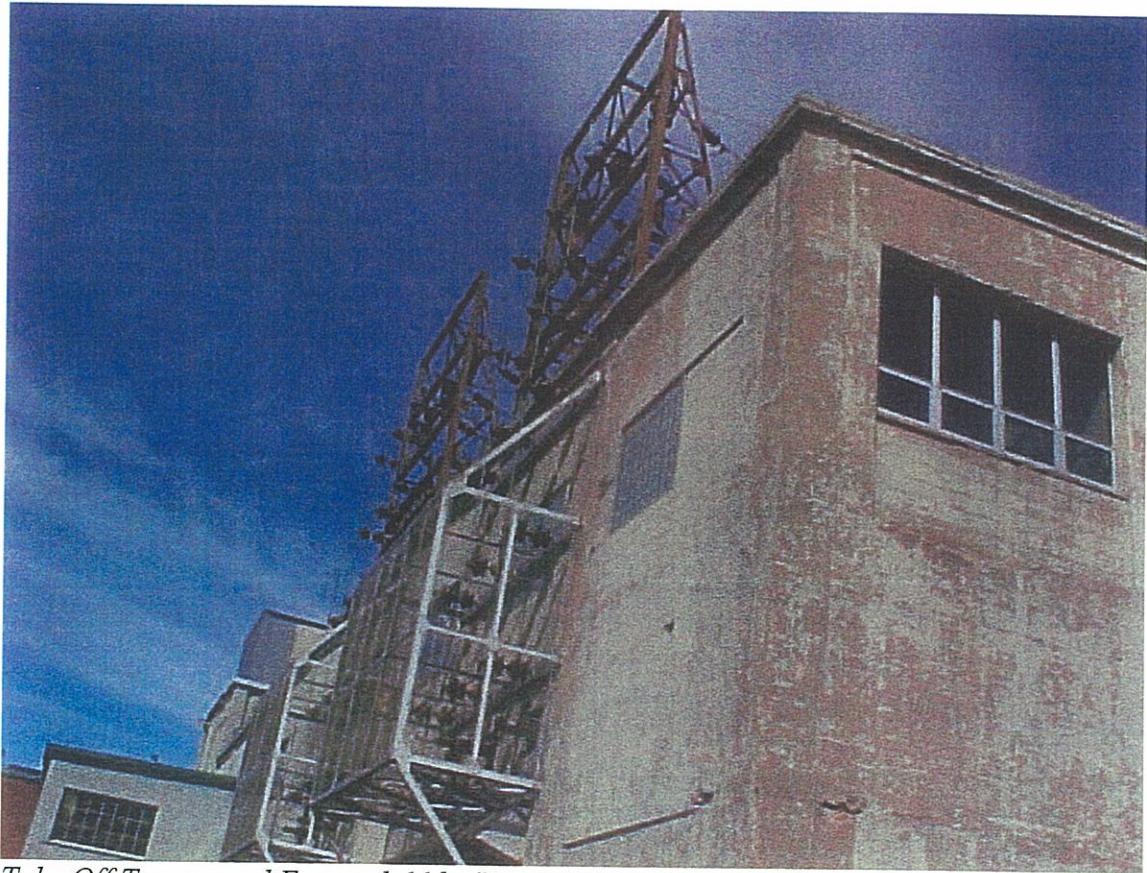
Take Off Towers and External 66 kv Bus associated with the Frequency Converter at Corner Brook Pulp and Paper.

Both towers are in good condition, including the bolted connections and leg anchors. Approximately 80 percent of the surface area of both towers is lightly corroded with some signs of mild pitting. Although maintenance of these steel towers is not urgent, it is recommended that a protective coating be applied to prevent any further deterioration of the structural steel. A two to three year delay in carrying out this maintenance would be acceptable.

As a protective coating, it is recommended that a good quality zinc or aluminium rich self priming paint be used. Surface preparation shall be in accordance with the SSPC-SP-2 standard (hand tool cleaning). Hydro currently stocks a high quality product that would be suitable for use on the towers. This product is Galvacon GC-243 cold galvanizing compound, however, it is quite expensive at \$232.00 per gallon.

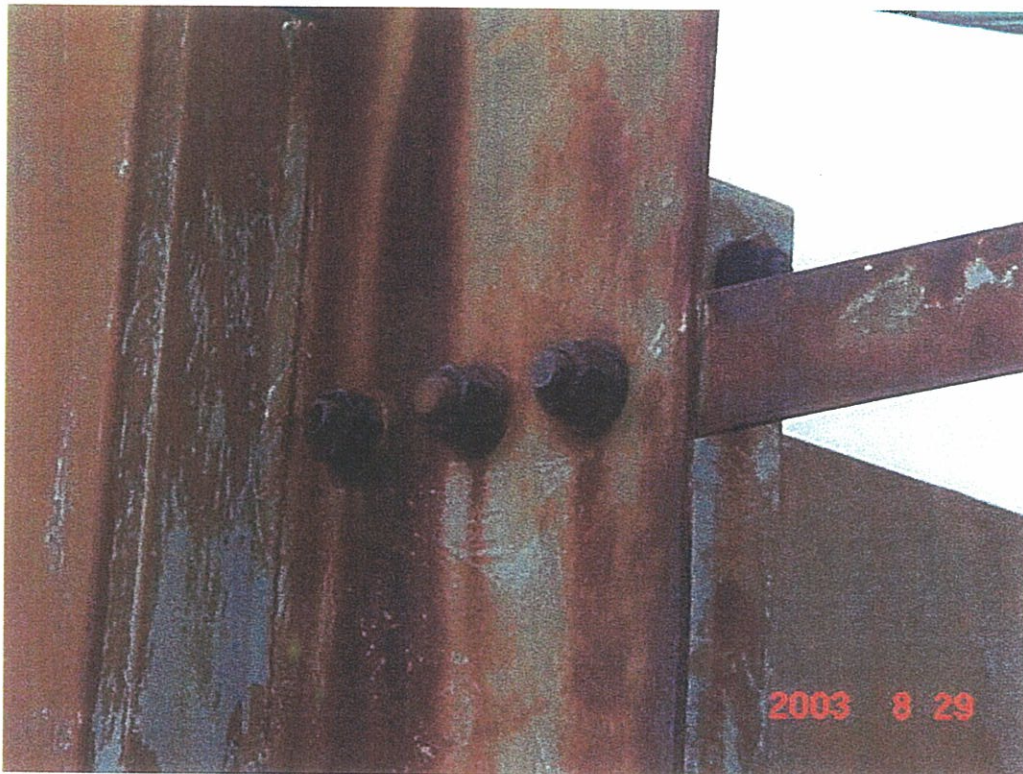
Take Off Tower for T1, bolted connection, leg to horizontal brace, light corrosion.

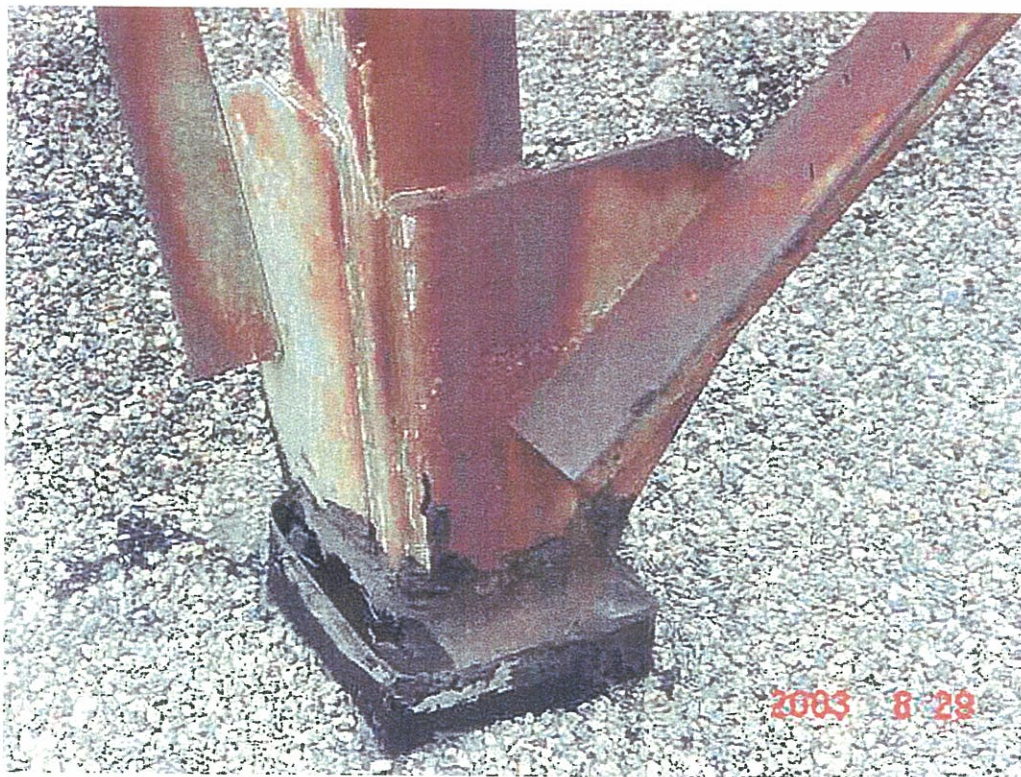
Take Off Tower for T2, leg anchor, light corrosion and mild pitting.

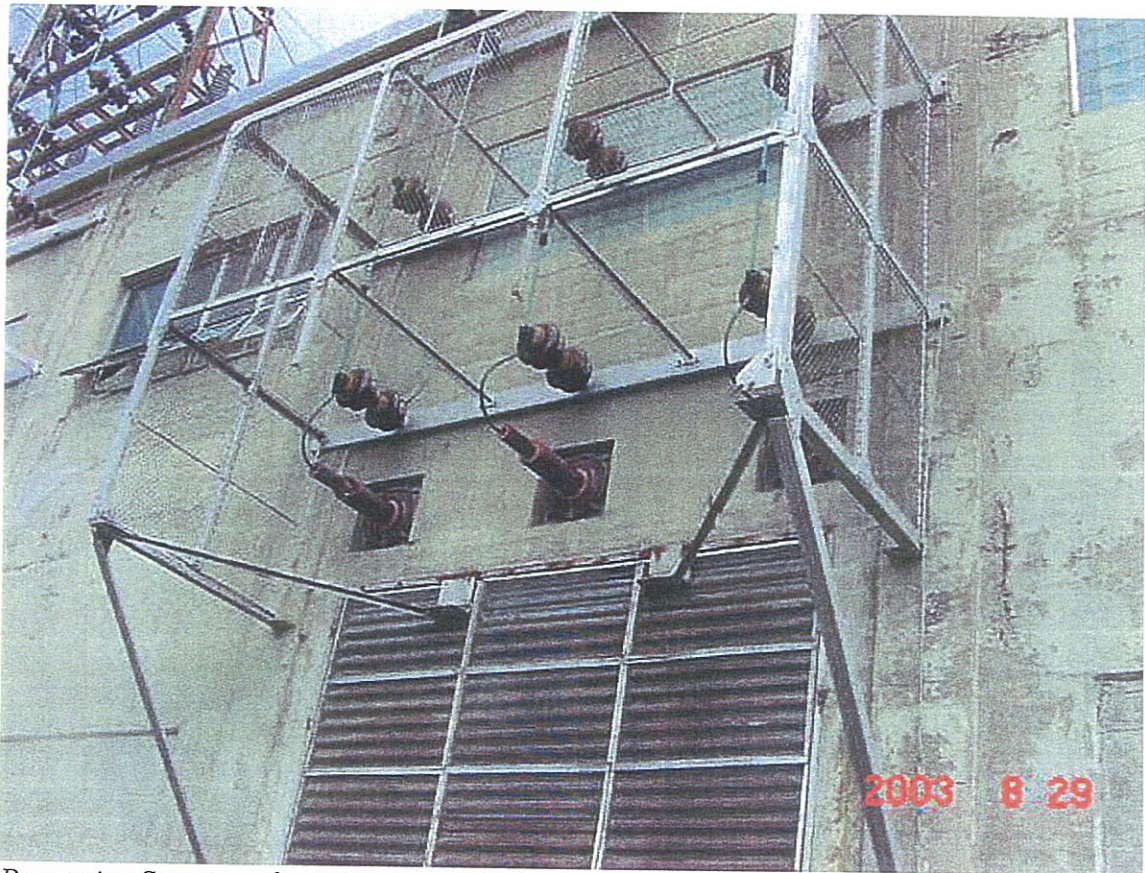
Last year, in order to facilitate the removal of T2 from the Frequency Converter Building, part of the protective structure that prevents the incidental contact between the 66 kv Bus and Mill Personnel/Equipment was removed. For safety reasons it is recommended that this structure be reinstated to its original condition as soon as possible. See drawing No. 401-S-16-Rev. 2.

Protective Structure for T2 External 66 kv Bus, steel frame and wire mesh removed.

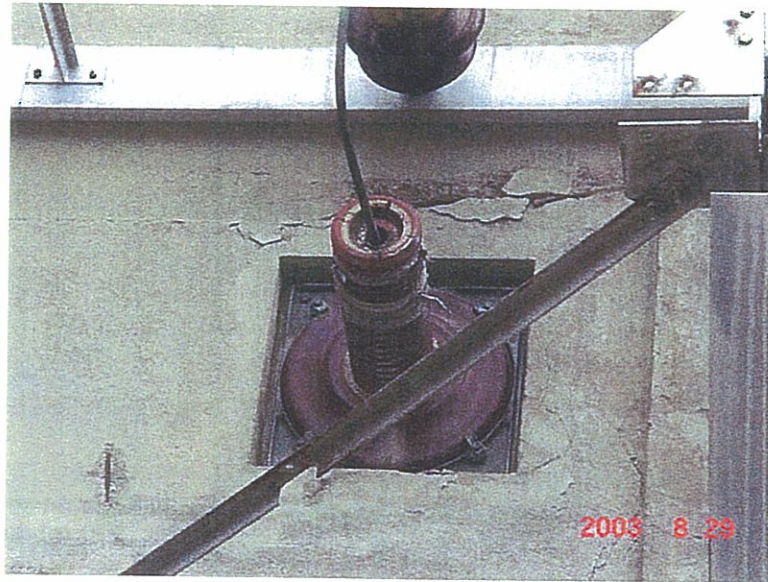
Both A and C phase entrance insulators for the 500 MCM Conductor leading to T2 have sustained considerable physical damage, resulting in reduced leakage distances and an increased probability of flashover. It is recommended that both A and C phase insulators be replaced as soon as a suitable substitute can be found. The existing insulators are vintage 1966, Canadian Porcelain, 69 kv, 350 BIL, catalogue No. 1216. Dave Hicks of TRO Engineering has been contacted for assistance in locating the replacement insulator.

Damaged A phase entrance insulator.

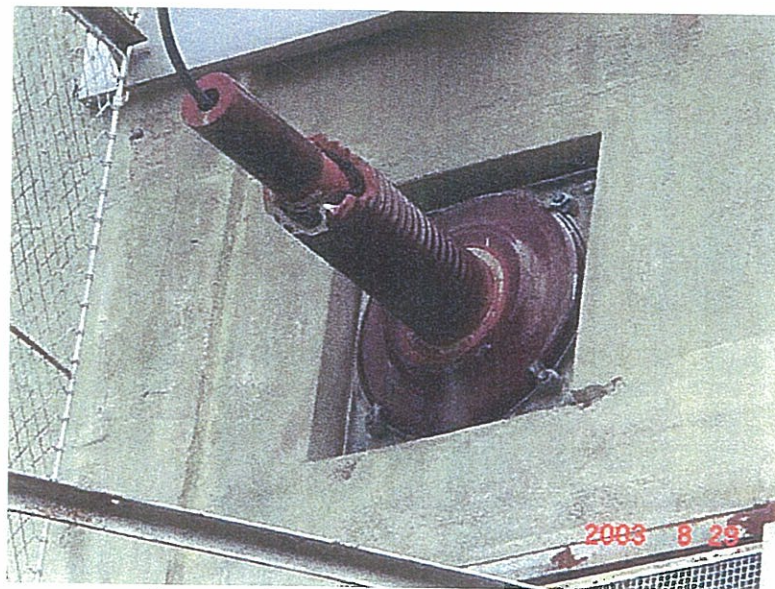
Damaged C phase entrance insulator.

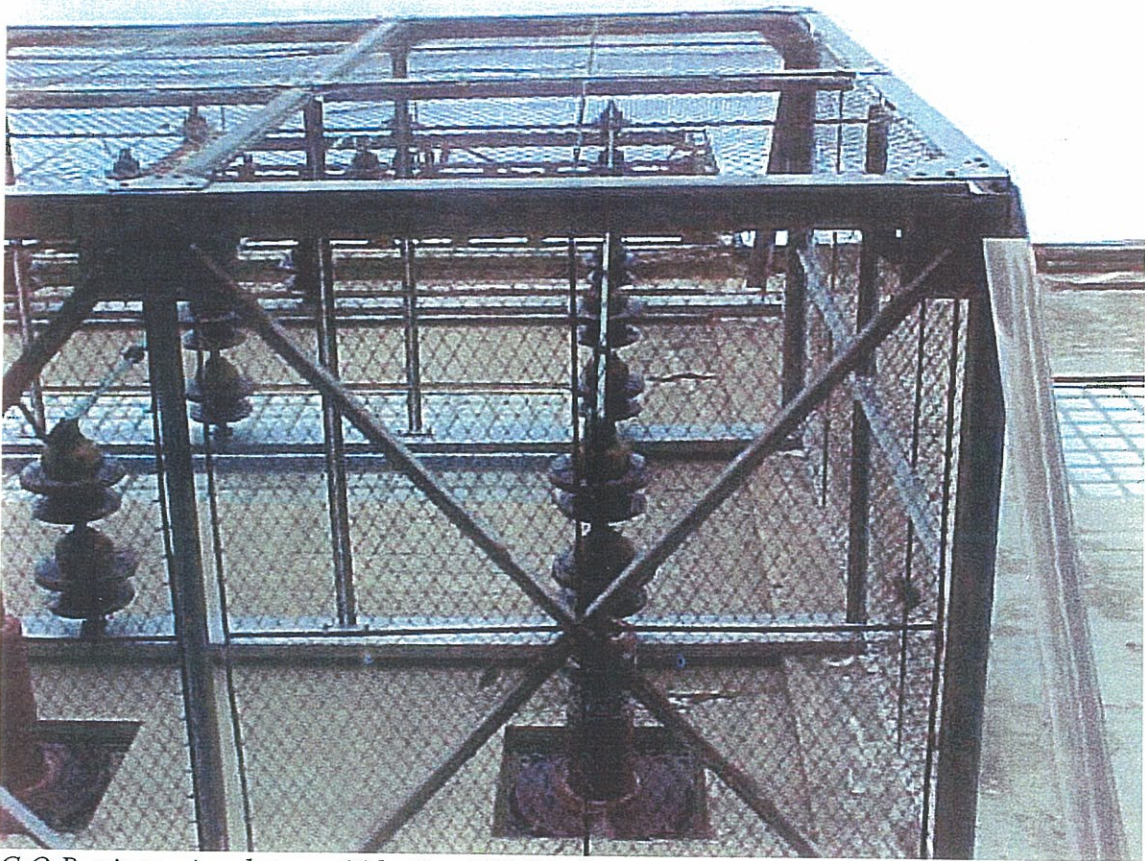
The current 66 kv Bus arrangement on the frequency converter building is supported by C.O.B. pincap and suspension insulators. These types and make of insulators have been failing at an ever increasing rate in many of our terminal stations, distribution, and transmission lines. Therefore, it would be prudent to consider changing out these insulators within the next several years. The pincap insulators are vintage 1966, C.O.B., catalogue No. 37769 (double units), 36 units would require replacement. The suspension insulators are vintage 1966, C.O.B., ball and socket type, catalogue No. 32436. 12 strings of 5 units would require replacement. Hydro currently stocks suitable station post and suspension type insulators for this work.

C.O.B. pincap insulators, 66 kv Bus CBPPL frequency converter building.
