1 **B-29 Reliability Upgrades-Frequency Converter, \$1,320,200**

Engineering Condition Assessment
of the
Corner Brook Frequency Converter

Prepared by: Paul Nolan, P.Eng.
TRO Engineering Department
Newfoundland and Labrador Hydro
April 7, 2005

APRIL 7, 2005

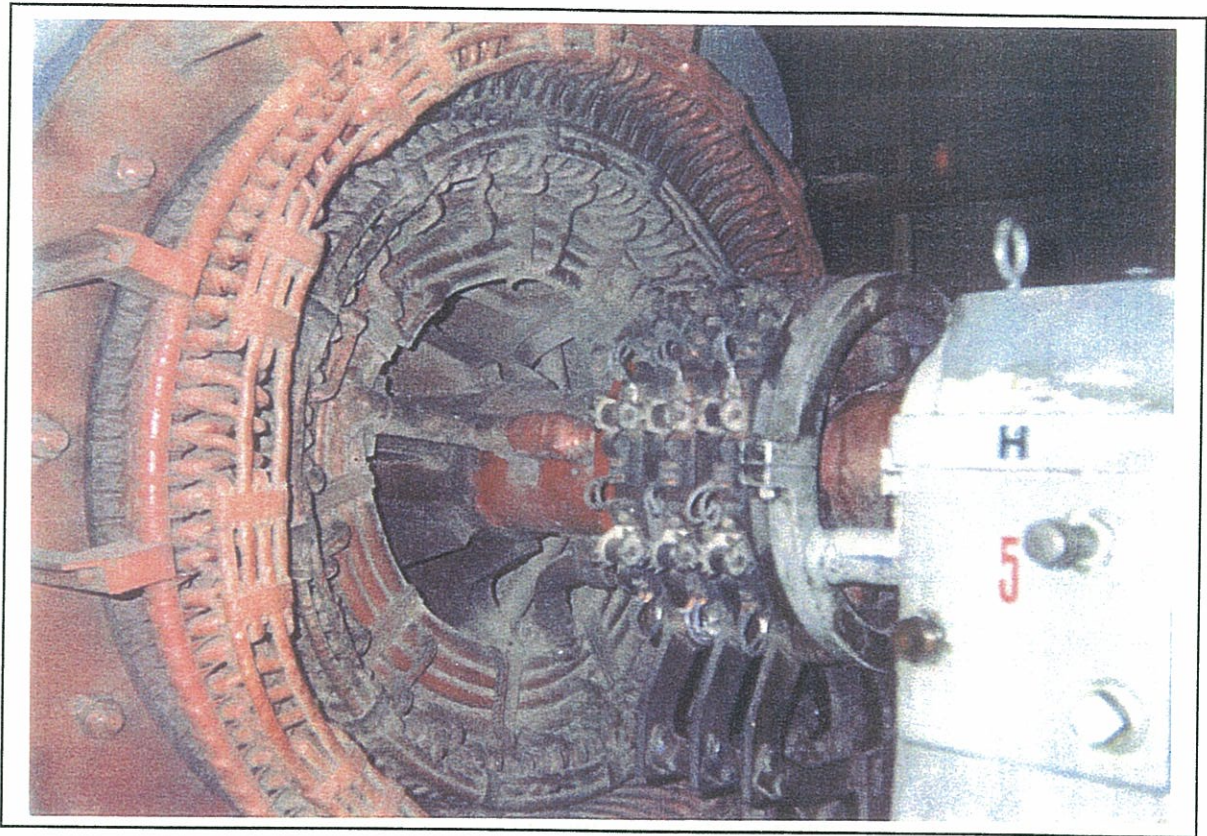
Photo 1: Dust and dirt on the machine windings and rotor - August 19, 1998

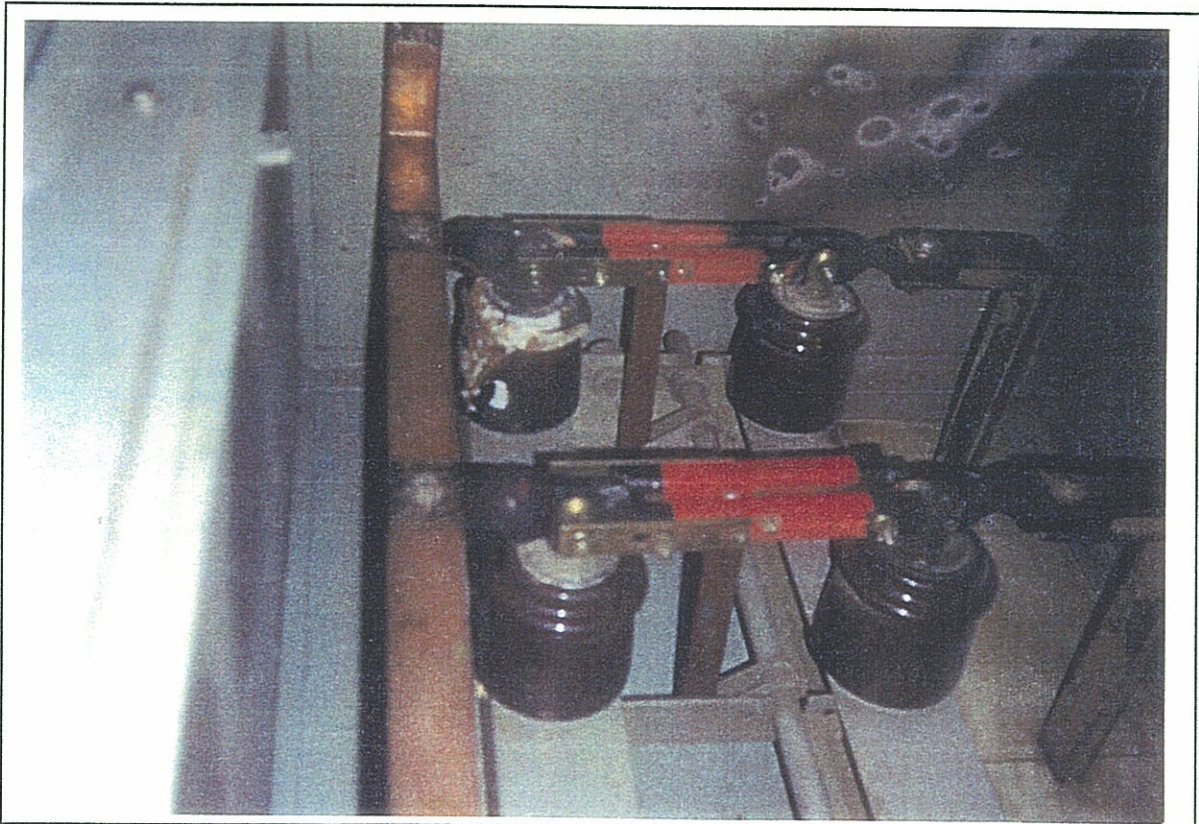
Photo 2: Arcing and burning found in cubicle - August 19, 1998

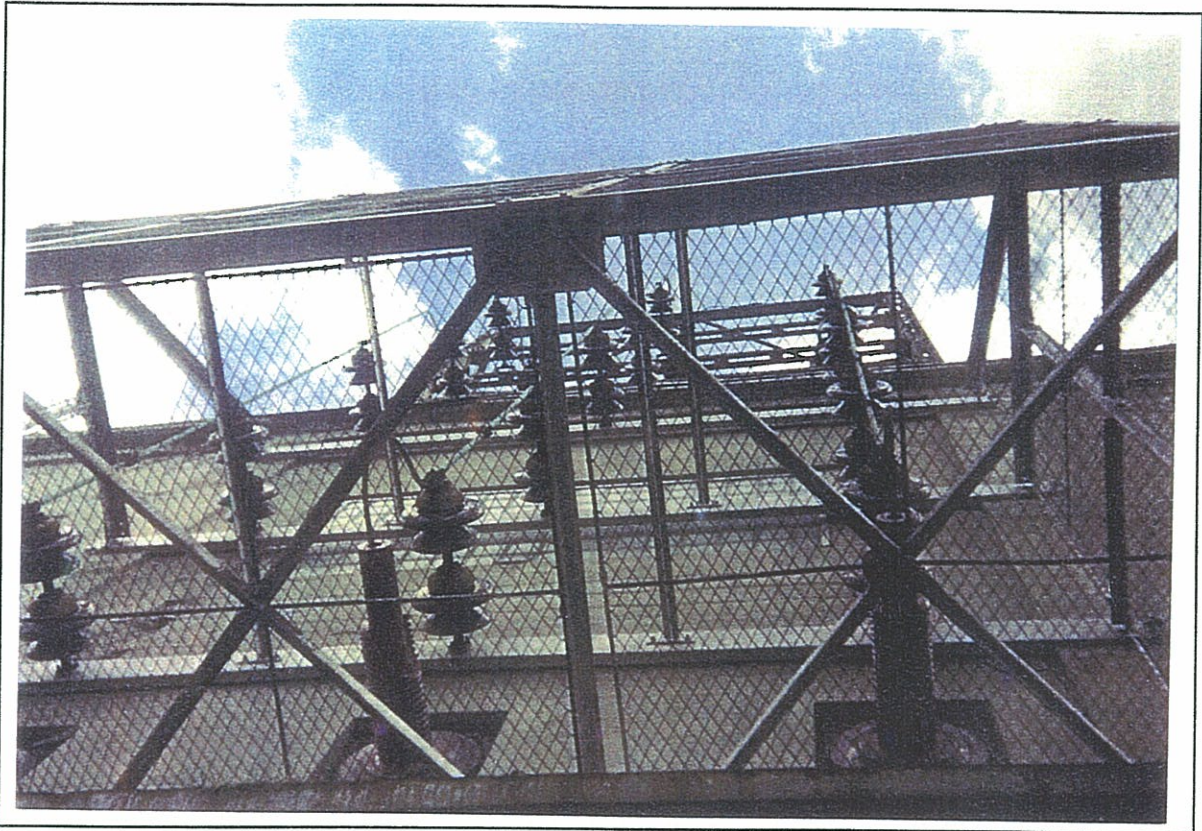
Photo 3: Damaged bushings outside the converter building - August 19, 1998

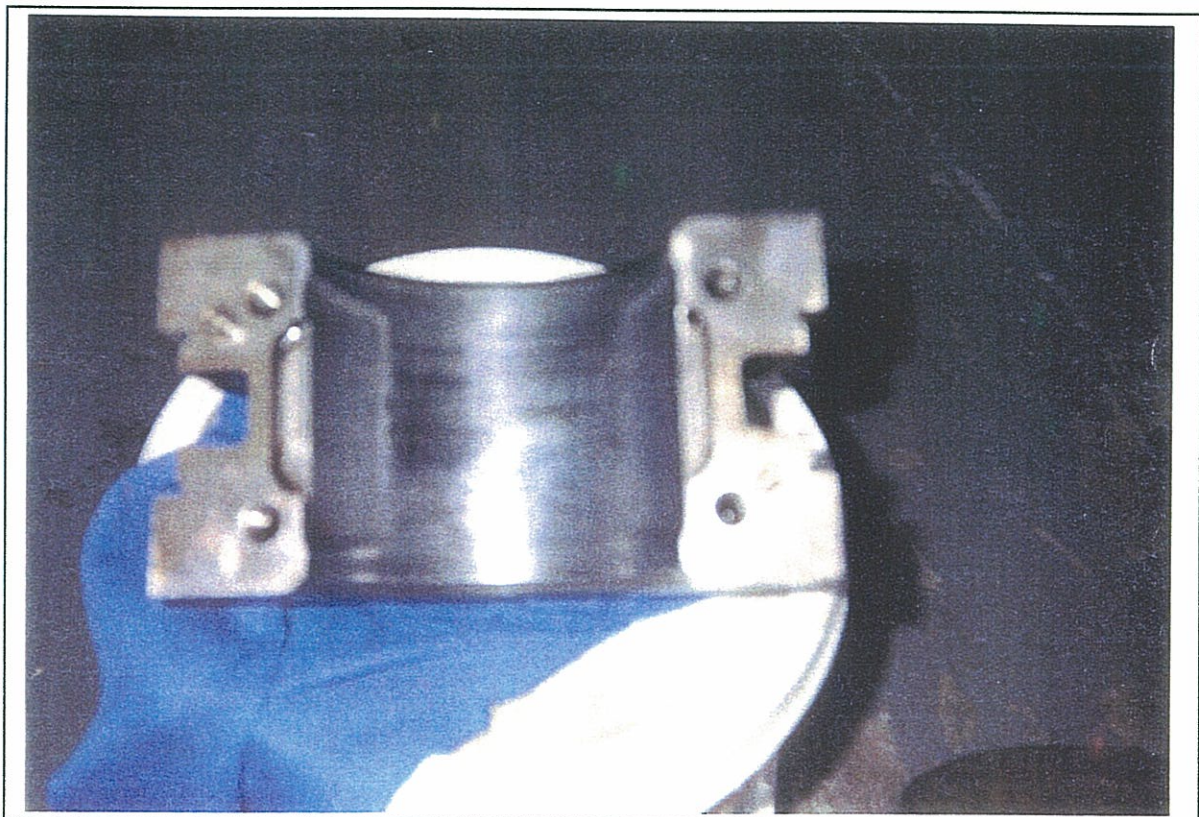
Photo 4: Shows scoring that has occurred on the pedestal bearing which has failed - August 19, 1998

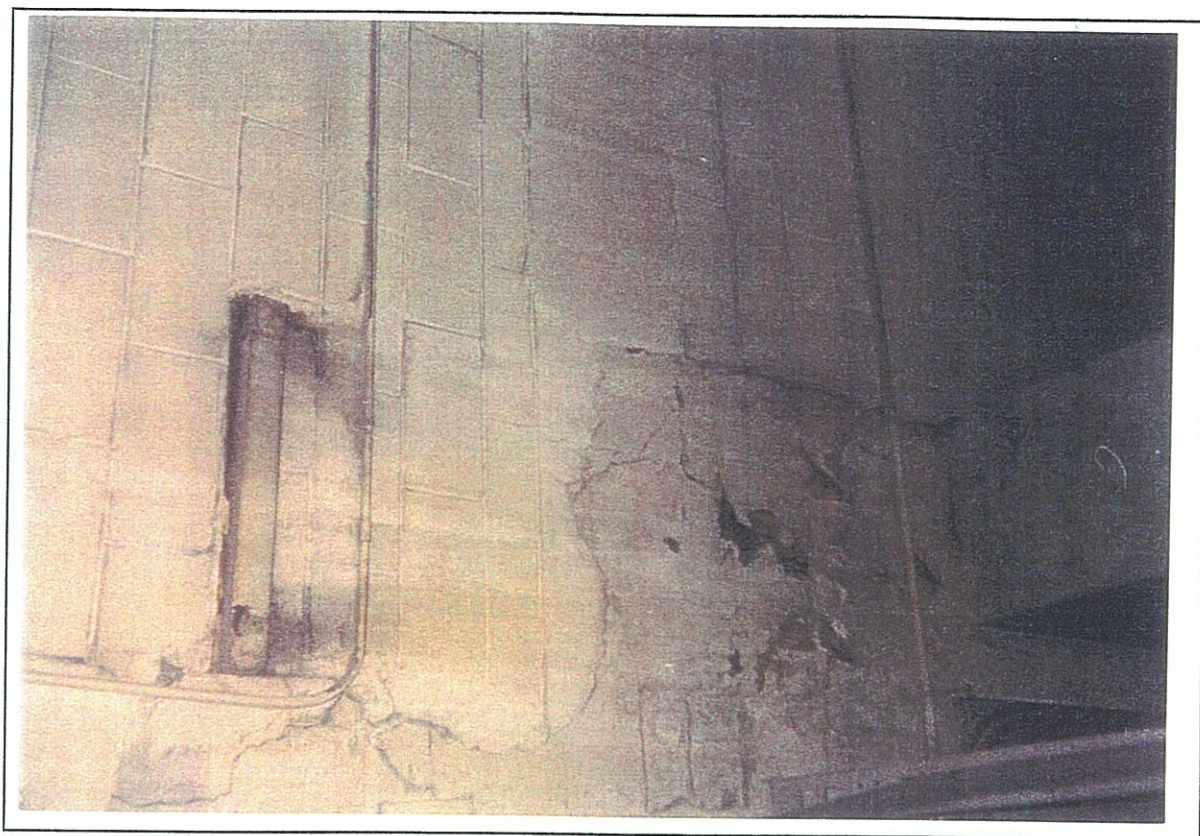
Photo 5: Type of structural deterioration in the building - August 19, 1998
