**NEWFOUNDLAND POWER INC.**

**MOBILE GAS TURBINE  
PLANNED REFURBISHMENT 2003  
PROJECT JUSTIFICATION**

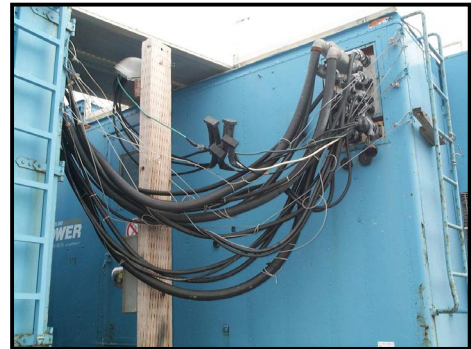
The work will also include replacing the existing auxiliary power cables between the two trailers. These cables as shown in the attached picture are deteriorated and require considerable effort to connect and disconnect. The system could be redesigned for quicker connection and disconnection to shorten preparation time when transporting the unit for emergency purposes.

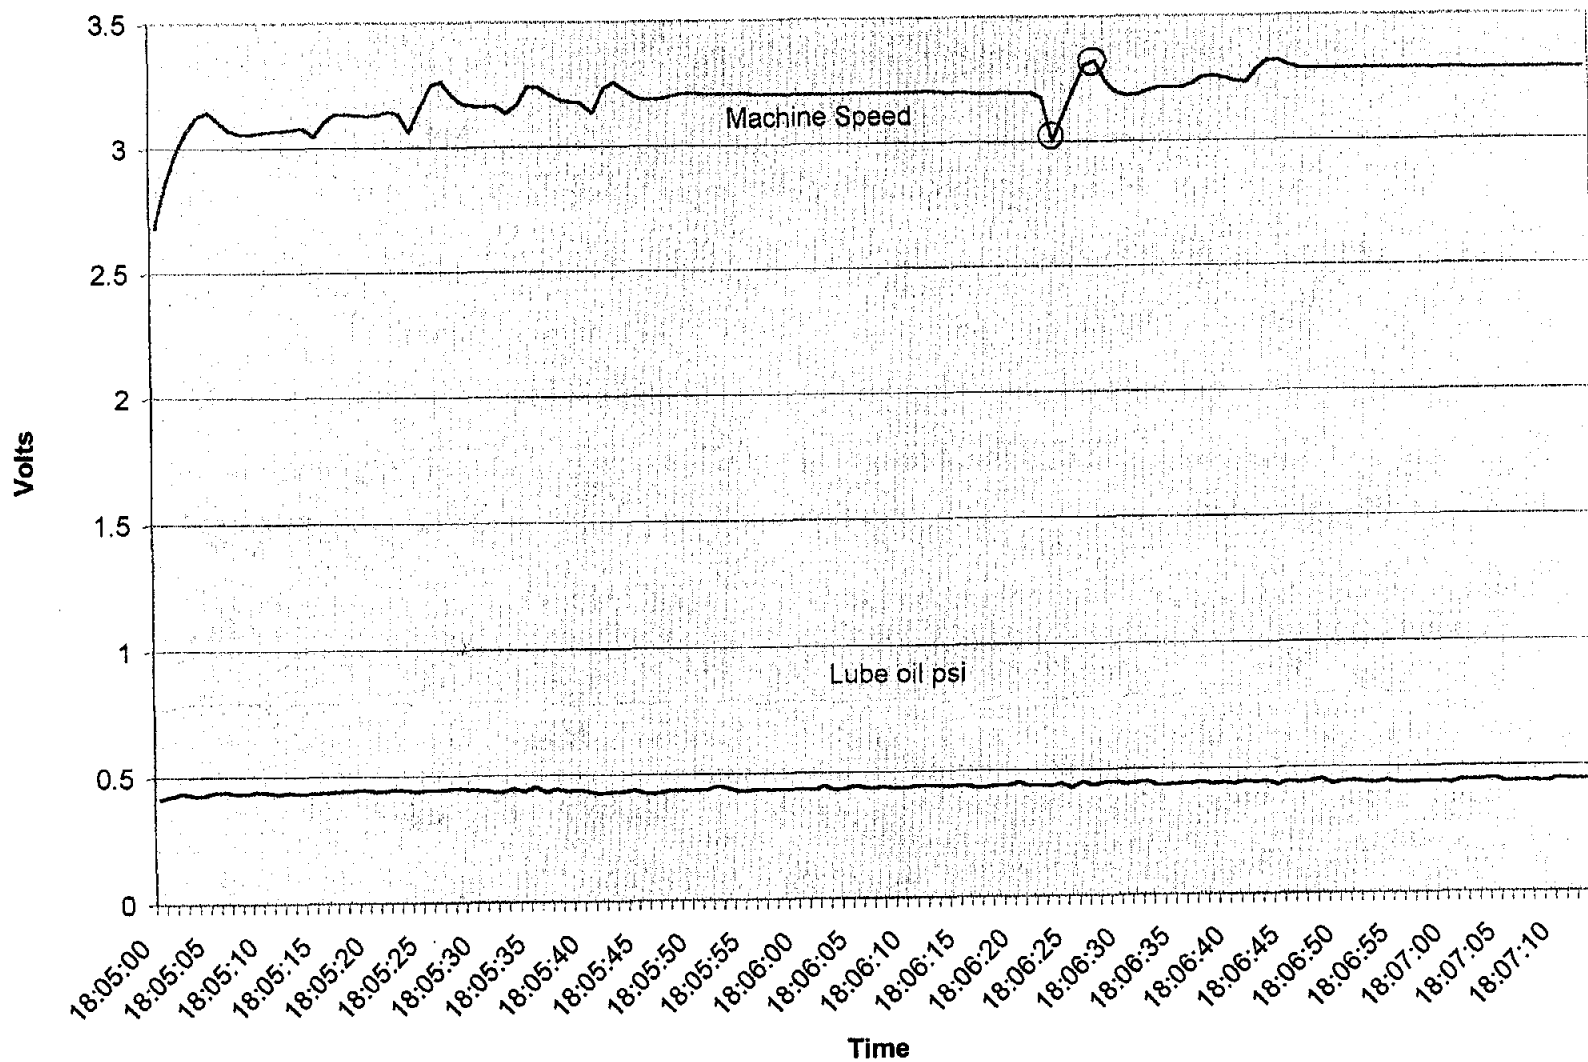
### Gas Generator Speed Oscillation

During the test there were severe speed fluctuations during loading. This has been intermittent problem with the unit over the last couple of years. The chart labeled, Gas Generator Speed Oscillation, shows speed swings of 614 rpm during loading. Photo of the combustion can shows the heat damage to the combustor during a run in January when the machine was surging during online operation supplying local load.

614 RPM pk to pk

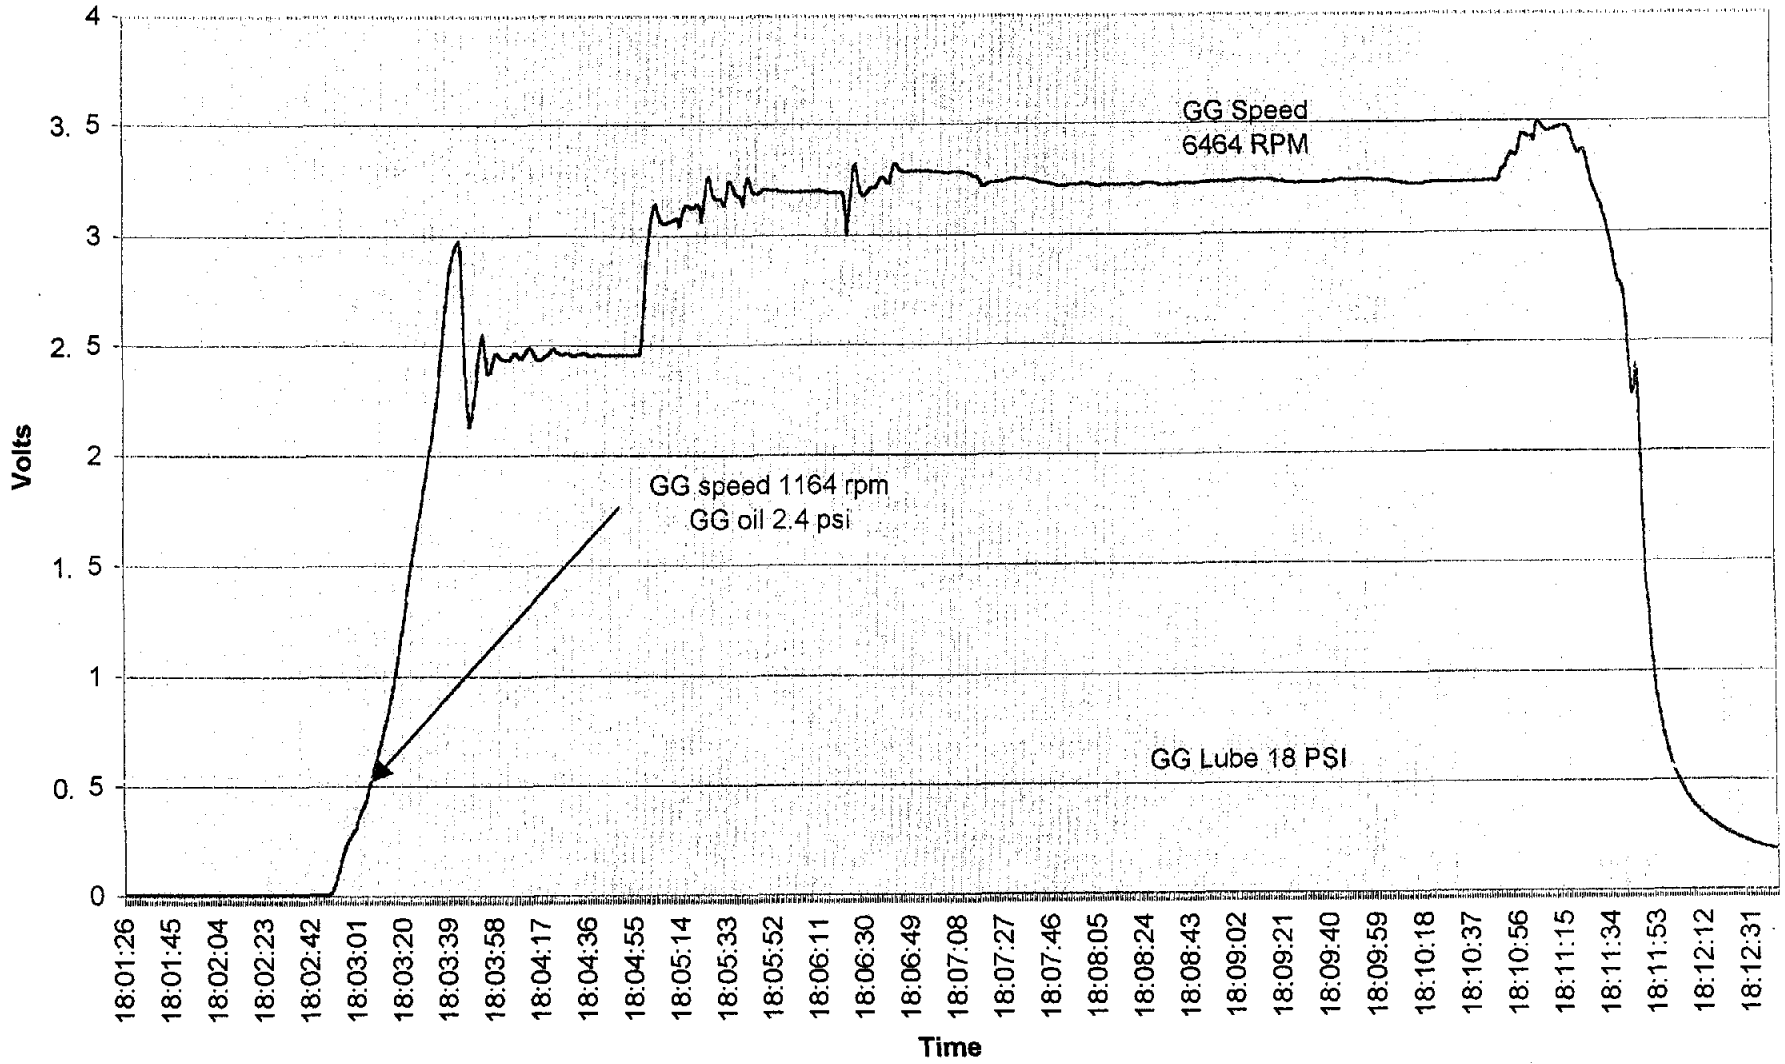
### Gas Generator Lube Oil Pressure & GG Speed

A pressure transducer was connected to the oil supply line and the engine speed and pressure were monitored with a data logger. The unit was motored to 700 rpm a small pressure increase noted prior to shutdown. A test run was performed the unit tripped on GG low oil pressure, during the test, relay 63 GGL was chattering. The pressure switch contacts were checked ok. The relay coil at this point had failed open circuit, the relay was replaced and the unit re started. The unit was placed on line GG lube oil supply pressure 18 psi. There is no significant increase in lube oil pressure until the GG reached 1000 rpm. See the attached chart showing lube oil pressure vs GG speed.

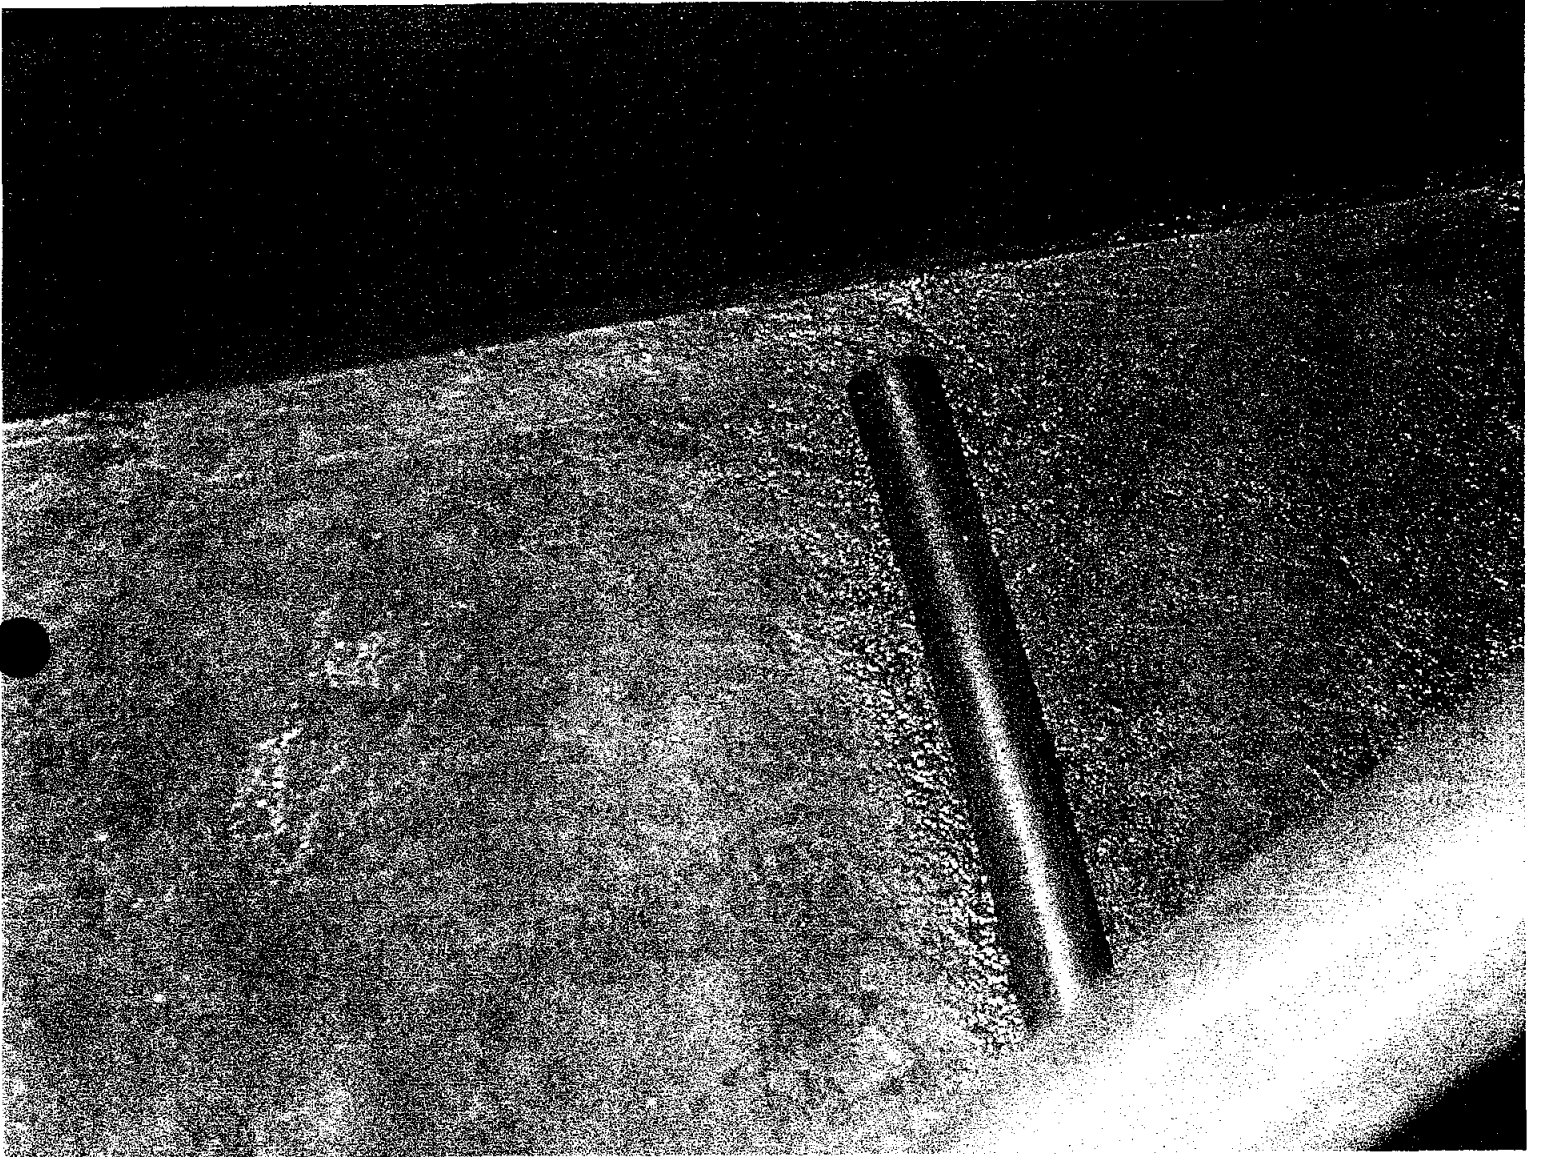
Over heating of The combustion can lead to surging  
on the governor
