Diesel Power Plant Review

Newfoundland Power Inc.

May 2000

Appendix A Condition Assessments of Diesel Plants

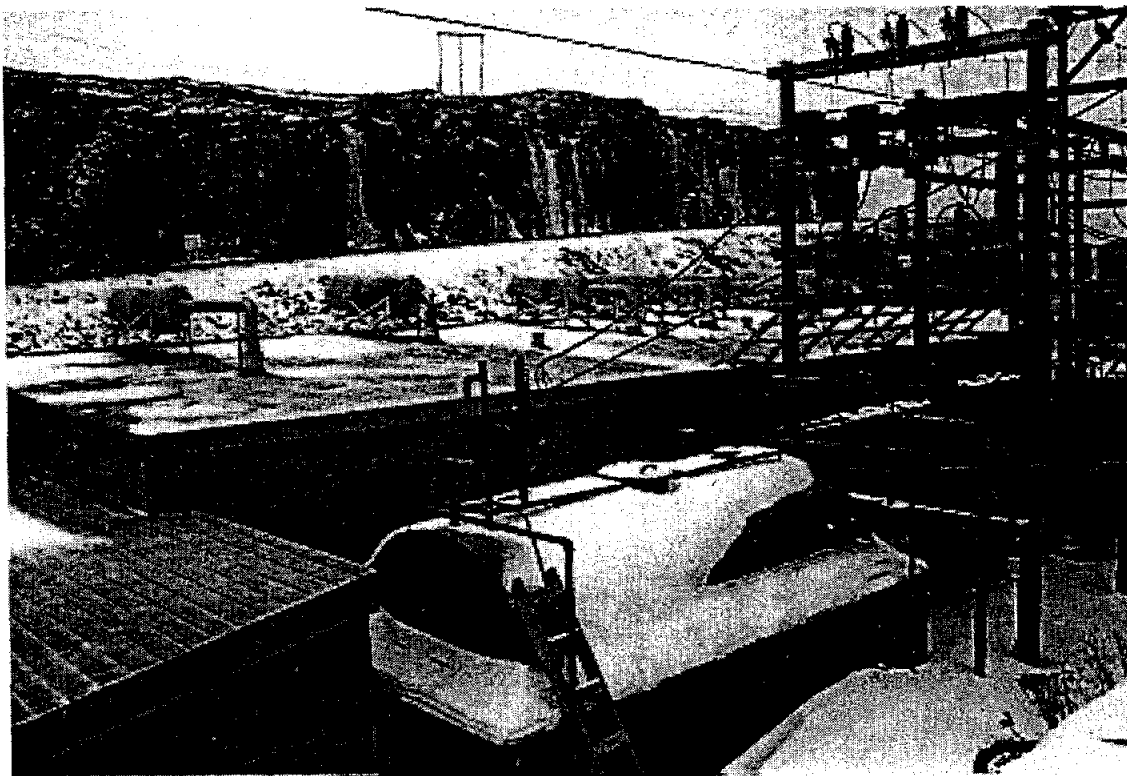
The Port aux Basques Main Diesel plant units are in poor condition. This plant has been approved for decommissioning by the Public Utilities Board in 1998.

Photo 5 View of the Port aux Basques Main Plant Powerhouse with fuel tank in the foreground.

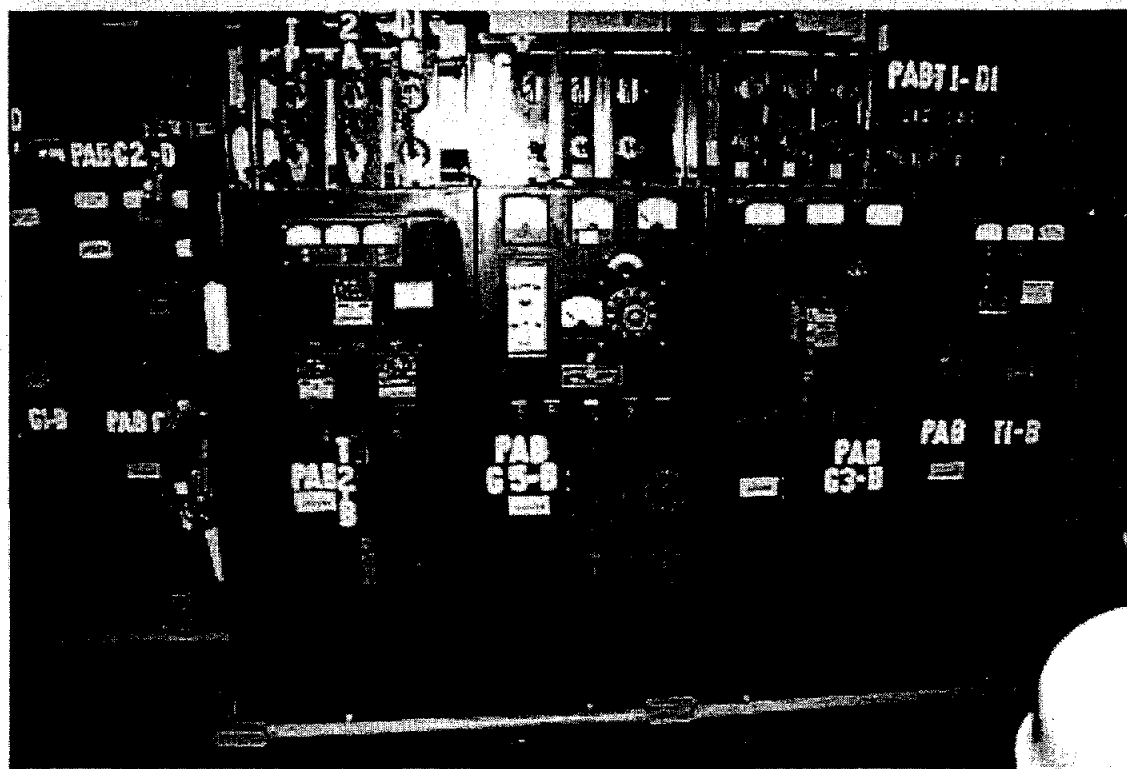
Overall units are in fair to good operating condition. Unit #2 generator is faulted and has yet to be repaired. Some mufflers require rebuild. Generators require cleaning. The switchgear was manufactured in 1937 and is obsolete. The only unit protection is overcurrent on the main breaker. Fuel tank system is in excellent condition.

Photo 8 Port aux Basques Main Diesel plant open contact-type switchgear.

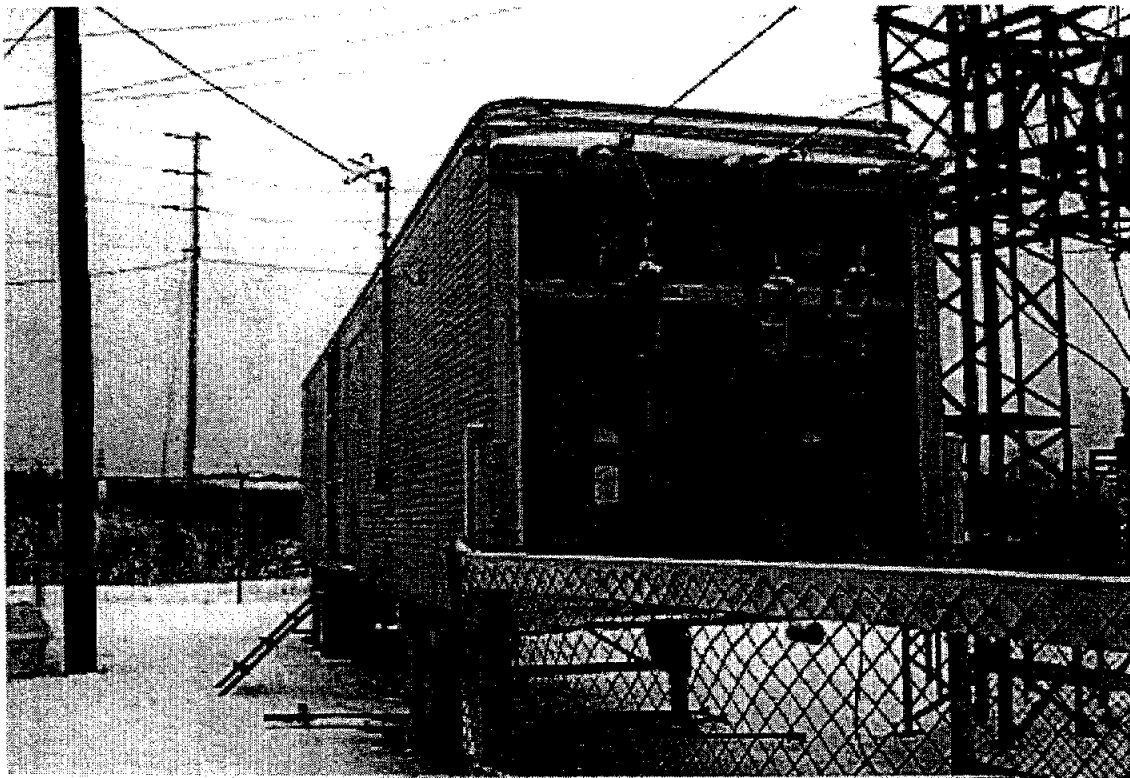
Portable Diesel #1 is in satisfactory condition with only minor oil leaks and dirty radiators and fans. The continued use of this unit will require the installation of secondary containment for the fuel tanks onboard, an engine overhaul, and some minor repair work to the trailer chassis.

Photo 10 View of Portable Diesel #1 unit with trailer unit and transformers.

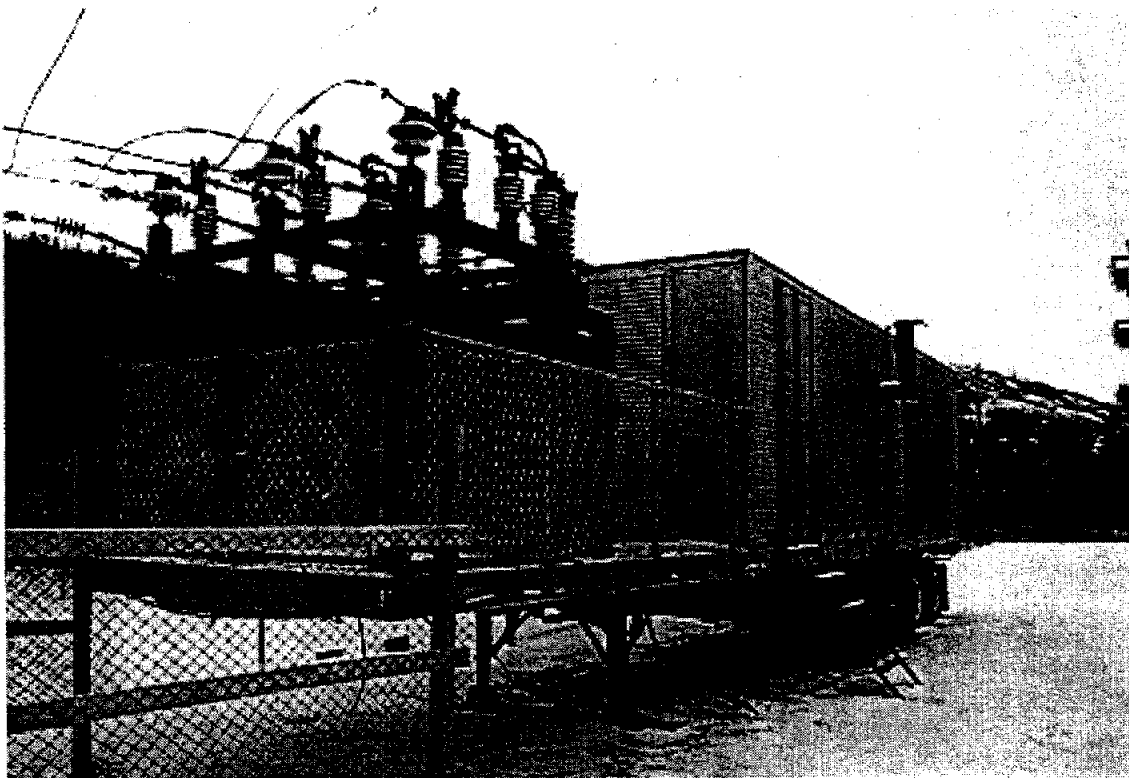
Portable Diesel #2 is in satisfactory condition with the exception of the trailer chassis. The chassis is in very poor condition and is not roadworthy. Continued use of this unit would require the replacement of the chassis with a new unit as well as an overhaul of the engine.

Photo 12 View of Portable Diesel #2 unit with trailer unit and transformer.
