Inspection and Testing of Substation Concrete Pads And Foundations

Newfoundland Power Inc.
55 Kenmount Road
P.O. Box 8910
St. John's, N.L.
A1B 3P6

SGE Acres Limited
Postal Service 1086
45 Marine Drive
Clareville, NF
A0E 1J0

SGE Project #: C022319.01
Date: August 2002

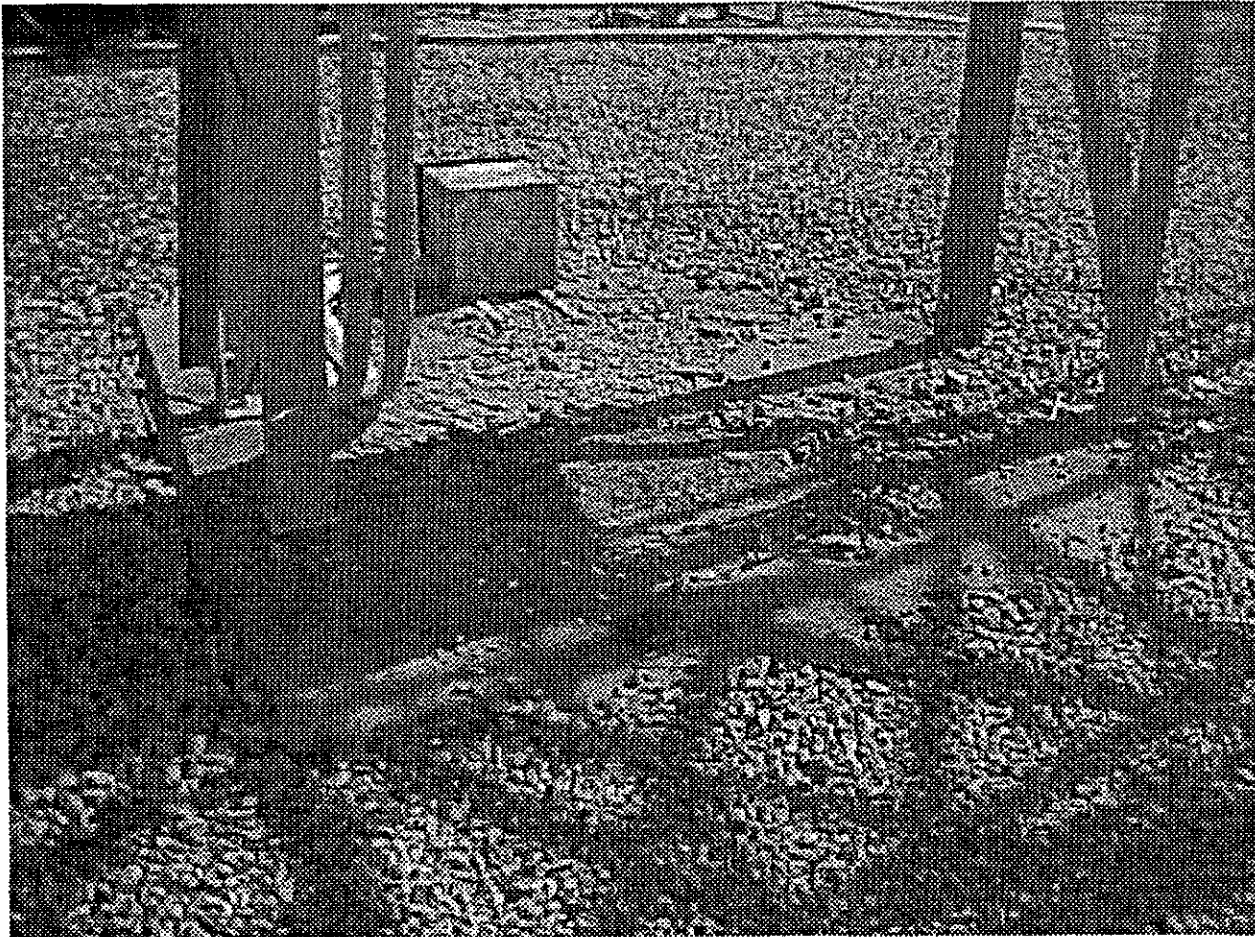
This is probably the most common deficiency condition observed in the concrete foundations and pads. It is characterized by spalling, chipping or scaling of concrete surfaces and exposure of aggregate on surface due to disintegrated sand cement matrix.

Figure 1.1 – Typical surface scaling of foundation.

- **Type 'A' Repair** – This repair procedure is recommended for concrete with Condition 'A' type deficiencies. All surface loose delaminated concrete should be removed as well as all dirt, rust stains and other inhibiting materials. The area for patching should be a minimum 6 mm in depth and this area should be thoroughly cleaned by means of high pressure water blasting or other appropriate mechanical means. Proper preparation of the substrate and the use of an approved bonding agent will ensure a good bond between the patch and the existing concrete. The substrate should be washed with clean water and should be saturated surface dry (SSD) prior to the application of an approved mortar. If the repair requires several lifts then each lift would normally be applied as soon as the previous lift will support the new one. The maximum thickness per lift should be no greater than 38 mm. Adequate curing of the patched areas is important to avoid shrinkage cracking in the repaired area.

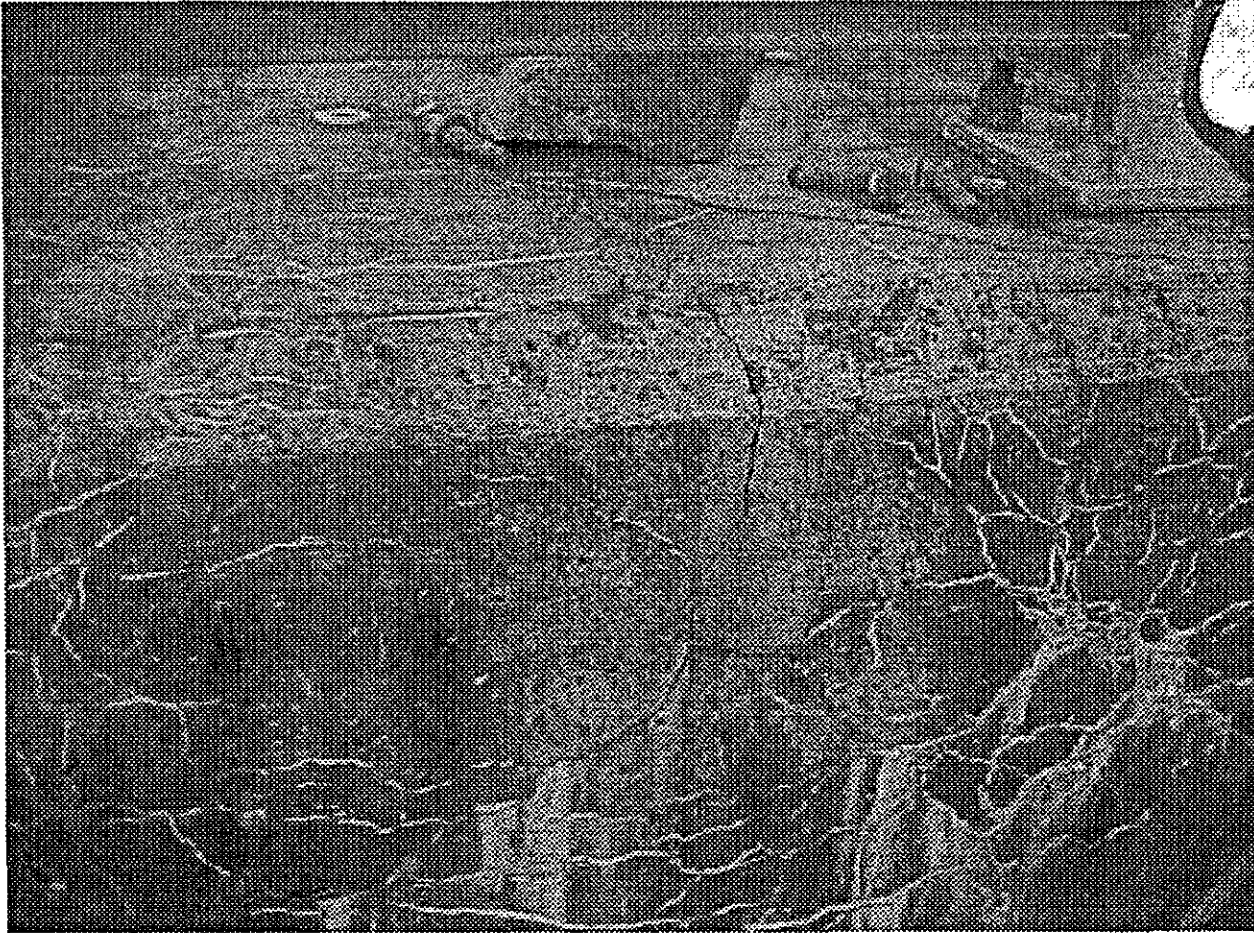
Condition 'B' includes all forms of cracks such as hairline and alligator (map) where the width across the crack is less than 1 mm at the widest opening. This condition was most prevalent on the top surface of the pads and foundations and on the sides down to ground surface level.

The alligator or map cracking observed at several sites had a white gel on the surface along the line of the cracks. This condition usually indicates an adverse reaction between the alkalis in the cement and some of the aggregates used in the mix.

Figure 1.2 – Severe alligator or map cracking with evidence of alkali-aggregate reaction.

- **Type 'B' Repair** – This repair procedure is recommended for concrete with Condition 'B' type deficiencies. Extensive hairline and alligator or map cracking throughout a structure is difficult to correct when the width of the cracks are small. A sealant coating is recommended as a preventative measure to avoid further deterioration that would be caused by moisture infiltration through the cracks. This sealant should be an approved epoxy coating, and if installed correctly, should extend the useful life of the concrete structure.

The concrete surface to be sealed must be clean and sound. This would normally be attained by hydro blasting (or other acceptable mechanical means) of the cracks and surface area surrounding the cracks. All laitance, rust stains and loose concrete to be removed and the surface of the concrete should be saturated surface dry during application of the approved sealer. These are the basic procedures used for application of epoxy coatings; however, it is very important that whatever product brand is selected, the manufacturers directions for application must be followed as closely as possible.

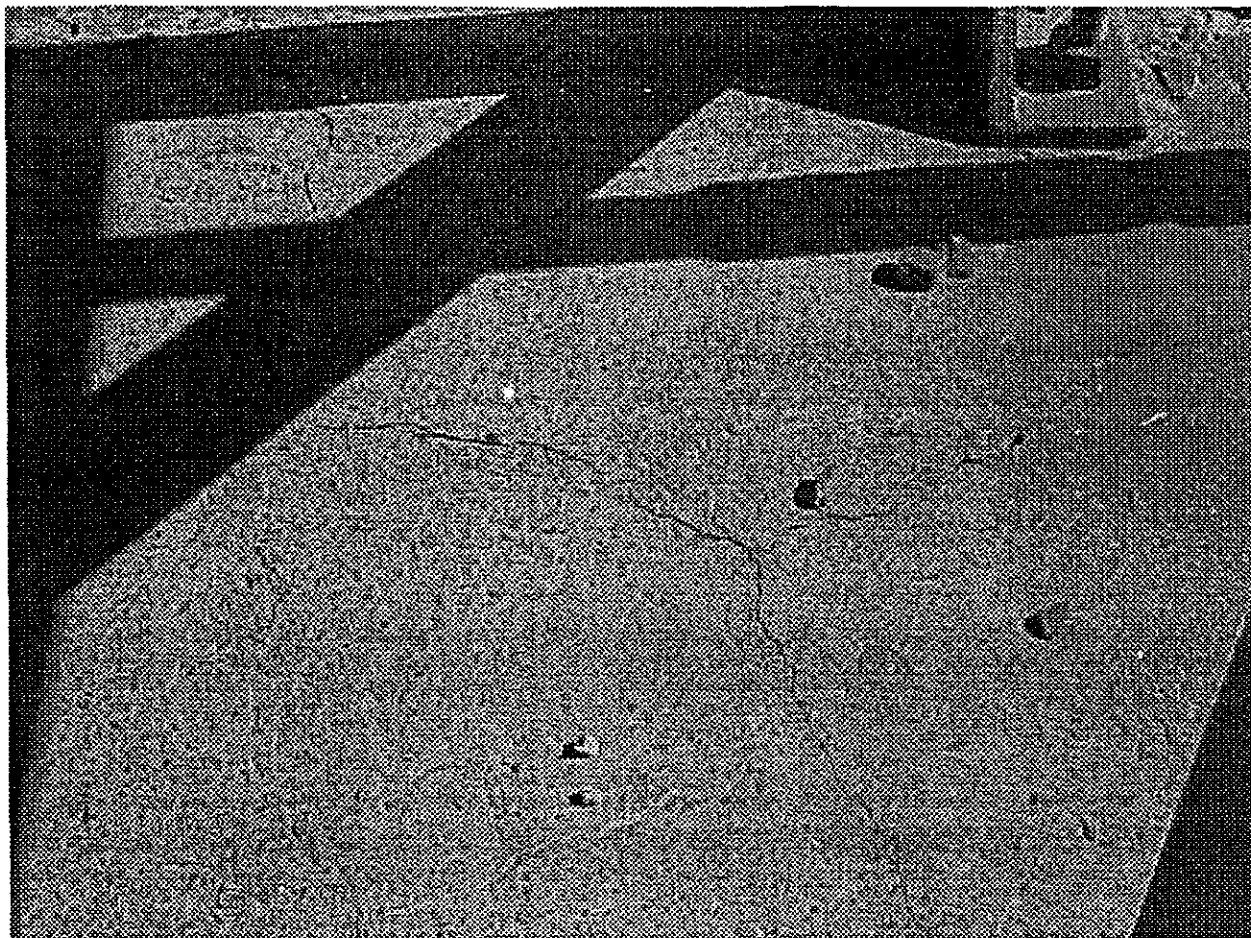
This condition is similar to Condition 'B', however, it is typical of cracking where the crack width is larger than 1 mm across. This condition was evident mostly in the high and low voltage structure foundations which typically had what appears to be shrinkage cracking that extends from the middle of the top surface of the foundation out to the four sides. There were very few cases where this type of cracking was observed in the concrete pads.

Figure 1.3 – Typical cracking for Concrete Condition ‘C’.

- Type 'C' Repair – This repair procedure is recommended for concrete with Condition 'C' type deficiencies. It is recommended that all cracks greater than 1 mm in width be epoxy injected with an approved epoxy injection material and injection system. Prior to injection, the cracks should be thoroughly cleaned to remove dirt, laitance, grease, foreign particles and disintegrated material.

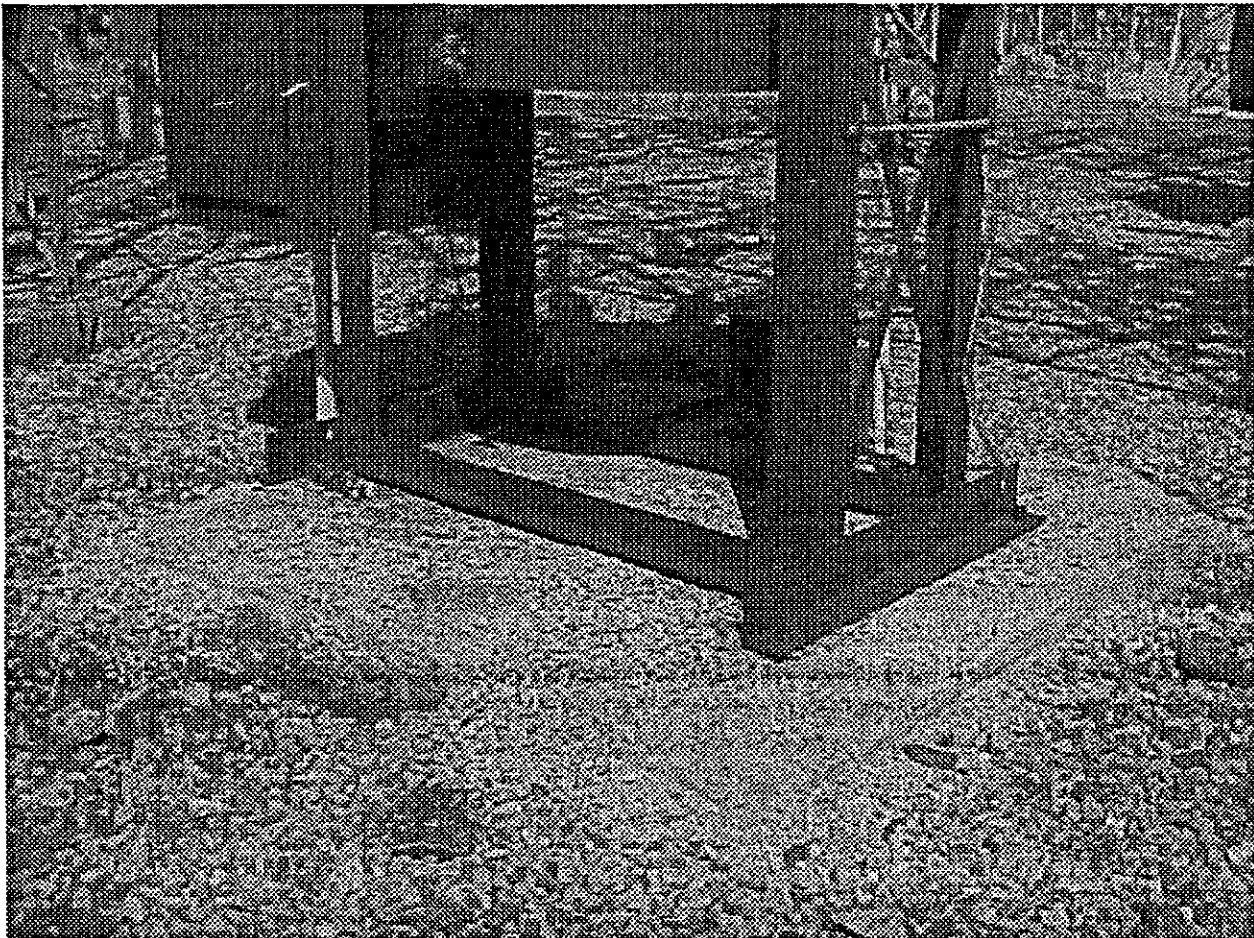
This condition is similar to Condition 'D', however, with more extensive deterioration or deterioration that extends well below ground surface level. A foundation/pad was put in this category because the cost to repair to an acceptable level compared to total replacement of the foundation or pad would not be cost-effective.

Figure 1.4 – A typical concrete pad that would be a Condition 'E'.

- Type 'E' Repair – This repair procedure is recommended for concrete with Condition 'E' type deficiencies. It is recommended that pads or foundations in this condition be removed completely and replaced with a new concrete structure. It is felt that the cost to repair these structures to an acceptable standard compared to total replacement would not be justified.
