1 **In reference to Schedule “B”, page 31 of 82 – Rebuild Transmission Lines – at a project**
2 **cost of \$4,129,000:**

Project 12790-36

RE: FAILURE ANALYSIS OF WINNIPEG AASC CONDUCTOR LINE

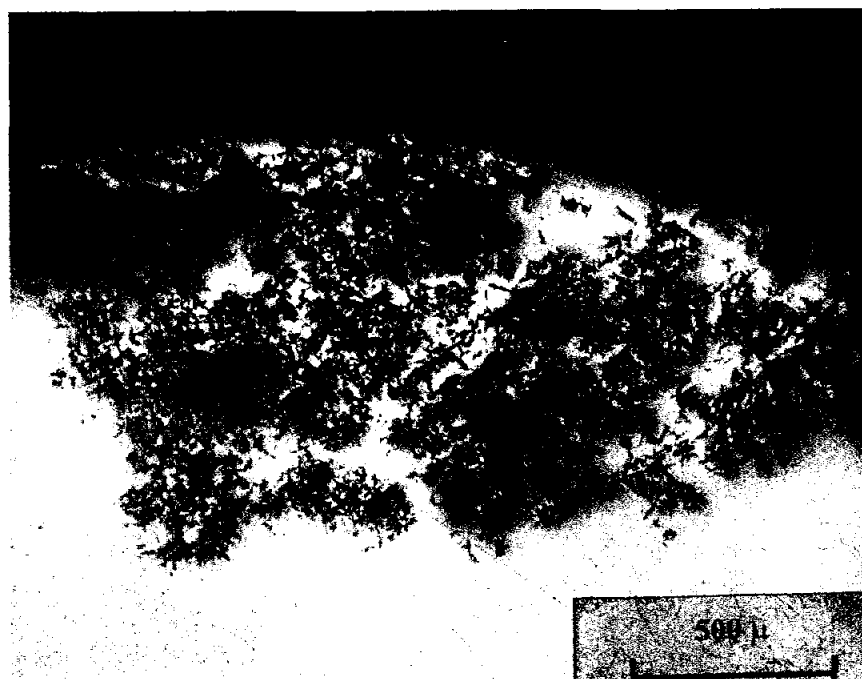
Cross sectional specimens from two outside strands and the center strand for both the damaged and undamaged samples were mounted in acrylic, and polished for metallographic examination. The aluminum wires had a fine-grained microstructure. Pitting due to corrosion was evident in all samples. Figures 4-7 are micrographs of the worst case pitting from each strand mounted. The center strand of both samples had extensive pitting around the whole cross section while the outside strands had extensive pitting in about a third of their cross sectional area, corresponding to the area that was in contact with the center strand. The strands from the failed sample had slightly worse corrosion pitting than the non-damaged sample.

Figure 4: Worst case corrosion from center strand of failed sample

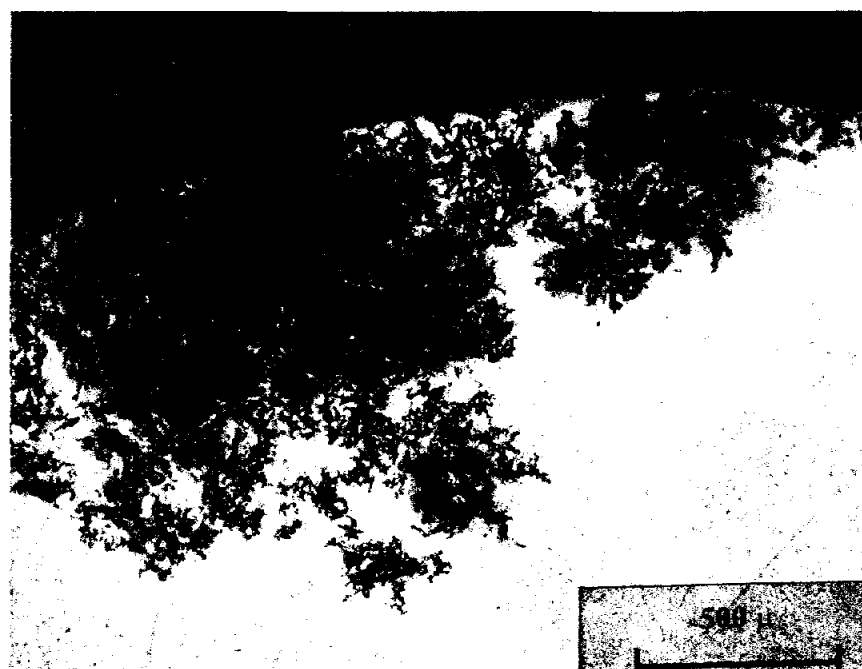
Figure 5: Worst case corrosion from center strand of non-damaged sample

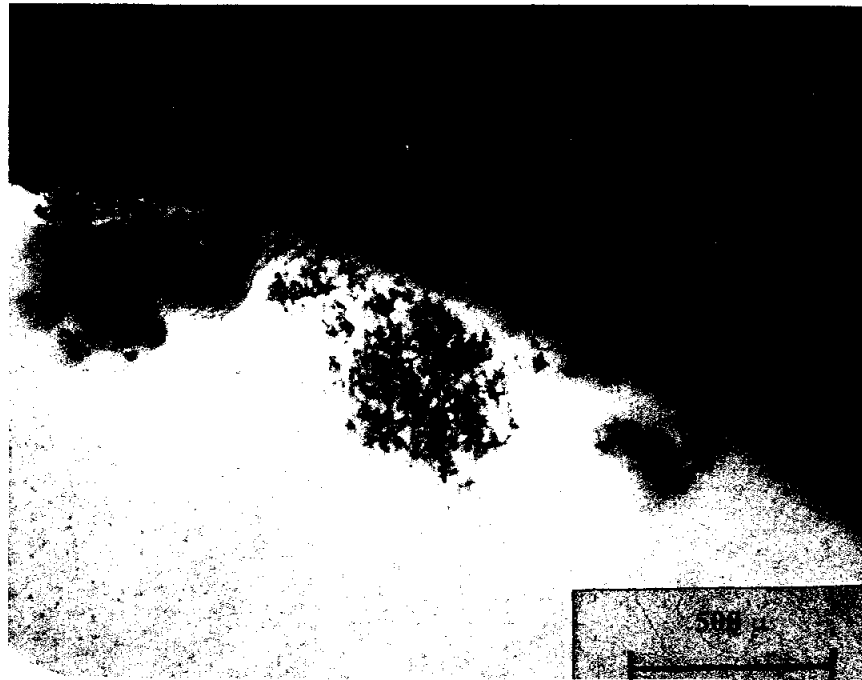
Figure 6: Worst case corrosion from outside strand of failed sample

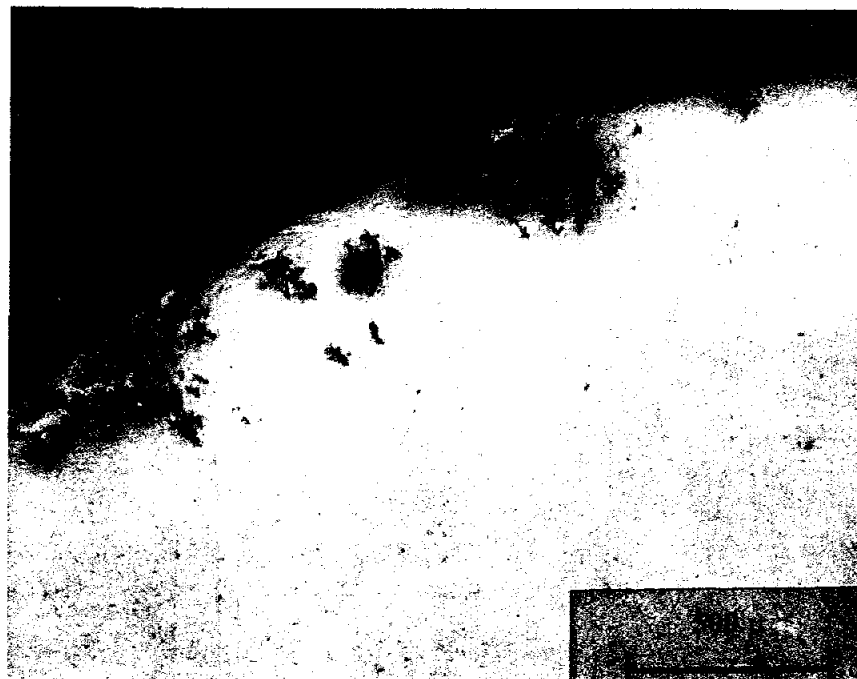
Figure 7: Worst case corrosion from outside strand of non-damaged sample
