Service Interruptions in the Community of Branch

Report on the  
Service Interruption History  
Community of Branch

Newfoundland Light  
& Power Co. Limited  
March 27, 1995

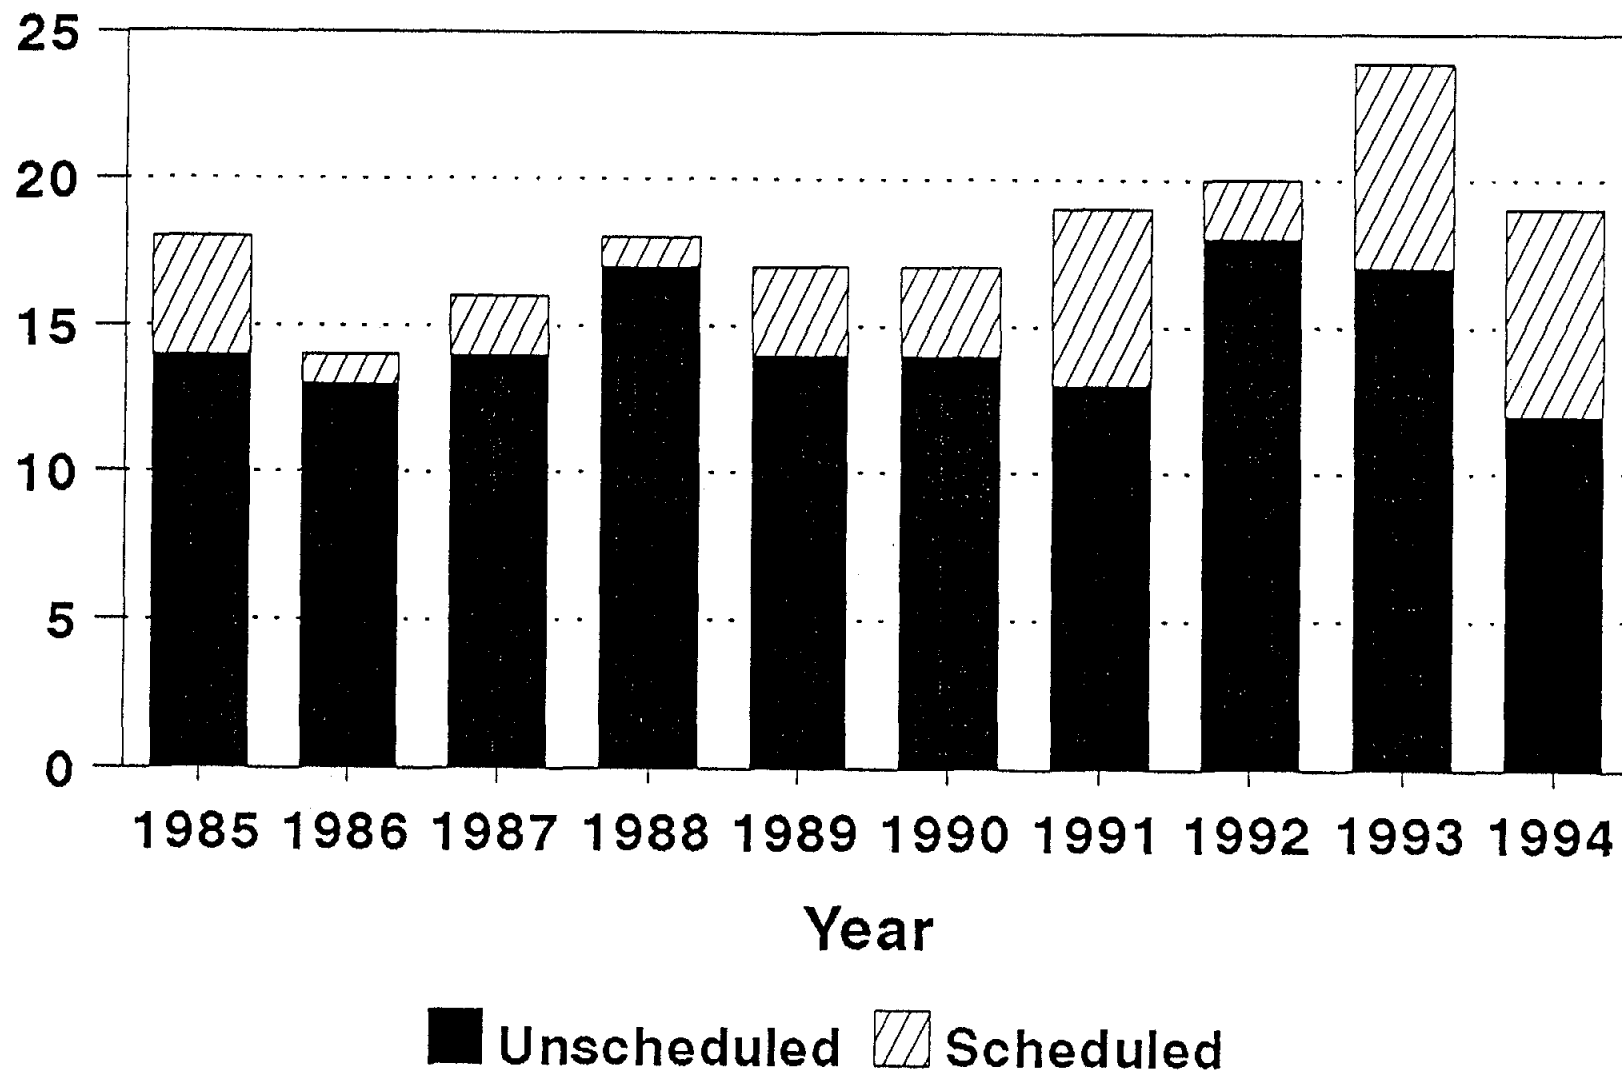
Fig. # 1 (Excludes the Dec. 08 outage)

To permit a review of these outages in an historical context, the Company has provided a ten year graphic history of interruptions in this area. (Figures 1, 2 & 3). While the total number of interruptions appear to be high at first blush, it is noteworthy that the number of unscheduled outages for 1994 (excluding the December 8th, 1994 experience) was the lowest of the past ten years for this feeder (Figure 1). The average duration of these unscheduled outages was the third lowest for the past ten year period and the total unscheduled interruption time for 1994 was the second lowest for the time period (Figure 2 & 3).

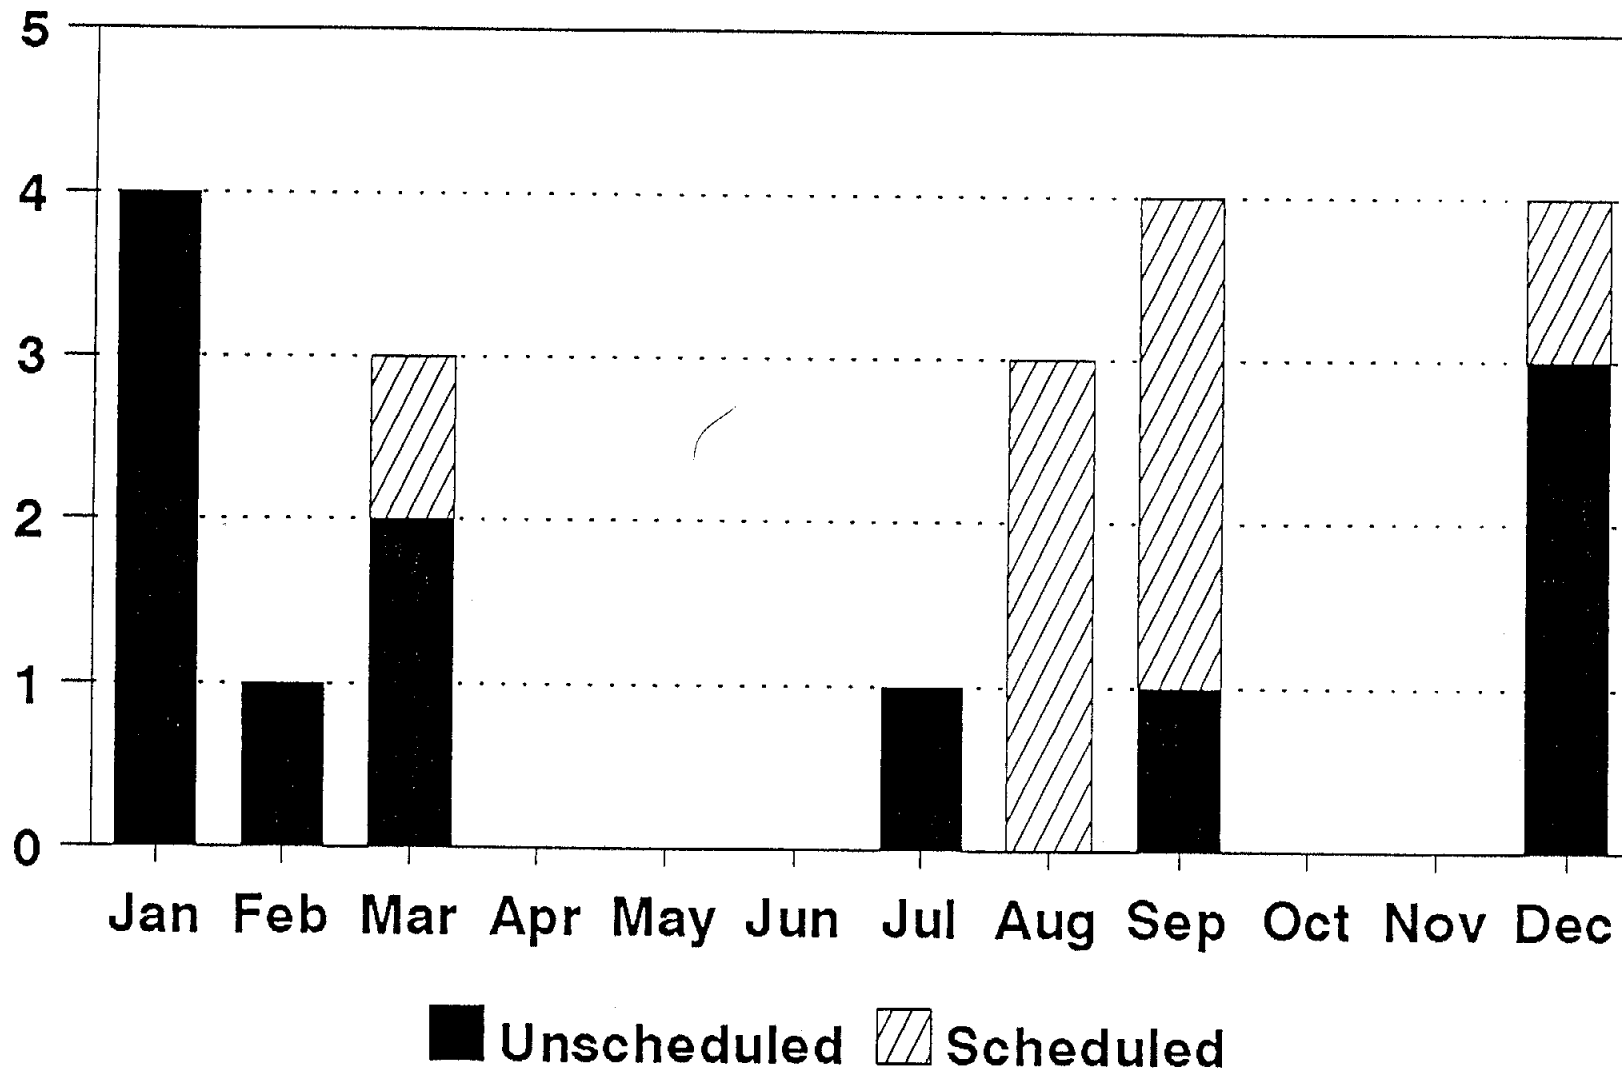
Fig. # 4 (Includes the Dec. 08 outage)

Also provided are graphic depictions of the frequency, average duration and total interruption time for 1994 interruptions by month (Figure 4, 5 & 6). From these it can be seen that January and December had the highest number of unscheduled interruptions. This is due to the weather conditions at that time of year. High winds combined with icing place extra loading on the line.
