1999 Dam Safety Inspection Reports

Seal Cove Development

NEWFOUNDLAND POWER

Subject: 1999 Dam Safety Inspection Reports
Seal Cove Development

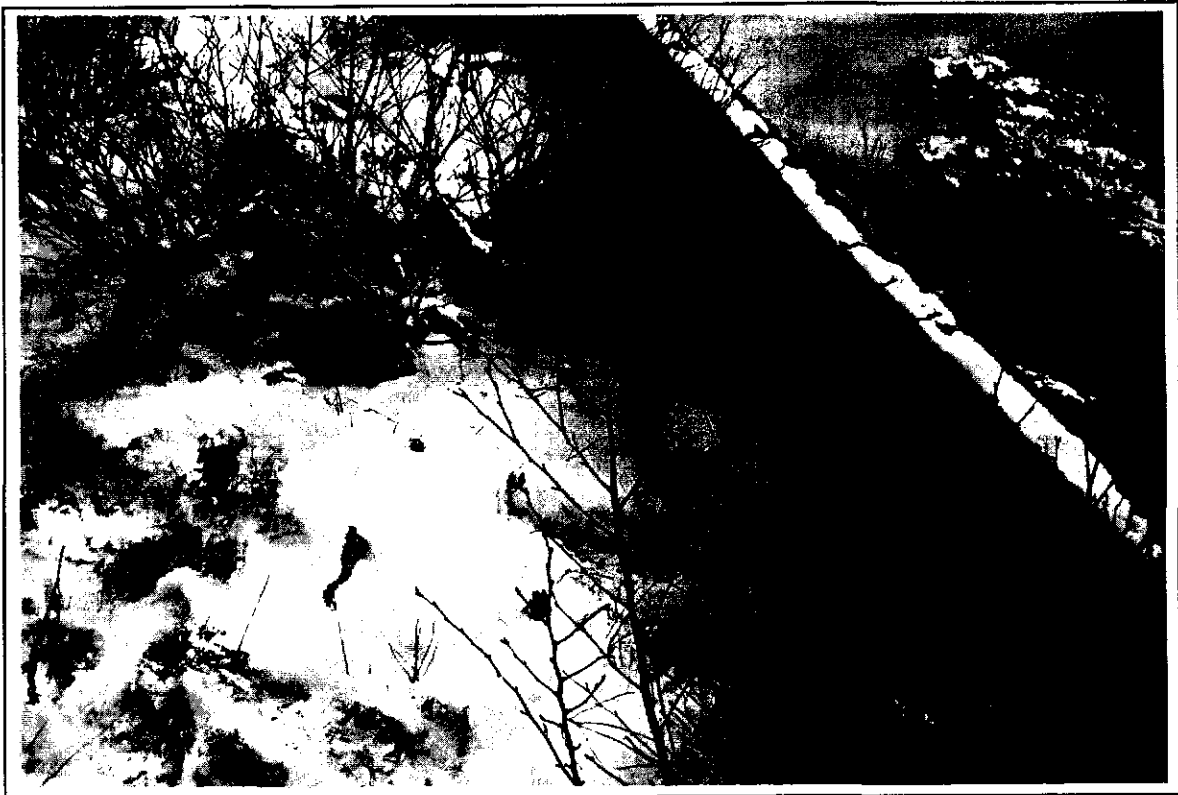
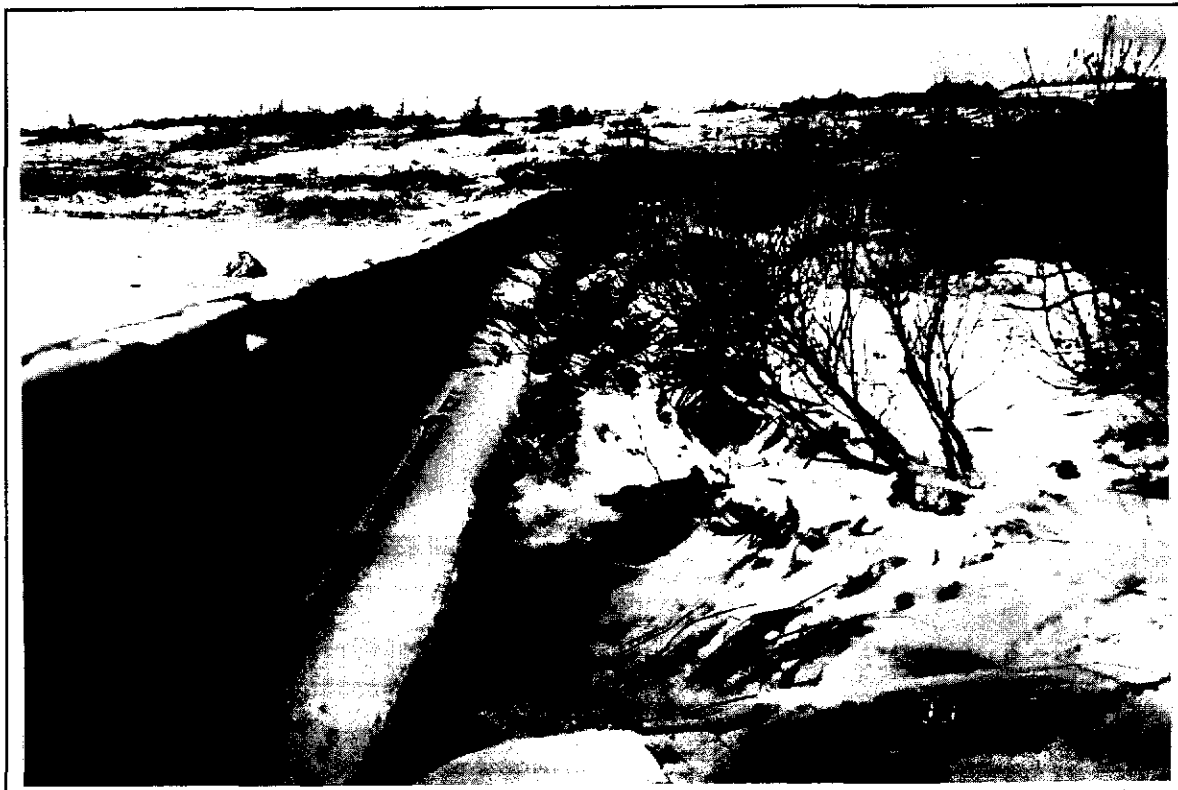
Surface cracking	<u>None</u>
Settlement	<u>Significant settlement just downstream of cutoff.</u>

Settlement of crest beind cutoff wall

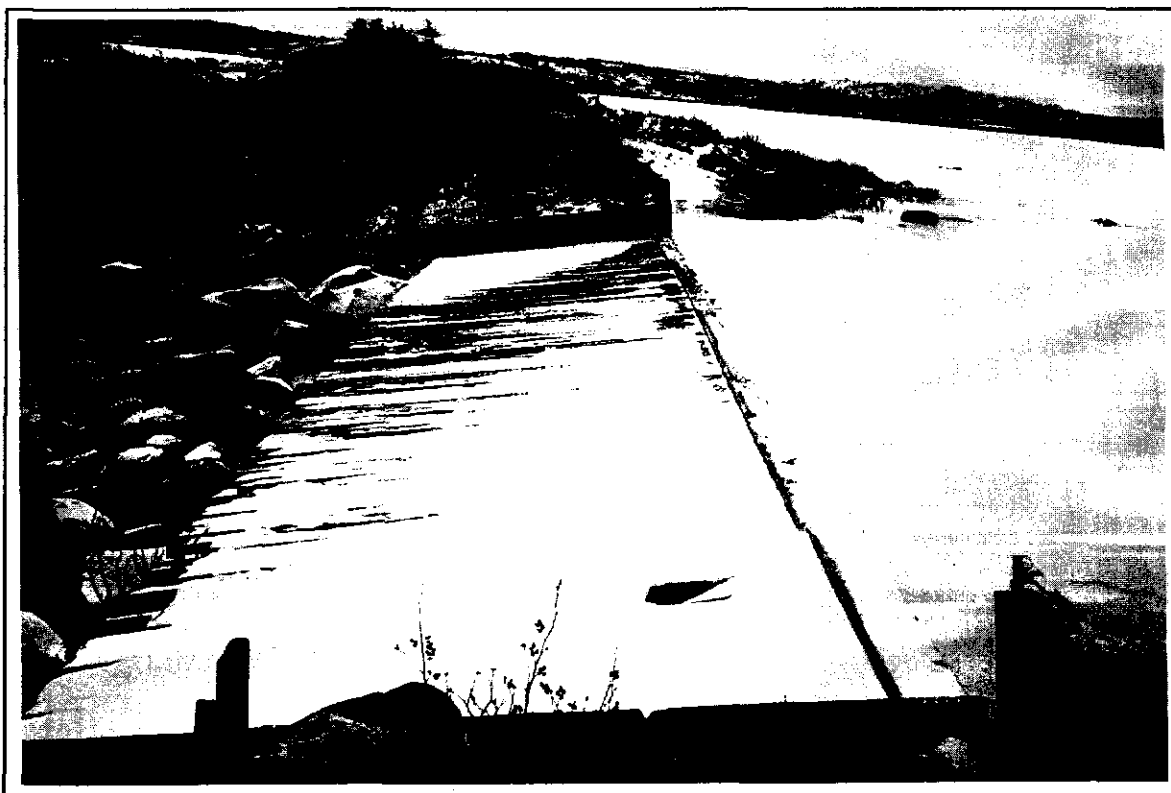
- Alders should be cleared along crest and D/S slope of dam sections.
- Excessive deterioration of structural members under spillway apron.
- Freeboard dam on right side appears low and should be checked.

Spillway apron

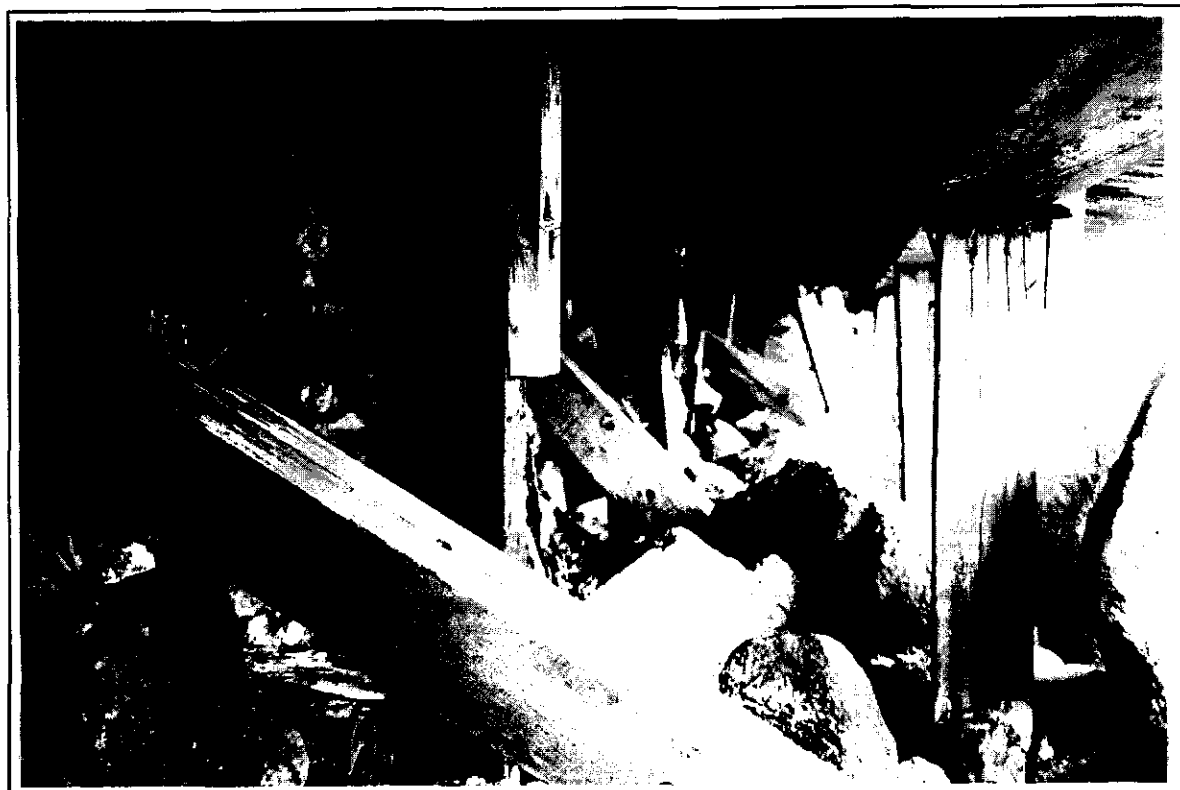
Timber structural members	<u>Deteriorated – several rotted members.</u>
Timber planking	<u>Good Condition.</u>
Crib Content	<u>Considerable settlement – additional fill required.</u> <u>Spillway requires additional rip rap under chute and downstream.</u>

Rockfill and structural members below spillway apron

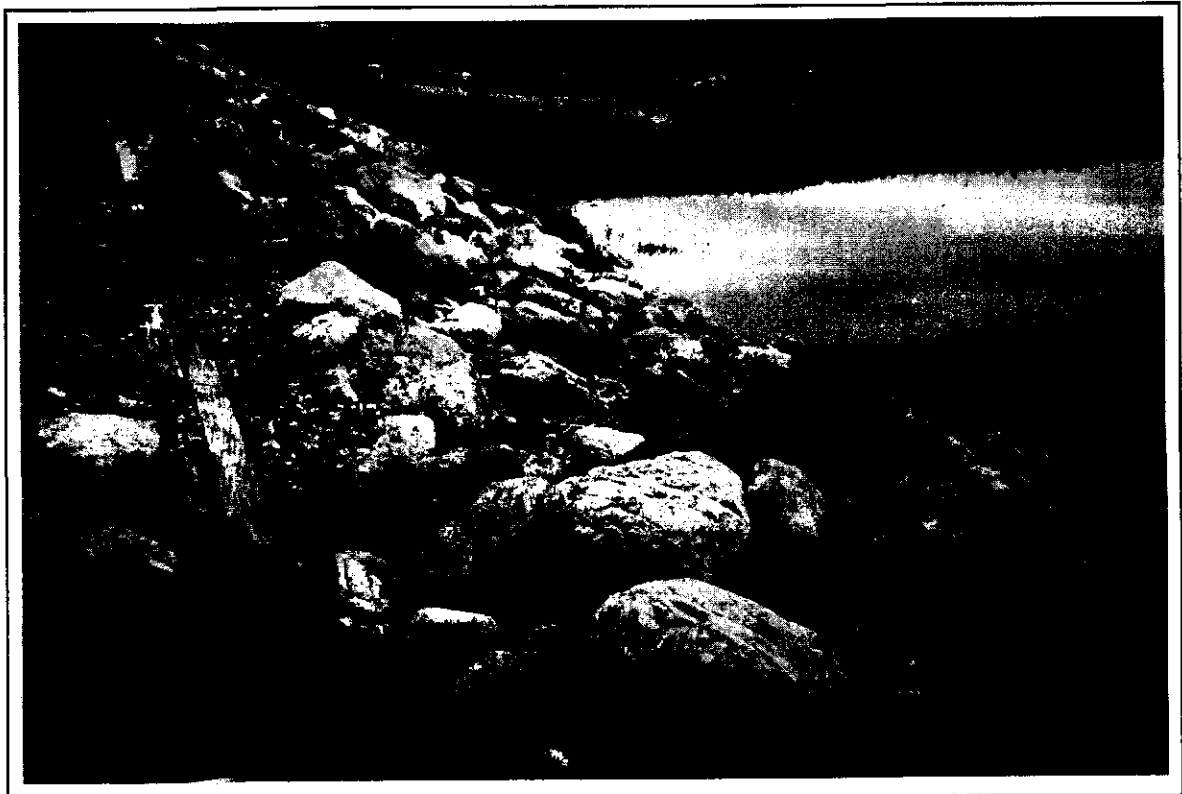
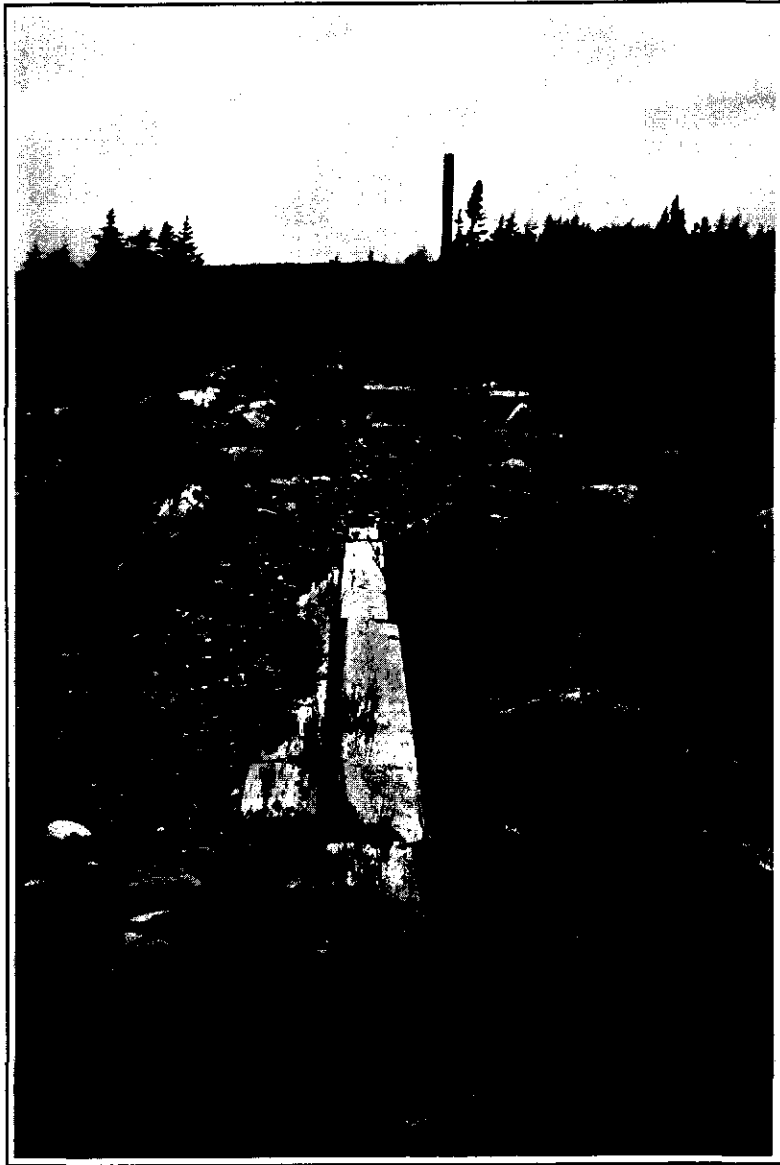
Surface cracking	<u>None - timber / parged concrete cutoff wall along crest in poor condition throughout.</u>
Settlement	<u>None</u>
Lateral movement	<u>None</u>
Camber	<u>None - crest fairly narrow. Some erosion / settlement in few areas near cutoff wall.</u>

Deterioration of crest and cutoff

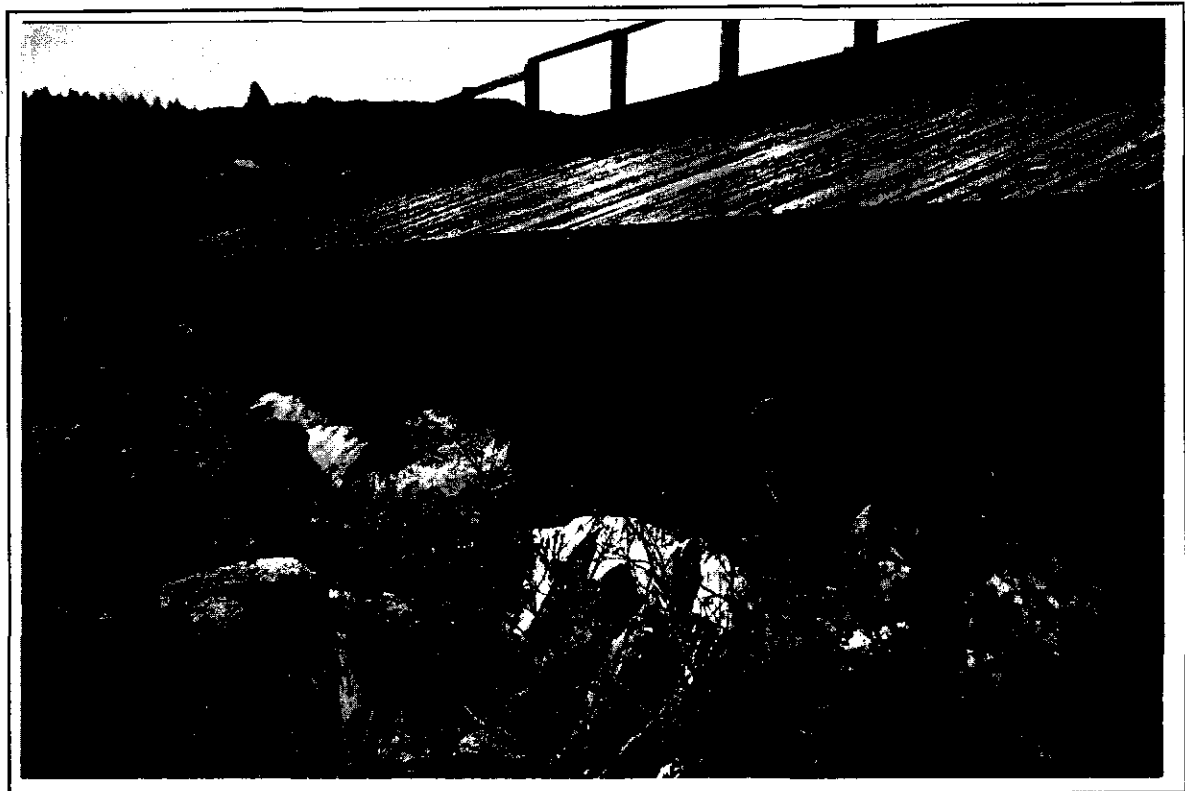
Remarks Downstream apron showing signs of deterioration.
Cribbing requires additional ballast/rockfill.
Handrail on spillway should be replaced.

Downstream apron

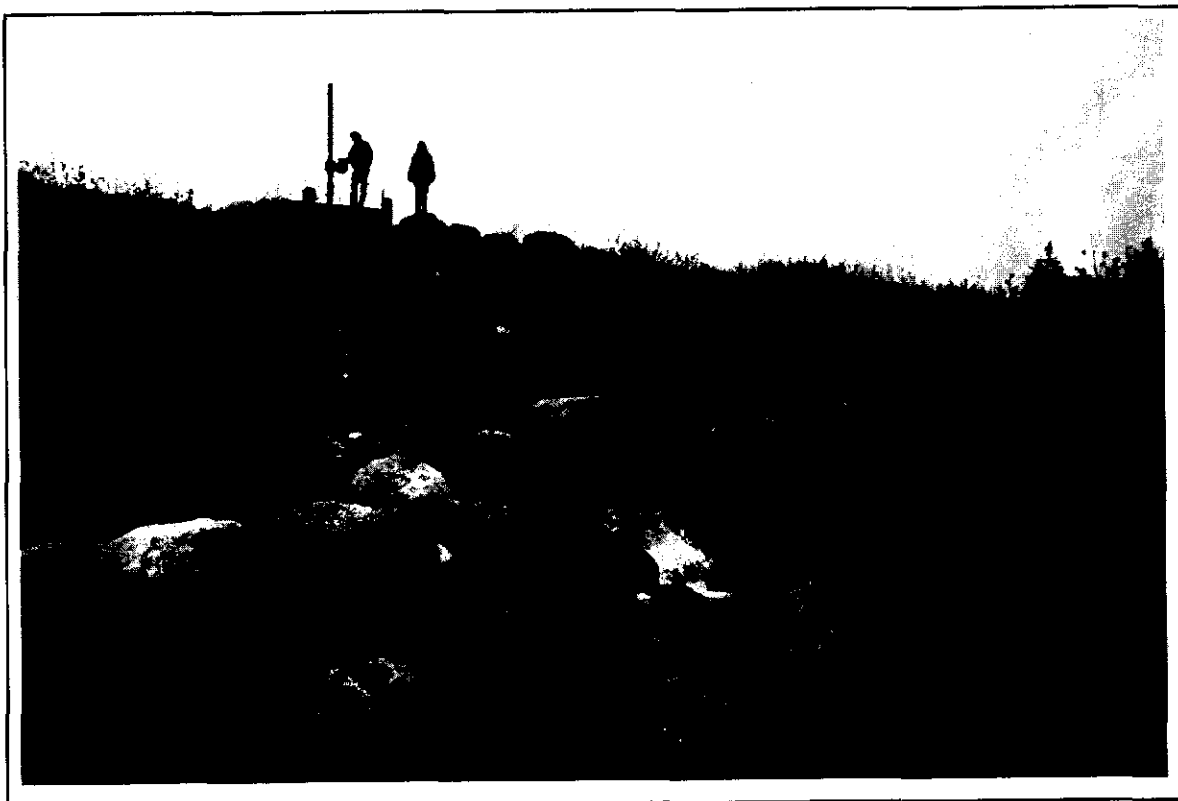
General condition Fair – Gate extremely difficult to operate at high W/L. Takes approximately 2 hours to open gate 15".

Operation at time of examination Fully closed. Approximately 5–10 l/s leaking through and under culvert.

Remarks	<u>Leakage on right side of culvert. Should be monitored, especially at higher water levels.</u>
---------	--

Downstream view of gate

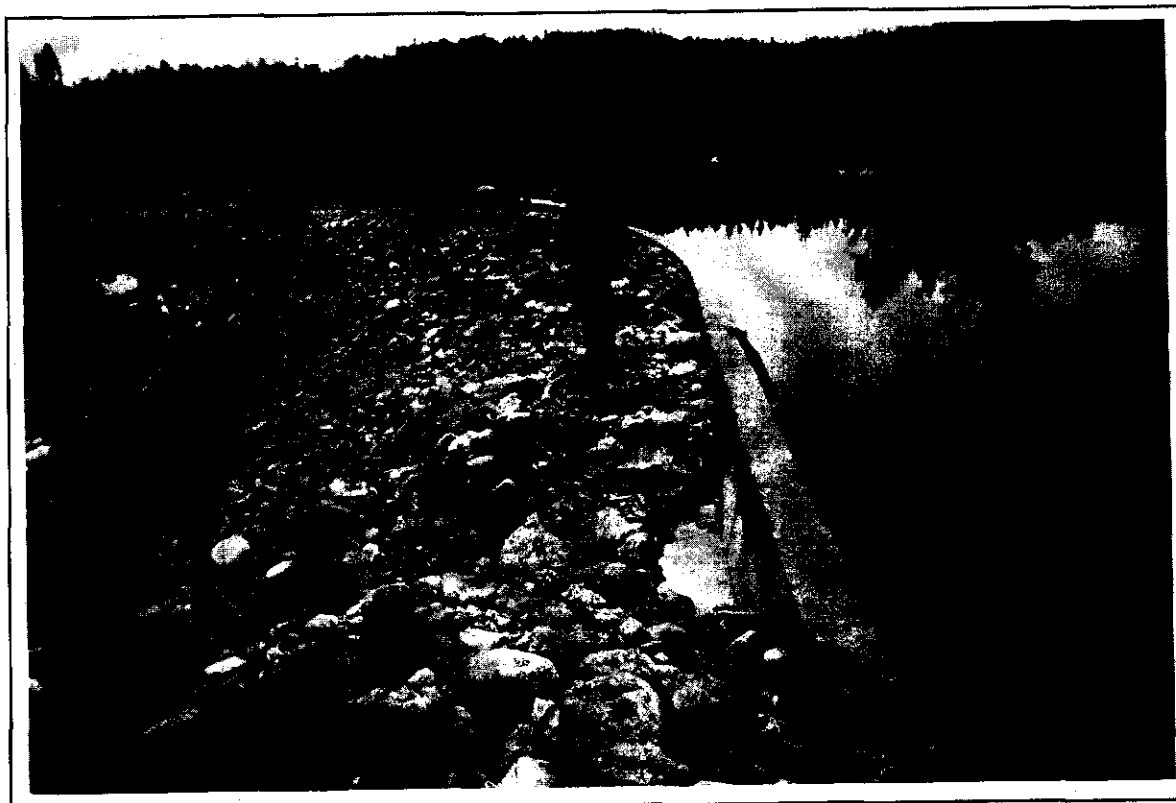
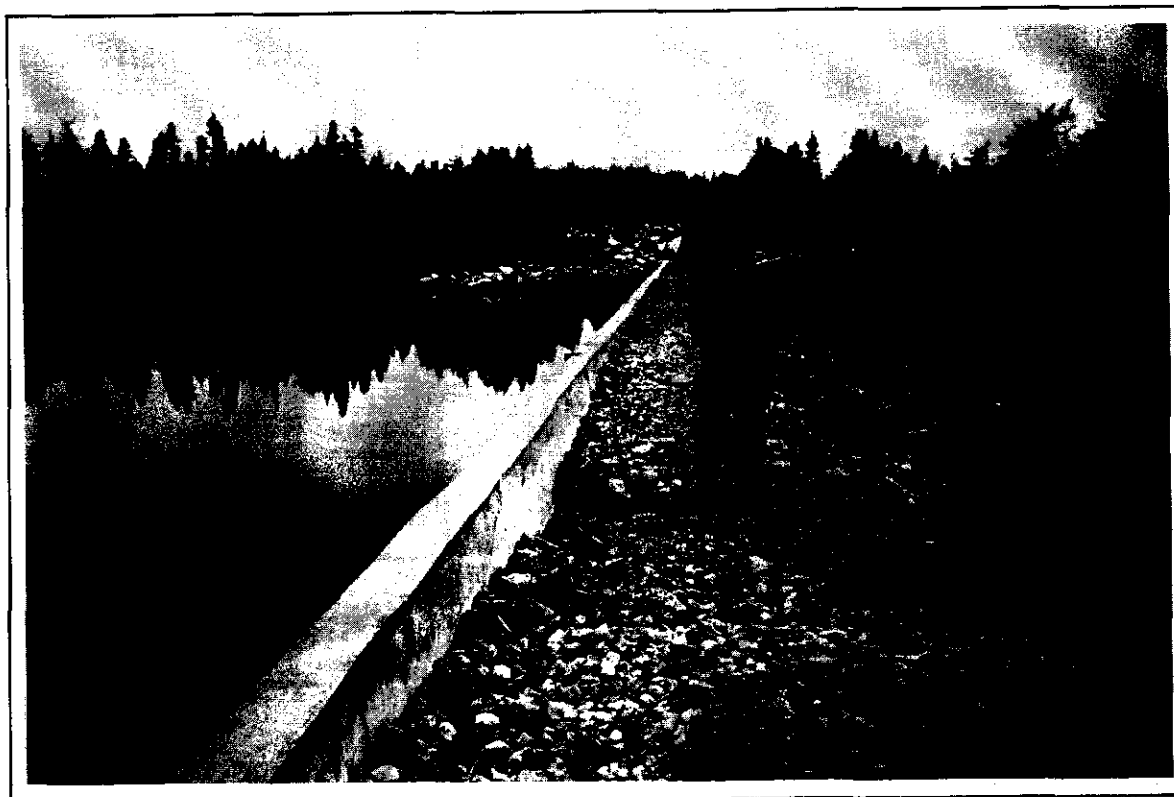
Roadway	<u>N/A</u>
Walks	<u>Minor settlement</u>
Parapet	<u>Some deterioration</u>
Lighting, etc.	<u></u>
Other	<u>Displacement of rockfill from crest due to overtopping</u>

Erosion/settlement at crest

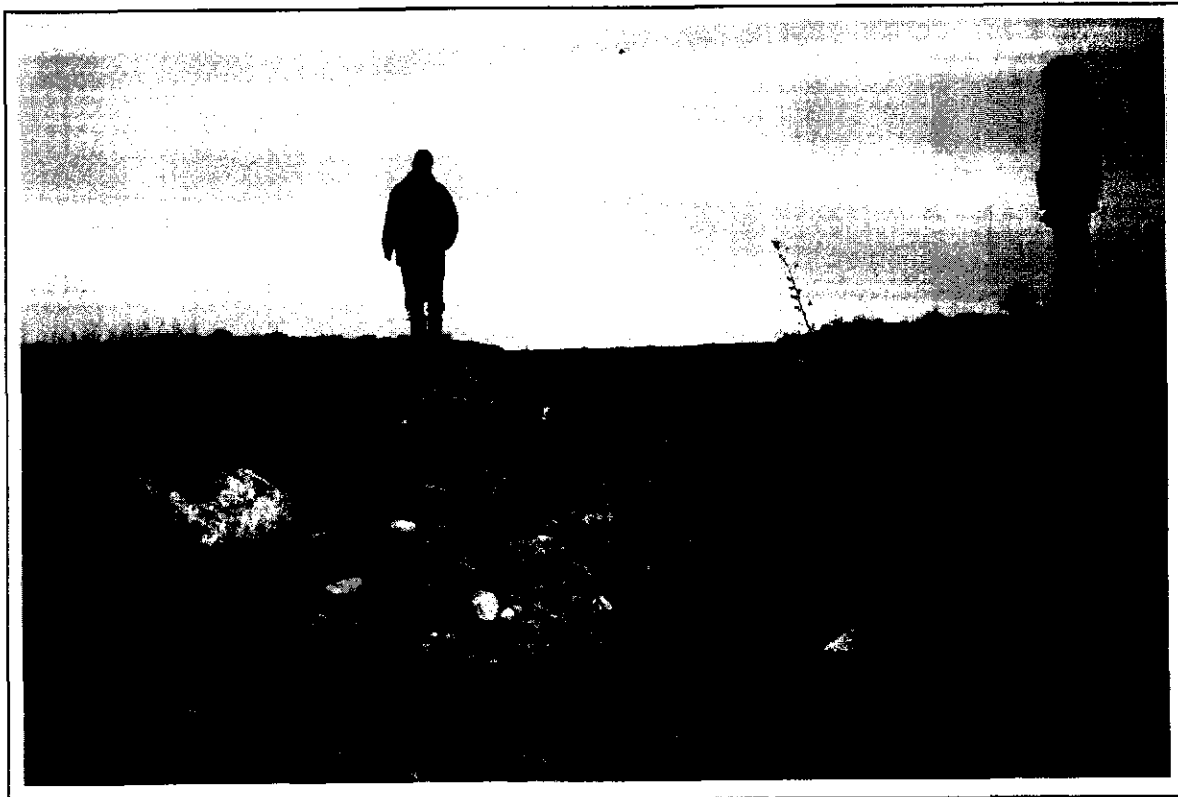
Cracks	<u></u>
Joint offsets	<u></u>
Seepage on Downstream Face	<u>Minor, few locations</u>
Other	<u>Erosion near crest at couple locations due to overtopping</u>

Erosion on downstream face due to overtopping

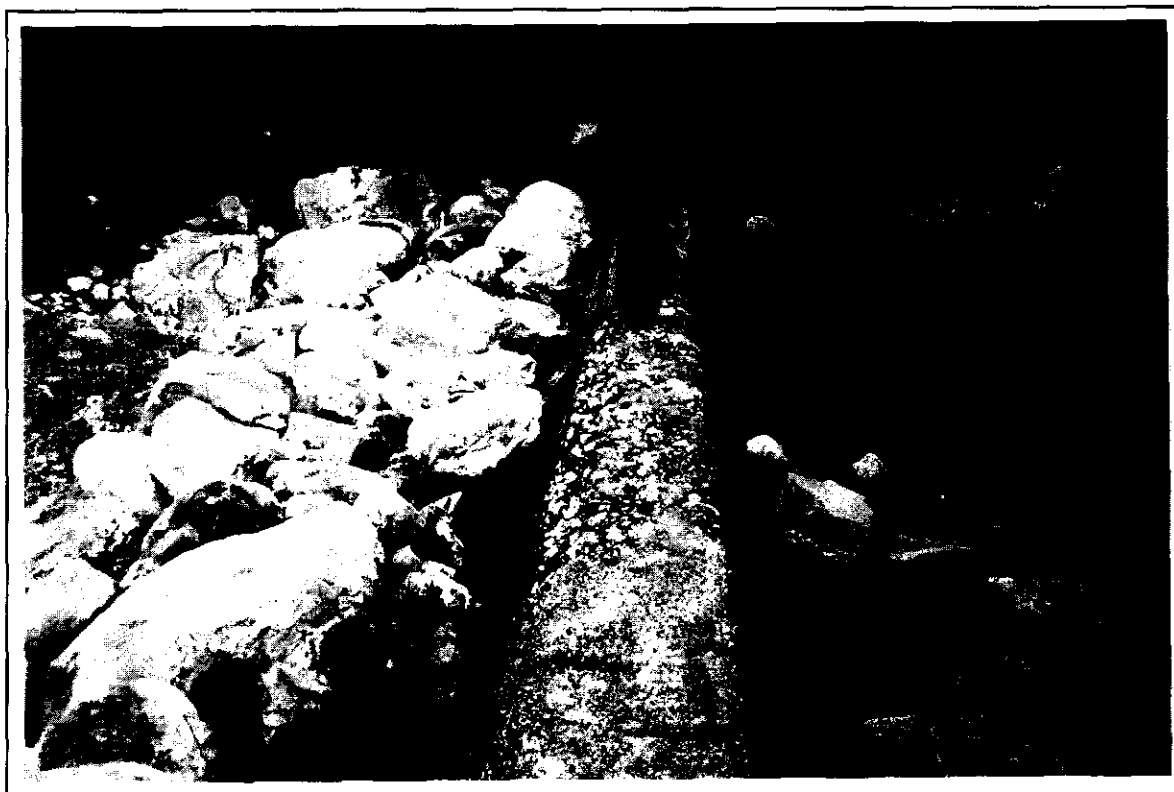
Crest	<u>Deteriorated with exposed steel and aggregate</u>
Orifices	<u>N/A</u>

Some deterioration of crest
