2001 Dam Safety Inspection Report

Seal Cove Development

NEWFOUNDLAND POWER

Subject: 2001 Dam Safety Inspection Reports
Seal Cove Development

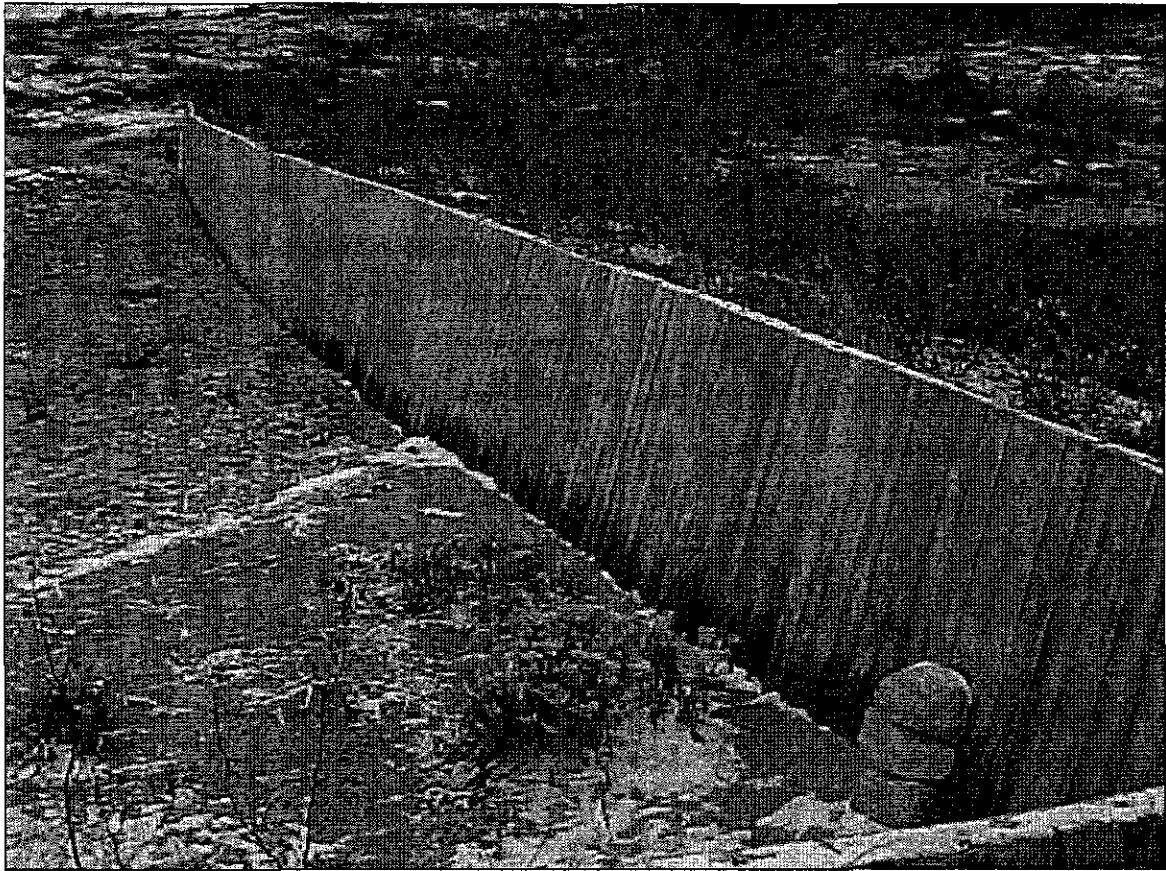
Overall good condition. Some settlement noted in some locations behind the timber facing.

Soldiers Pond Dam - Left Side Timber Face

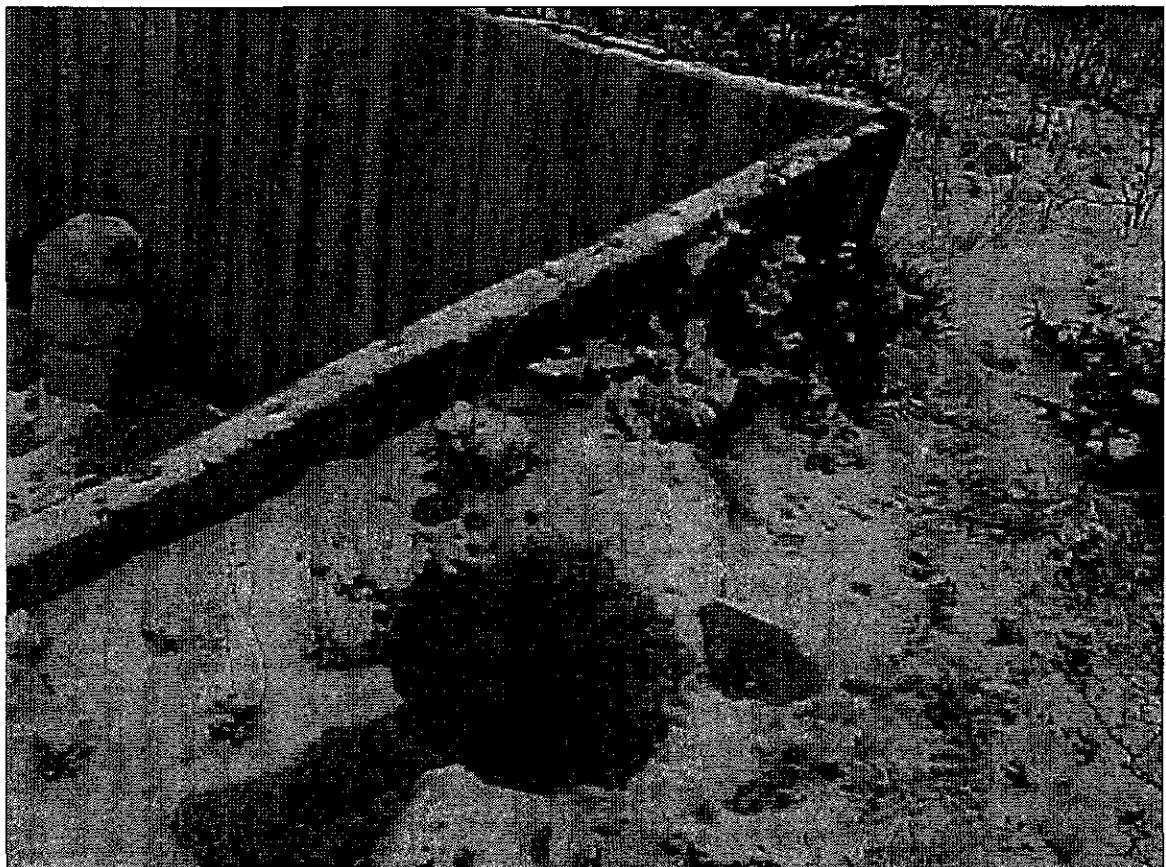
Soldiers Pond Dam - Small Sink Hole

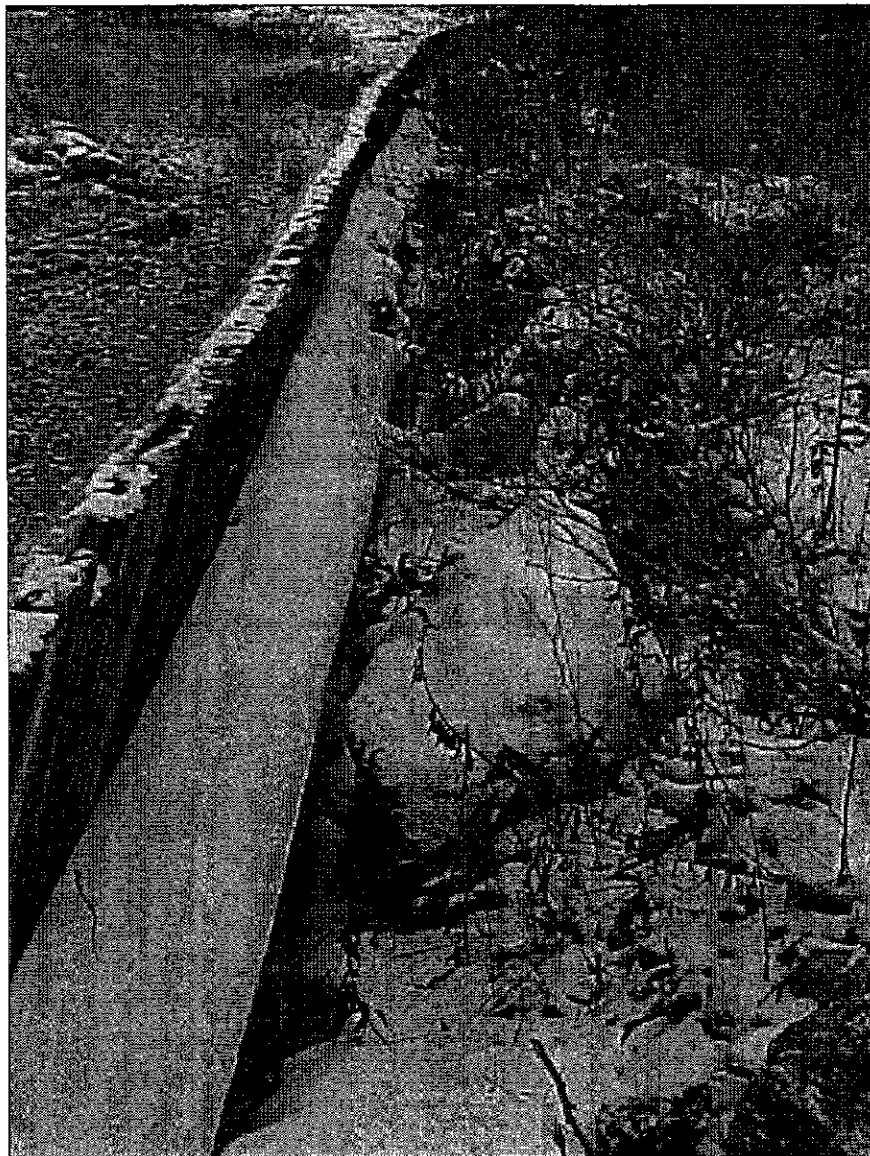
Some settlement of backfill in places.

Settlement of Backfill – Left Side of Soldiers Pond Dam

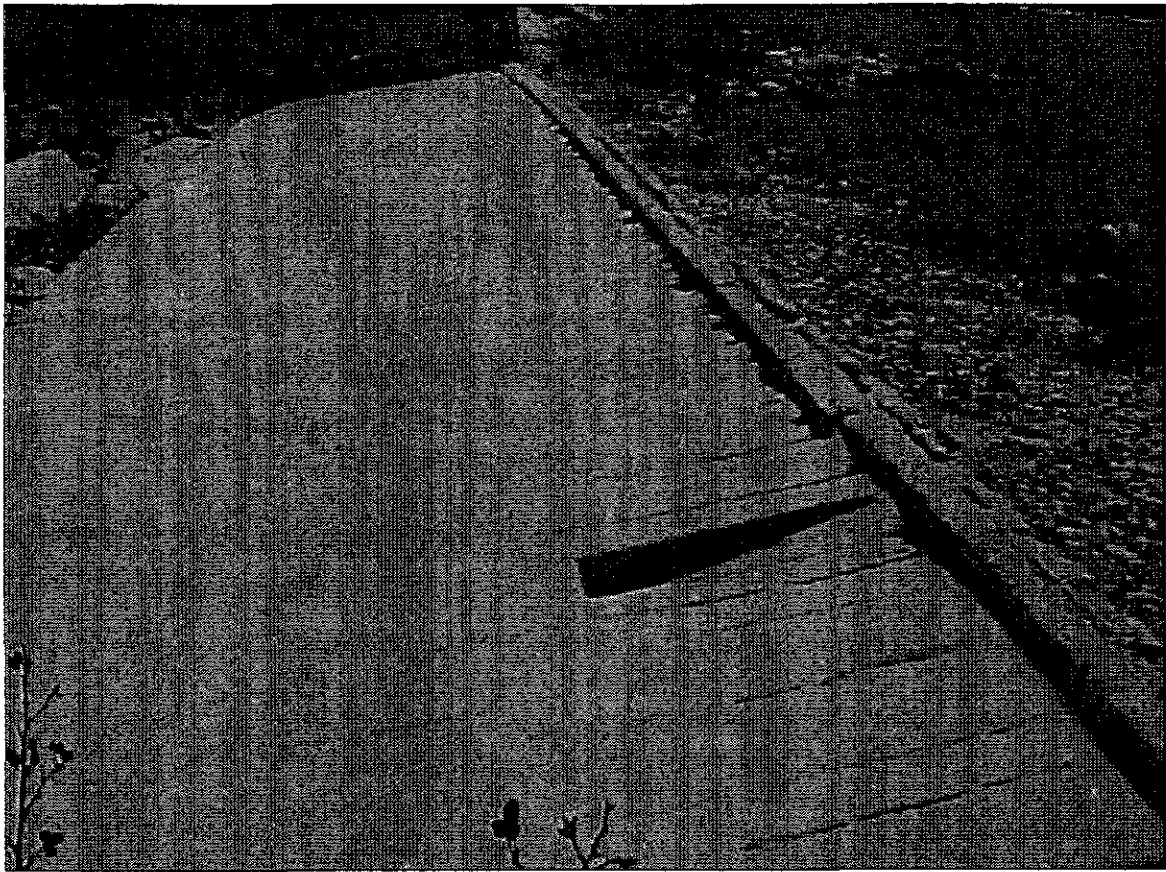
Timber face in good condition. Face separated in places along the left wing wall. Gopher hole present on crest.
Some depressions along the crest. Vegetation needs to be cleared. Plank missing on the spillway crest.
Spillway timber in poor condition.

Soldiers Pond Spillway - Apron and Crest – Missing Plank

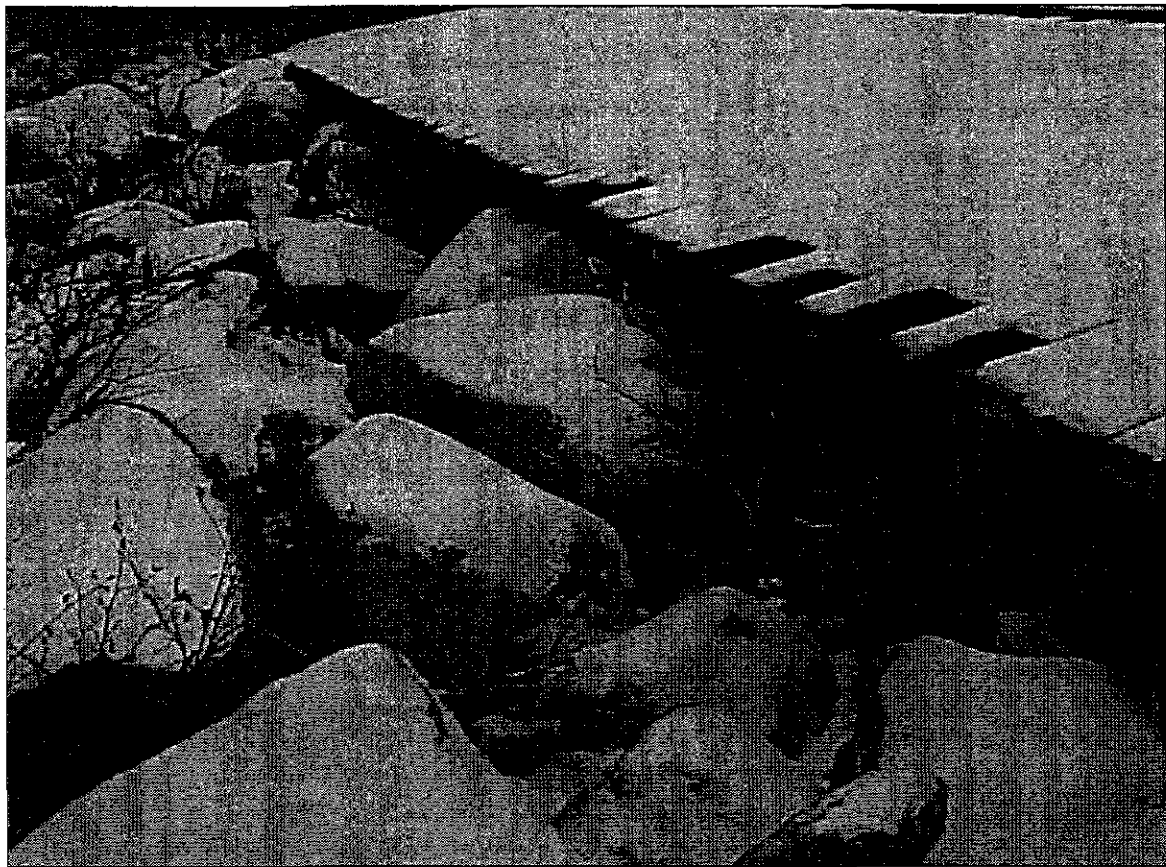
Soldiers Pond Spillway - Apron and Rip-Rap

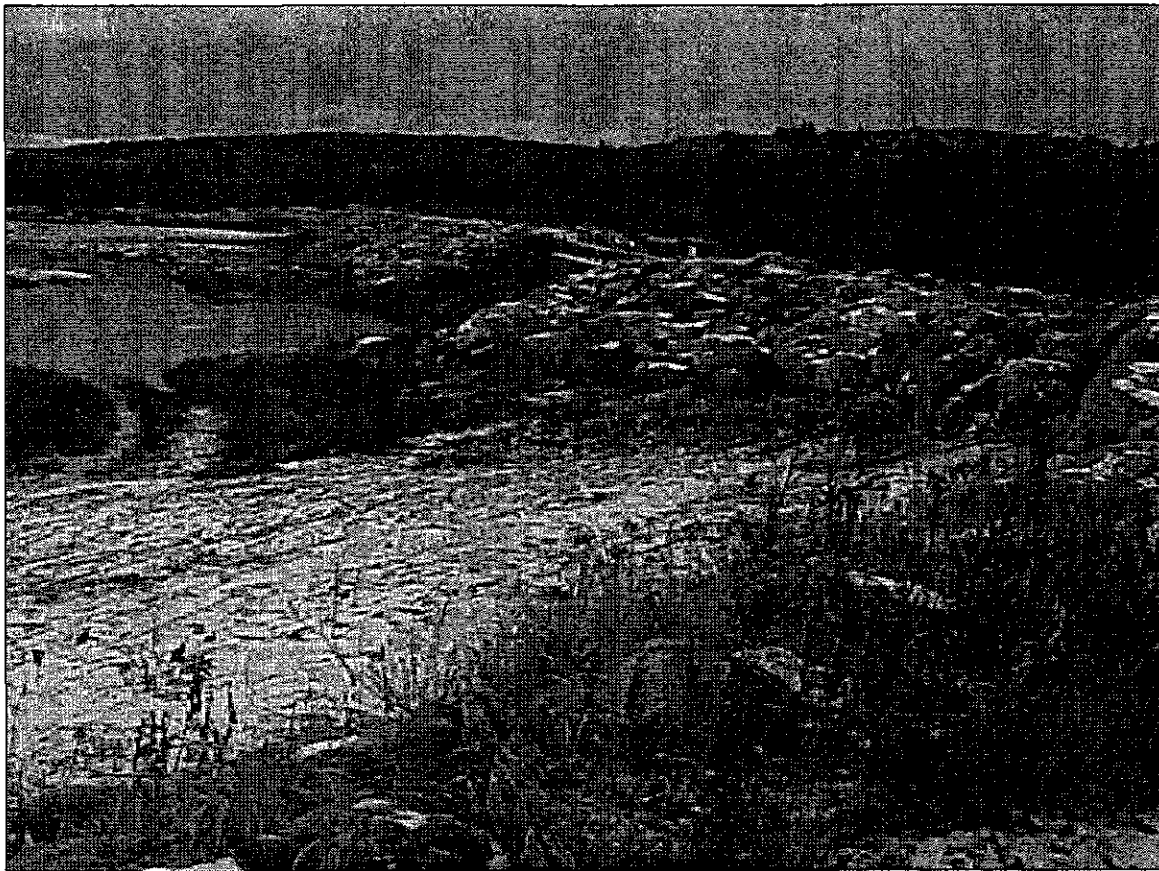
Riprap sparse in places. Riprap not well graded. Some erosion near the crest.

Overall condition fair to poor. Riprap was not well graded, and sparse in places.

Upstream Face of Fenelons Pond Dam

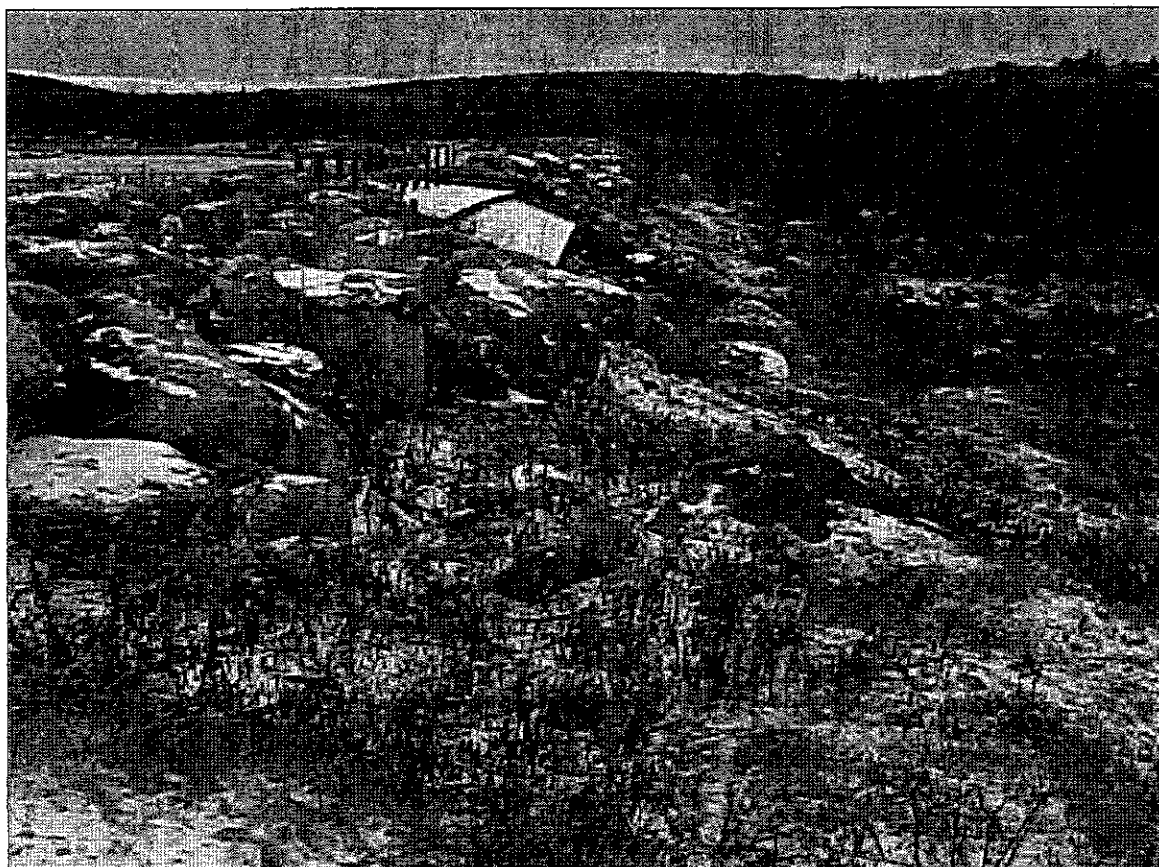
No movement observed. No seepage observed water level was low. Vegetation cleared.

Leakage observed around the outlet culvert.

Downstream Slope of Dam

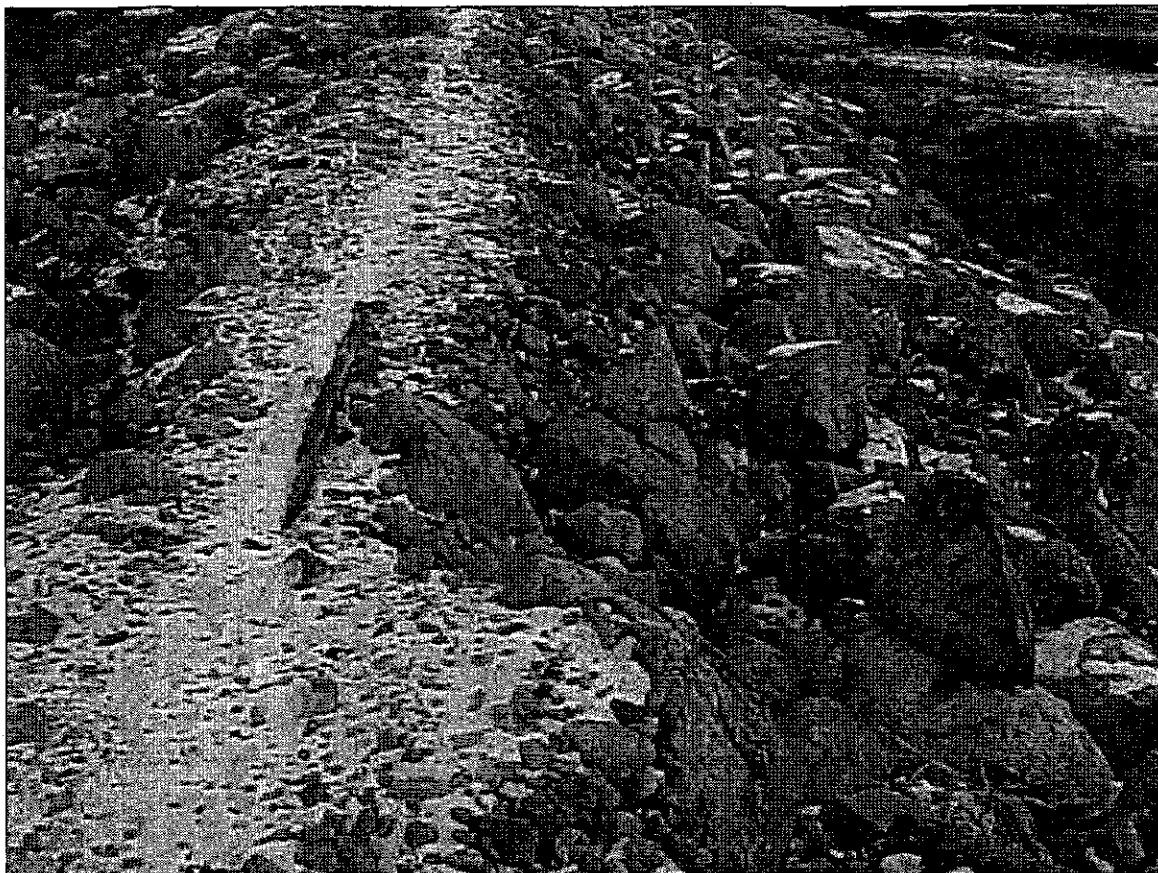
Further deterioration of the timber/shotcrete cut-off wall since previous inspection. Some erosion of the crest.

Crest was narrow in places. Migration of fines noticeable along the crest.

Erosion at Fenelons Pond Dam Crest

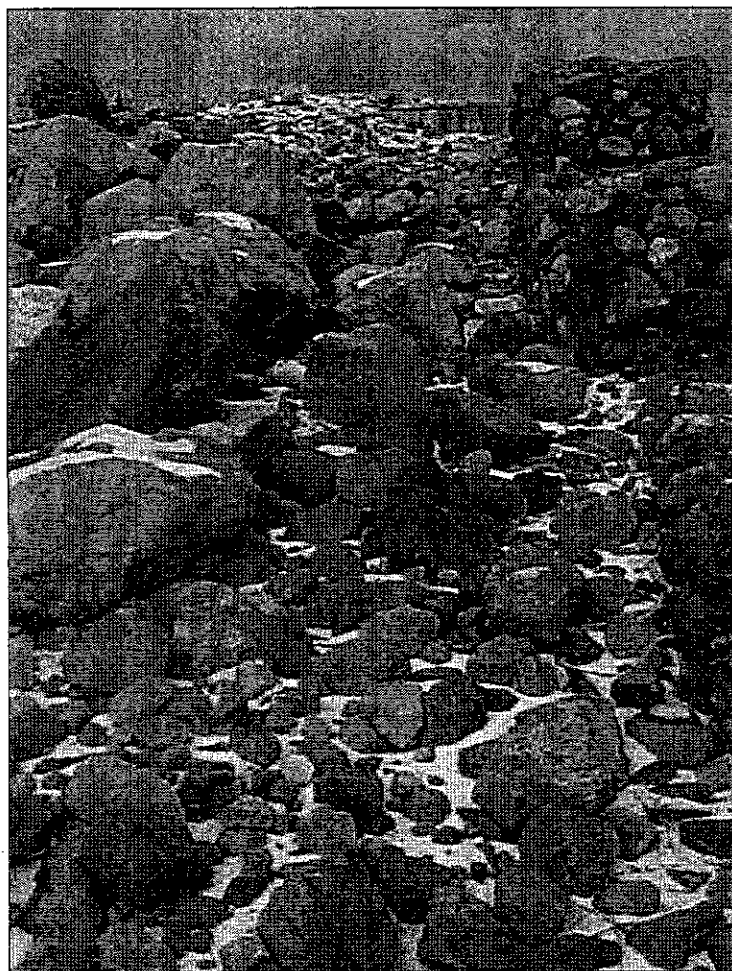
Erosion of Downstream Slope Near Spillway

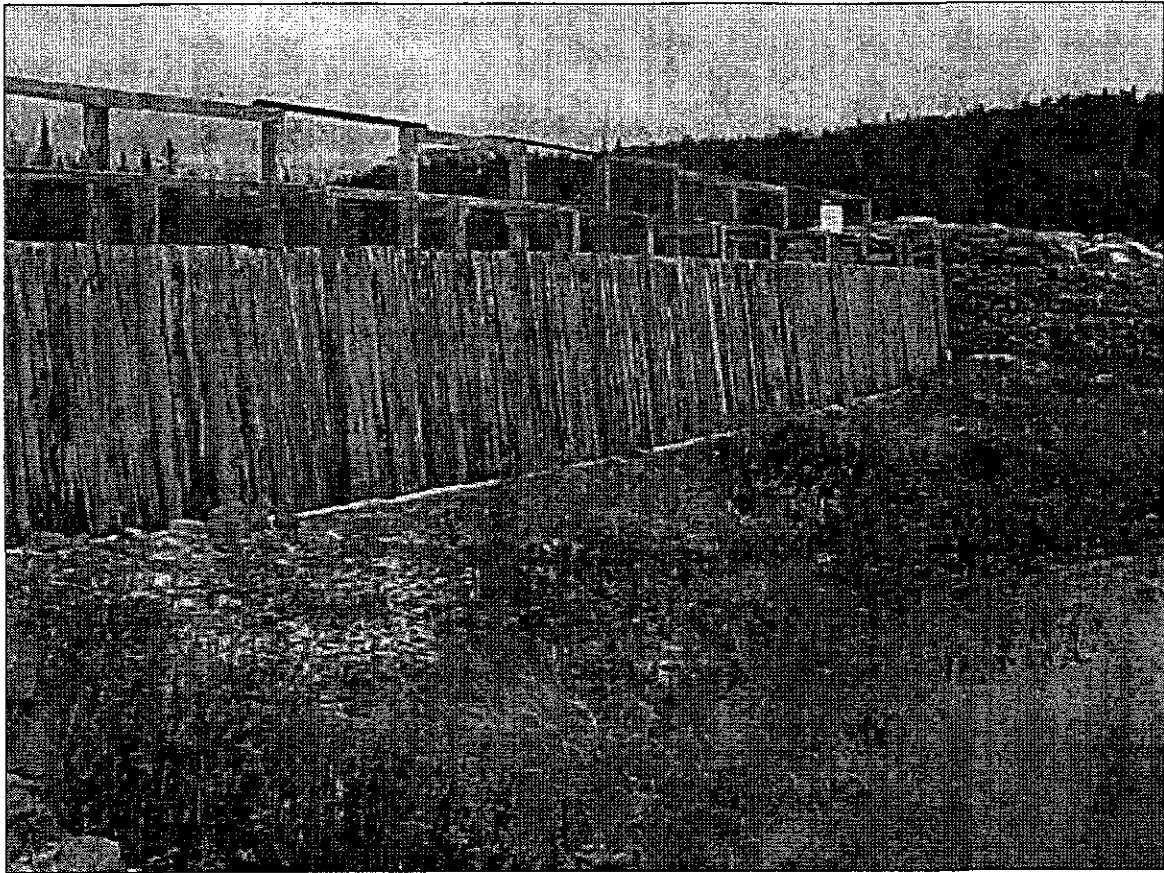
Fair to poor condition. Timber showing signs of further deterioration. Crib ballast missing.

Upstream View of Fenelons Pond Spillway

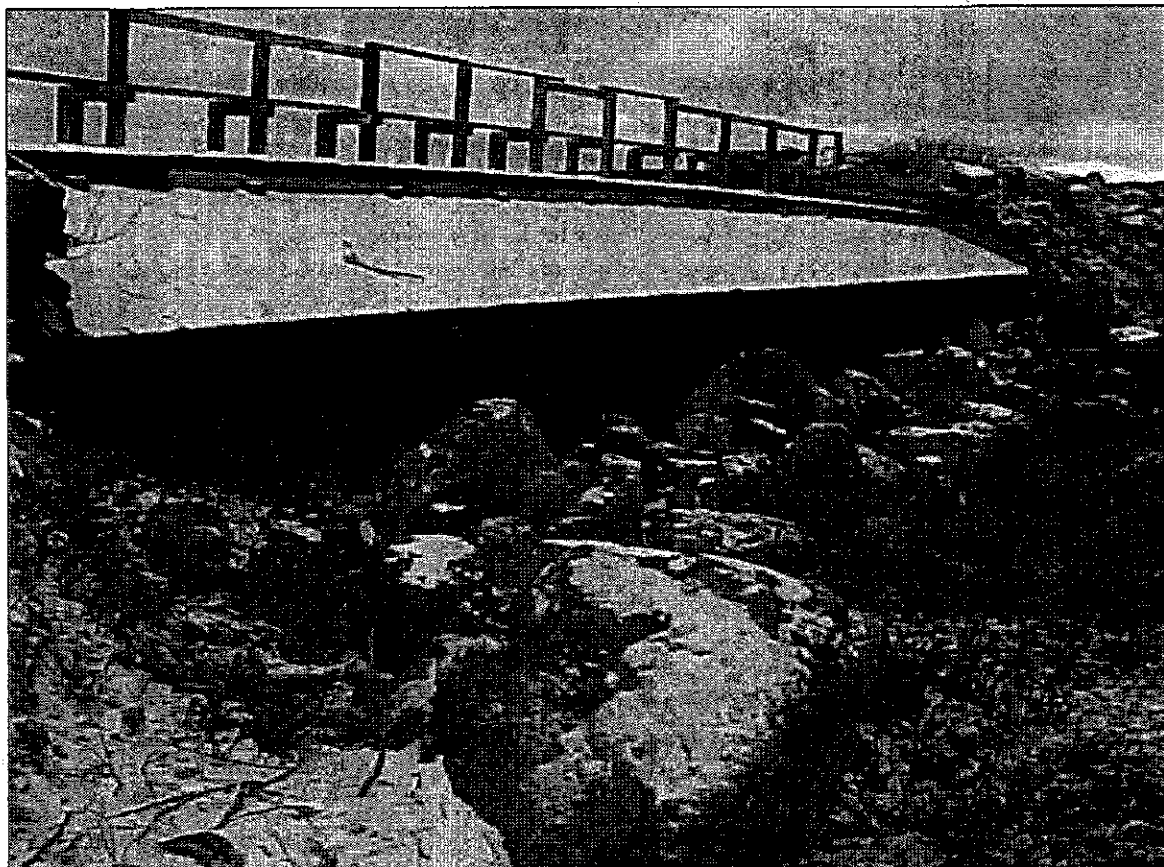
Poor condition. Downstream rail missing in places, no upstream rail, decking deteriorated.

Downstream View of Fenelons Pond Spillway

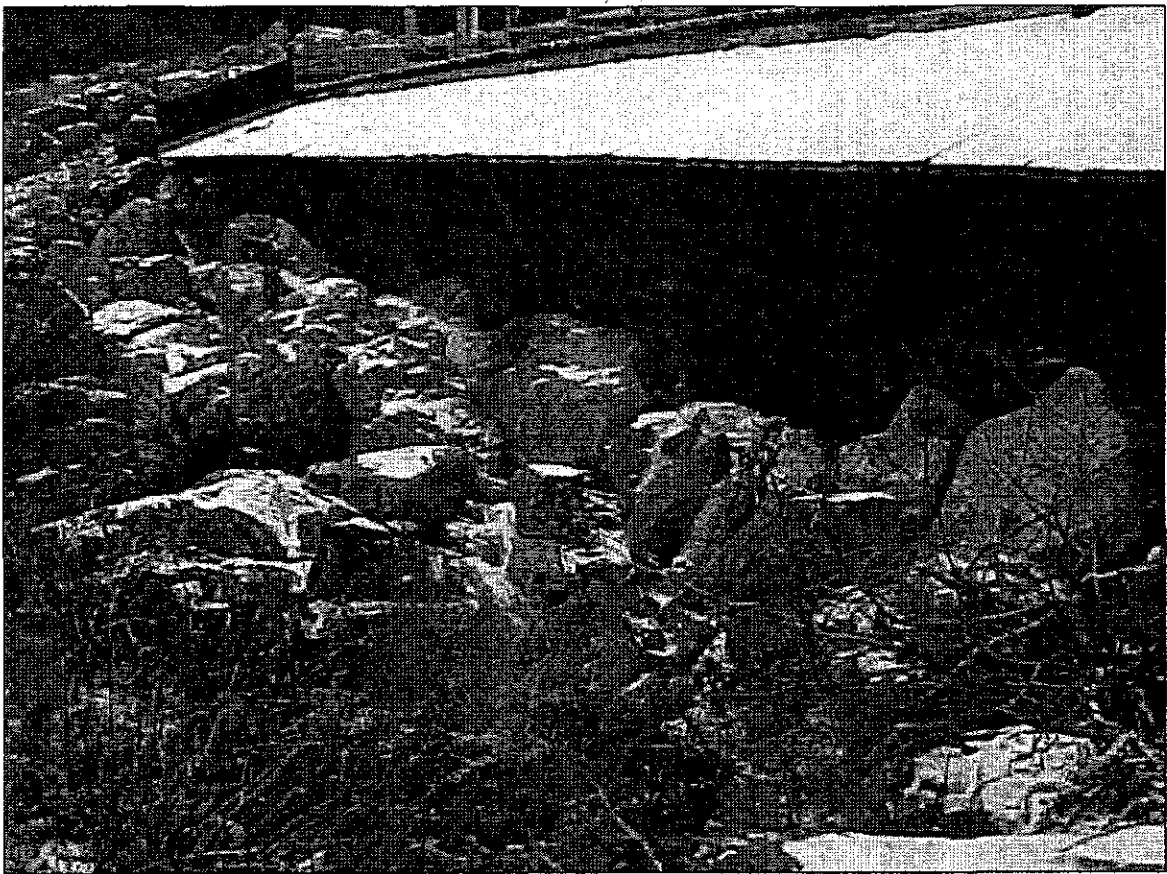
Minor erosion noted. Clippings from brush cutting present.

Fenelons Pond Spillway - Apron and Riprap

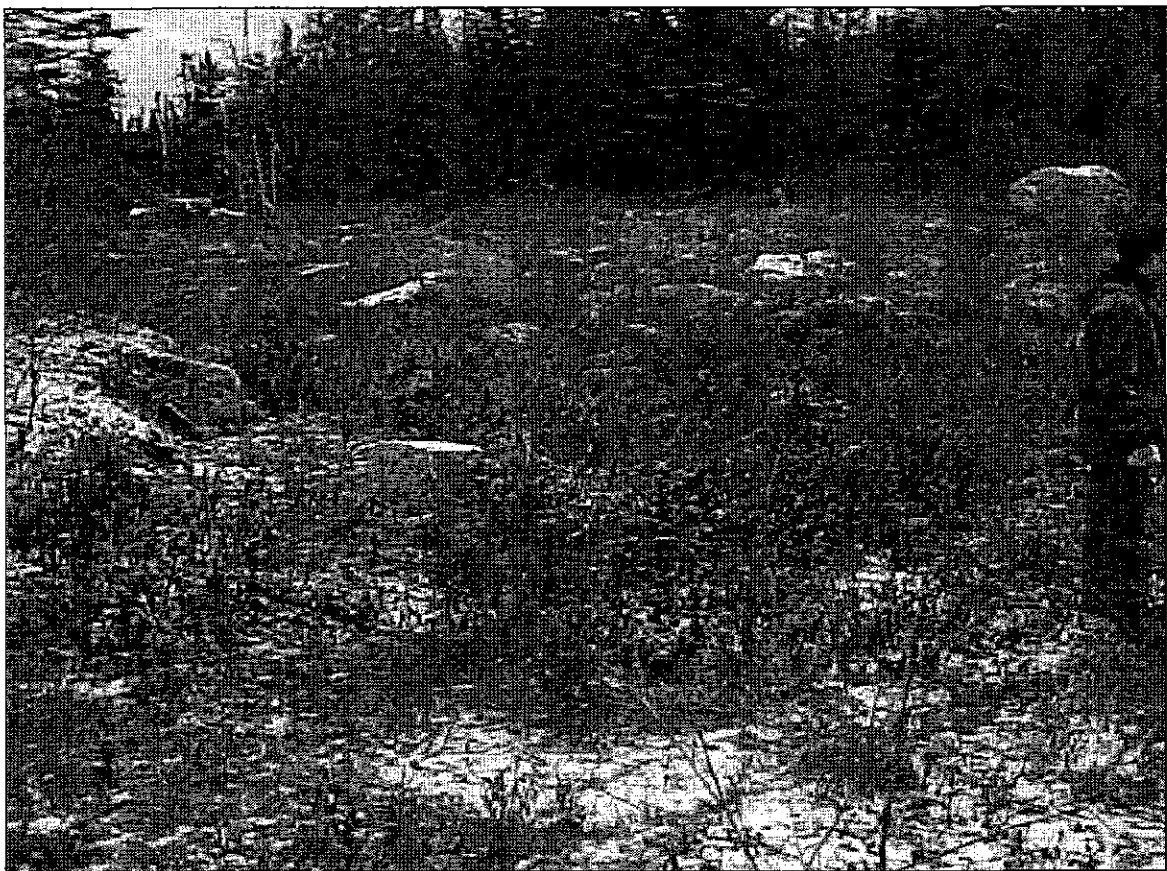
Fenelons Pond Spillway Channel - Vegetation

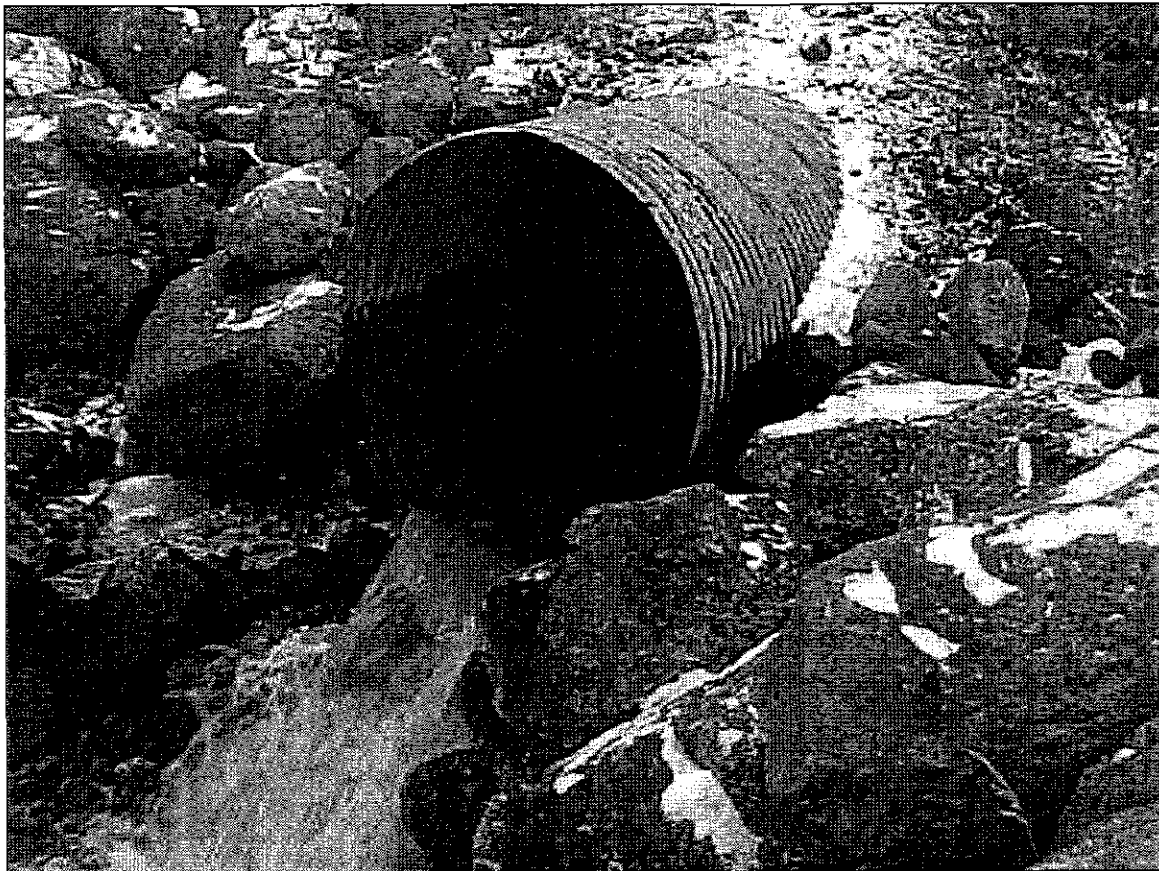
No gatehouse. Timber gate/mechanical lift. Fully closed with considerable leakage noted.

Leakage noted on the right side of the culvert.

Fenelons Pond Outlet Culvert – Leaking with Gate Closed

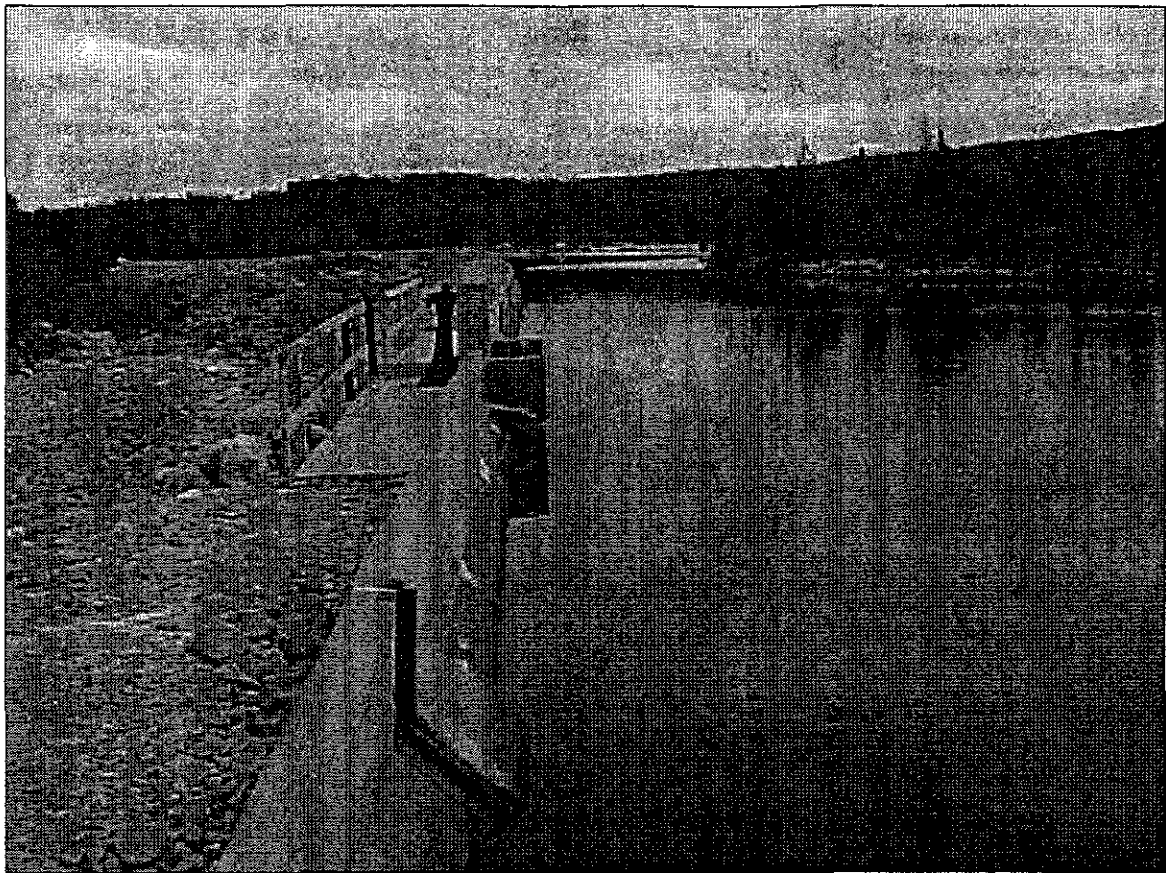
Minor cracks, some spalling, some deterioration. Joint offsets OK.

Seal Cove Forebay Dam -- Upstream Face

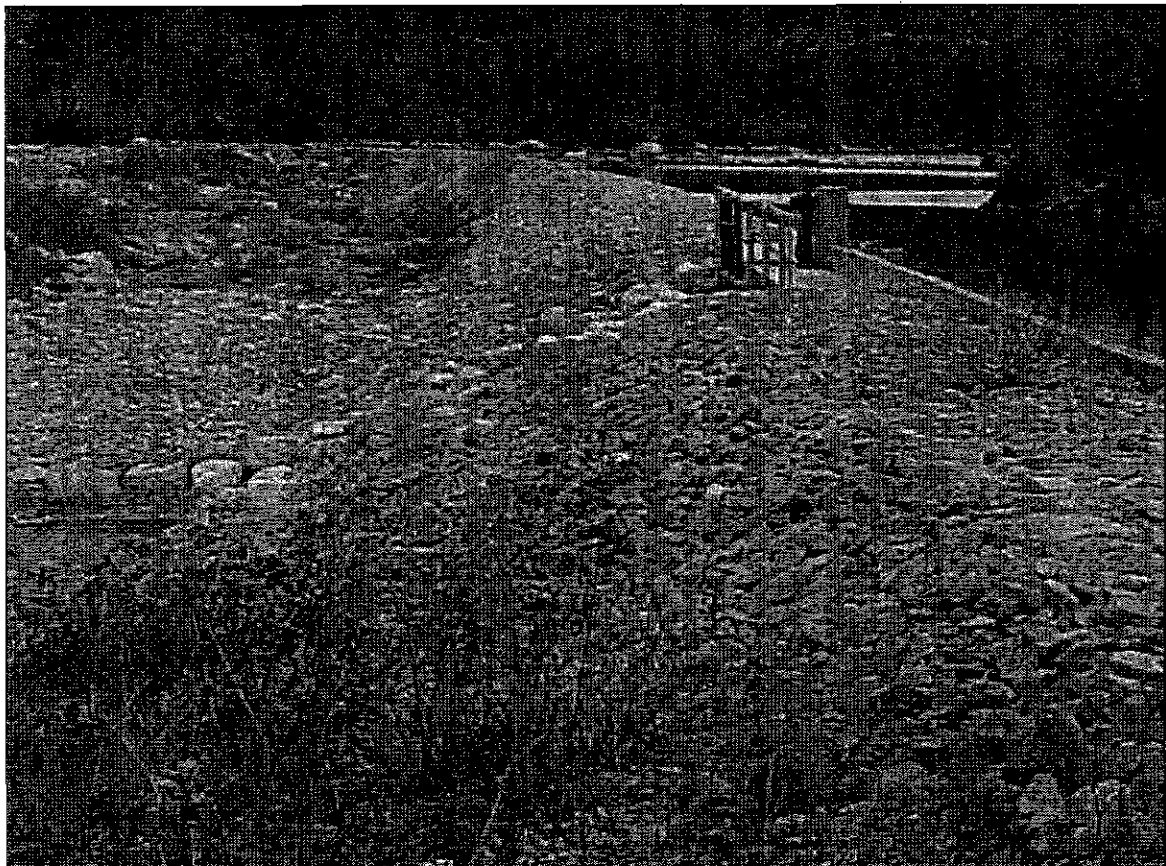
Minor seepage on the downstream face. Some erosion of the crest and downstream face due to overtopping.

Minor erosion. Some ponding of water due to seepage.

Seal Cove Forebay Dam -- Downstream Slope

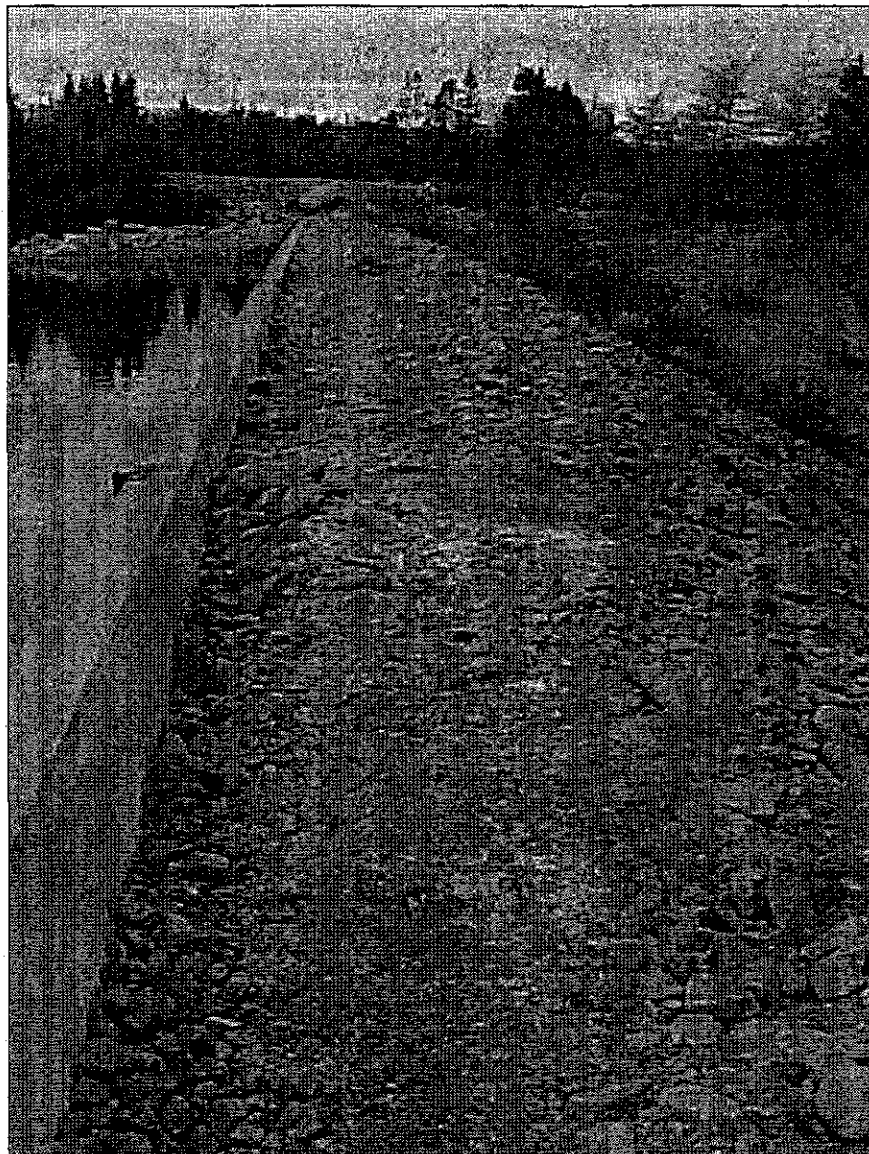
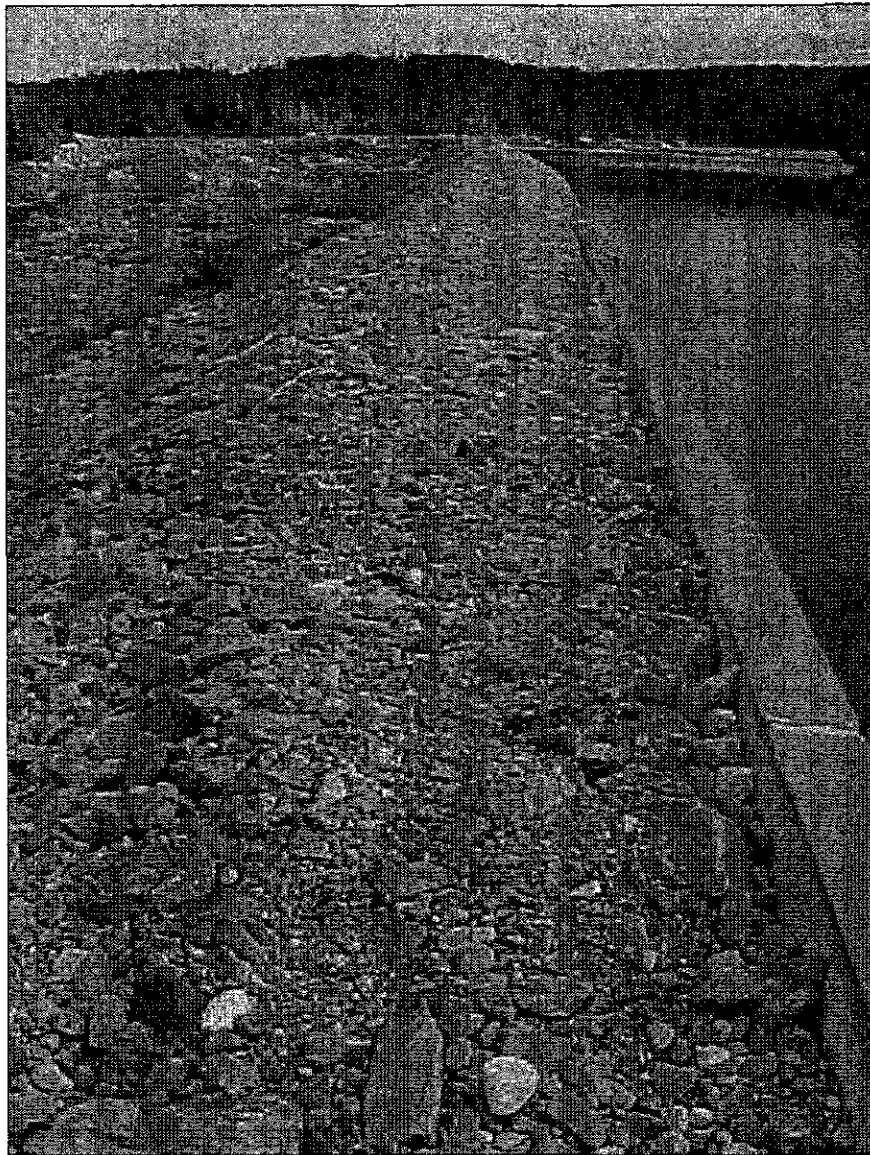
Minor settlement noted in places along the crest.

Some deterioration, some displacement of rock fill due to overtopping.

Seal Cove Forebay Dam – View of Crest

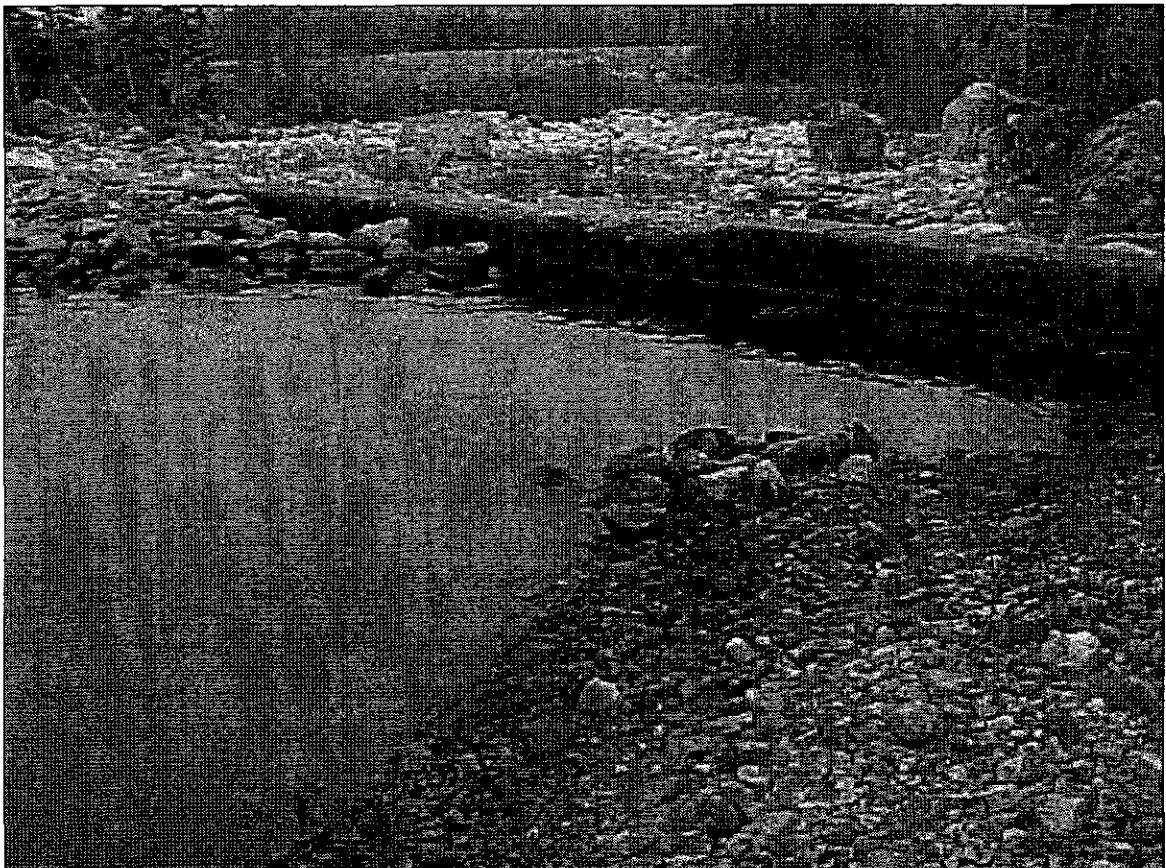
One minor slide noted on the RHS, some rock fill needs to be replaced.

Seal cove Forebay Spillway – Crest With Missing Rock Fill

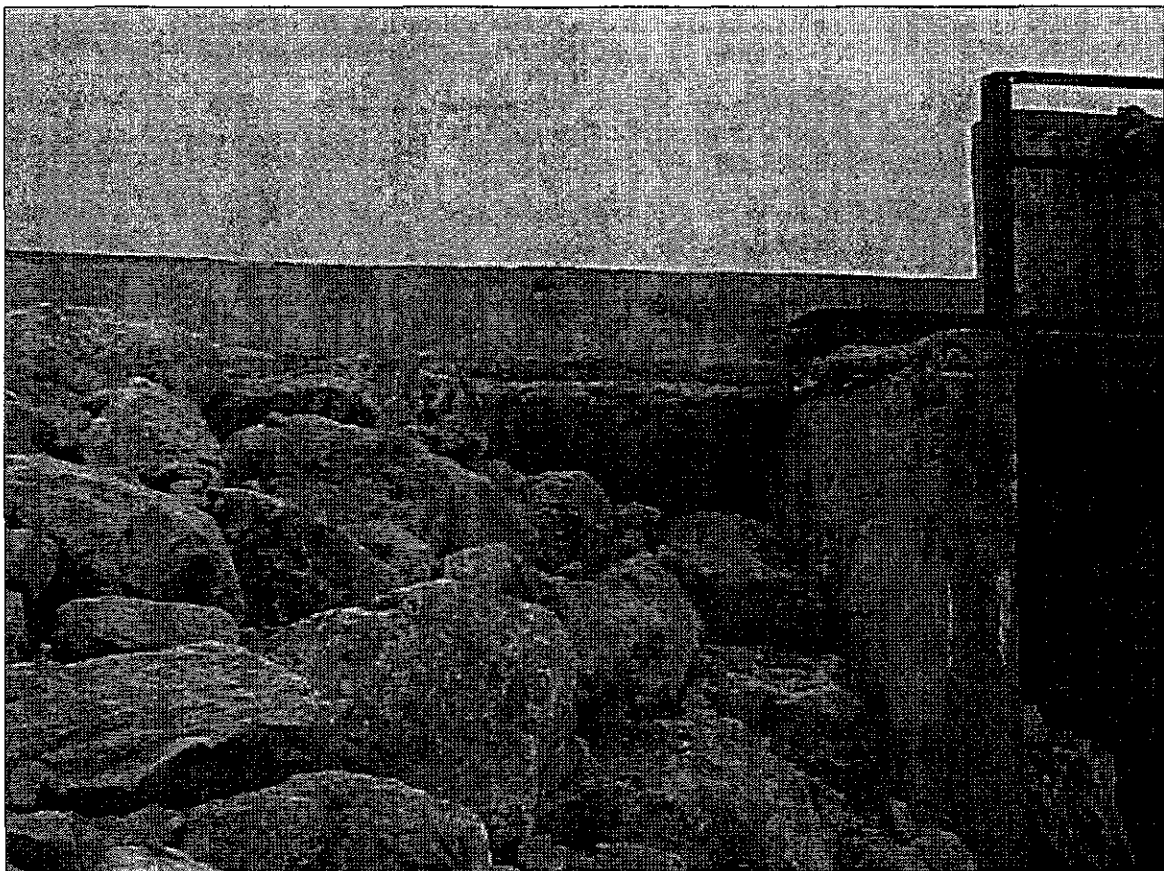
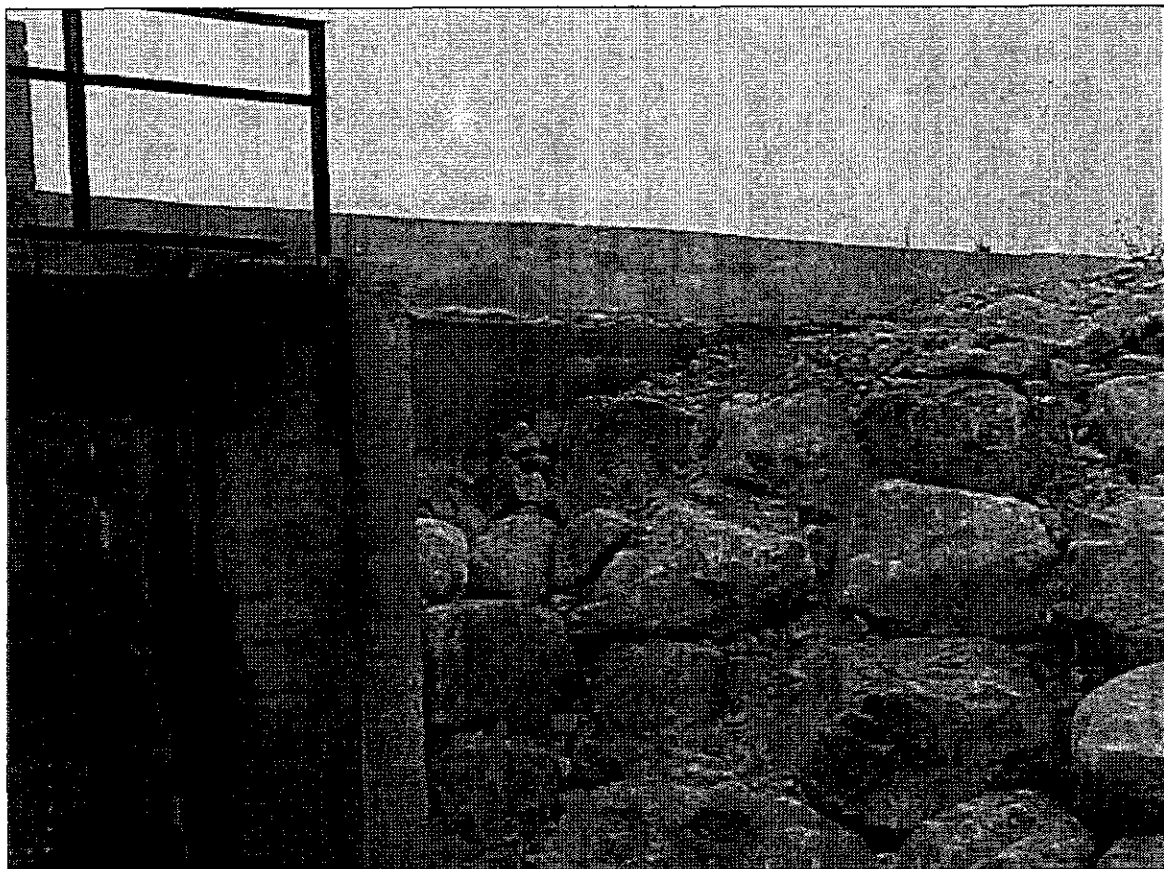
Seal Cove Forebay Outlet – Replace Walkway

Walkway over the sluice gate should be replaced immediately.

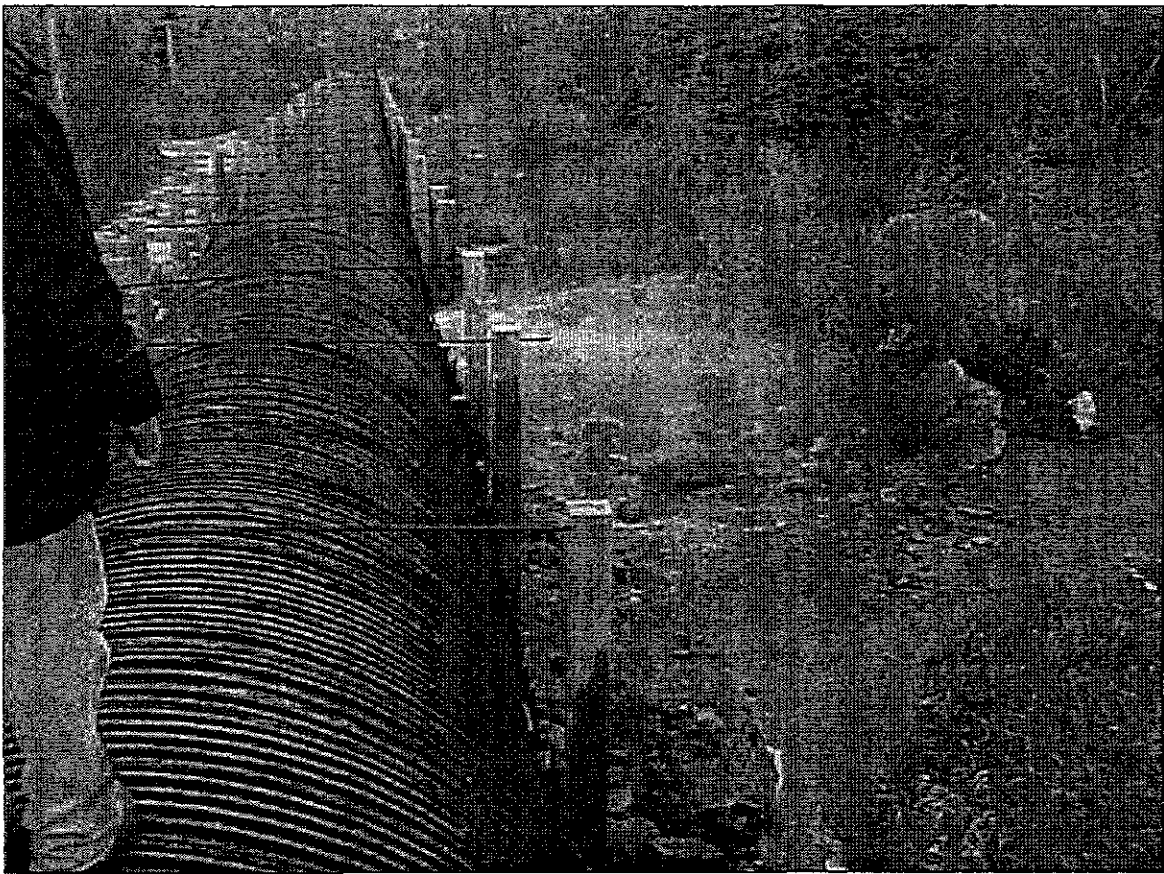
Condition of Pipe (*Type, Cracks, Stresses, Leaks, Bands, Plates, Joints, Other*)
Wood staves deteriorated, significant leakage. Bands rusted.

Expansion Joints (*Leaks, Stress cracks*)
Significant leakage.

Seal Cove Penstock - Leak

Remarks
Significant leakage, in scattered areas. Wood staves deteriorated throughout, bands rusted throughout.
Areas having major leakage should attempt repairs.
