2001 Dam Safety Inspection Report

Seal Cove Development

NEWFOUNDLAND POWER

Subject: 2001 Dam Safety Inspection Reports
Seal Cove Development

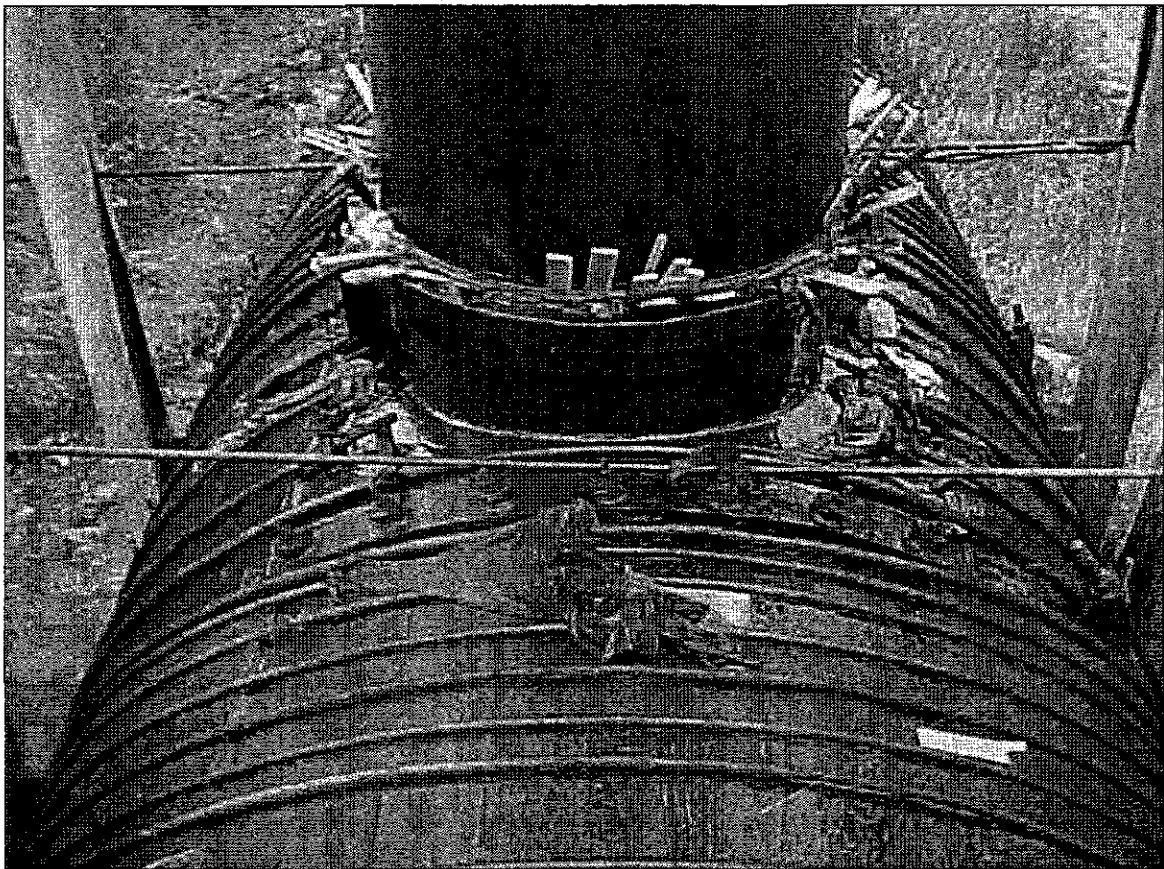
Seal Cove Penstock - Leak Repair

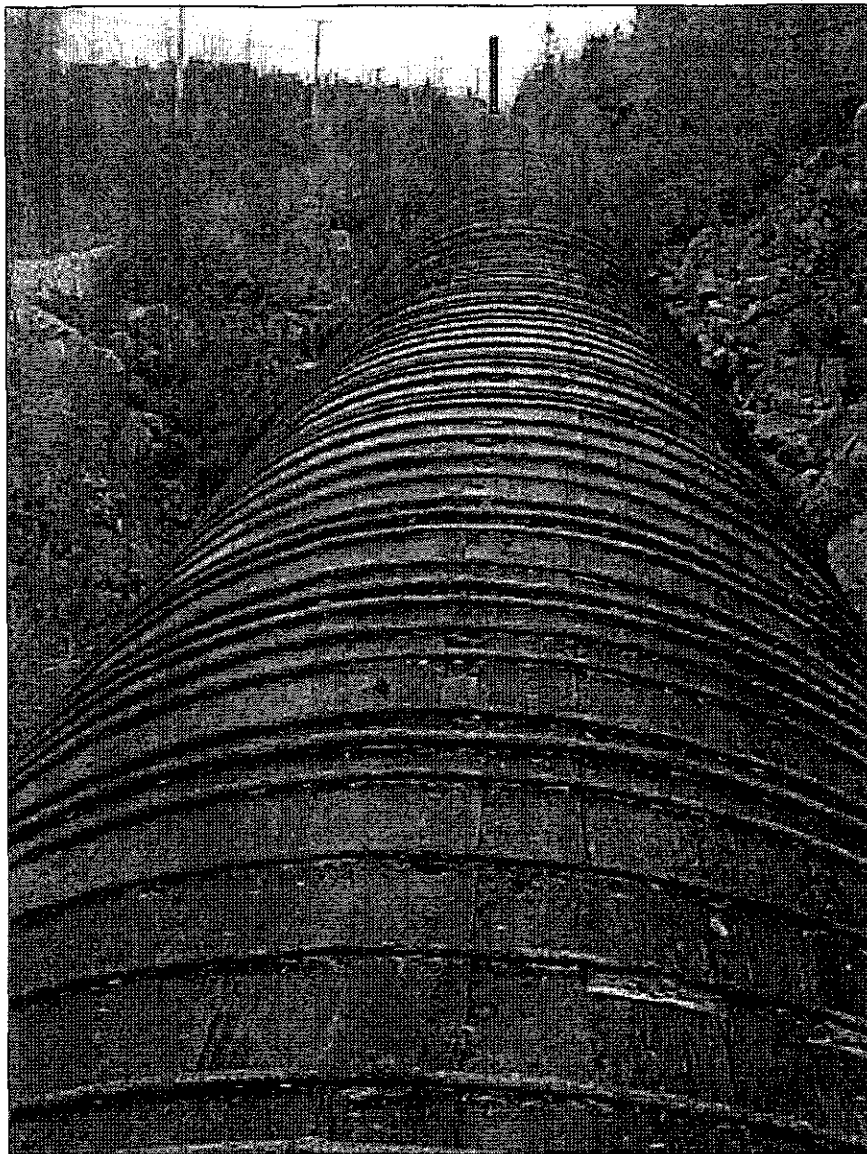
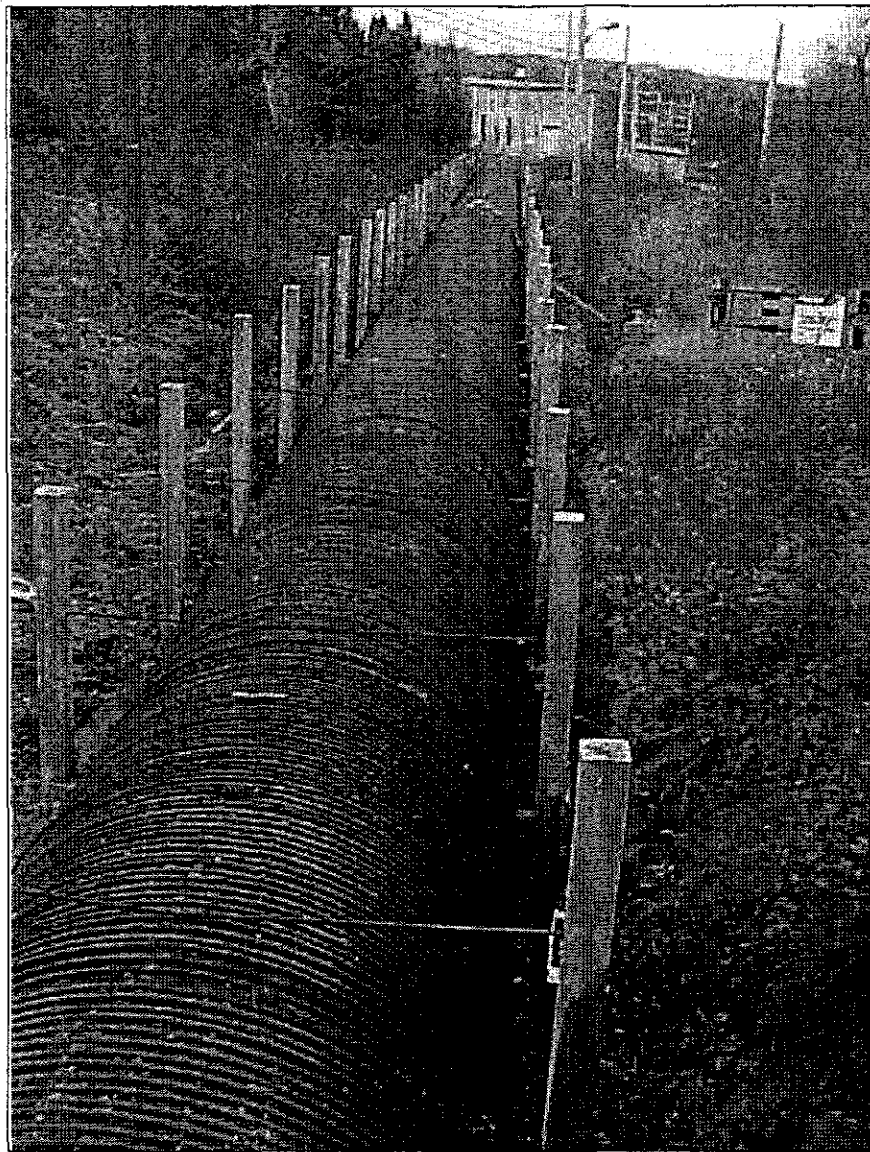
Condition of Penstock Bed (*Alignment, Settlement*)
Poor drainage in places.

Seal Cove Penstock – Condition and Alignment

Seal cove Penstock – Condition and Alignment
