1999 Dam Safety Inspection Reports

Port Union Development

NEWFOUNDLAND POWER

Whirl Pond Dam & Outlet

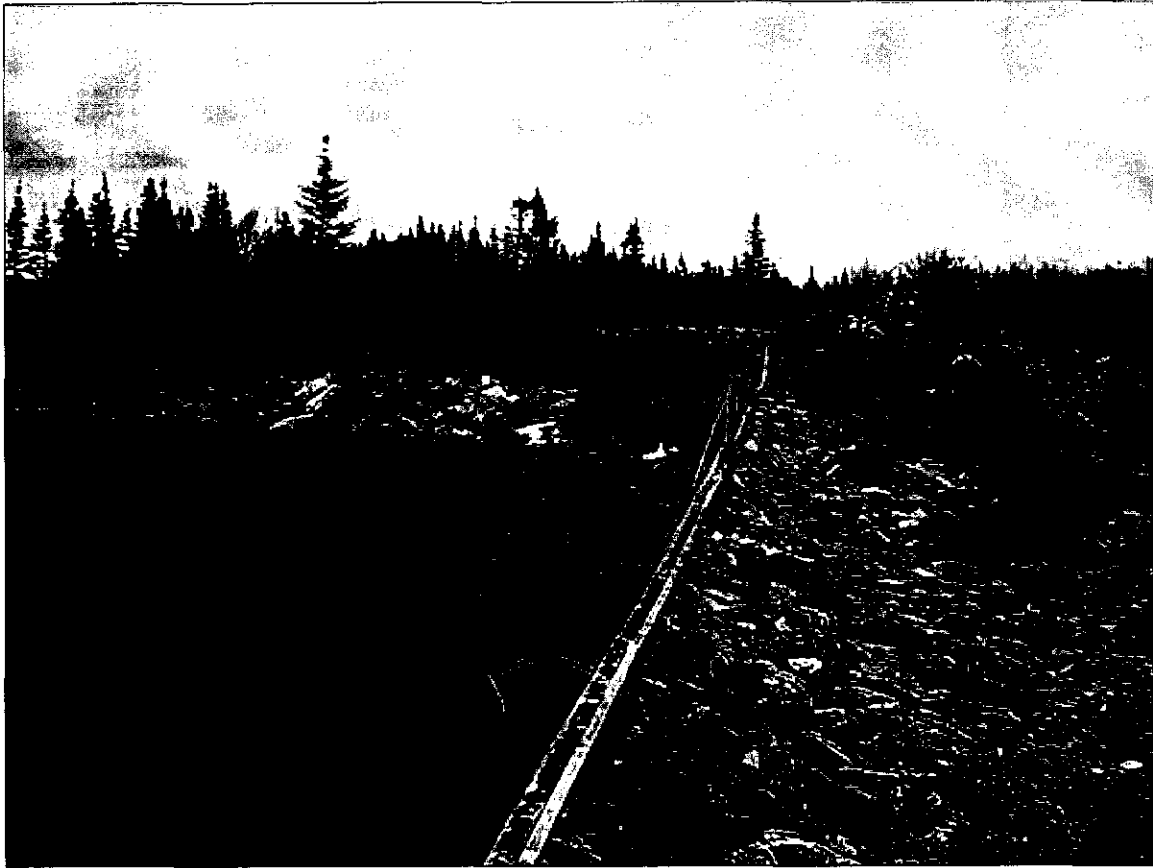
Looking toward left abutment

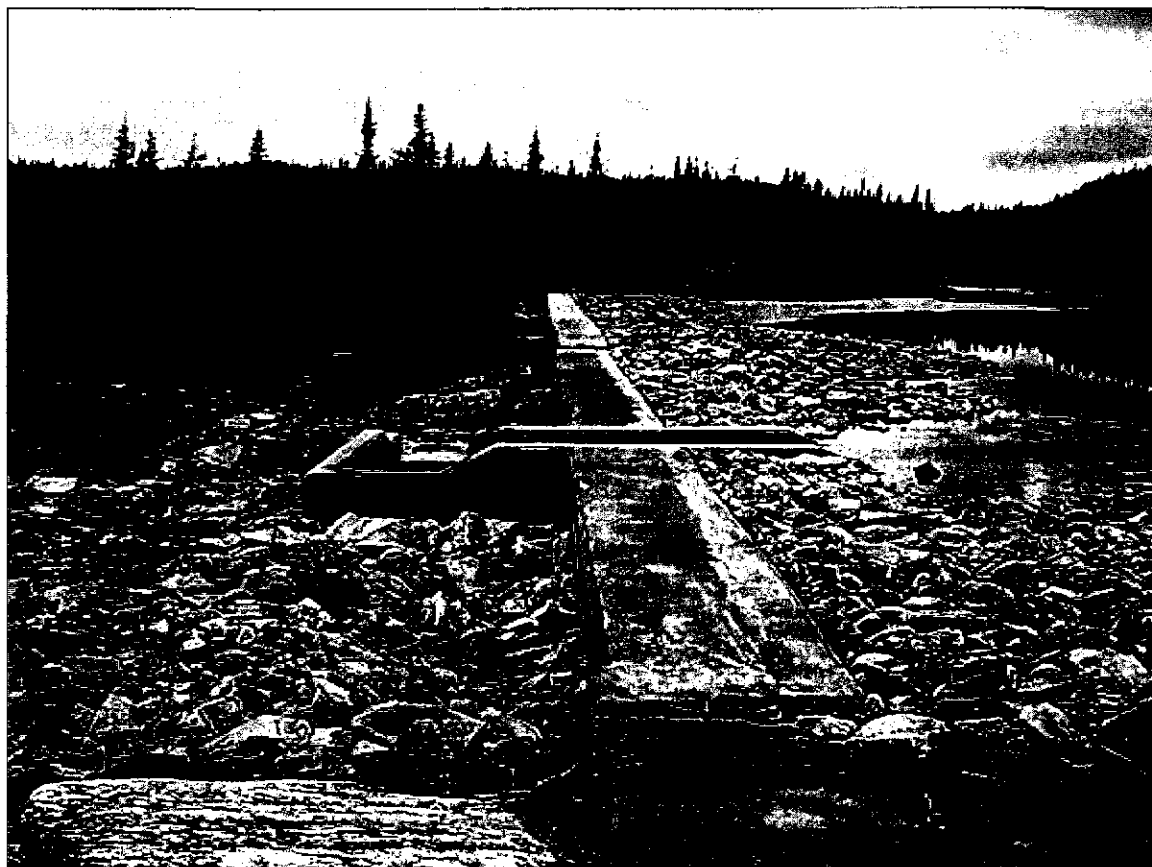
View from left abutment

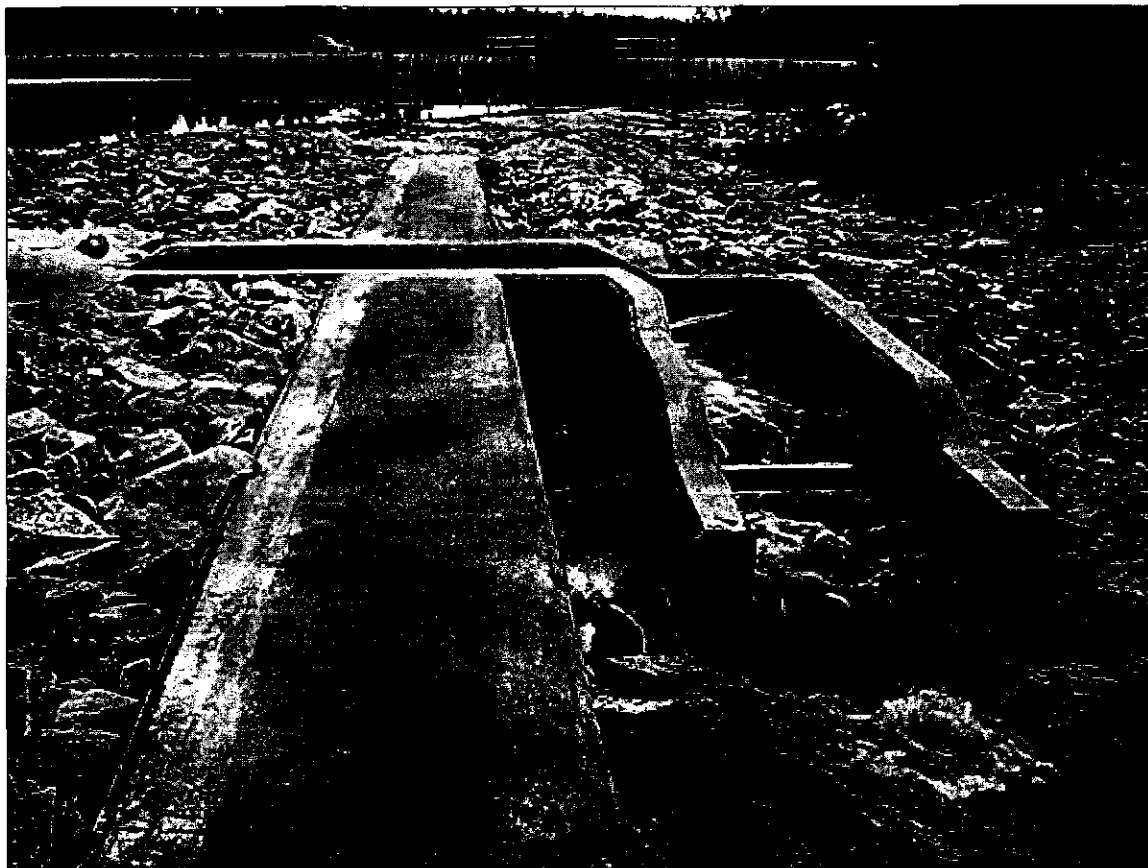
New fish ladder(constructed in 1999)

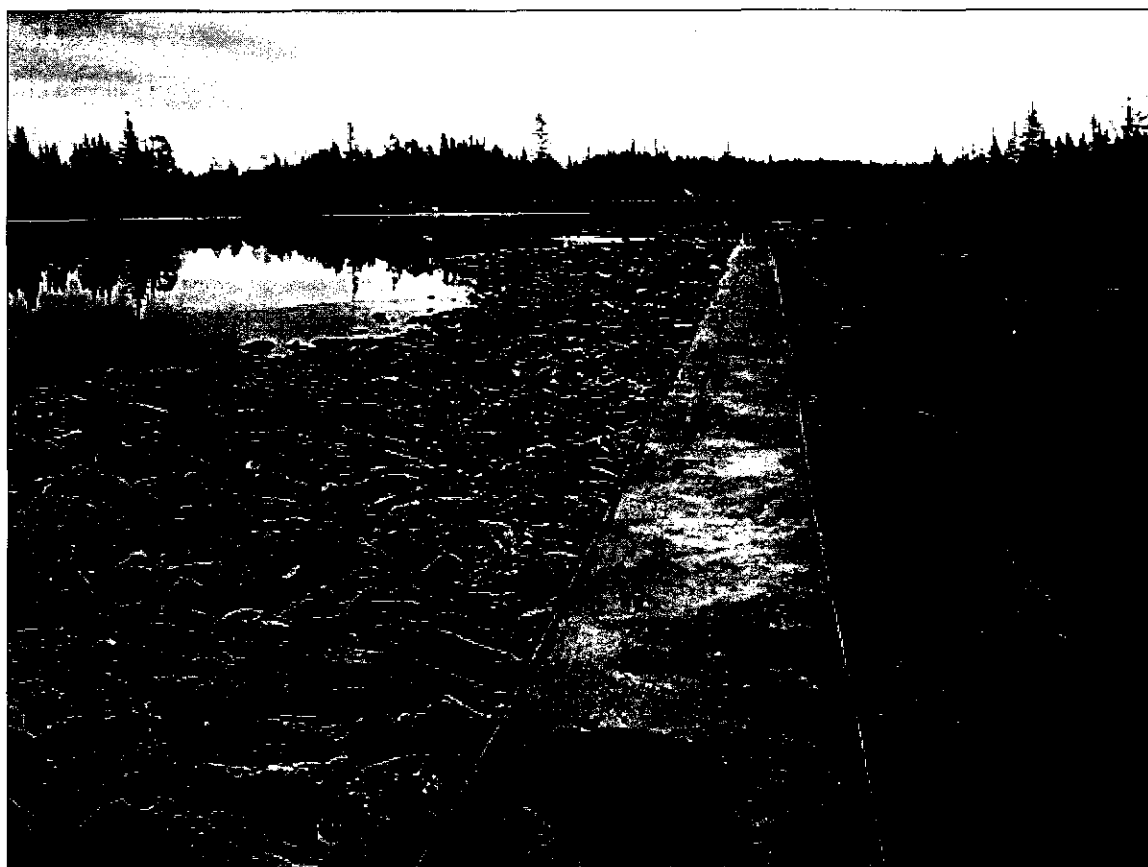
View along crest
