***NEWFOUNDLAND POWER***  
***DAM SAFETY EVALUATION***  
***PORT UNION DEVELOPMENT***

**NEWFOUNDLAND POWER**  
**DAM SAFETY EVALUATION**  
**PORT UNION DEVELOPMENT**

**DECEMBER 31, 2000**

**NEWLAB  
ENGINEERING  
LIMITED**

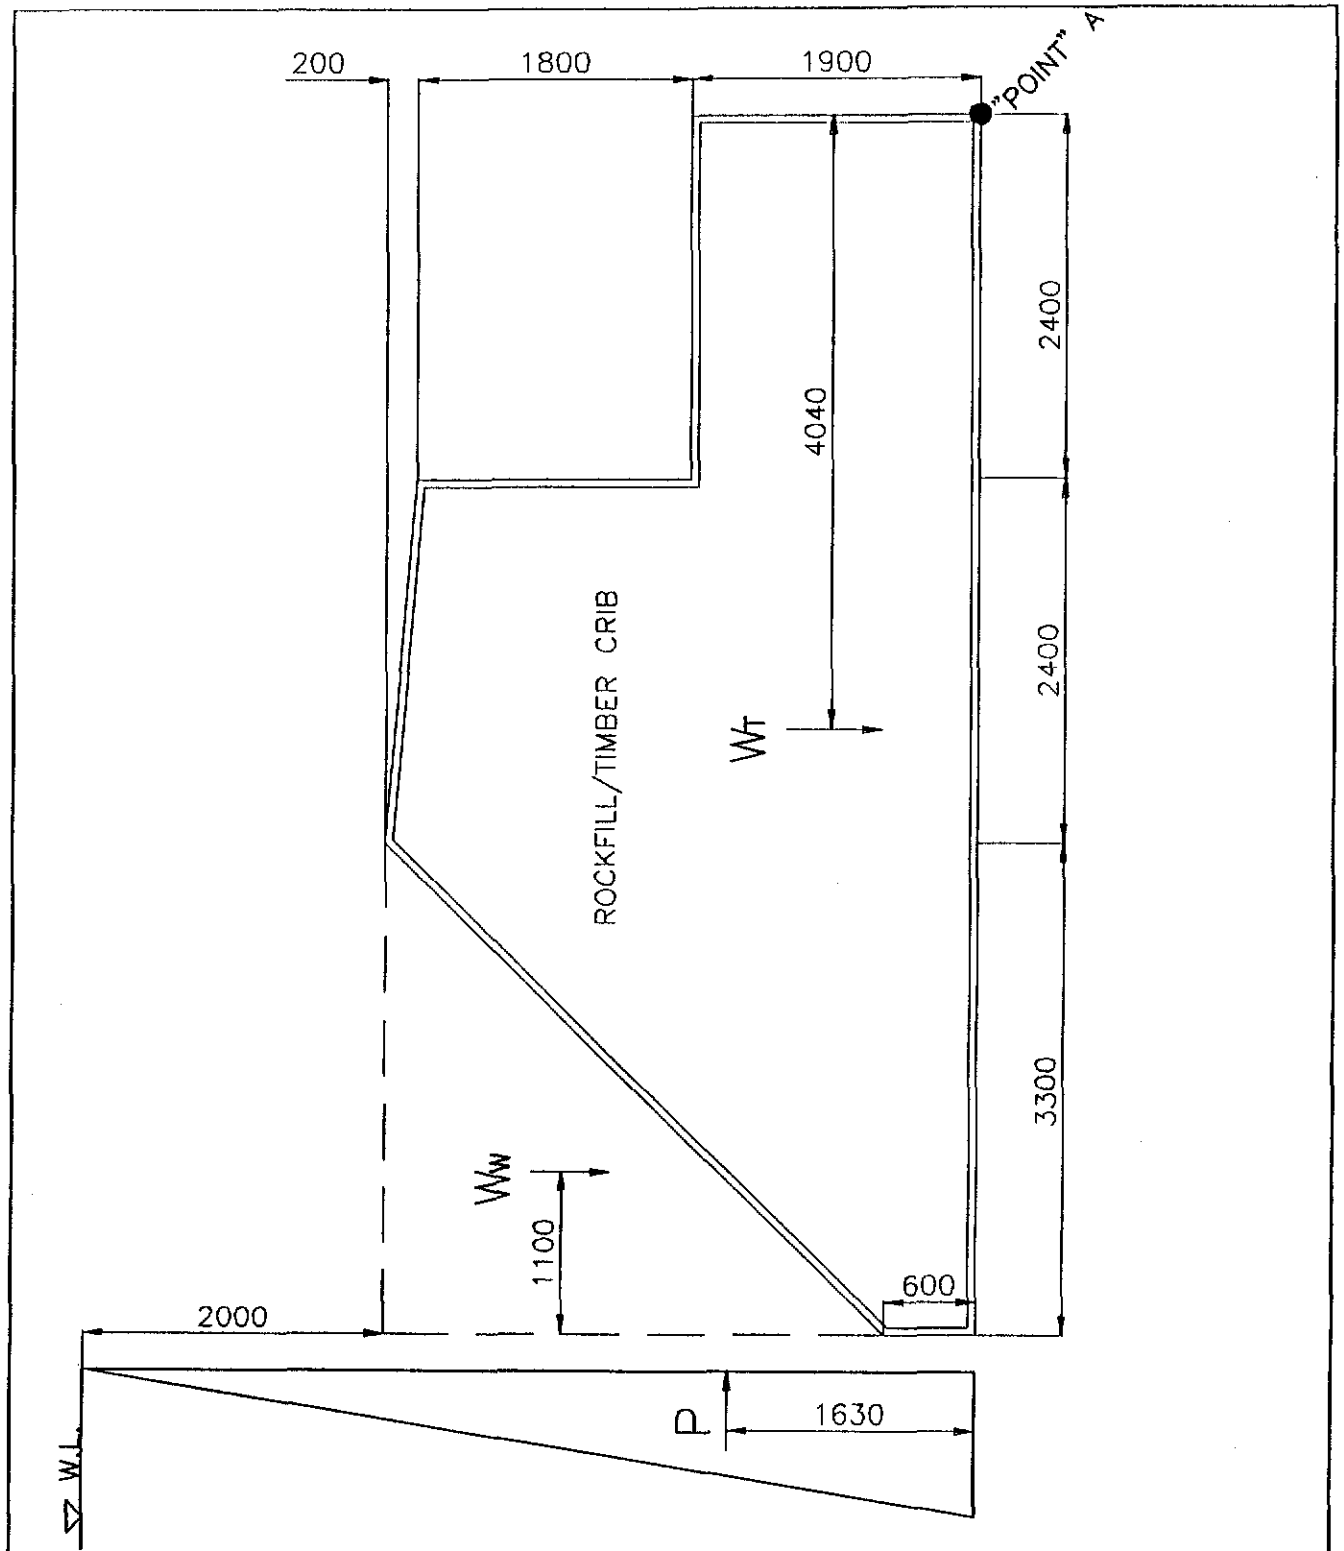
# LONG POND DAM OVERTURNING ANALYSIS LOAD DISTRIBUTION

Resisting Moments: 1951.42 kn.m

Factor Safety: 7.92

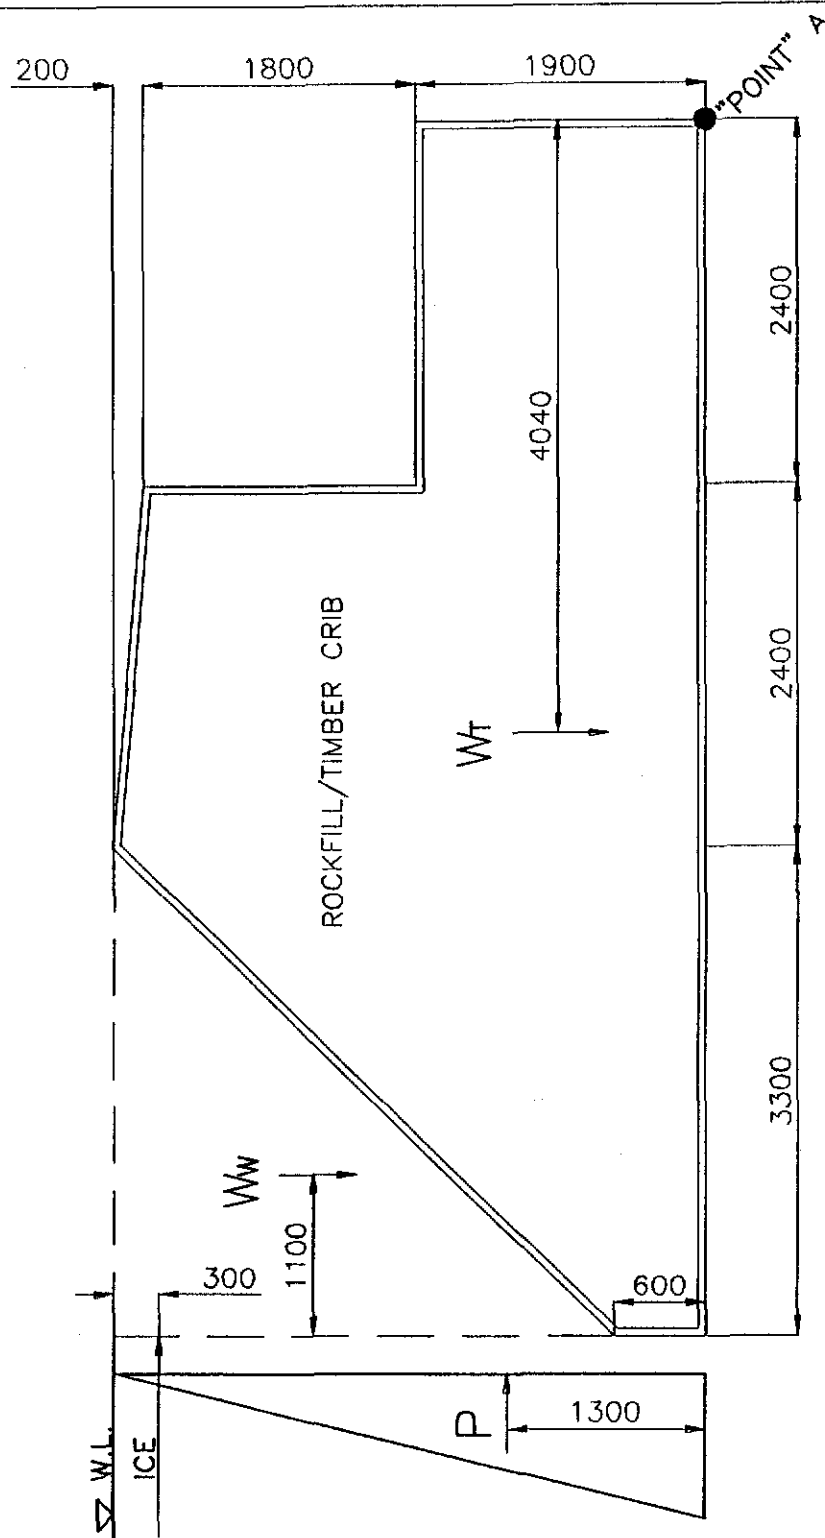
# LONG POND DAM OVERTURNING ANALYSIS LOAD DISTRIBUTION

Resisting Moments: 1951.22 kn.m

Factor Safety: 5.42

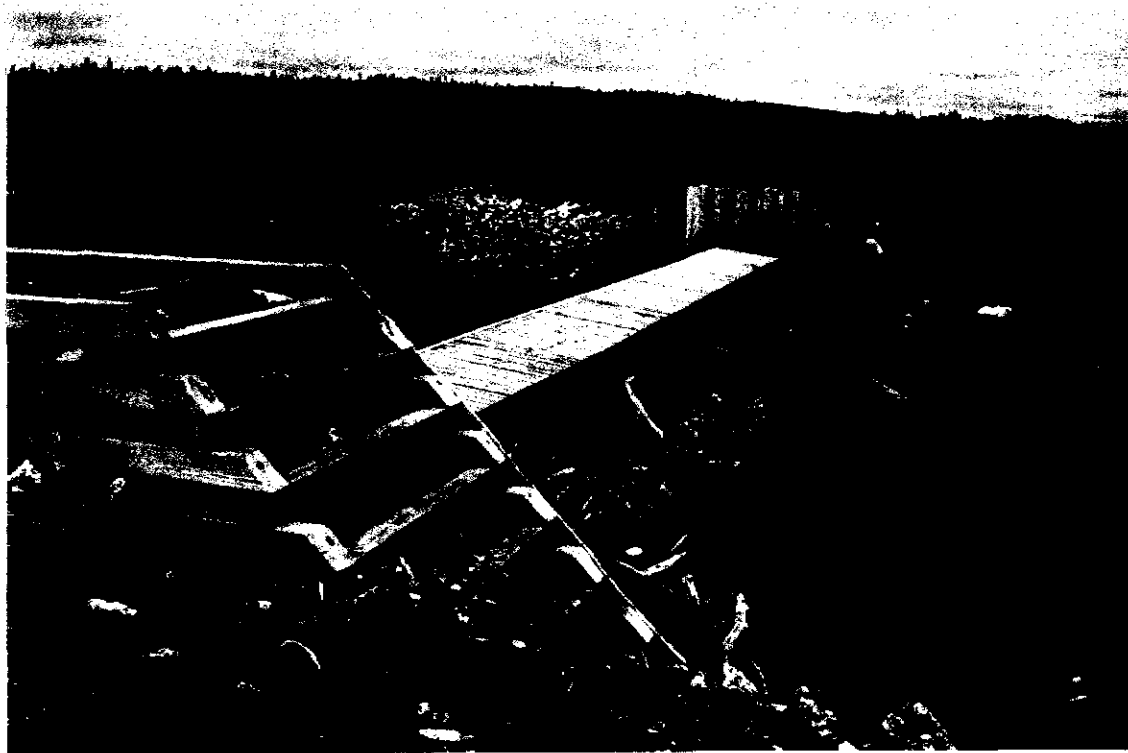
The spillway is a relatively new structure, constructed of treated timber, rock fill and gabions. The gabions, downstream of the spillway, are rusted and rock fill is missing where the spillway flow impacts on the apron. This is likely due to the small size of rock used to fill the baskets. There is also driftwood and debris deposited on the gabion apron. The gabions are placed without any slope which has resulted in an eroded trench immediately downstream of the gabions.

*Halfway Pond Spillway, note Gabions  
& Trench*

| RESERVOIR AND STRUCTURE | RECOMMENDED ACTION | PRIORITY |
|--|---|---|
| | Repair gabions and rockfill | 3 |

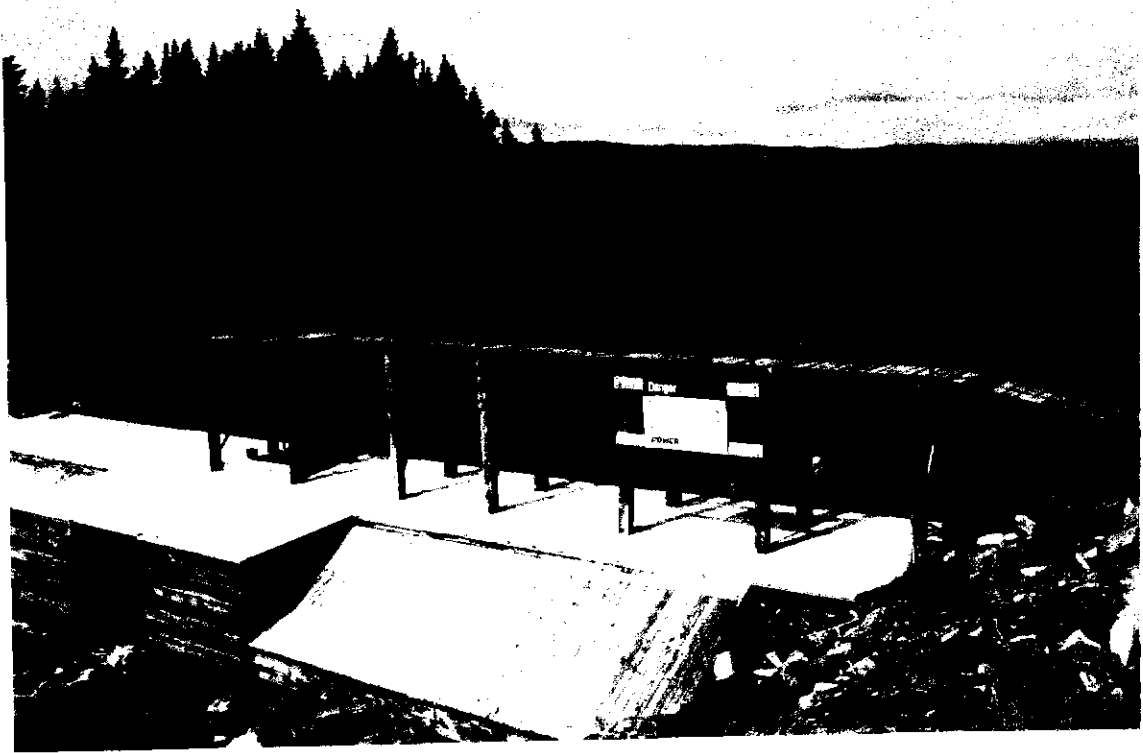
## *Long Pond Dam & Spillway*

The structure is in good condition. The gate was replaced four years ago. The top deck, including supports, of the dam and spillway has also been replaced. The upstream and downstream plank facing has not been replaced since 1985/86. The facing is in good condition with some isolated areas of rot.

The walkway to the gate structure is in good condition. One plank was noted as missing. The gate mechanism is in good working order.

| RESERVOIR AND STRUCTURE | RECOMMENDED ACTION | PRIORITY |
|--|---|---|
| Long Pond Dam | Replace plank in walkway | 1 |

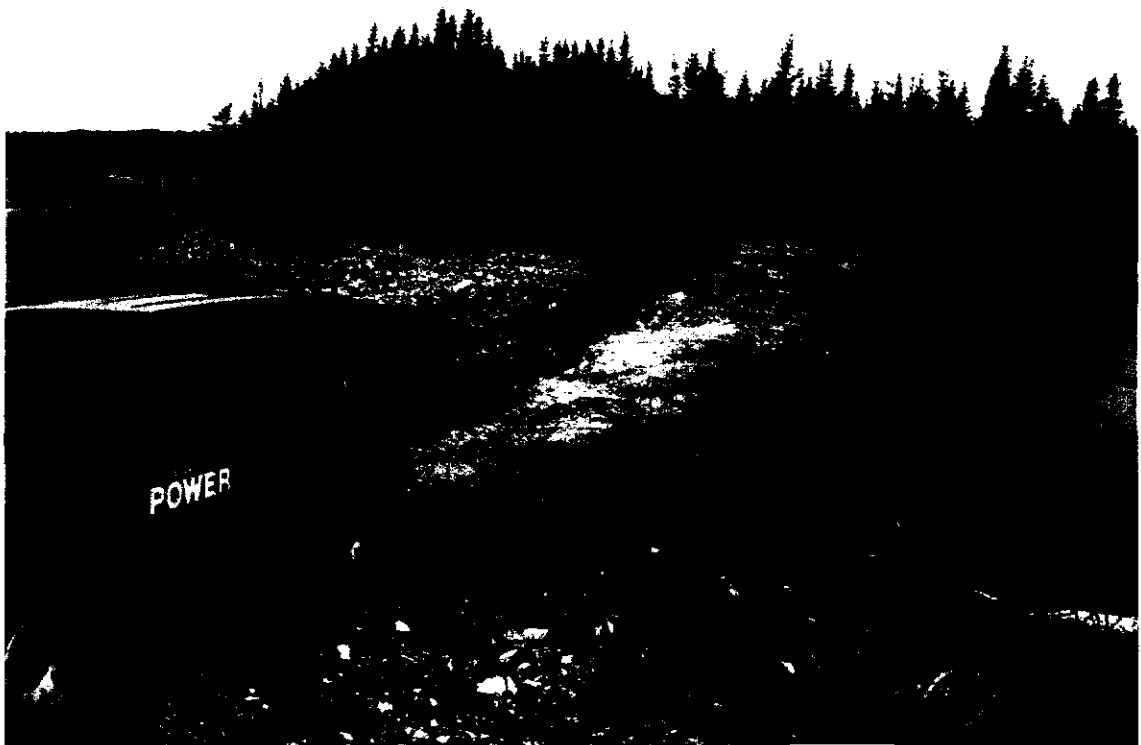
*Wells Pond Freeboard Dam*

The dam is now an earth fill structure. The rip rap is sparse on the upstream face, there is some vegetation growth, and the dam crest is undulating. With low water levels in the main reservoir, the water level on the reservoir side of the dams is approximately 1 meter lower than on the freeboard side of the dam.

The dam should be investigated for decommissioning as part of the main structure study.

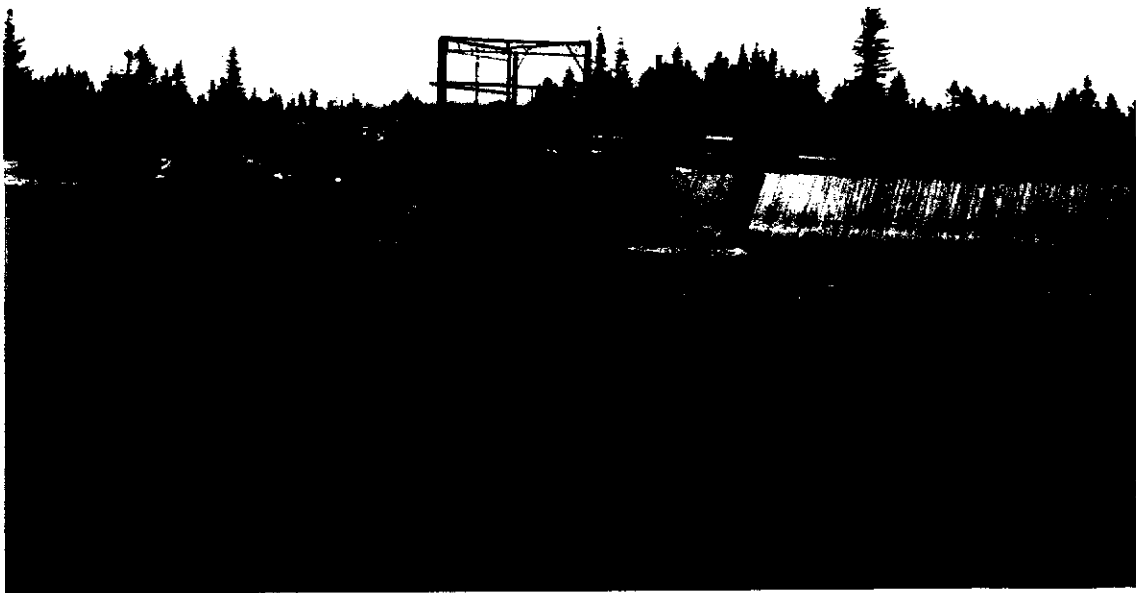
*Whirl Pond Spillway*

The spillway is in good condition. The work in 1999 consisted of pouring new concrete onto the existing concrete structure. The older concrete will require ongoing repair and maintenance.

Leakage was noted through the overflow spillway. This leakage has been present for many years, likely since construction of the original structure. While the 1999 work has reduced the leakage, it has not been eliminated. The leakage likely originates in the reservoir, some distance from the spillway.

| RESERVOIR AND STRUCTURE | RECOMMENDED ACTION | PRIORITY |
|--|---|---|
| | Monitor leakage through spillway | 5 |

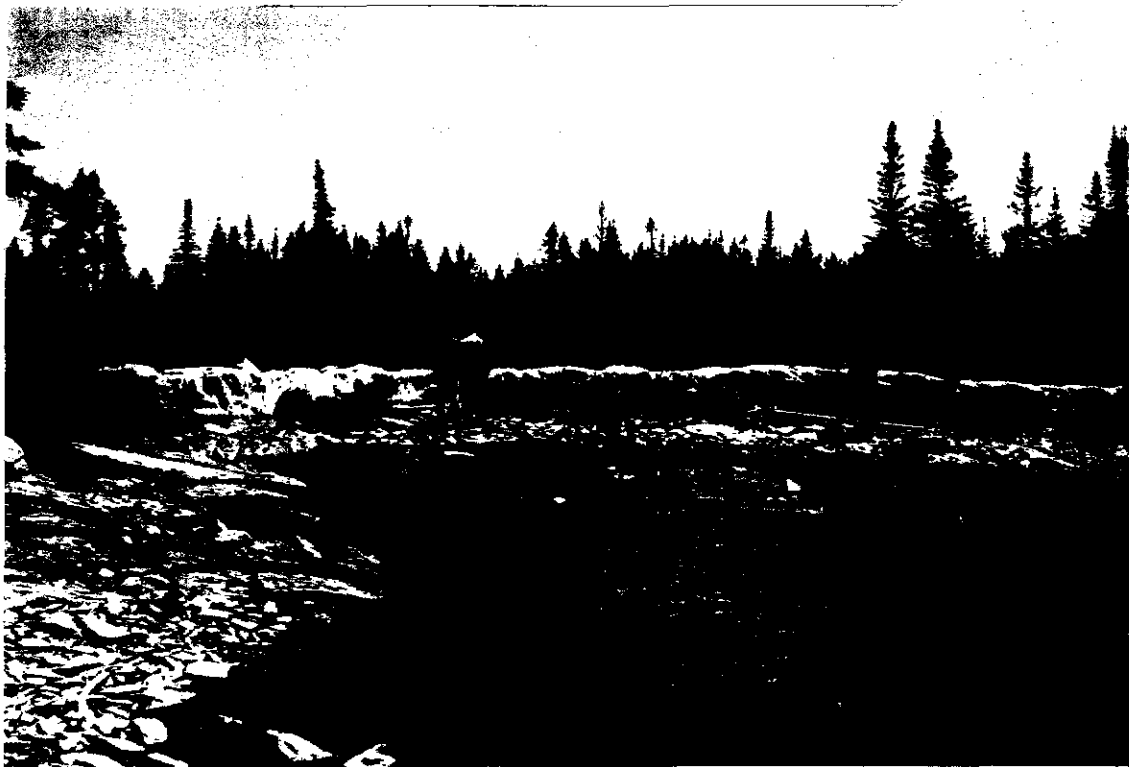
*Whirl Pond Freeboard Dam - No. 1*

Dam No. 1 is a rock wall structure. At the time of inspection, Site No. 2 consisted of a temporary sandbag structure. The two structures should be rebuilt. Newfoundland Power will be constructing a new embankment dam at both sites as part of it's 2000 Capital Works Program.

| Whirl Pond Freeboard Dams | Reconstruct Dam #1 | 2 |
