NEWFOUNDLAND POWER
1993 DAM SAFETY
EVALUATION REPORT
LOCKSTON DEVELOPMENT
JULY, 1993

**1993 DAM SAFETY
EVALUATION REPORT**

LOCKSTON DEVELOPMENT

JULY, 1993

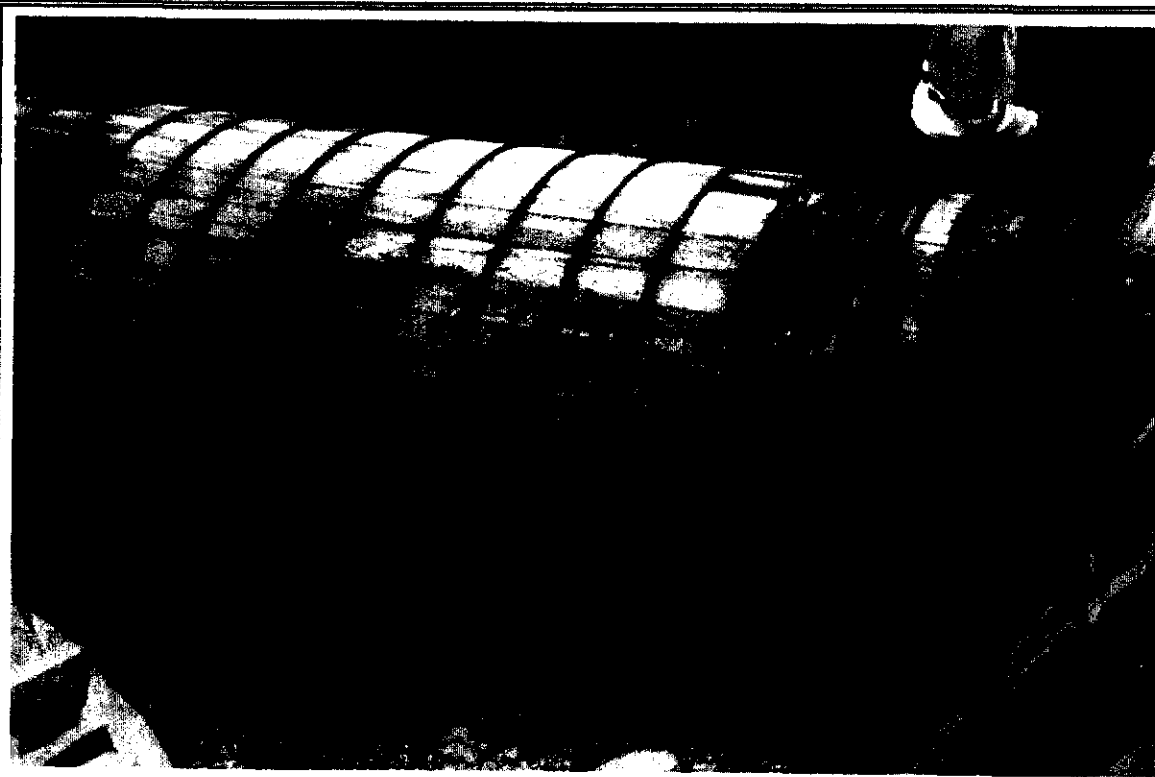
The Lockston woodstave penstock appears to be generally in a poor to fair condition. The staves are generally dry. Creosote coating should be reinstated. The steel band threads should be lubricated to avoid corrosion and those badly corroded should be replaced.

Photo 19
Penstock at intake structure.
Note lack of coating on woodstaves.
