1995 Dam Safety Inspections

**Lockston
Development**

NEWFOUNDLAND POWER

Subject: 1995 Dam Safety Inspections
Lockston Development

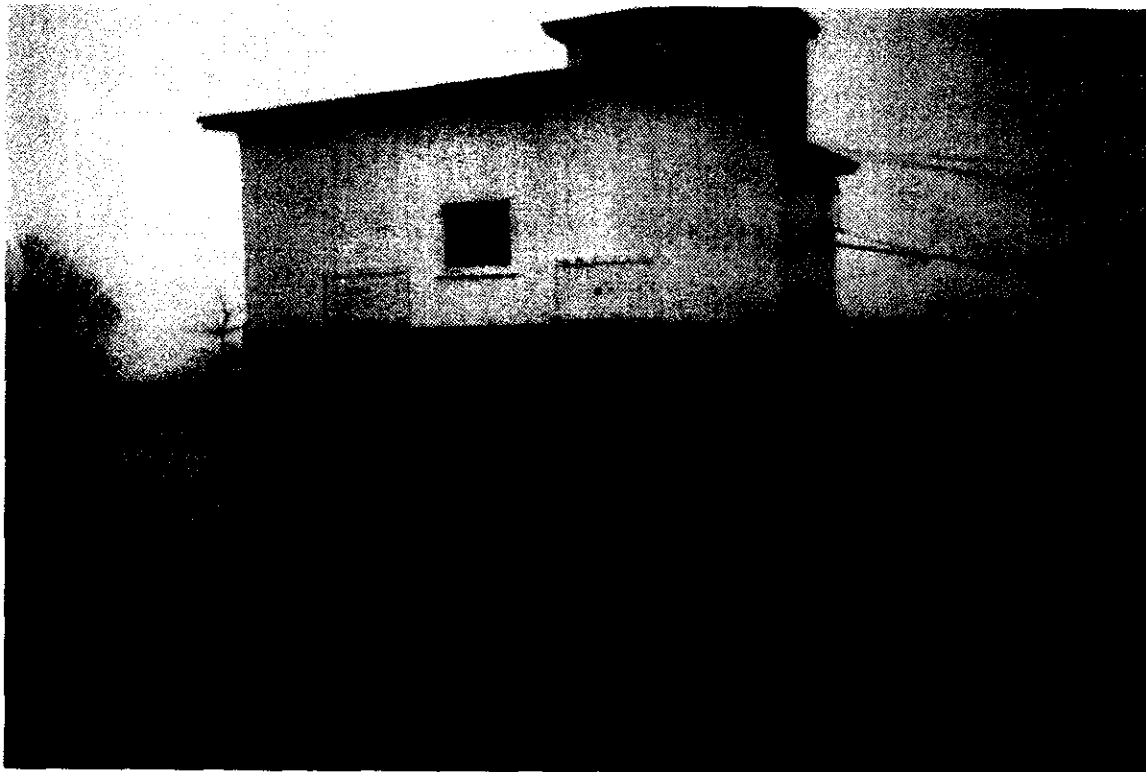
INTAKE STRUCTURE - UPSTREAM
