# **1997 Dam Safety Inspection Lockston Development**

# NEWFOUNDLAND POWER

Subject: 1997 Dam Safety Inspections  
Lockston Development

Please find attached the 1997 Dam Safety Inspection Reports for structures located within the Lockston Development. Structures in this development are in generally good condition and should operate safely with general maintenance and minor capital improvements.

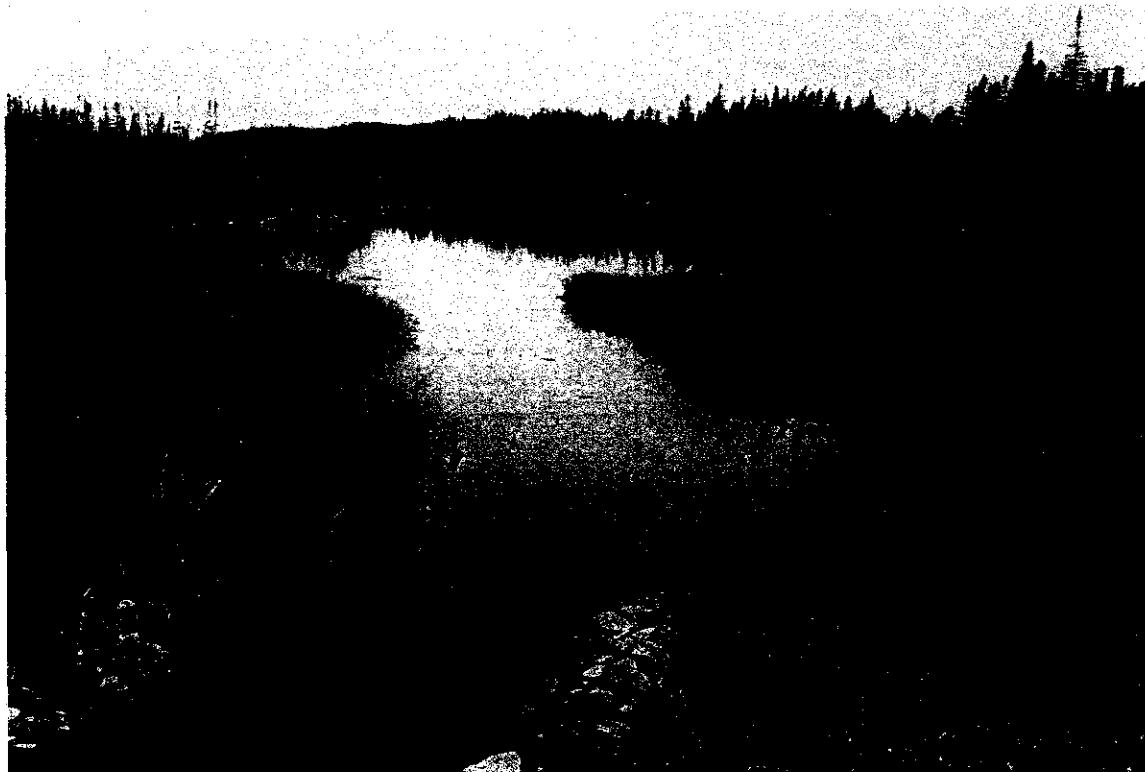
**INLET TO CANAL LOOKING UPSTREAM**

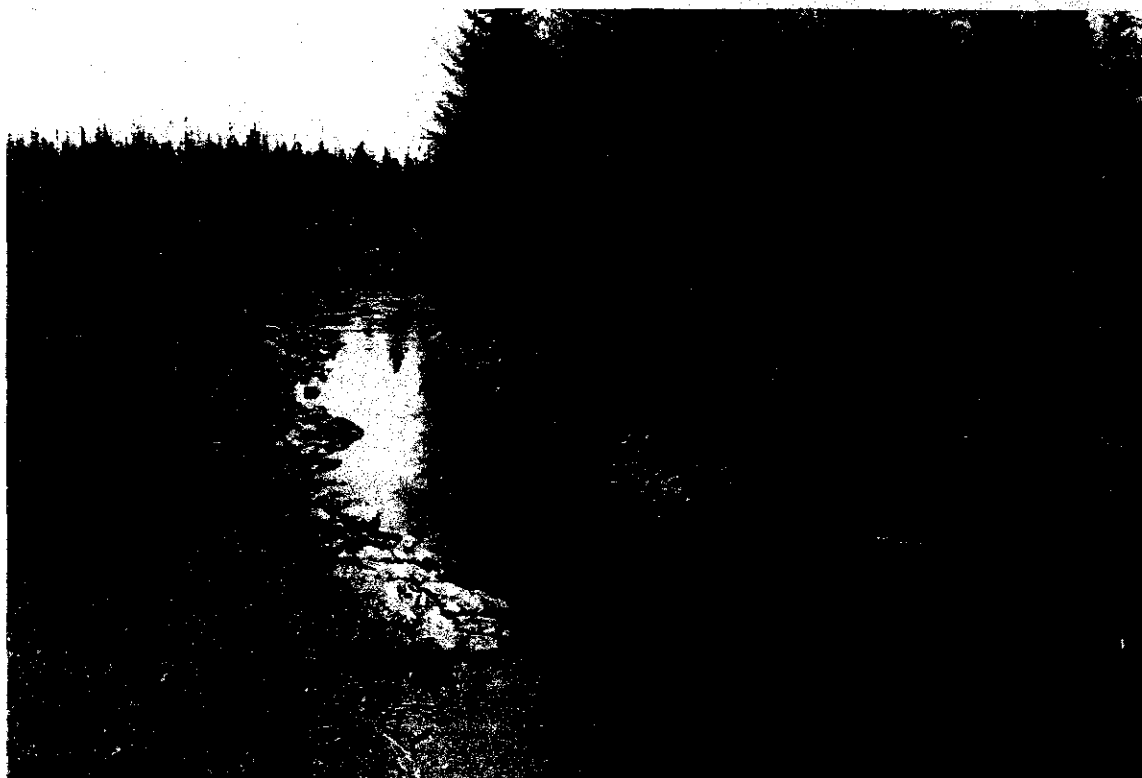
Debris Some evidence of beavers. Gauge should be installed at entrance to canal to ensure invert elevation remains at design elevation and canal is not blocked by mud and debris.

**ENTRANCE TO CANAL LOOKING DOWNSTREAM. THIS AREA SHOULD BE  
INSPECTED AND CLEARED AS NECESSARY.**

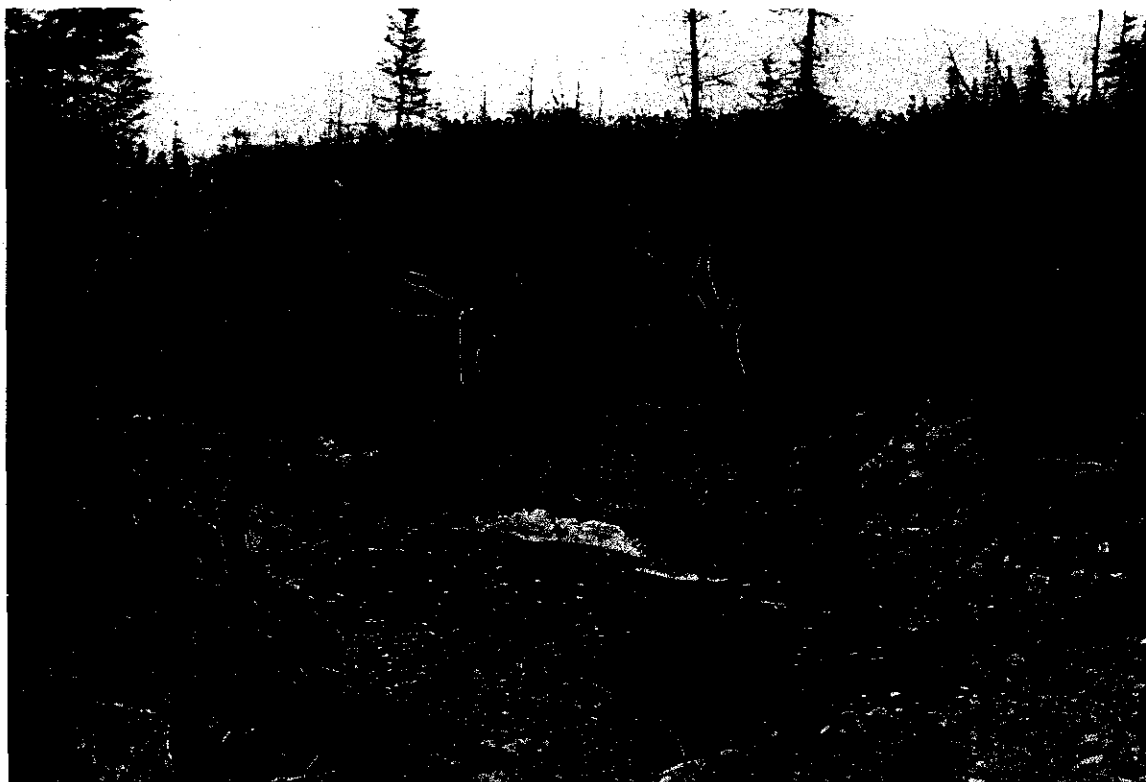
Stability of side slopes Bog has fallen into canal in several areas near upstream end.

**AREA WHERE BOG HAS FALLEN INTO CANAL**

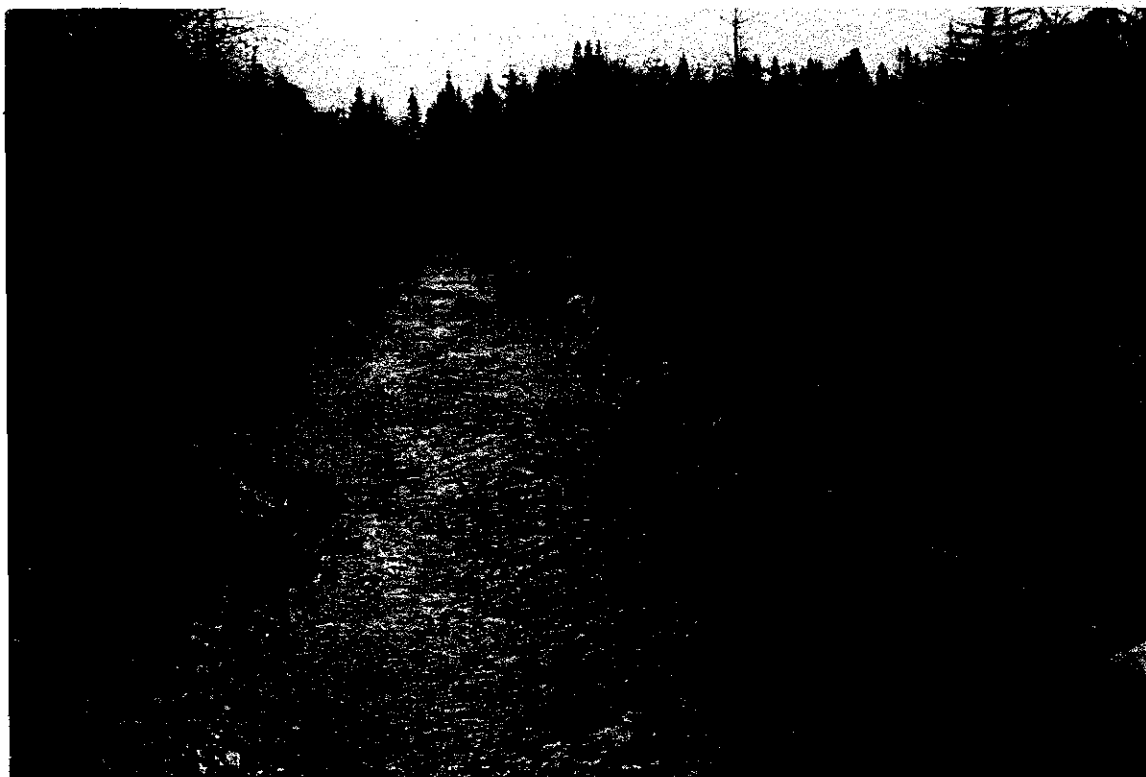
**LOOKING DOWNSTREAM. NOTE BOG HAS FALLEN INTO STREAM**

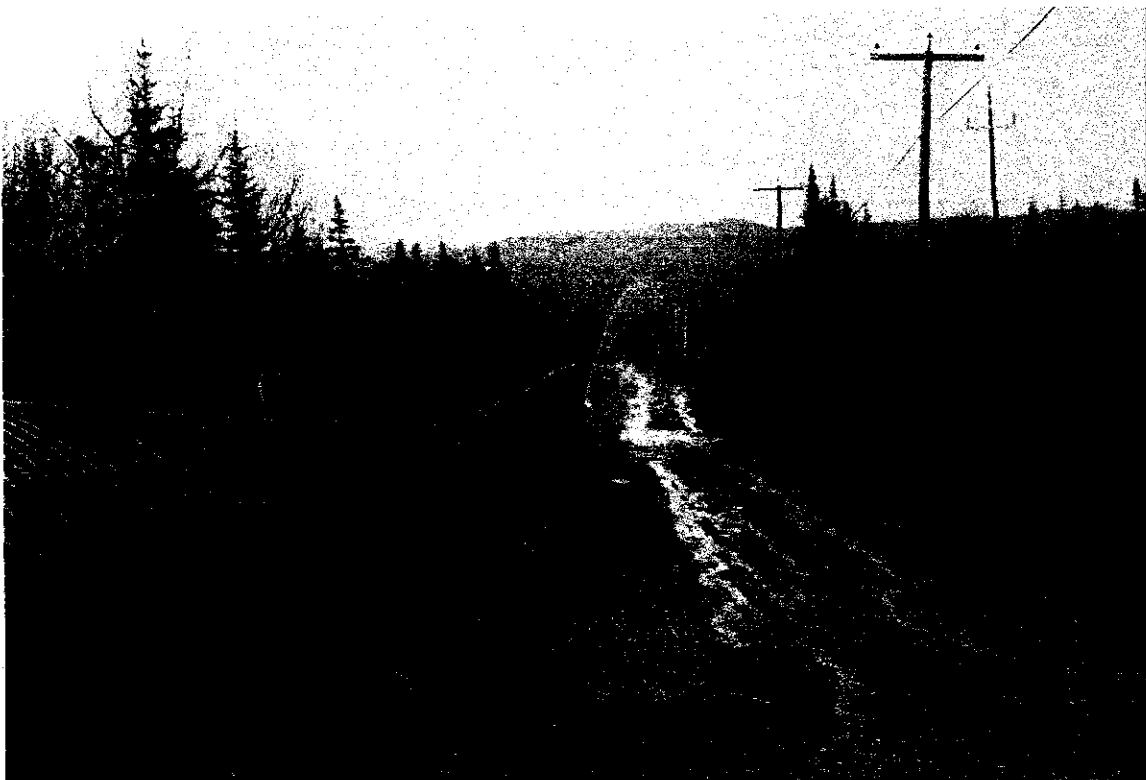
Remarks Penstock is leaking substantially throughout.

**SECTION NEAR MIDDLE OF PENSTOCK. NOTE LEAKAGE.**

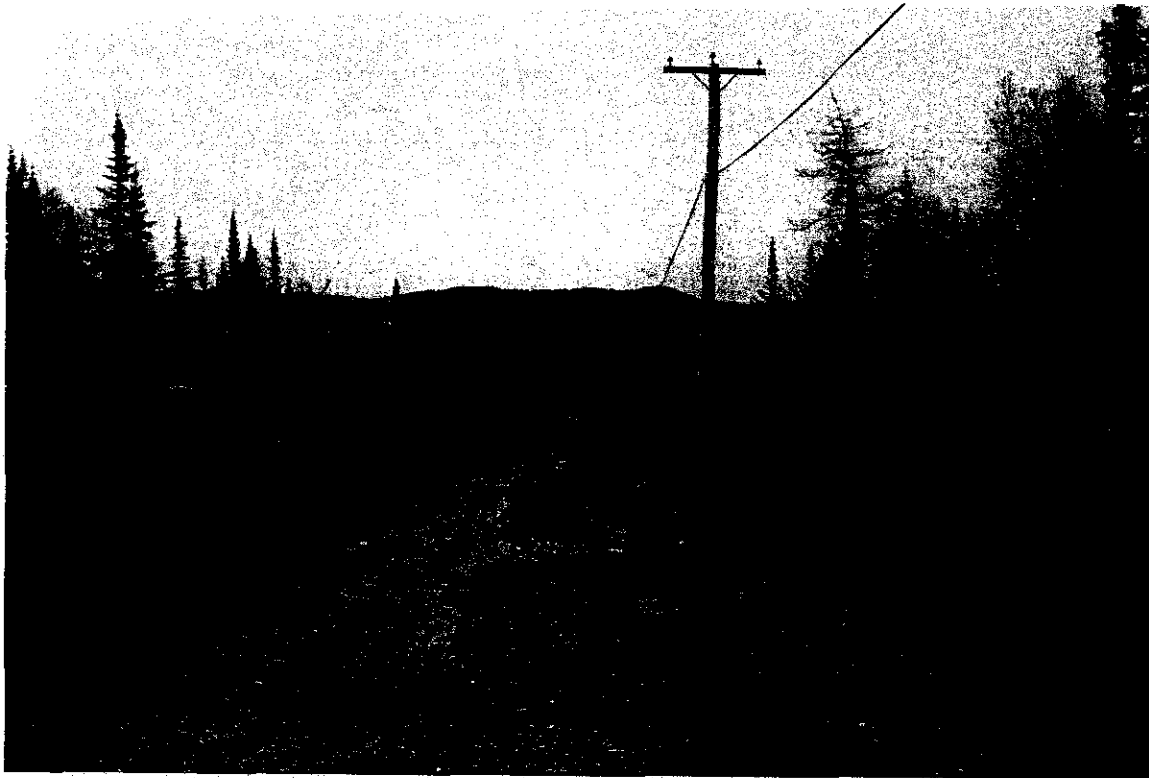
**PENSTOCK SECTION. NOTE WATER IN ROAD DUE TO LEAKAGE.**

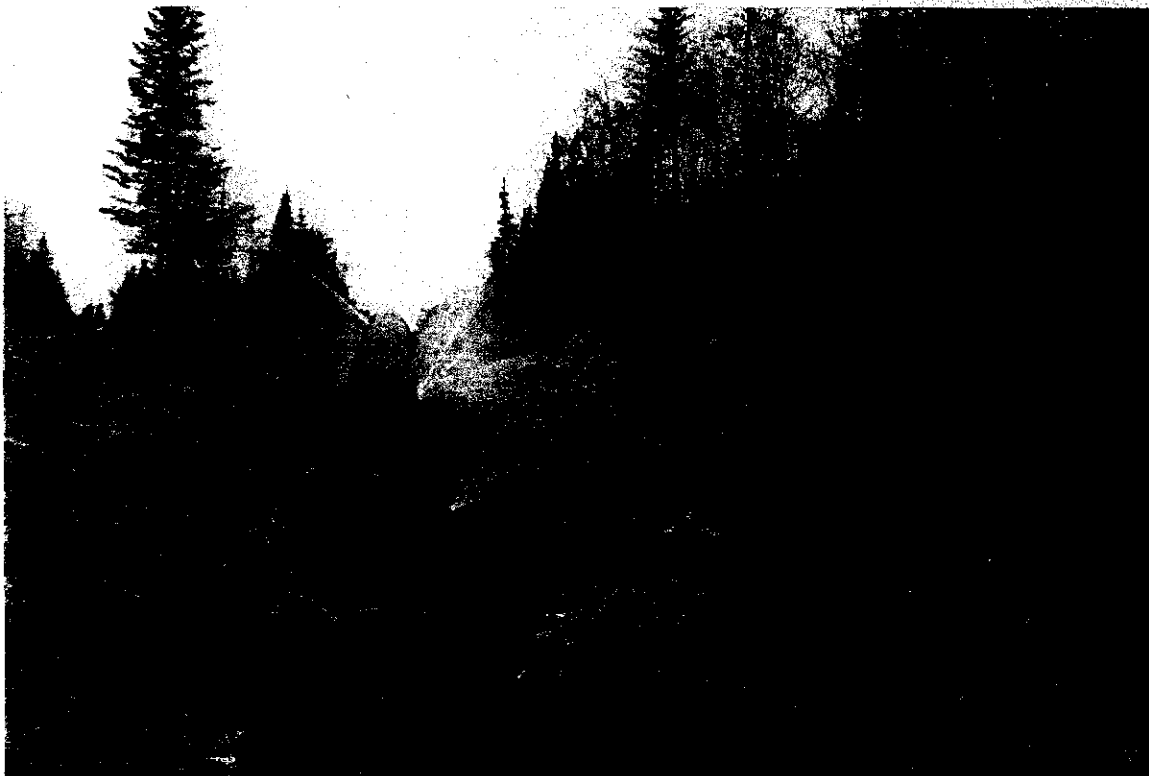
**PENSTOCK SECTION NEAR POWERHOUSE. NOTE LARGE LEAKS.**

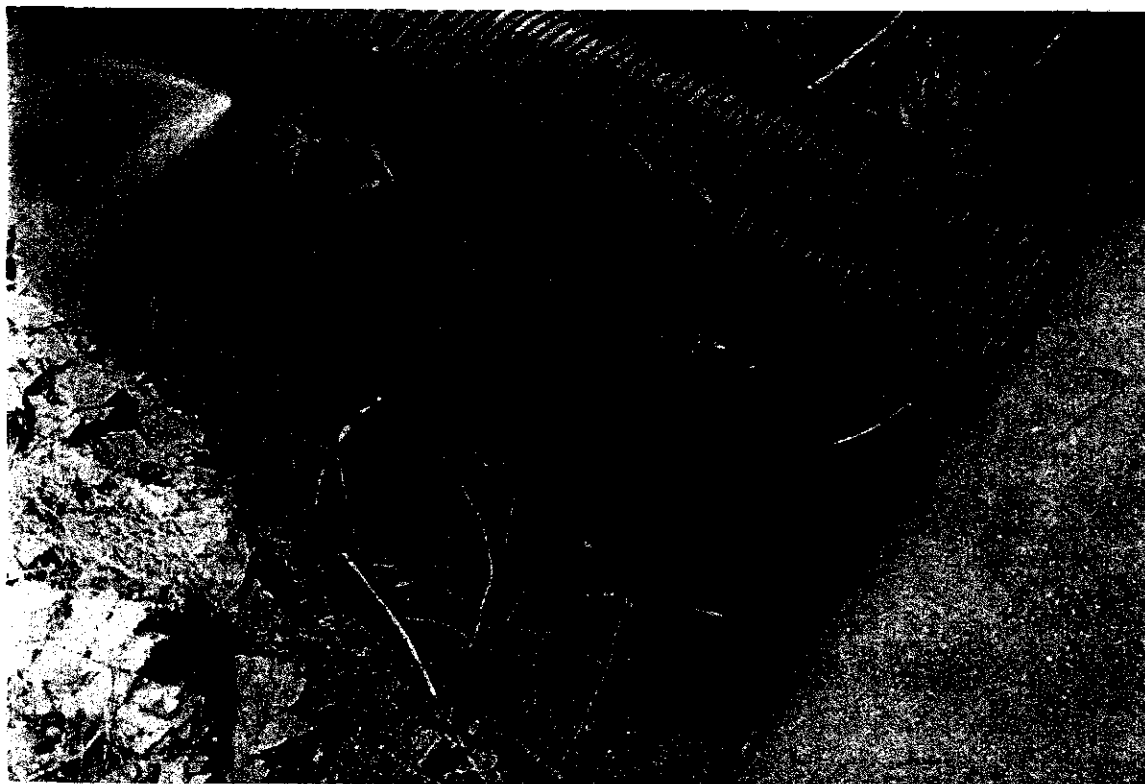
**SECTION NEAR BIFURCATION. NOTE SECTION OF BROKEN CRADLE AND CUT BRUSH**
