1999 Dam Safety Inspection Reports

Lockston Development

NEWFOUNDLAND POWER

Memo From: J. P. Halliday
To: M. C. Hunter
Subject: 1999 Dam Safety Inspection Reports
Lockston Development
File: 401.01.03.30.01

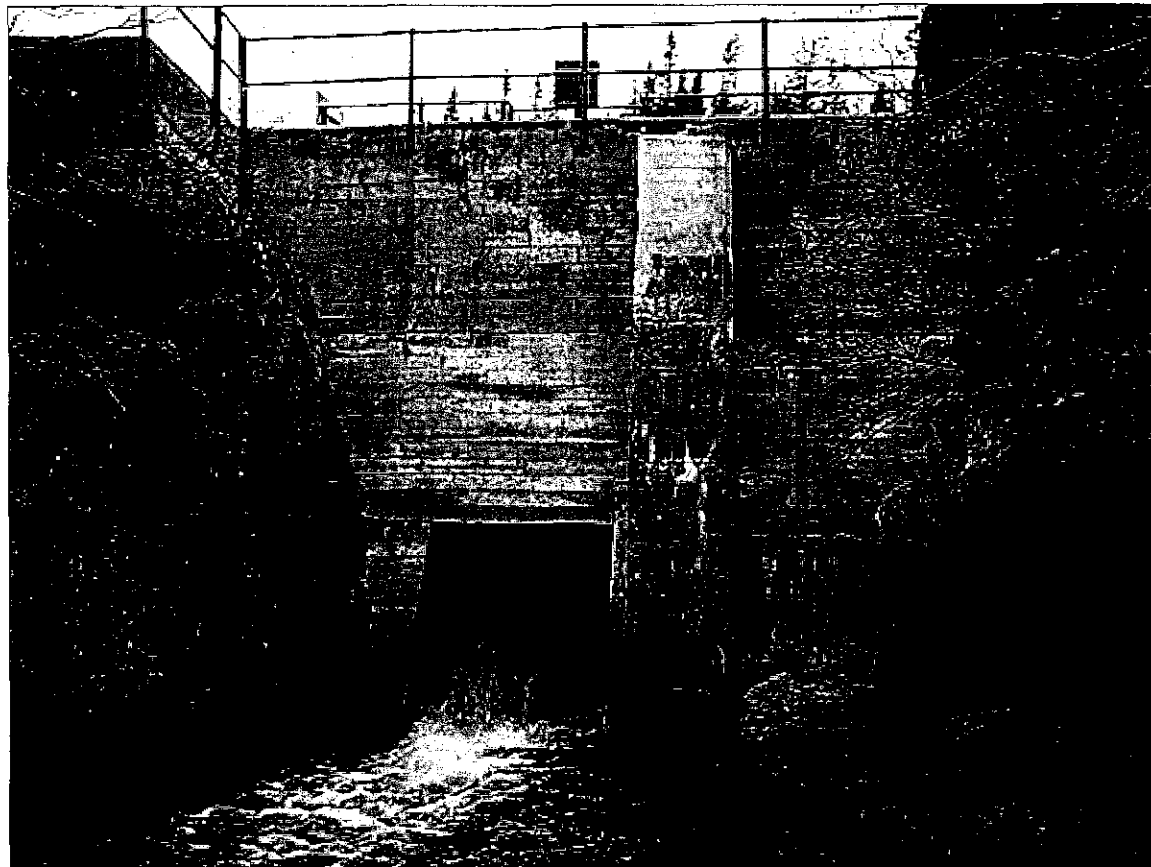
General view from downstream

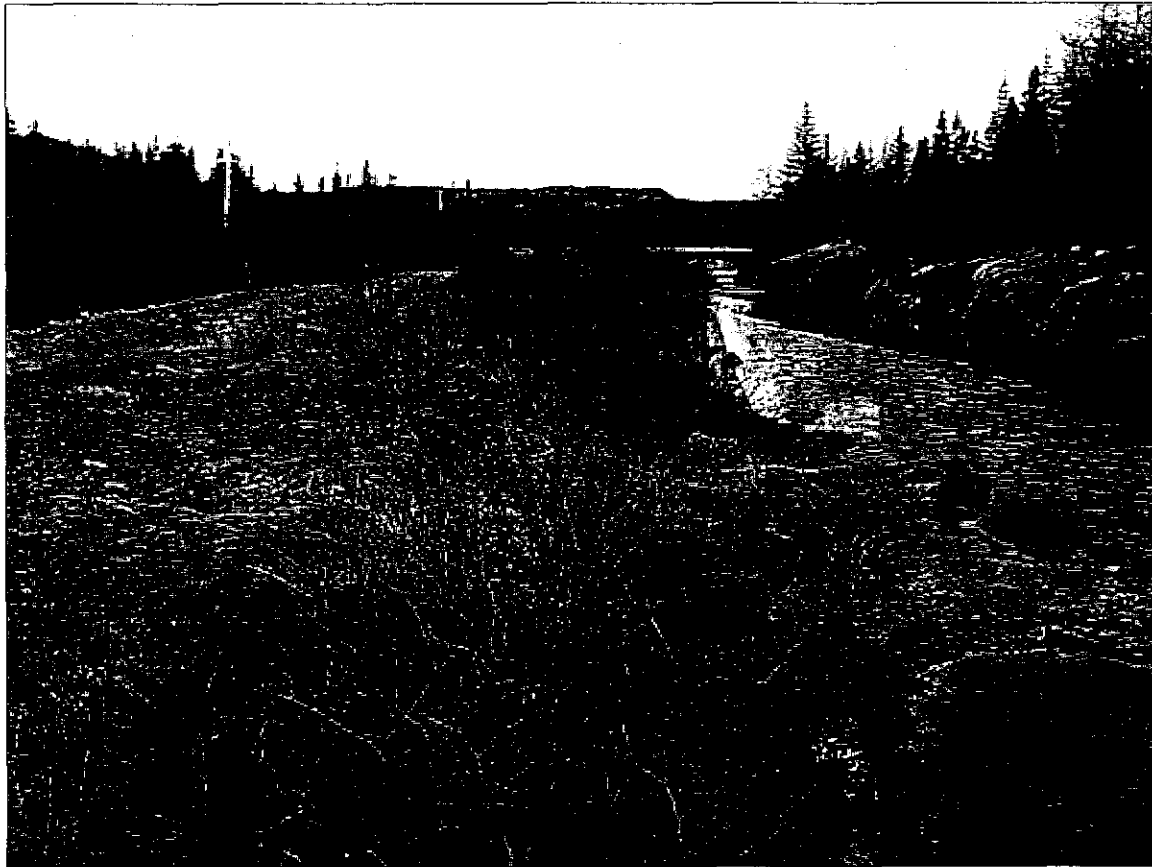
Remarks: Concrete in fair condition. Several audible leaks all along canal but should be stable due to rockfill. Canal has little vegetation. Several areas along canal, and intake have been repaired/patched in recent years.

Canal embankment looking upstream

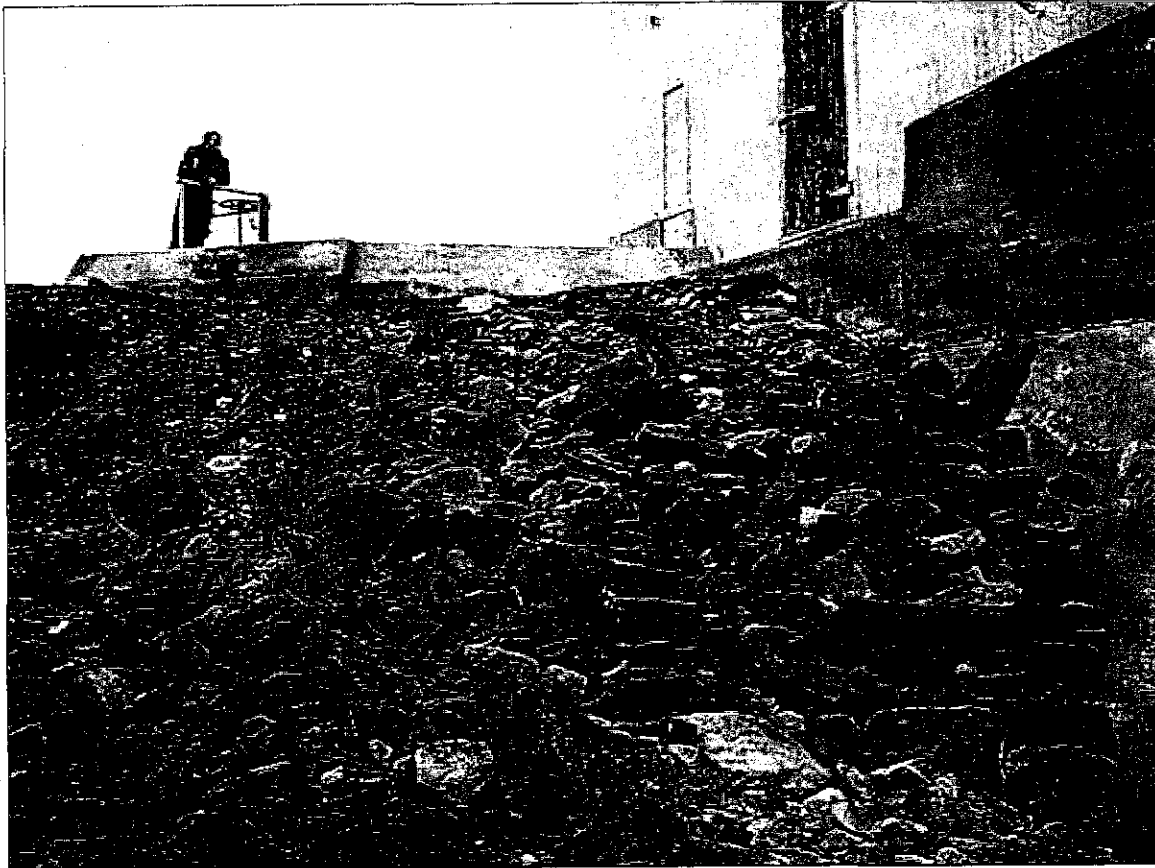
Downstream slope to right of intake

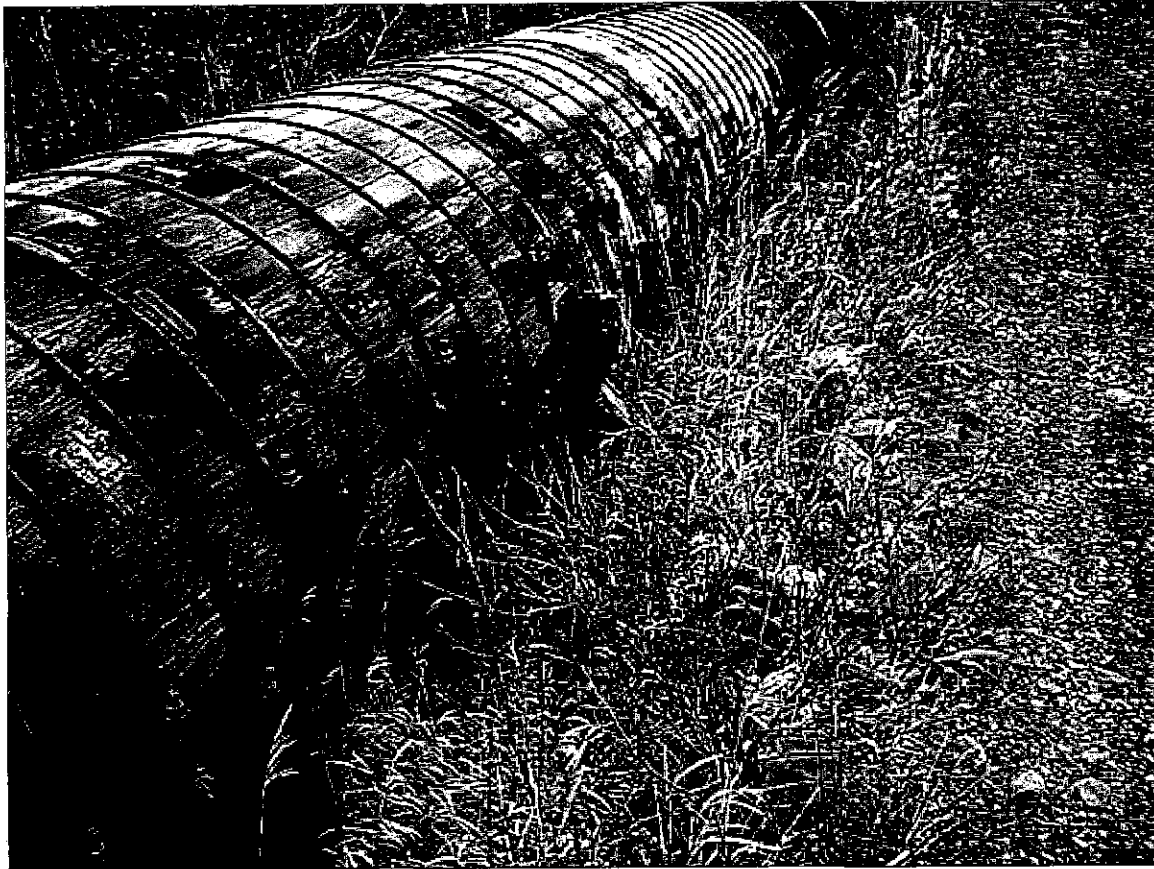
Looking downstream near intake

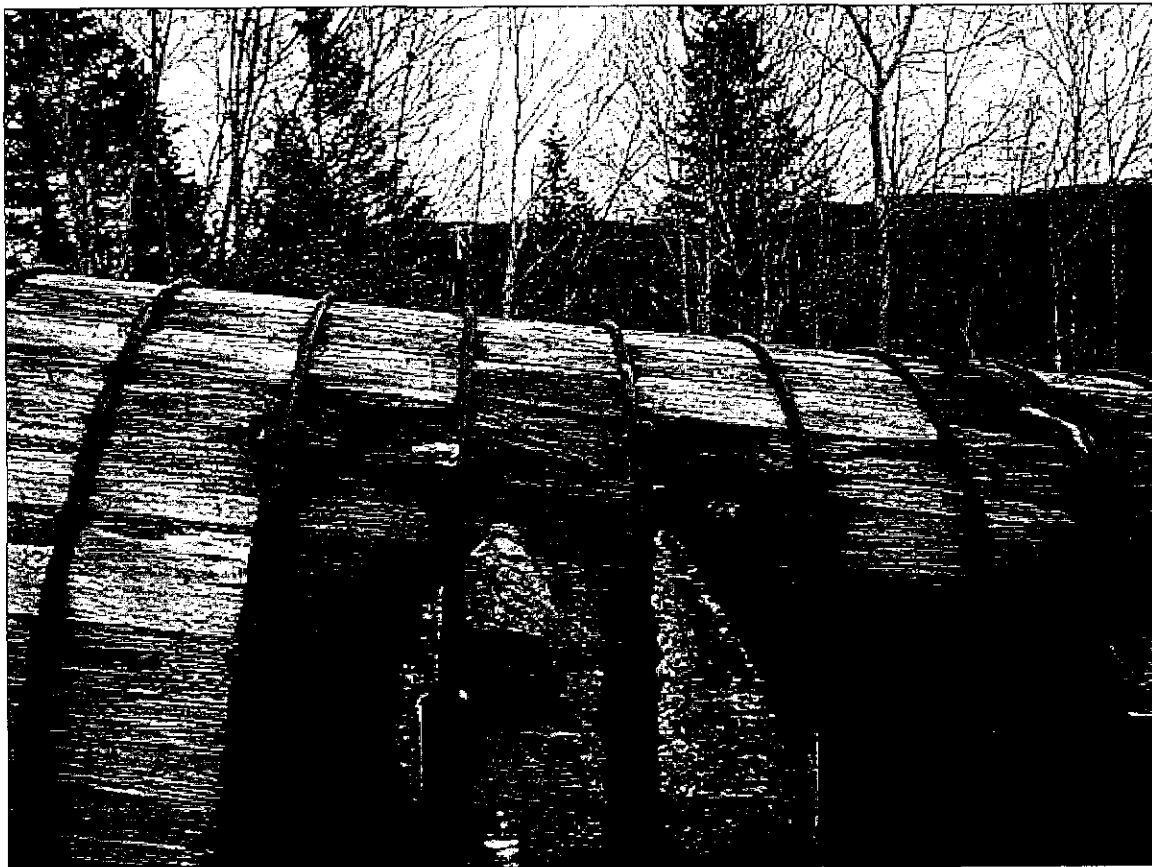
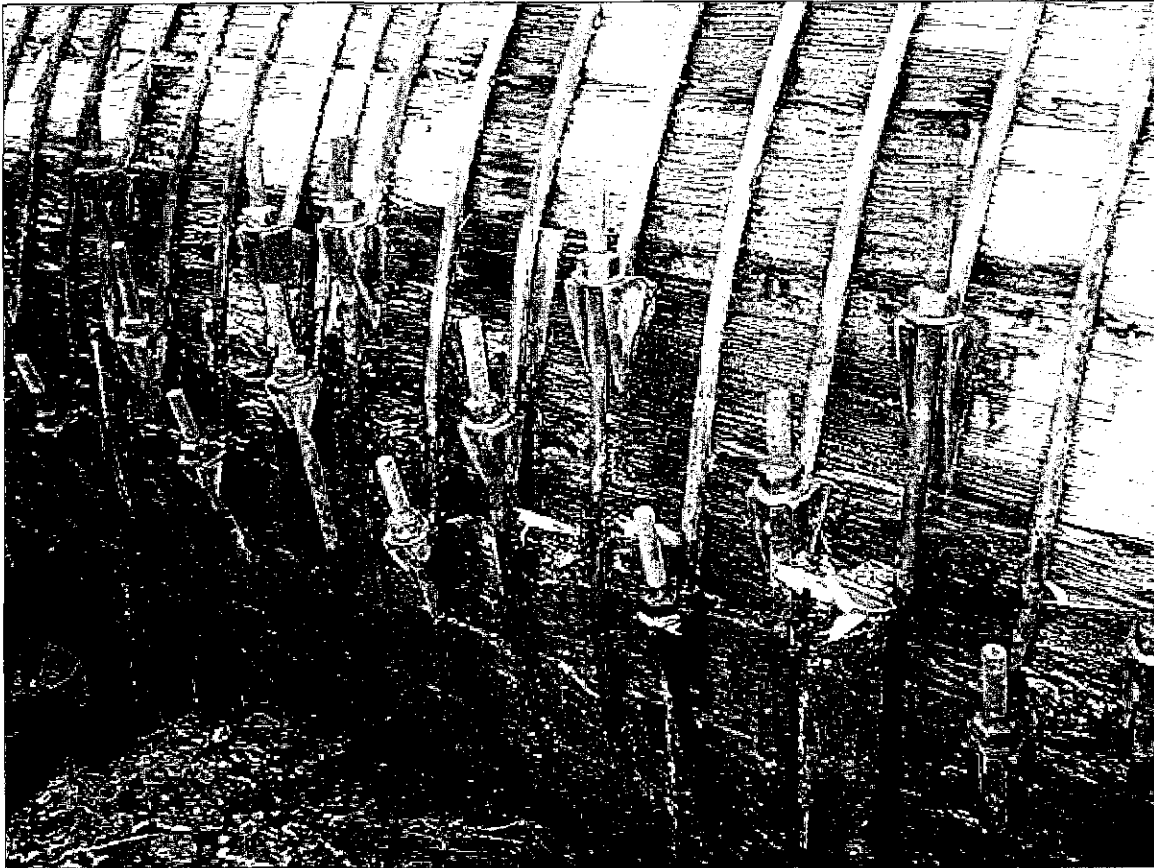
Condition	<u>Wood in poor condition, especially in lower section where staves are crushed.</u>
Cracks	<u>Several cracks in lower section.</u>
Stresses	<u>Several staves crushed, probably due to stresses in pipe or overtightening bands.</u>
Other	<u></u>

Remarks: Penstock in poor condition with several staves crushed and/or rotted. Cradles and penstock supports are in fair condition, with several undermined. Considerable work has gone into repairs to leakage.

Typical crushed staves

The woodstave penstock, however, is in poor condition, and consideration should be given to replacement in the near future.

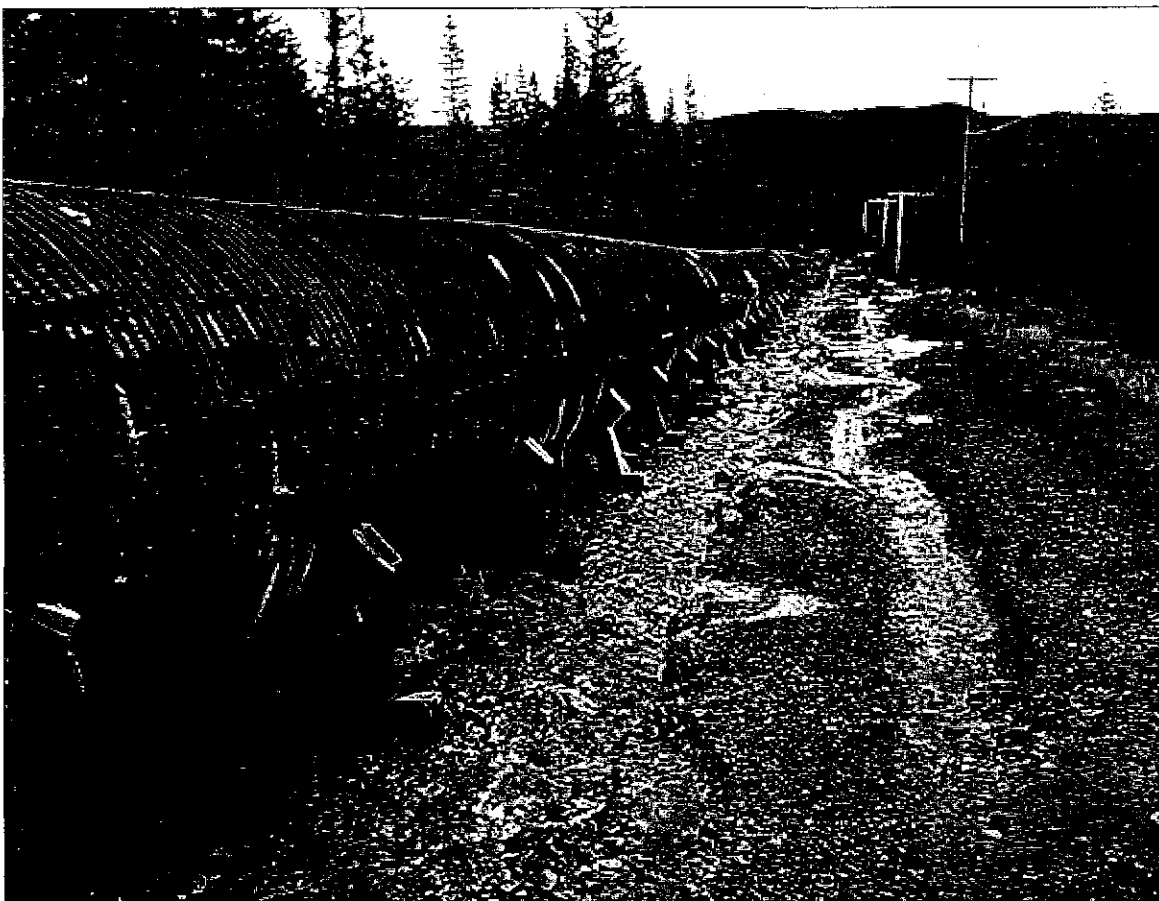
<u>Bed Stable – however, drainage poor & several support cradles undetermined.</u>
Alignment	<u>O.K, some areas of settlement, however they don't appear recent.</u>
Settlement	<u>Few areas</u>

Looking downstream showing leakage along bedding and access road

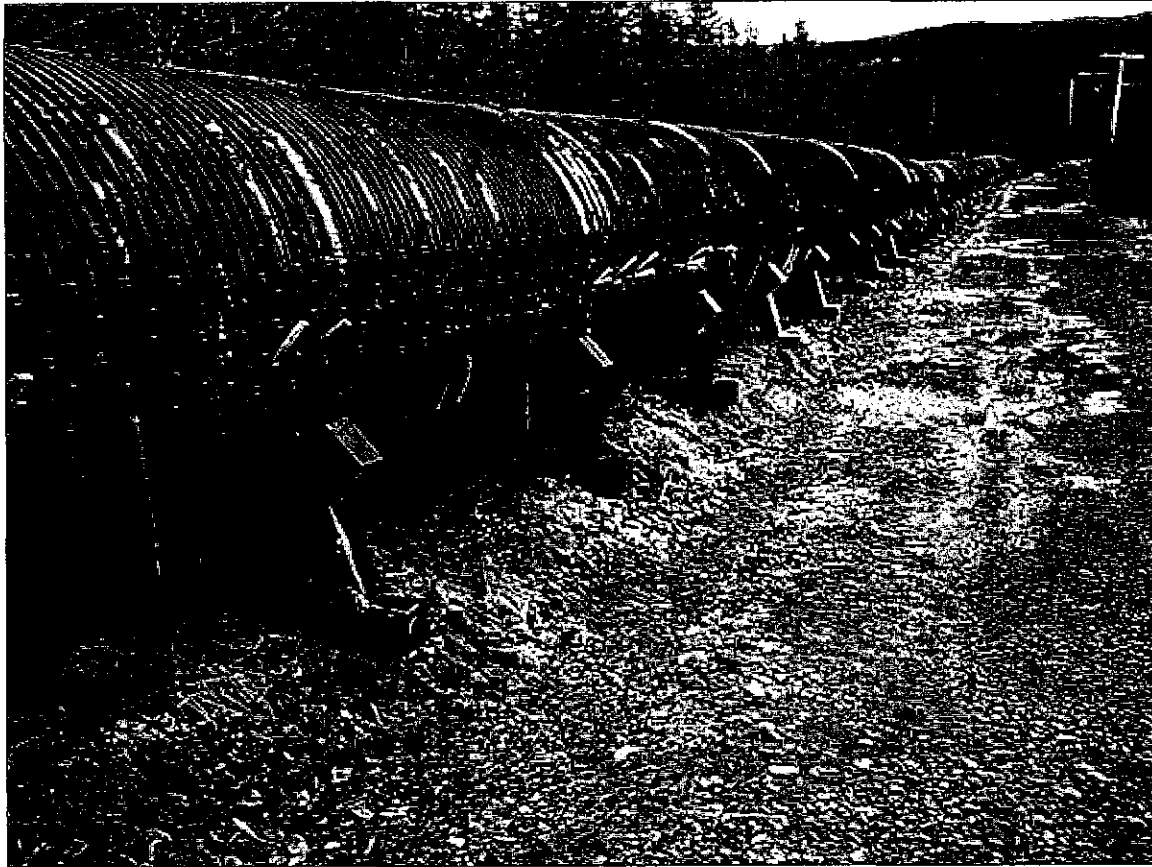
Looking downstream from access road

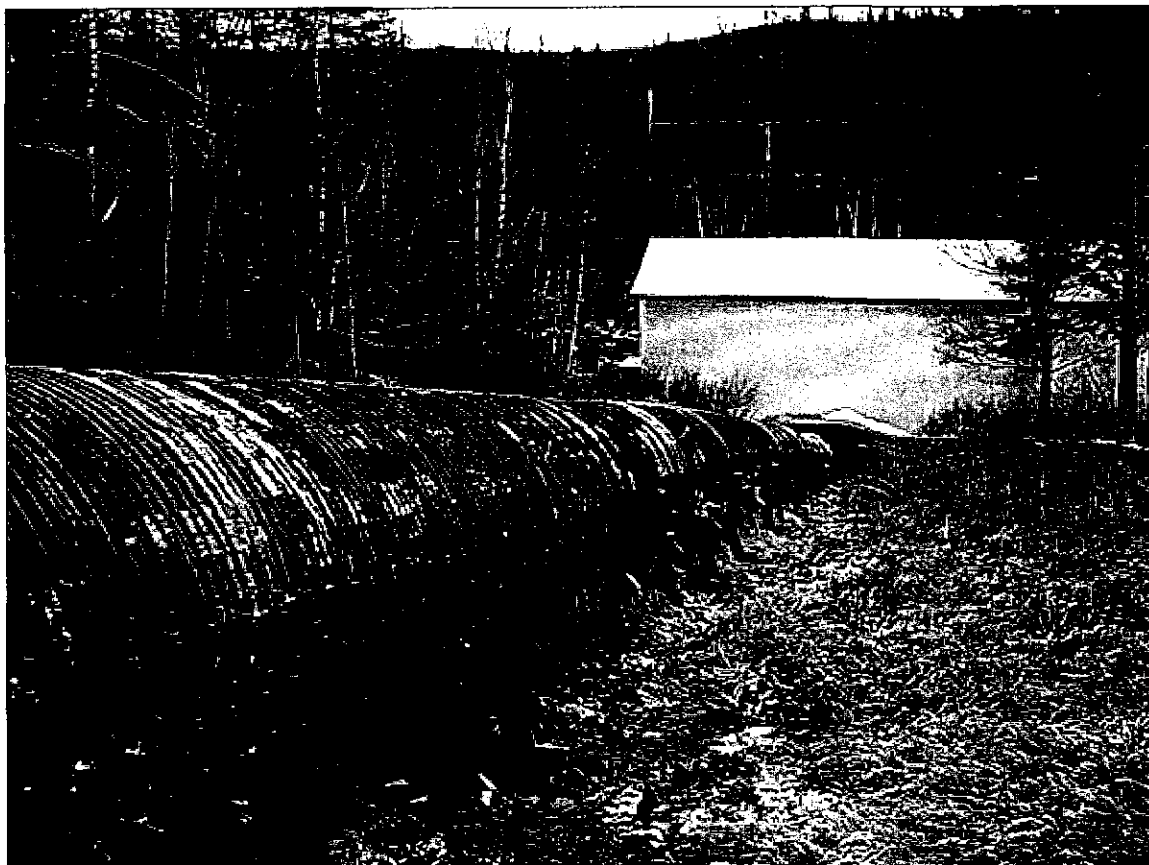
Looking downstream towards powerhouse
