NEWFOUNDLAND POWER
DAM SAFETY EVALUATION
LOCKSTON DEVELOPMENT

**NEWLAB
ENGINEERING
LIMITED**

DECEMBER 31, 2000

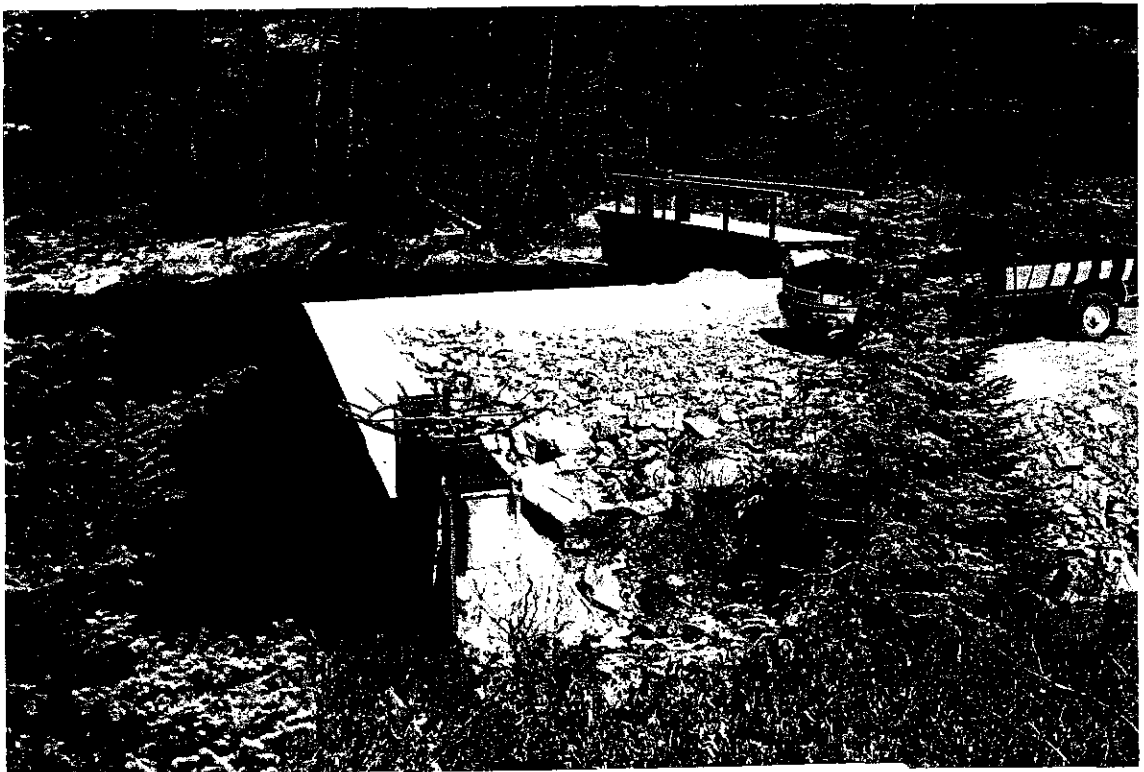
Rattling Pond Dam & Canal Outlet

The dam/inlet structure is in fair to good condition with minor concrete repairs necessary, as noted above. Both the sluice gate and the outlet gate are working properly. Minor seepage was noted through the sluice gate. Minor seepage was also noted at the concrete/rock interface near the sluice gate.

There is a new wood walkway and deck along the dam structure to the sluice gate. There is no walkway to the canal outlet valve. Without such a walkway, the valve may not be accessible during high water levels. The need for a walkway and work deck should be investigated.

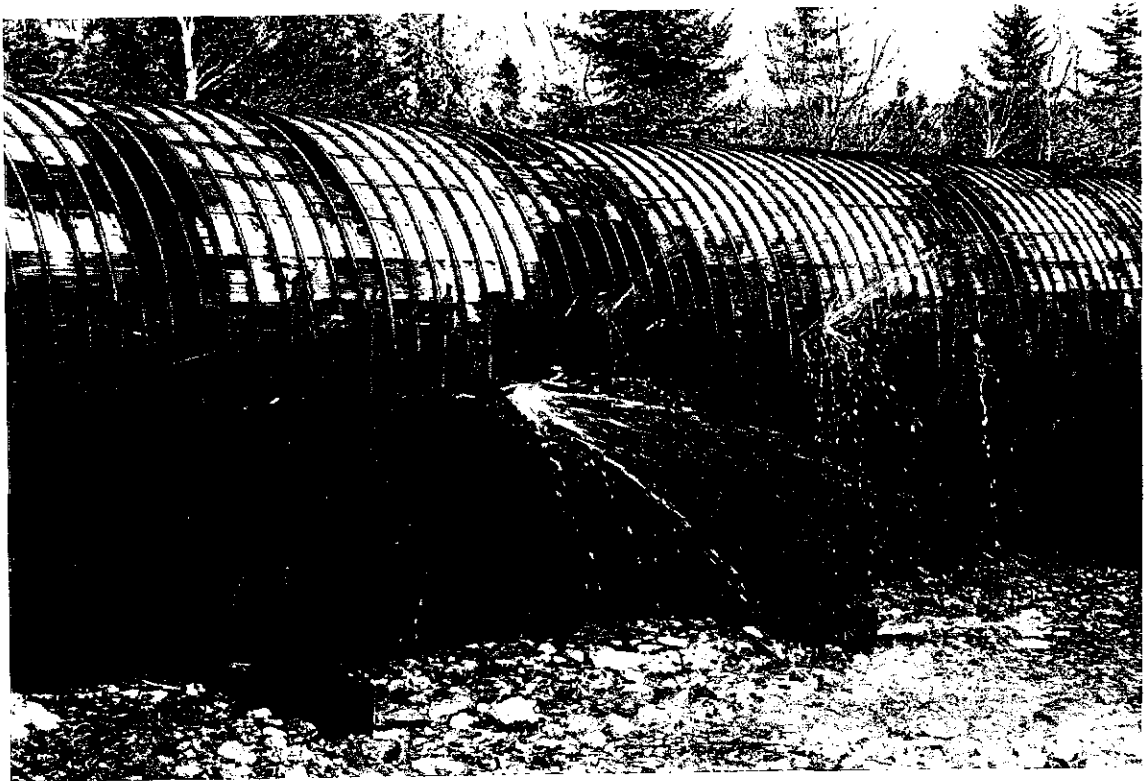
The penstock is a wood stave pipeline on wood cradles and sills. The penstock is in poor condition with significant leaks throughout the full length. The extent of flow from the leakage has caused the bedding to be washed away and cradle supports eroded.

In attempt to repair the leakage, steel bands have been continuously tightened resulting in crushing of the wood staves. Steel bands were noted missing in at least two locations.

*Penstock Spring Line: Note Excessive
Leakage*

The penstock needs to be considered for total replacement. In the interim, direct leakage away from the penstock supports.

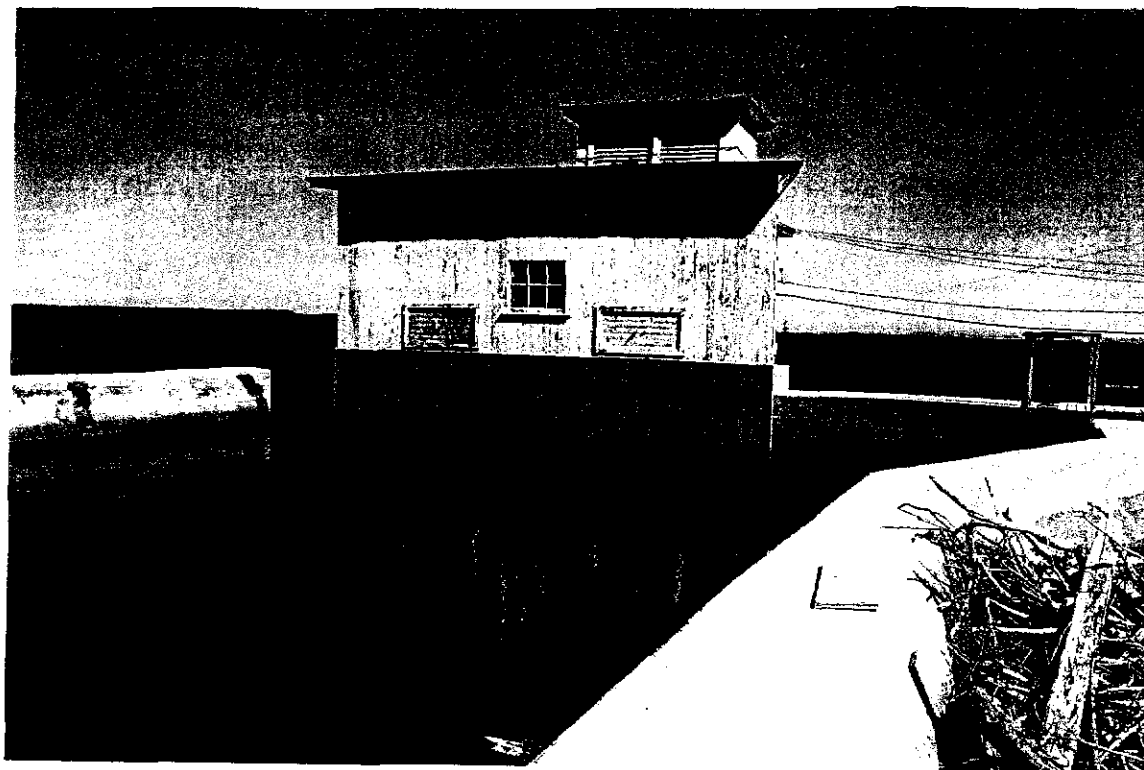
Intake Gate House

The intake is a concrete structure with a wood gatehouse. The structure has a new gate and lift mechanism. Some deteriorated timbers were noted, which should be replaced.

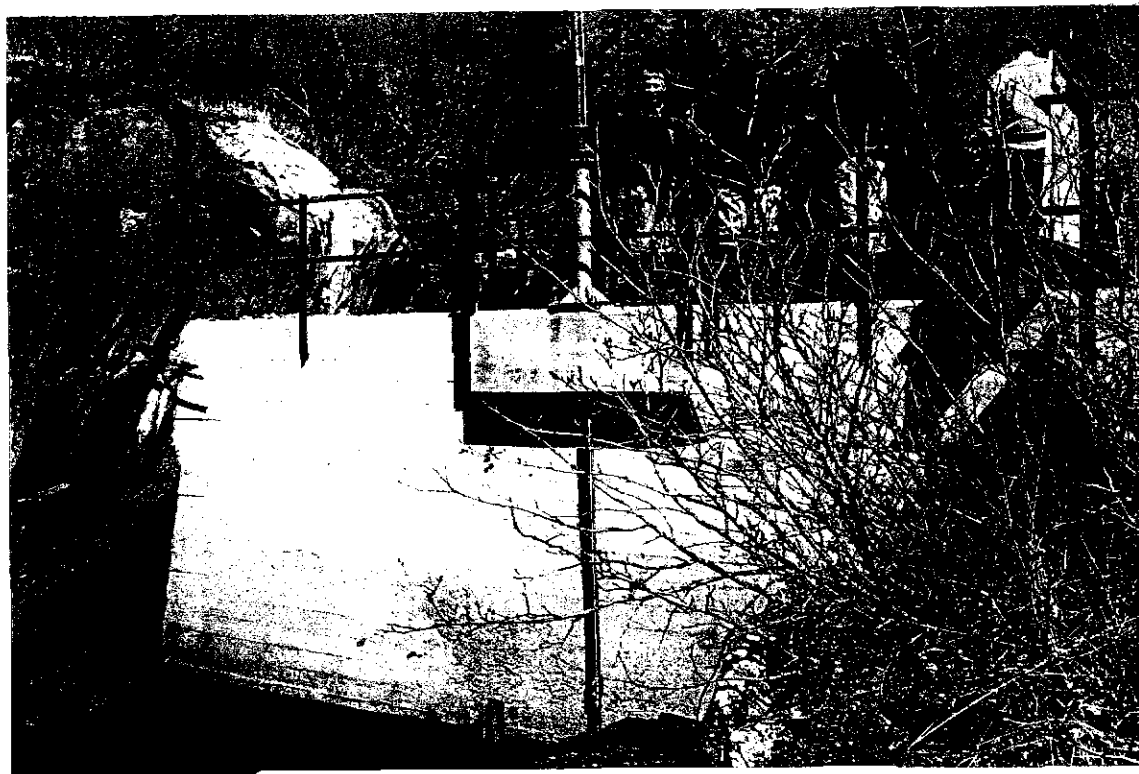
Trinity Pond Structure

The structure is in good condition. Concrete repairs should continue as a maintenance

program. The metal railing appears low and should be raised. The bolts fastening the sign should be cut off flush at the sign.

It was noted that the gate stem is exposed to damage from ice and debris. Protection may be necessary.

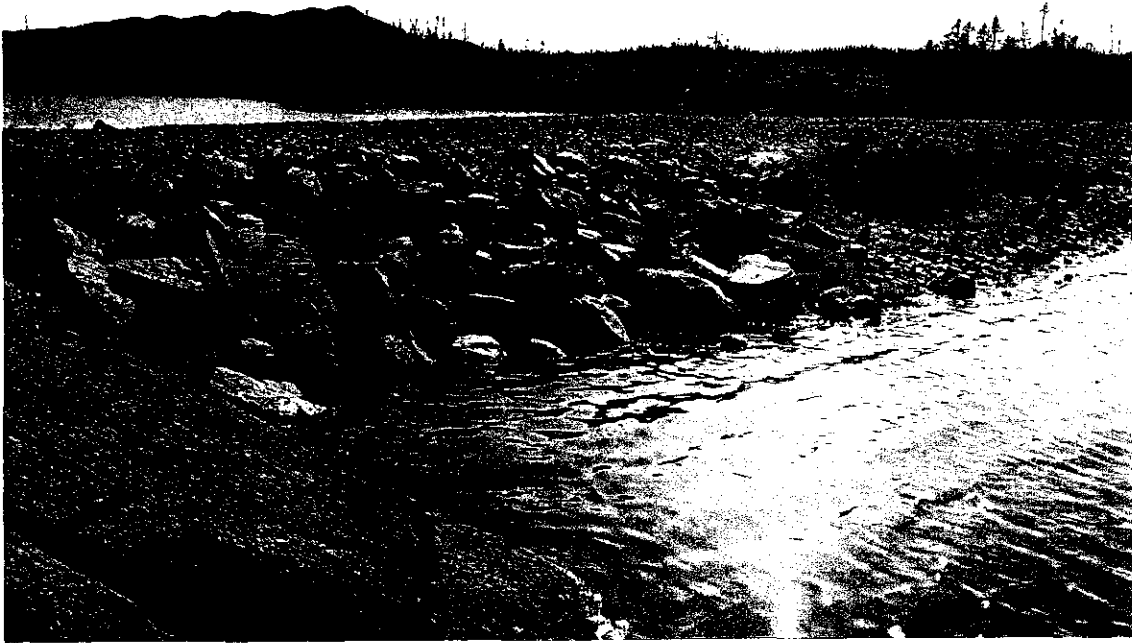
Copeley's Pond Diversion Dam

Copeley's Pond Dam was the original railway track bed. The culvert through the track was plugged to form the diversion. Differential head is approximately 1 metre. There is no rip rap on the dam face.

The structure is very low with minimal impact anticipated from failure. The structure should be monitored for performance.
