**A Report on the Power Restoration Difficulties on the
Burin Peninsula and the Solutions Proposed to Address Them**

Newfoundland Power Inc.

July 2, 2002

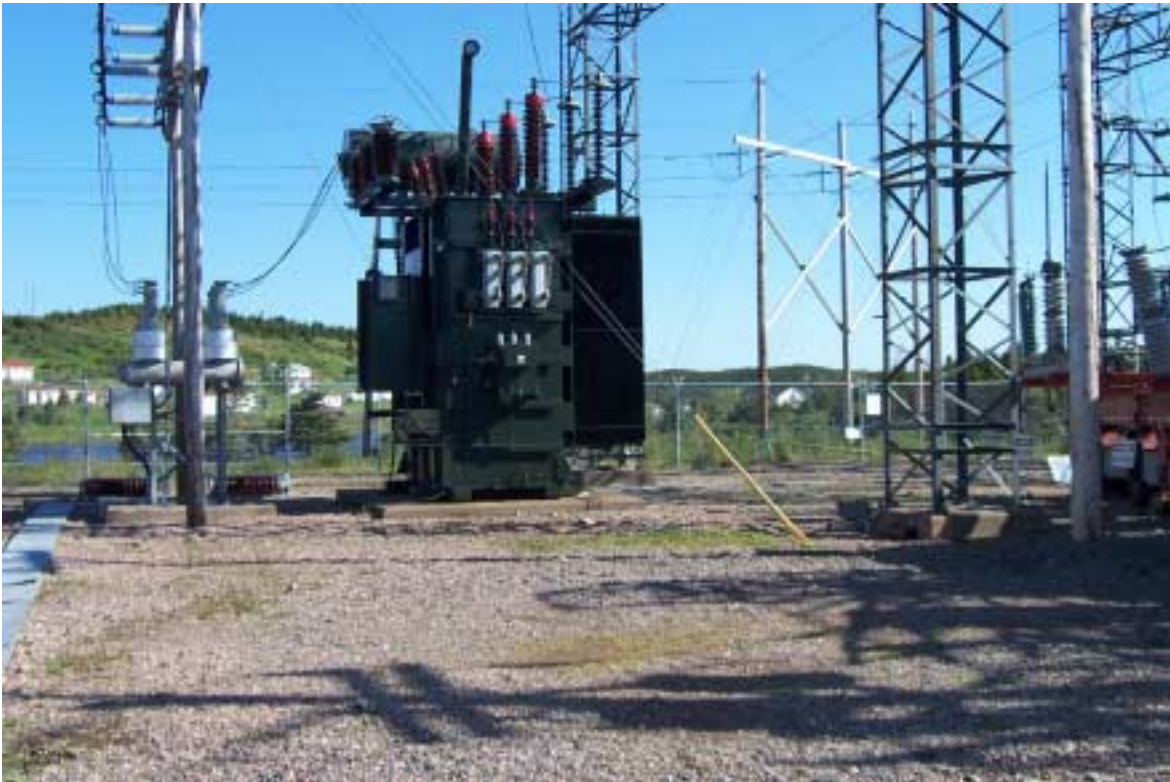
Appendix 2

The interconnection point between the 138 kV and the 66 kV networks at Salt Pond Substation consists solely of a 1971-vintage system transformer with a total capacity of 41.6 MVA. This is the unit that failed on April 19th. In effect, this transformer comprises a bottleneck in an otherwise redundant system.

The April 19th incident involved the failure of the Salt Pond transformer's on-load tap changer. The transformer itself was not damaged in the incident. However, in conducting its review of the incident, the Company encountered a recently published industry report (the "Hartford Report") that identifies a correlation between the age of transformers and their rates of failure in service.¹ The Hartford Report, which was authored by the principal electrical engineer for a major American utility equipment insurer, states that, under ideal conditions, a transformer can be expected to last between 30 and 40 years. However, the report also notes that many do not last as long as that.

The system transformer at Salt Pond was installed in 1971. At over 30 years in service, the transformer is approaching the end of its expected life. In light of the conclusions of the Hartford Report, the probability that the transformer will fail in service is high. While it is not economic to retire such a major piece of utility equipment on the basis of age alone, prudence dictates that the Company be prepared for the contingency of failure.

**Photograph of Existing
Salt Pond System Transformer**

Given that the other alternatives identified to improve the security of supply for customers served by the 66 kV transmission system on the Burin Peninsula are either impractical or uneconomic, it is recommended that the Company purchase a new 138 kV – 66 kV system transformer to be located at the Salt Pond Substation.

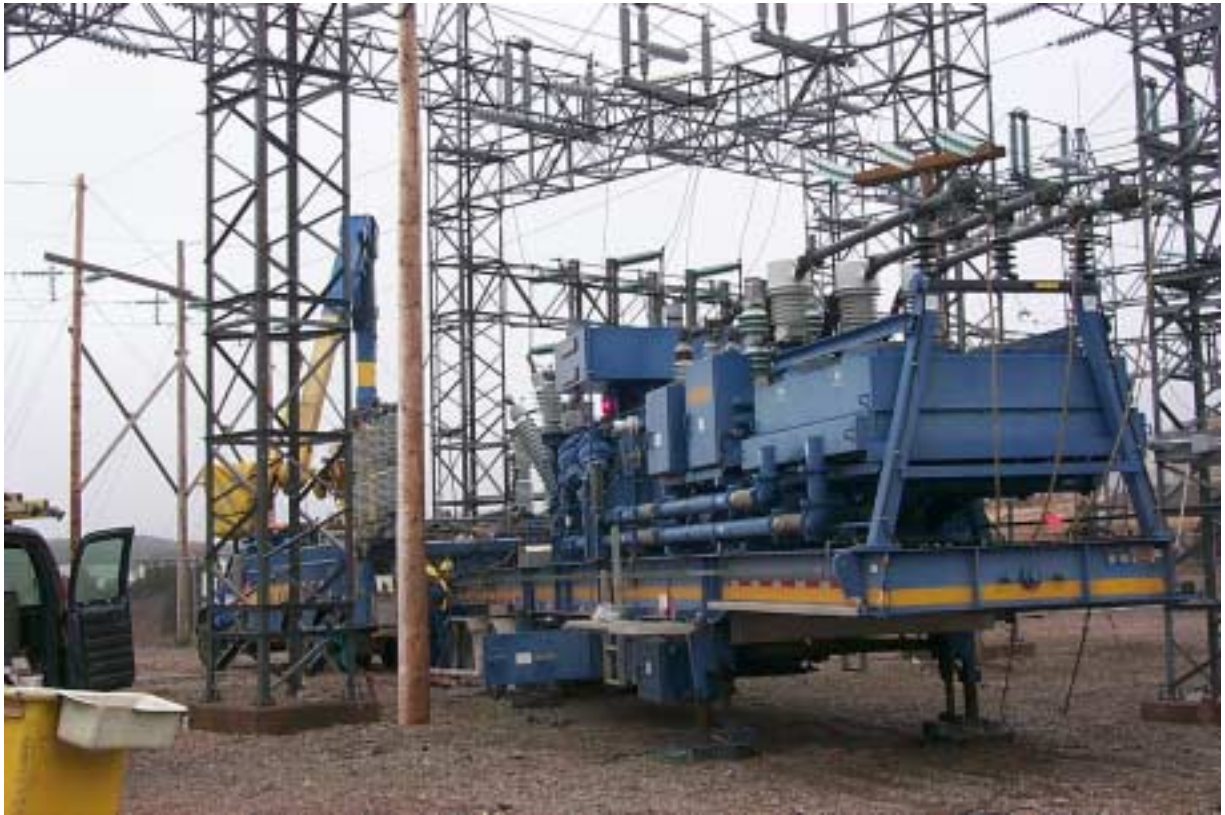
Appendix 3

At 8:58am on May 11, 2002, NP's 50MVA portable transformer P-435 (in service at the time at Salt Pond substation) faulted leaving 6,080 customers on the 66kV loop without power. This portable was replacing the permanent 138/66kV SPO-T4 which faulted on April 19th and was in the process of being repaired. The customers affected were served by feeders from the Salt Pond (SPO), Laurentian (LAU), Webber's Cove (WBC), Greenhill (GRH), Grand Beach (GBE) and Garnish (GAR) substations (i.e. the same customers affected by the April 19th outages).

The portable transformer P-435 has been transported to the Siemens-Westinghouse facility in Hamilton, Ontario for further assessment and repair. This unit will be out of service until December 2002. Portable transformer P-335 will remain on the Burin Peninsula unless required to address any unplanned substation outage elsewhere on the island.

Photograph of Failed Portable Transformer

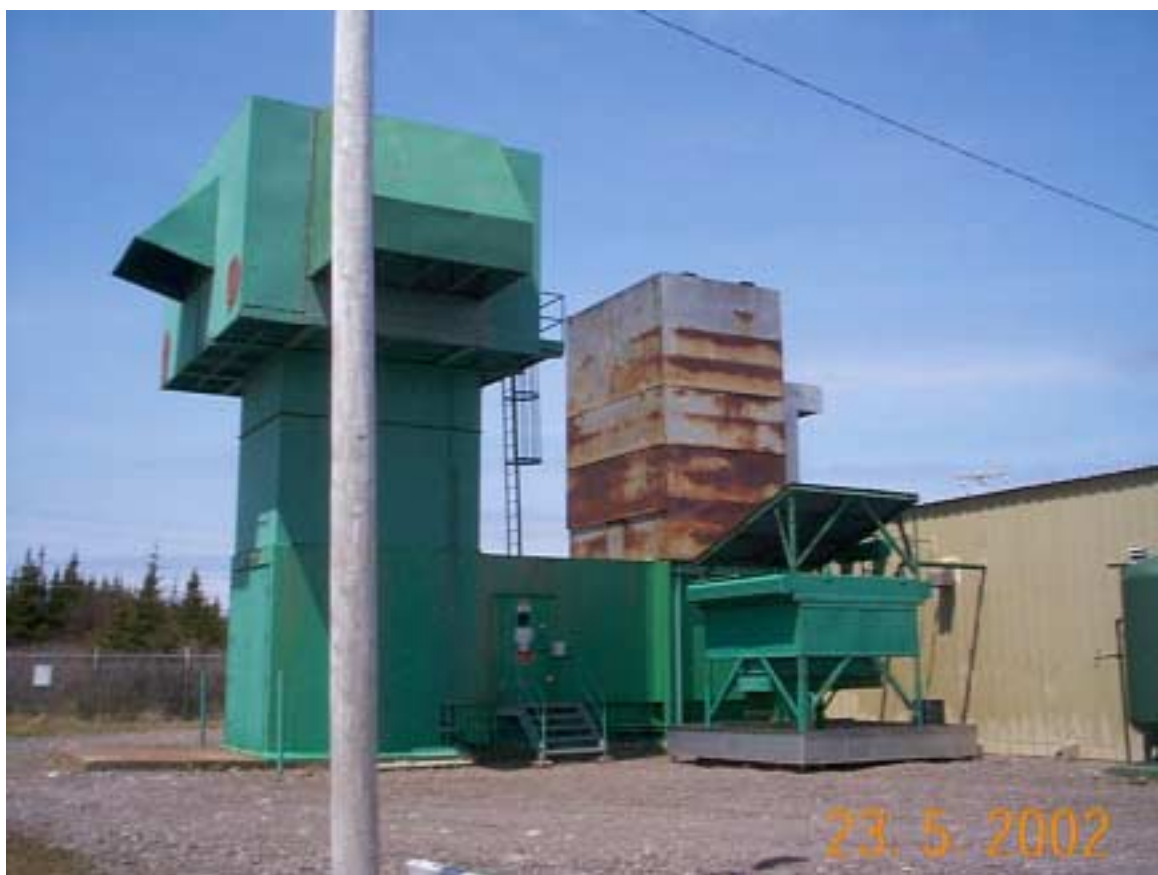
Appendix 7

rotating outages at times when the Salt Pond Gas Turbine was unavailable. The Company's review has identified a number of factors that contributed to the problems experienced with the unit's operation. These are: (1) the "black start" capability of the unit; (2) the amount of vibration present in the unit when it is running under full load; and (3) deficiencies in the unit's temperature monitoring and cooling systems. Each of these items is discussed below.

The Greenhill unit's vibration monitoring system is an obsolete five-channel system that is no longer supported by the manufacturer. The manufacturer's expert noted that the vibration sensors on the generator alternator and exciter bearings should be relocated to provide more accurate and meaningful vibration measurements. In order to ensure adequate vibration protection and to assist with vibration diagnostics, the Company proposes to incorporate a new 12-channel vibration monitoring system, complete with relocated vibration probes, into the unit's protection and control scheme.

The Greenhill unit's glycol cooler, which is the unit's primary heat dissipation mechanism, is deteriorated. During operation of the unit in May, the glycol cooler failed to keep the temperature of the lube oil within safe operating limits. With an outdoor ambient temperature of approximately 8 degrees Celsius and a load of approximately 13 MW on the unit, the unit tripped off as a result of excessive lube oil temperature. To reduce the lube oil temperature to acceptable levels, the auxiliary town water supply system had to be used to supplement the cooling system. To correct this problem, it is recommended that the glycol system be refurbished and upgraded.

During its most recent operation, the Greenhill unit also tripped off on several occasions due to high exhaust gas temperatures. Exhaust gas temperature monitoring provides an indication of the internal operating temperature of the gas engine. If the operating temperature exceeds recommended limits for an extended period, the engine could be seriously damaged. The Greenhill unit's exhaust gas temperature is monitored by eight dual element thermocouples. These thermocouples, which are original equipment and are 25 years old, were tested during the Company's review of the unit. One quarter of the sensors proved to be defective. The defective sensors appear to have been responsible for the false high temperature readings that caused the unit to trip off. To correct this problem and avoid a recurrence, it is recommended that the thermocouples be replaced.

Photograph of Greenhill Gas Turbine

It is recommended that the following upgrades and improvements to the Greenhill Gas Turbine be carried out immediately:

- (a) reinstallation and realignment of the power turbine to reduce overall vibration levels;
- (b) installation of a new vibration monitoring system into the unit's protection and control scheme;
- (c) installation of a new cooling ventilation system to lower the lube oil room temperature;
- (d) refurbishment and upgrading of the glycol cooler;
- (e) replacement of all exhaust gas temperature monitoring thermocouples; and
- (f) replacement of all lube oil and bearing temperature monitoring thermocouples.
