**Newfoundland Power Inc.
2005 Capital Budget Application
Filing Contents**

**Volume I
Application**

**Volume II
Expenditure Details, Reports and Studies**

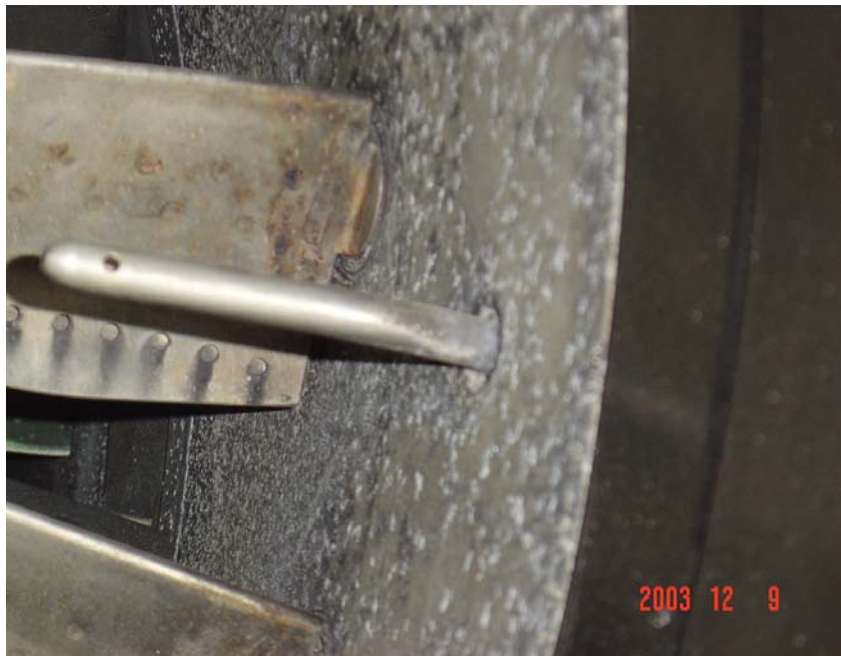
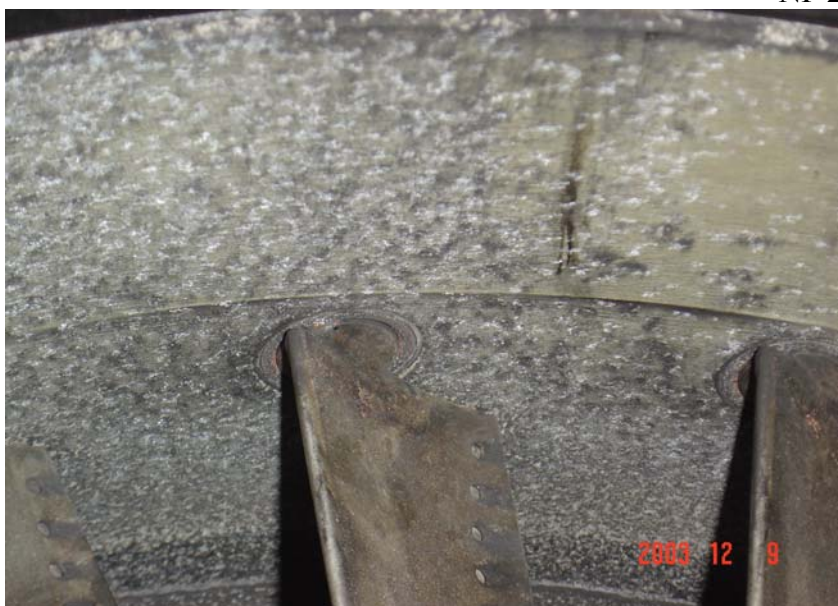
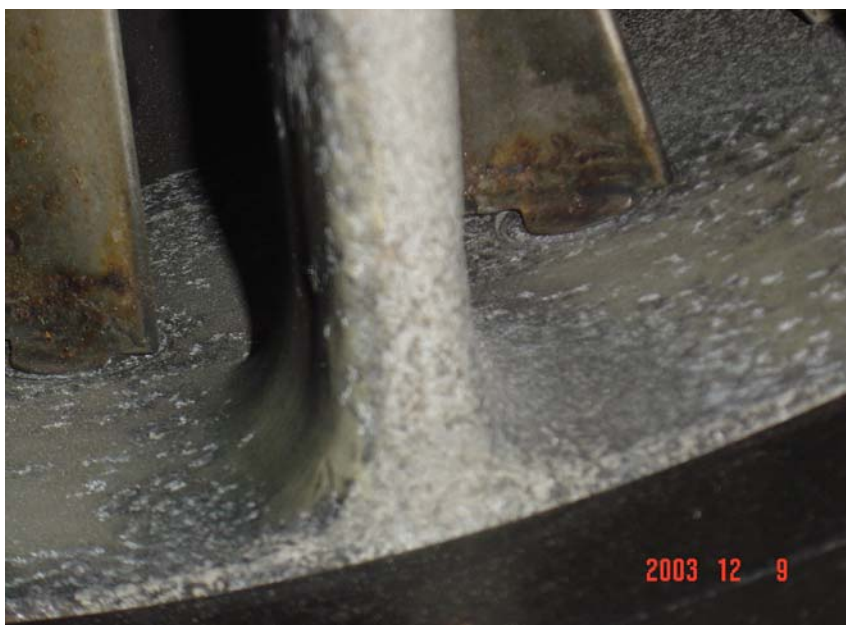
- 4.1 After arriving at site the engine installation was inspected. The front mounts were found installed correctly, the rear mounts were also found installed correctly. The rear exhaust section was already installed and had been inspected by site personnel; the complete alignment checks were therefore not completed.
- 4.2 A further inspection of the engine externals was carried out which led to the recommendation as reported above.
- 4.3 The top and bottom intake assemblies were inspected prior to motoring the engine. This was then signed off along with NFP personnel.
- 4.4 A boroscope inspection was carried out and the following pictures will show the poor condition of the gas generator. The first few pictures show the intake casing and guide vanes. Both the casing and vanes are extremely salt corroded, eroded and pitted:

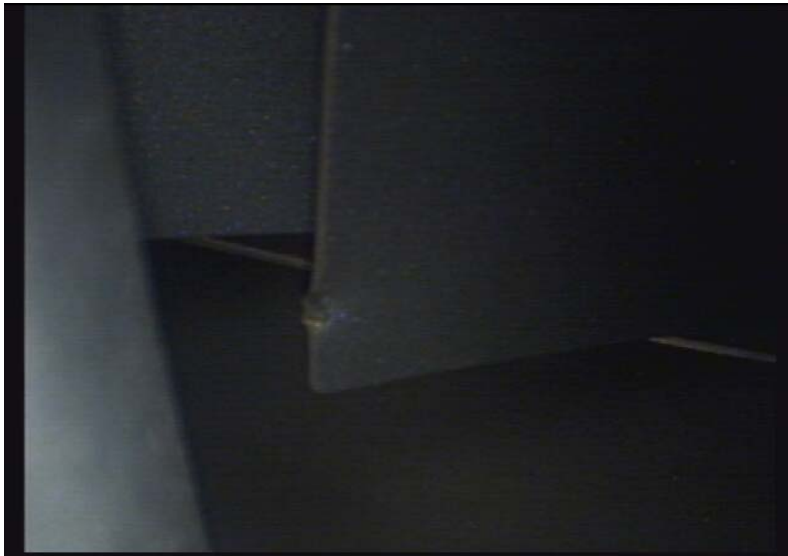
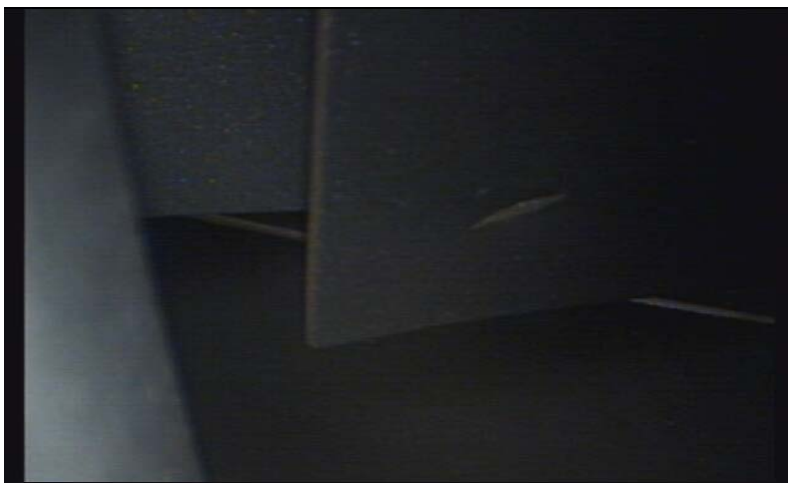
- 4.5 The next two pictures show the last stage of compressor blade with FOD impact damage:

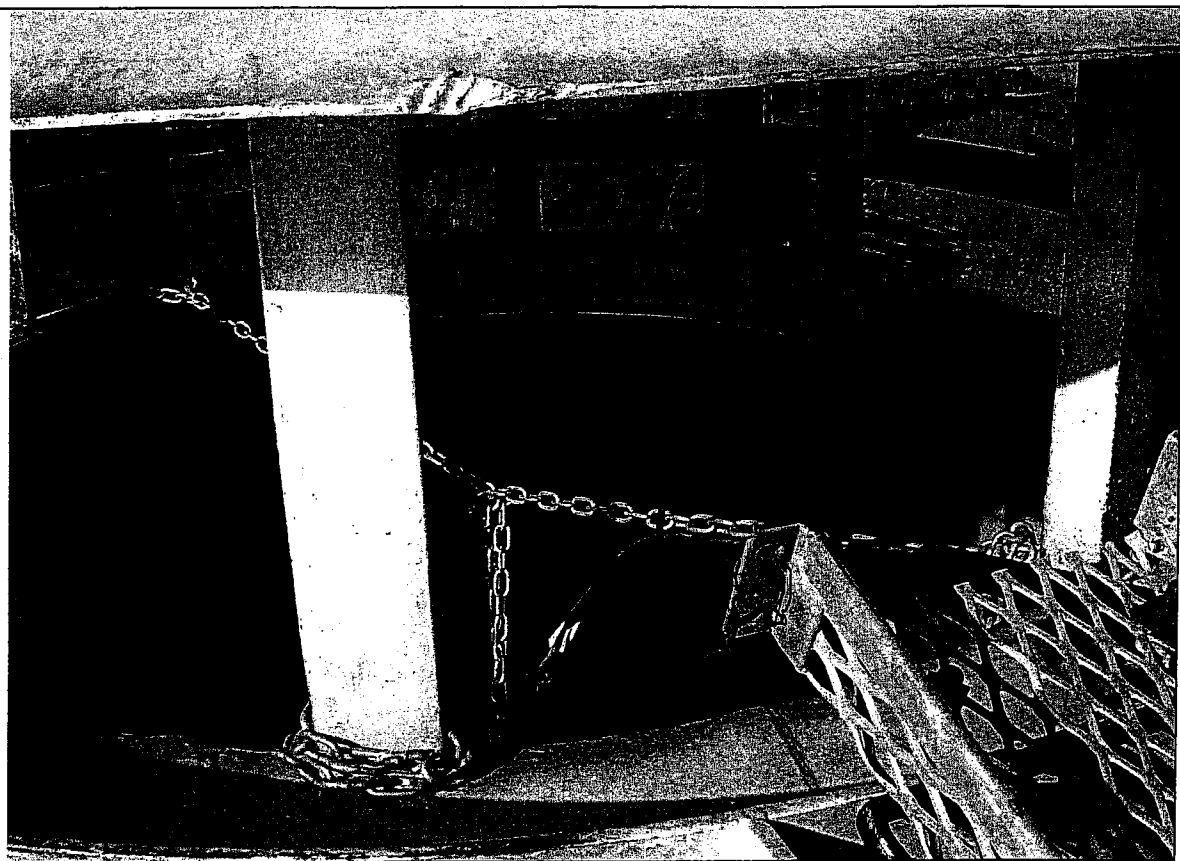
1. Rolling platform loose expanded metal mesh.

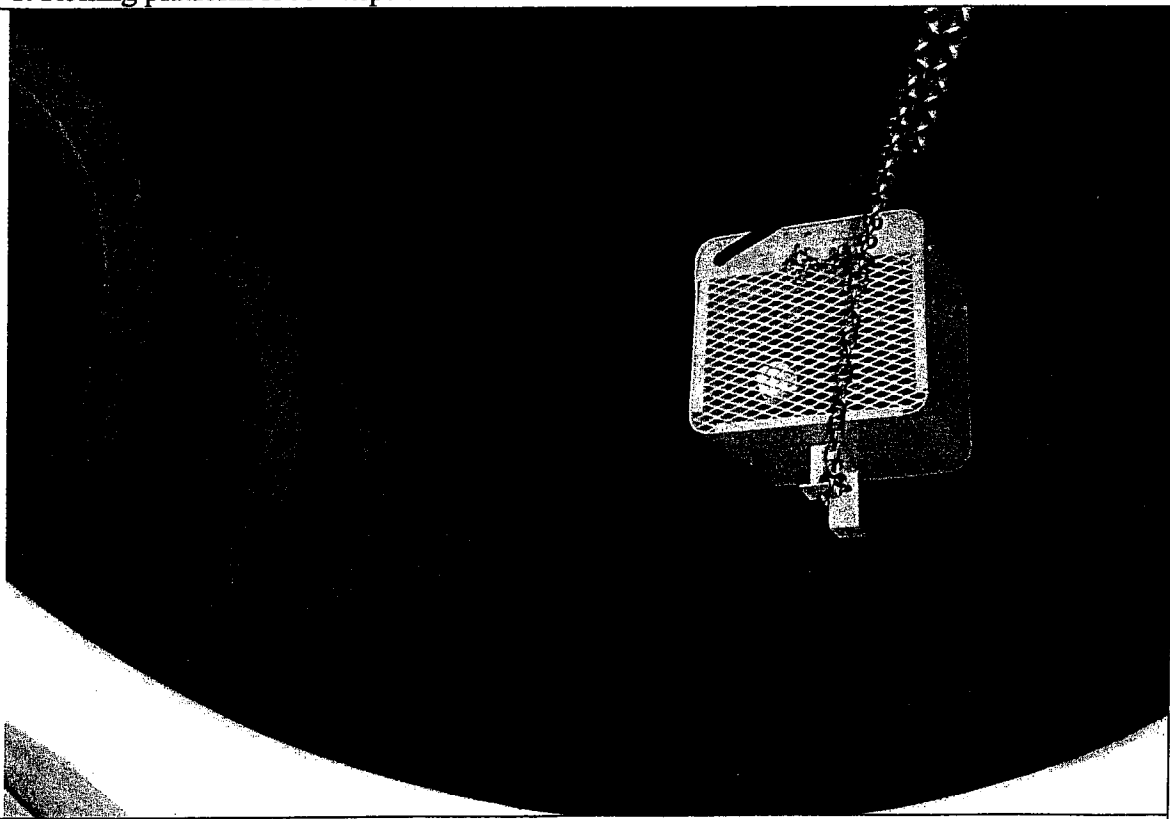
2. View of internal riser and surge tank from roof hatch.

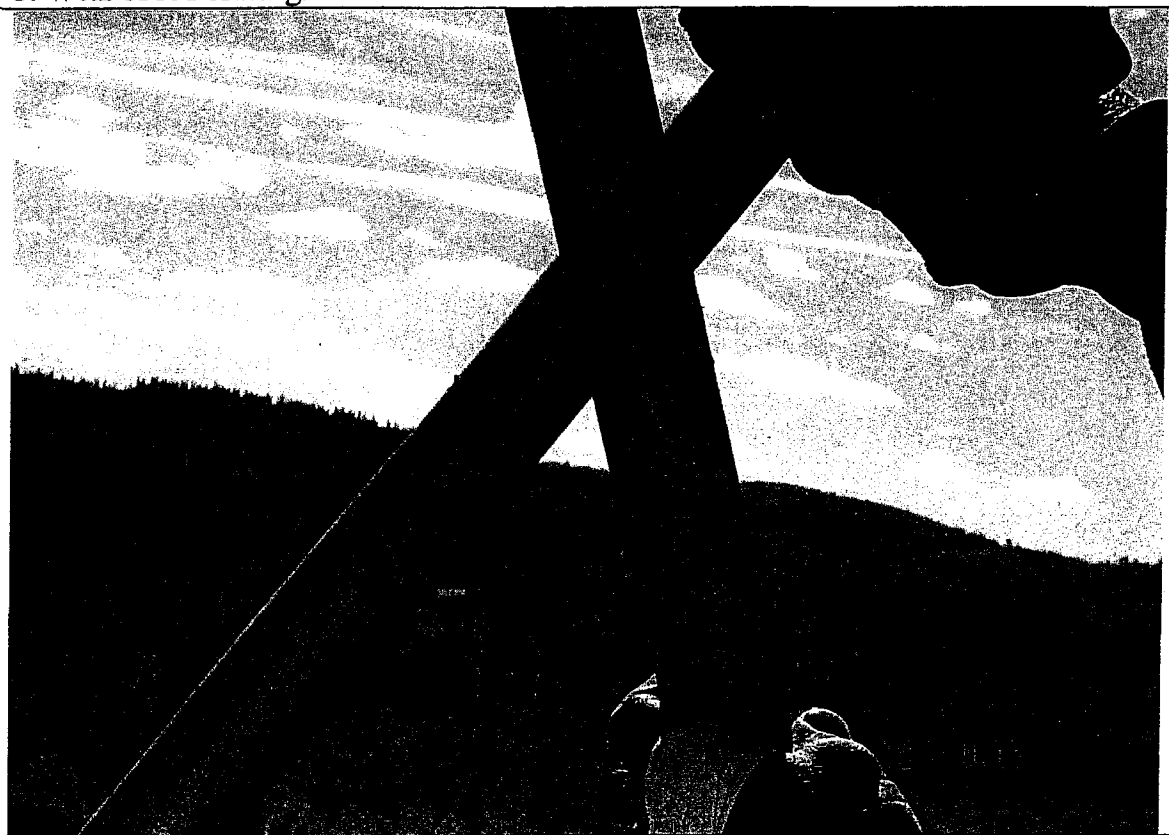
4. Wear of diagonal rod bracing.

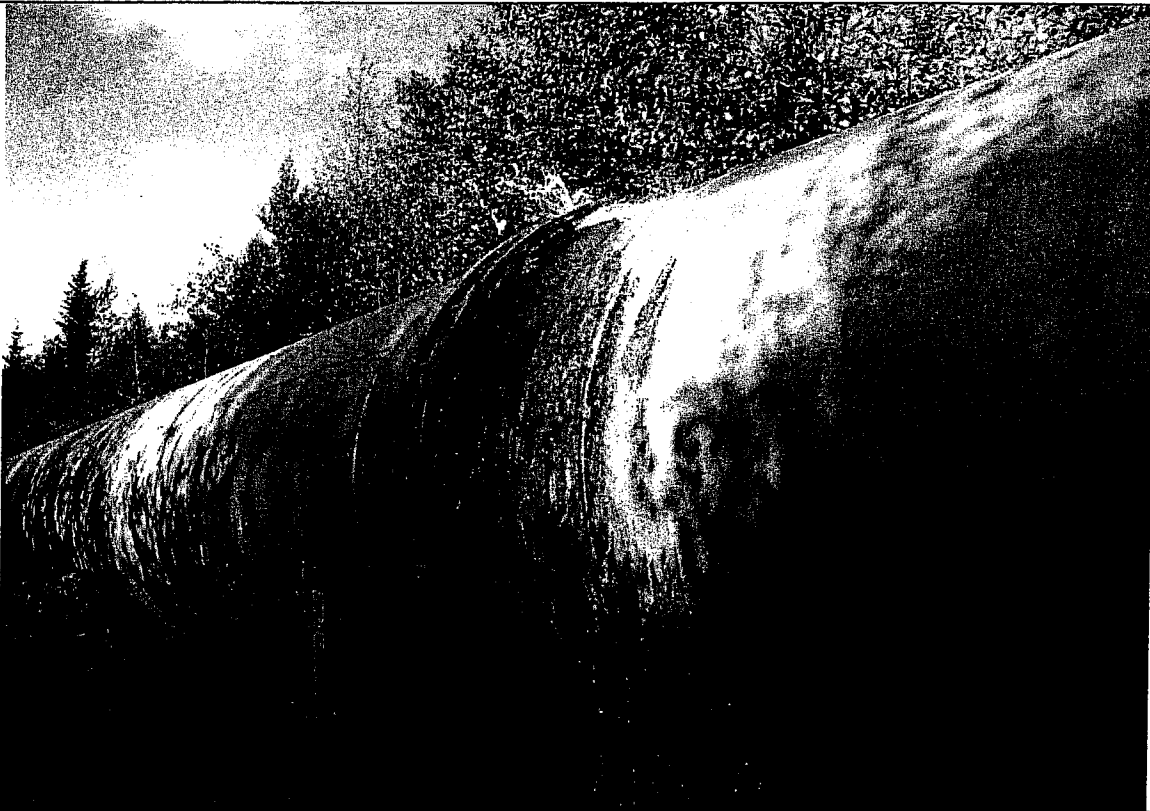
12. Expansion joint #2 leaking at top.

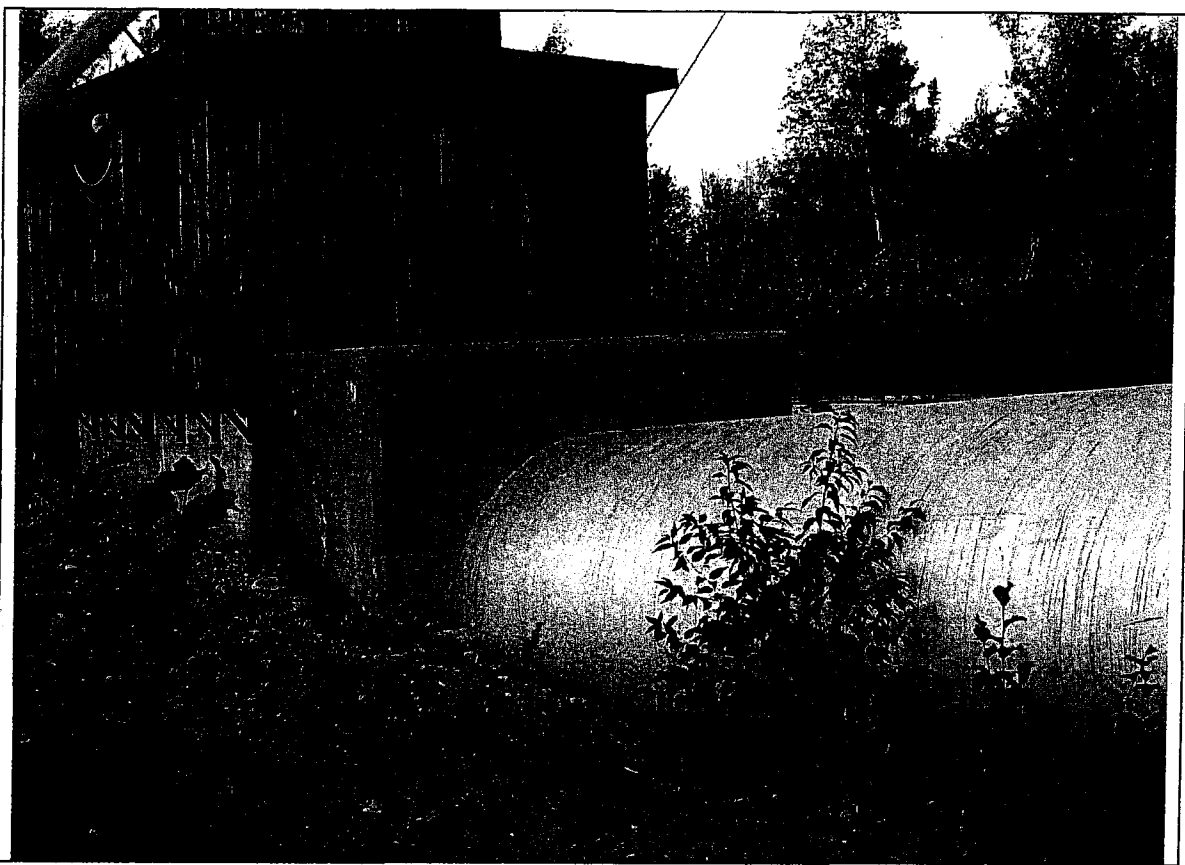
13. Surge tank anchor block with shrinkage crack.

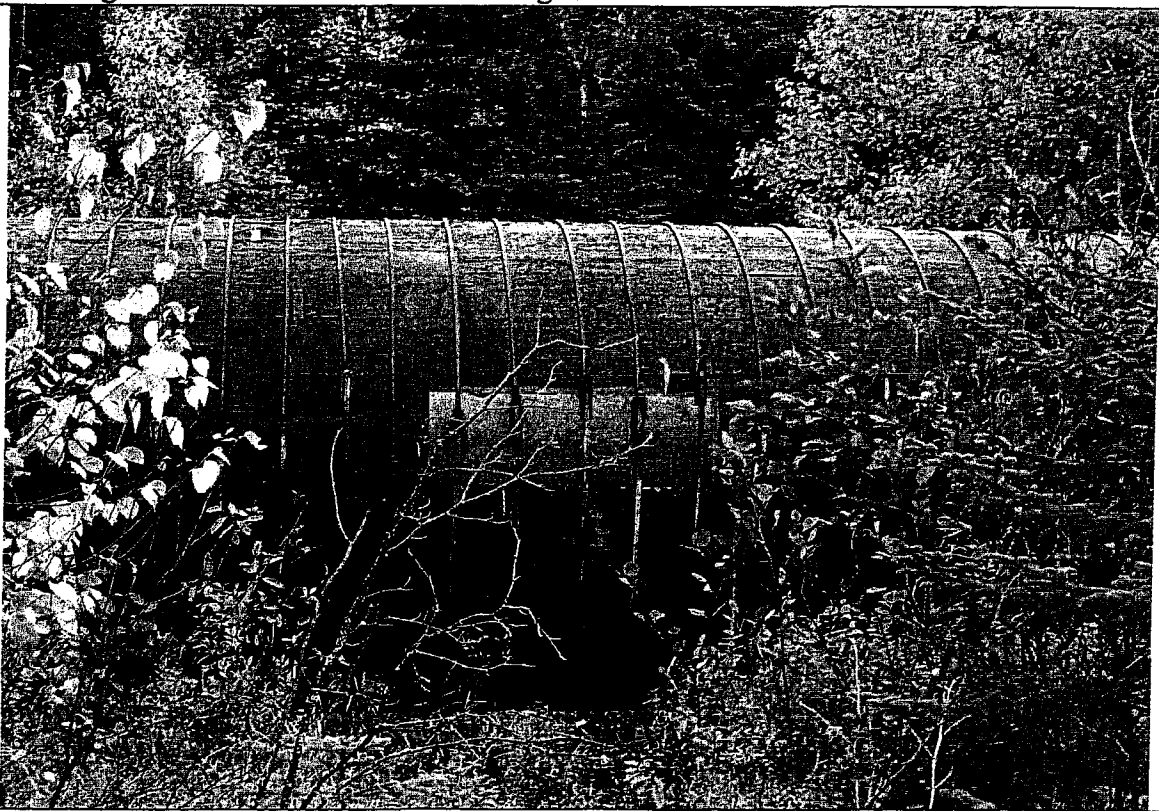
14. Wood stave penstock steel plate patch.

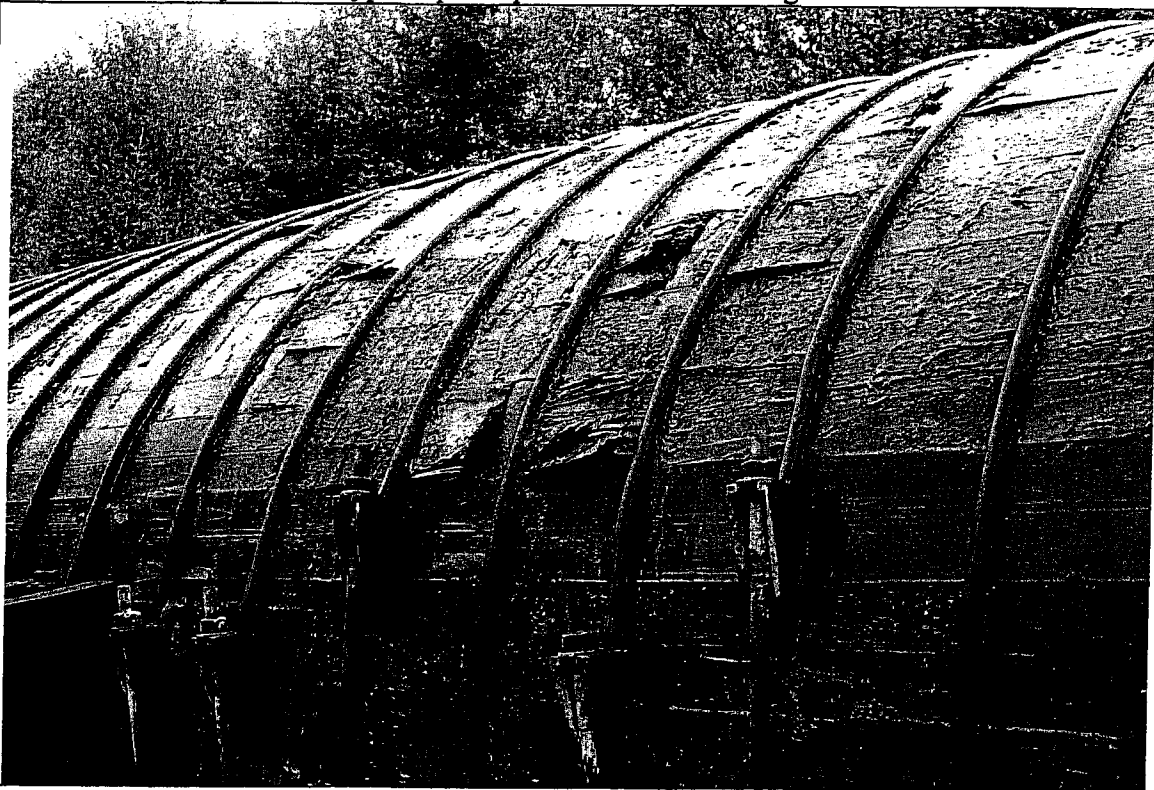
16. Wood stave penstock surface condition.

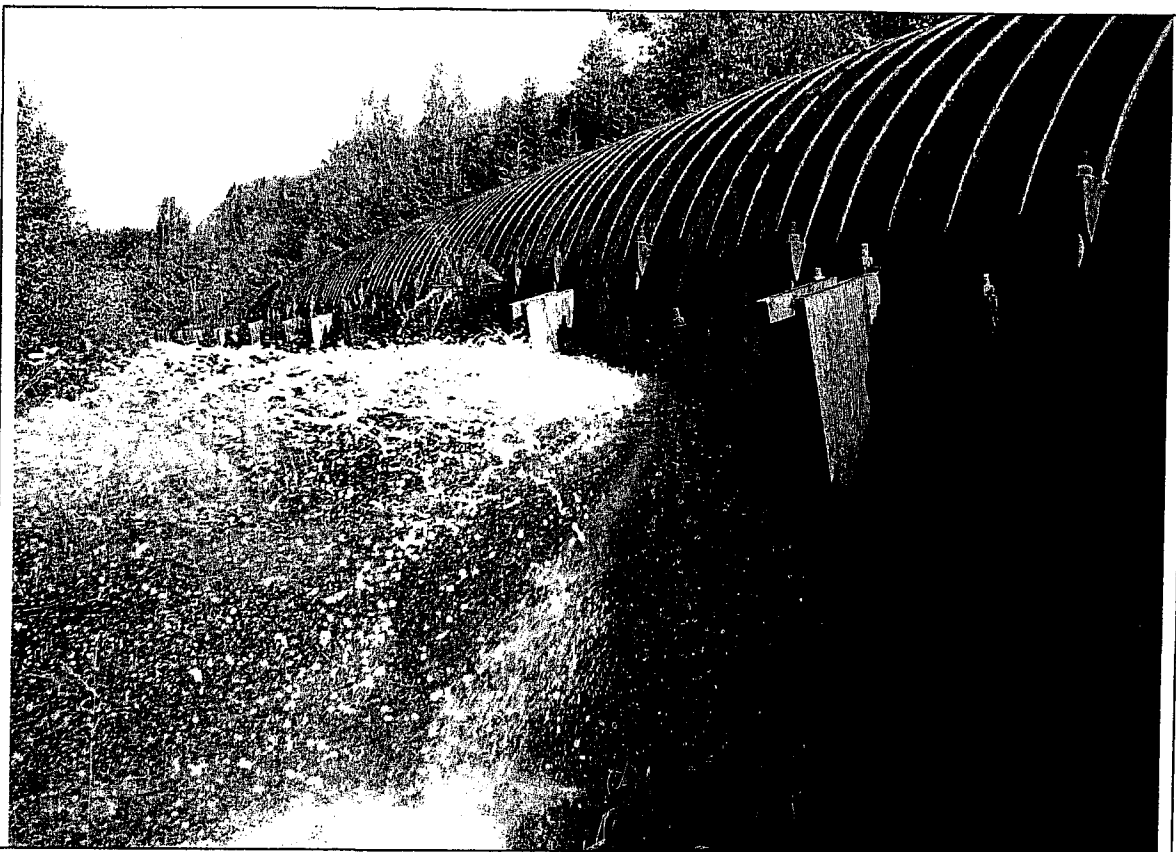
17. Wood stave penstock leakage.

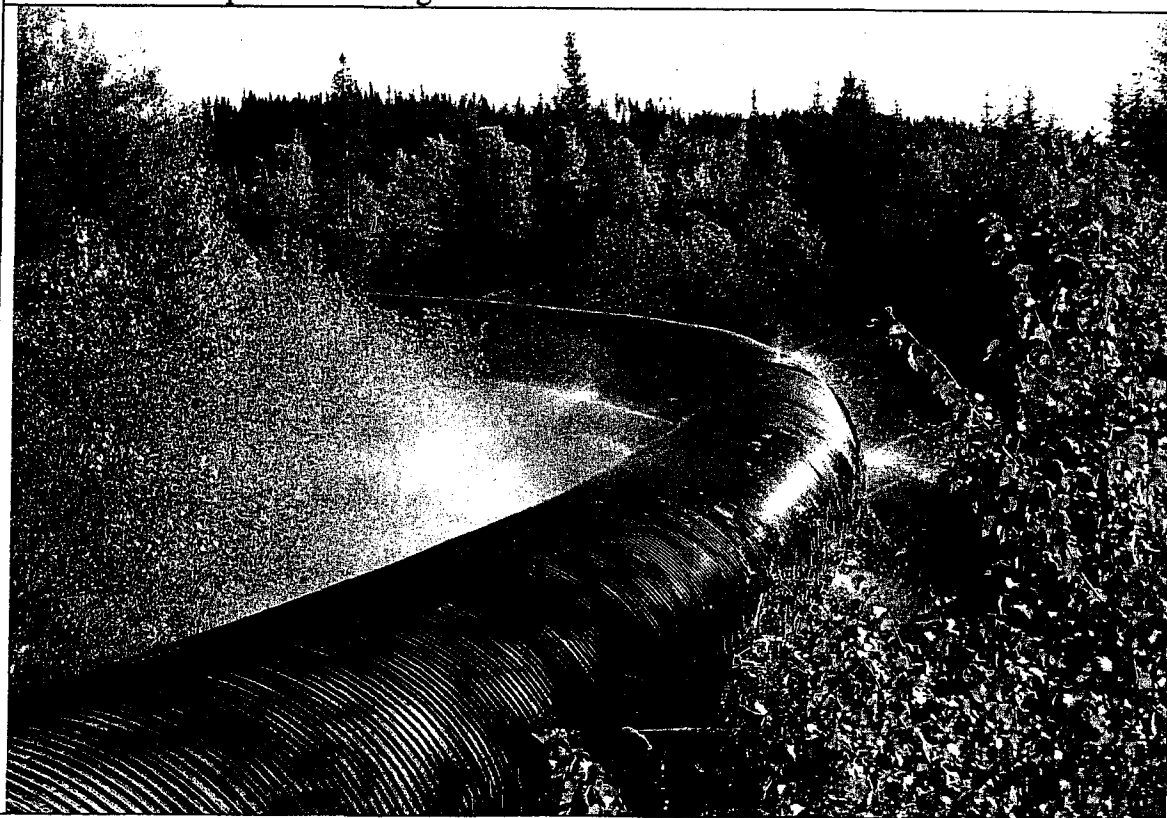
18. Wood stave penstock leakage.

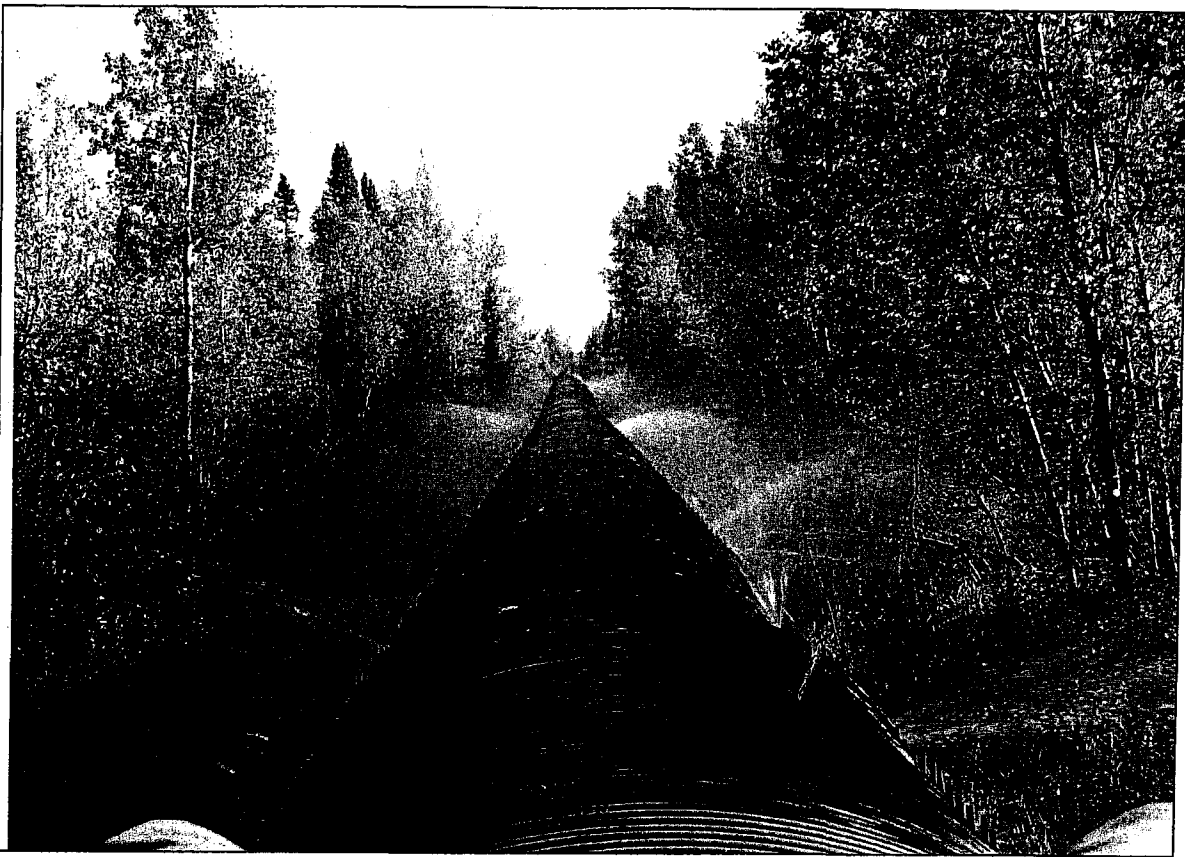
19. Wood stave penstock leakage.

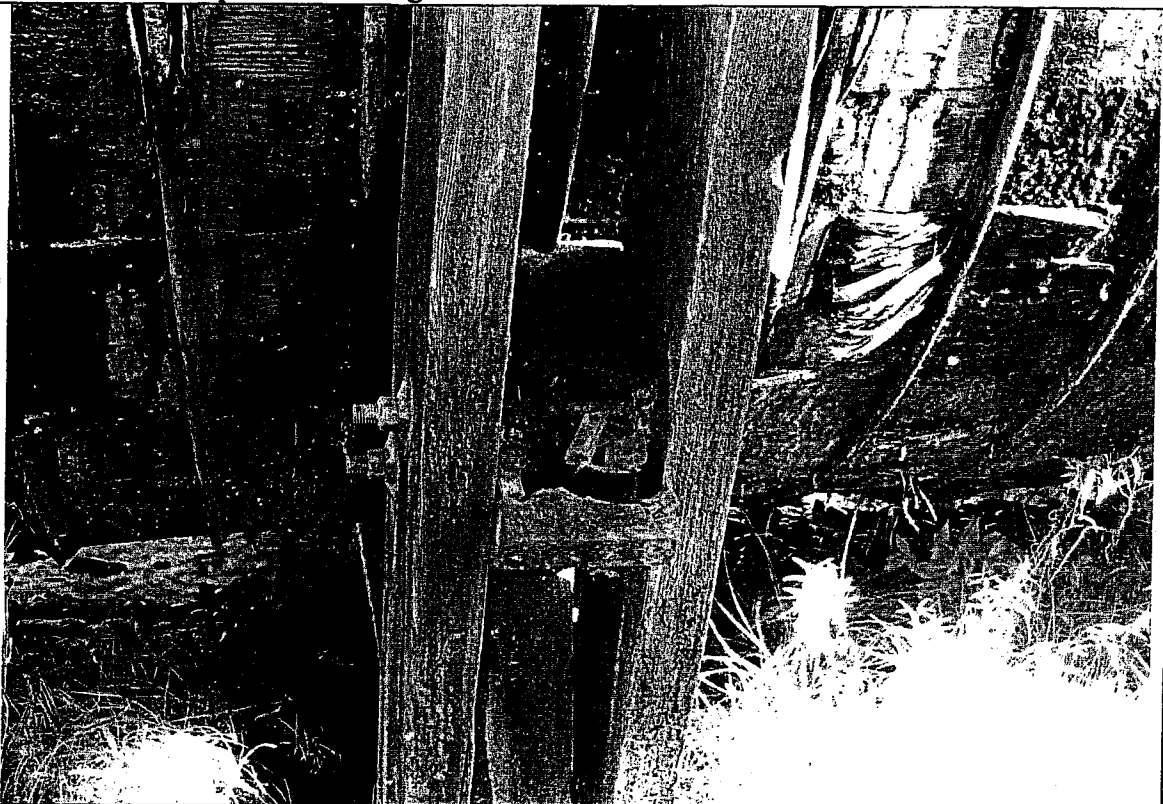
20. Wood stave penstock saddle deterioration.

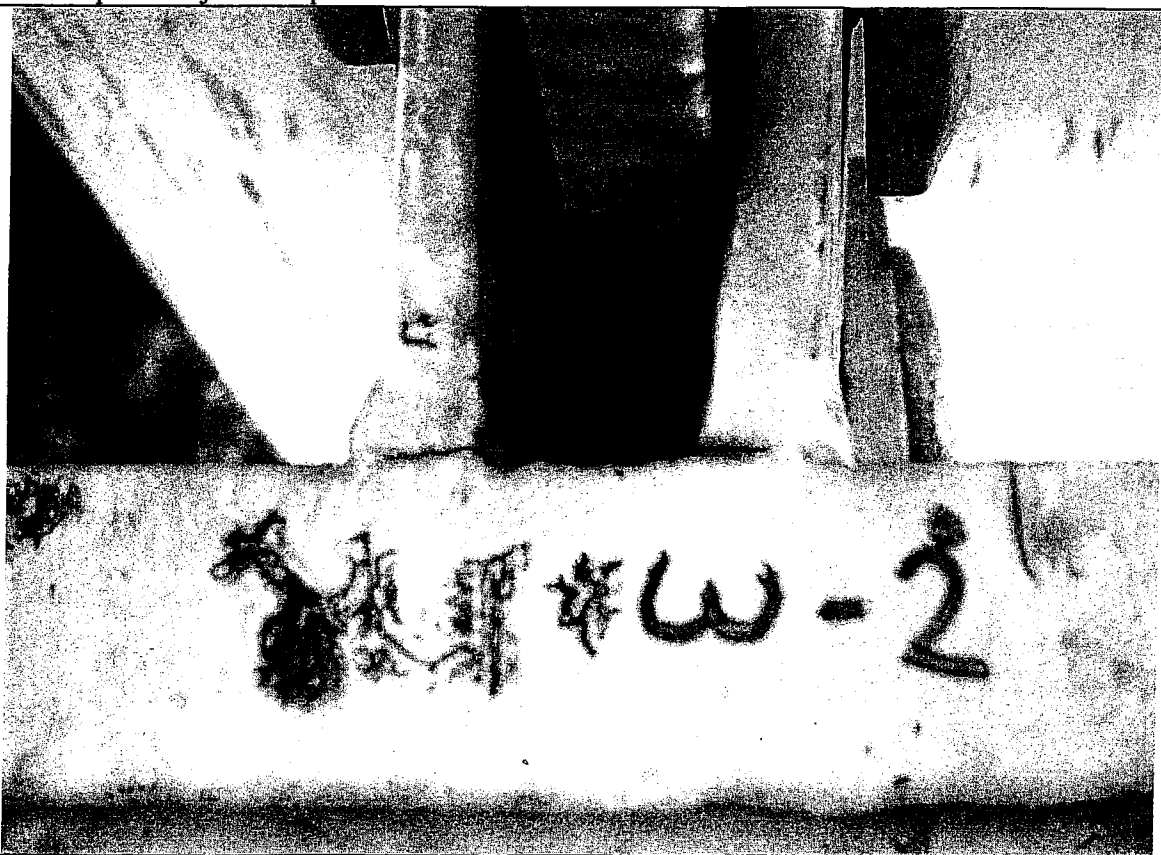
22. Horizontal brace north face at leg #3. Cracks in welds.

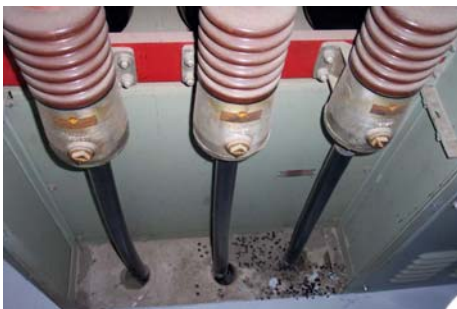
Unit #1 Switchgear
Cable Terminations

The power cables from the generator termination cabinets to the switchgear are the original 1000 MCM paper insulated lead covered (PILC) cables with pitch filled pothead terminations. PILC cables typically have a long life expectancy. However, these cables are susceptible to stress fractures if the insulation is subjected to movement following years of resting in a fixed position. It is expected that the movement these cables will be subjected to during the reconstruction will cause stresses in the cables leading to premature failure. Therefore the power cables and terminations will need to be replaced when the switchgear is replaced.

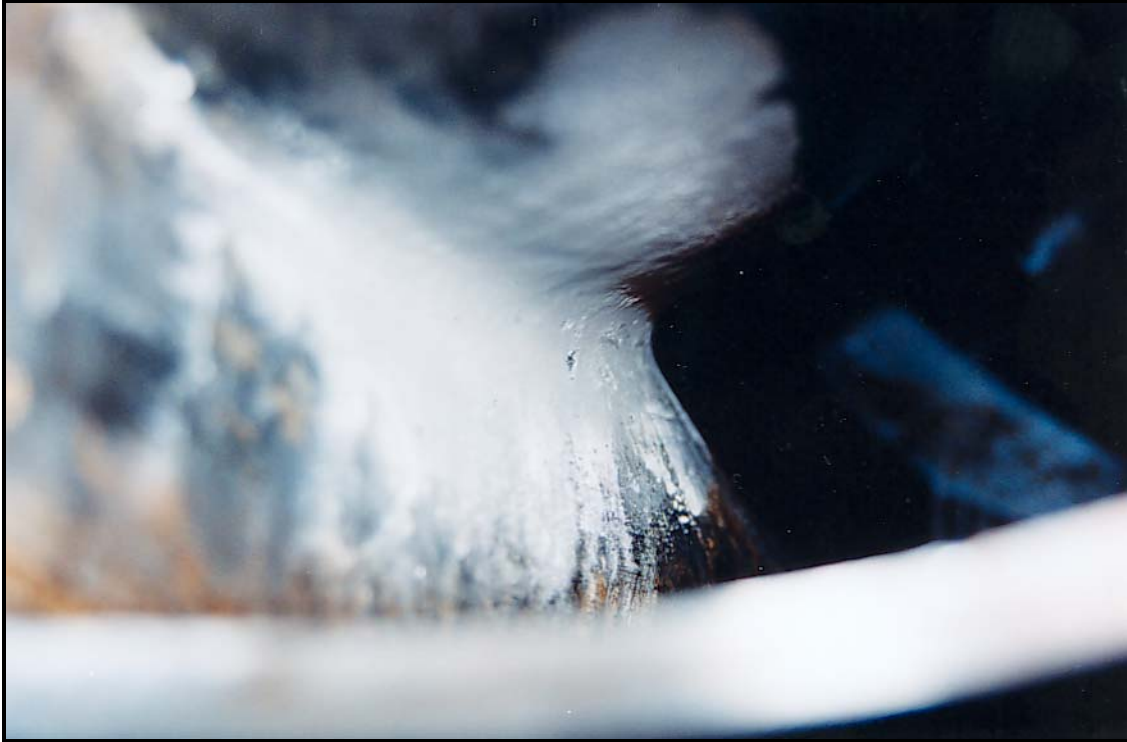
The runner has several areas where erosion and cavitation has exposed faults in the stainless steel casting. This erosion is concentrated near the root of the blading. There is evidence of hair line fractures tracking between the faulted areas. The wicket gates were repaired in the late 1980s with Belzona. This material has since eroded leaving large crevasses in the wicket gate body. The general condition of the scroll case is good. The draft tube door on Unit #2 is not sealing properly and will require some work.

Photo 1 – Shows localized cavitation and erosion of the turbine runner blades.

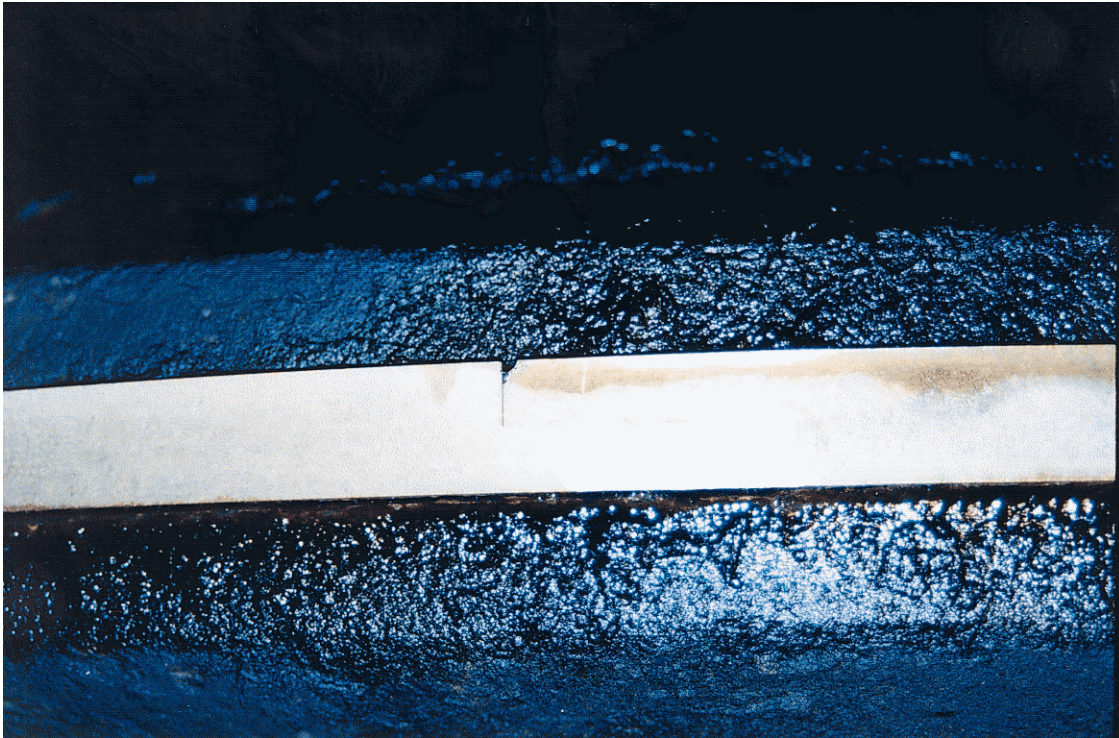
The main valve disk seat is in fair condition with one area approximately 3/4" long x 1/2" wide where pitting is evident. The visual inspection showed that the disk and the stationary seat are in good condition.

Both valves do however leak around the disc edge on the butterfly valve. During our last internal inspection of the scroll casing the employees had to install a tarp downstream of the main inlet valve to cut down on the amount of water spray coming from around the circumference of the valve disc. It is recommended that the existing adjustable seats on the valves be adjusted to try and eliminate the leakage around the valve disc; if this is not successful the valves may require new valve seats on the disc and the stationary components.

Photo 2 – Shows a chipped and cracked area on the main inlet valve disc seat.

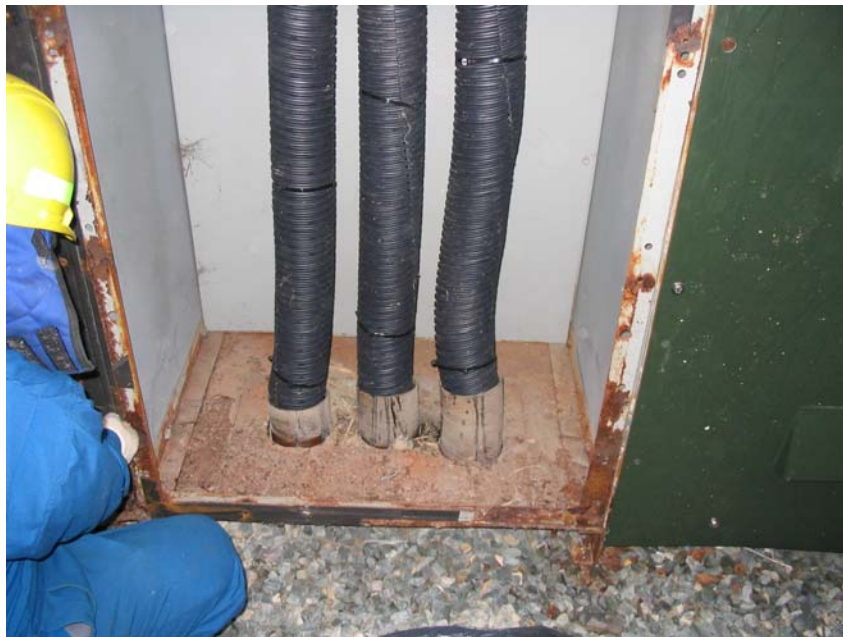
Operating Experience: The existing weather enclosures for the three sections of switchgear are in advanced stages of deterioration. Deterioration is such that the roofs of the existing buildings are leaking and there is rusting of the metalclad weather enclosures and switchgear support frame to the extent that the buildings are no longer weatherproof. Corrective action needs to be taken to stop further deterioration (see attached pictures).

St. John's Main Substation
Deteriorated Metal Clad Switchgear
Picture #1

Description: At St. John's Main substation there are three sections of 15kV metalclad switchgear housing a total of 17 air circuit breakers. This project involves the construction of two buildings around the switchgear to enclose and protect them from the weather.

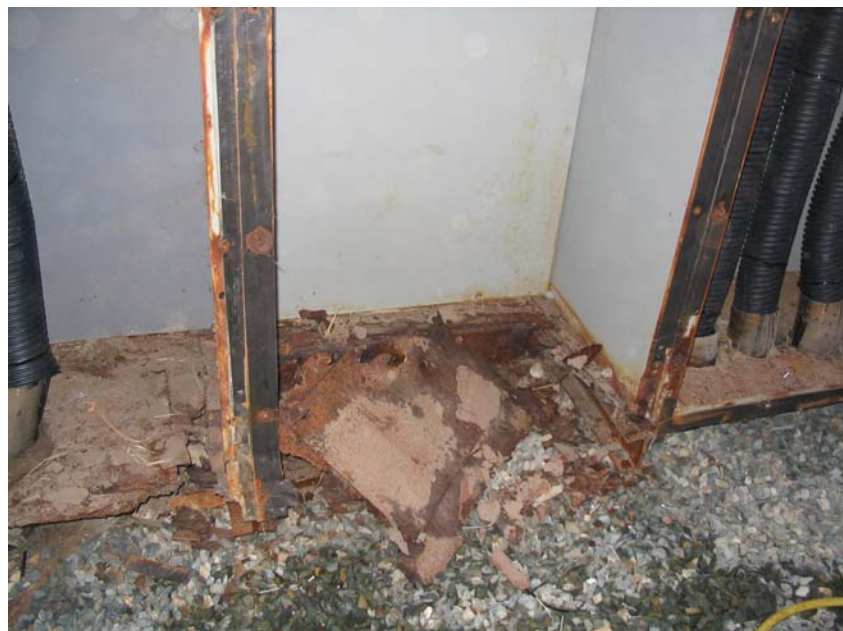
St. John's Main Substation
Deteriorated Metal Clad Switchgear
Picture #2

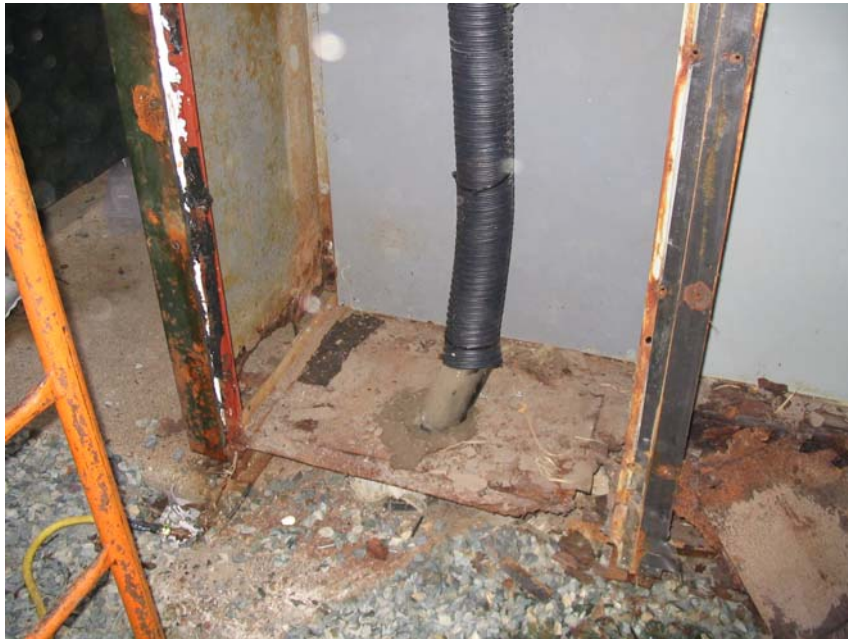
**St. John's Main Substation
Deteriorated Metal Clad Switchgear
Picture #3**

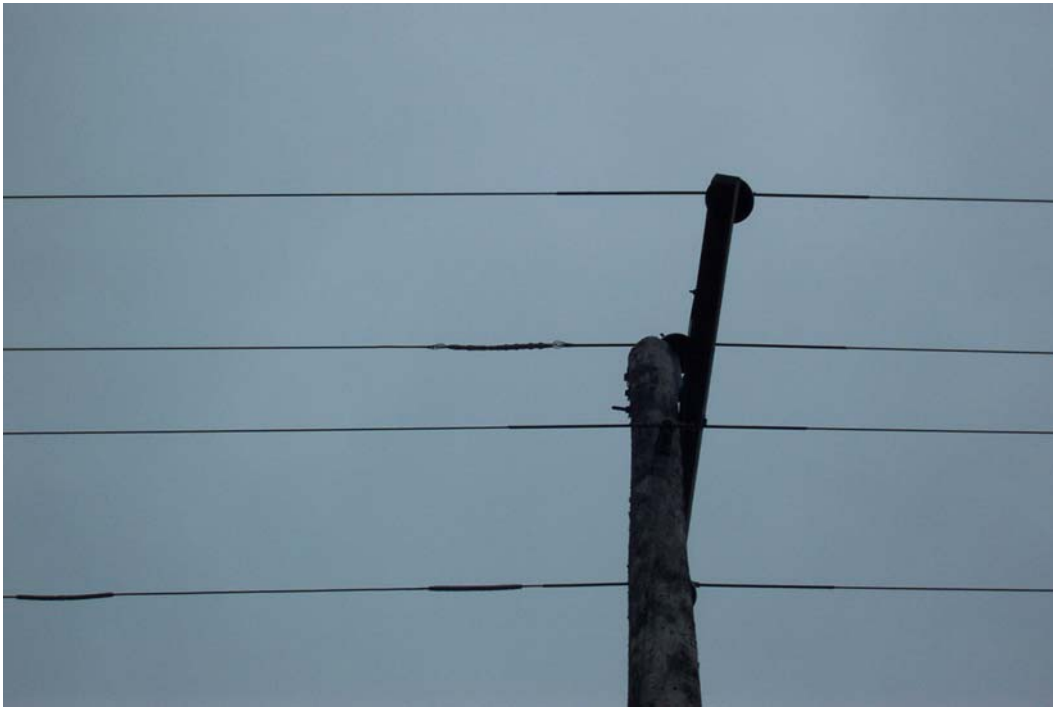
**Center Phase has “Bird caging” along old splice.
Note previous repair on outside phase.
Picture #1**

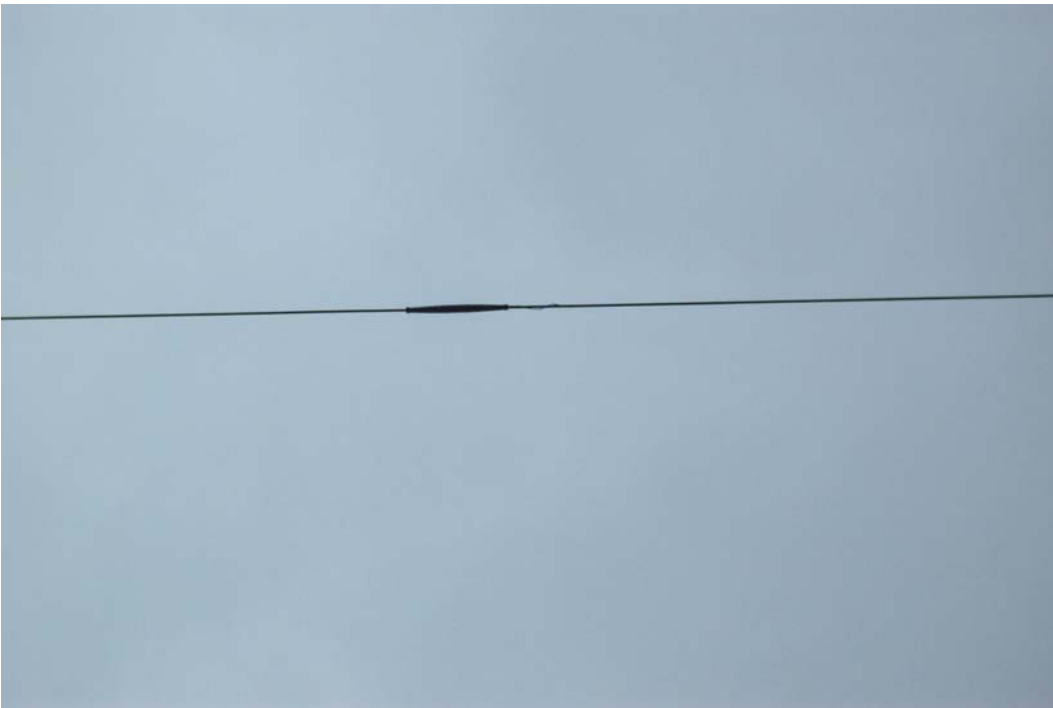
**Another location with “Bird Caging” with a splice in the conductor.
Picture #2**

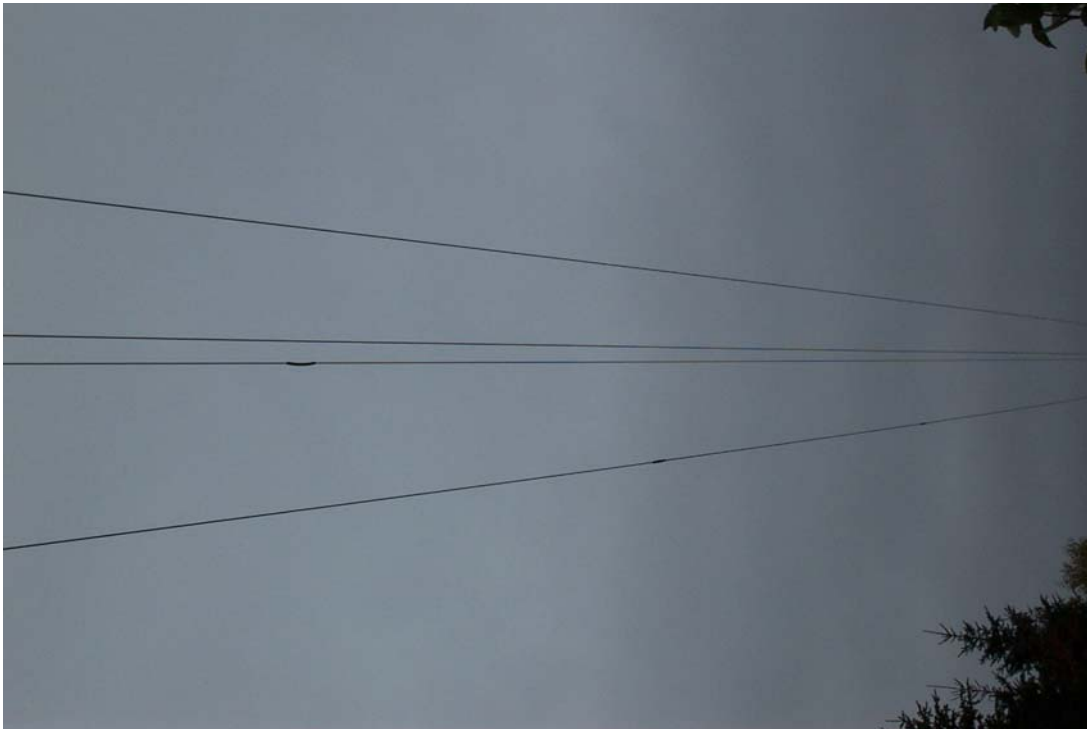
**Another Span with 3 splices in the #2 ACSR.
Picture #3**

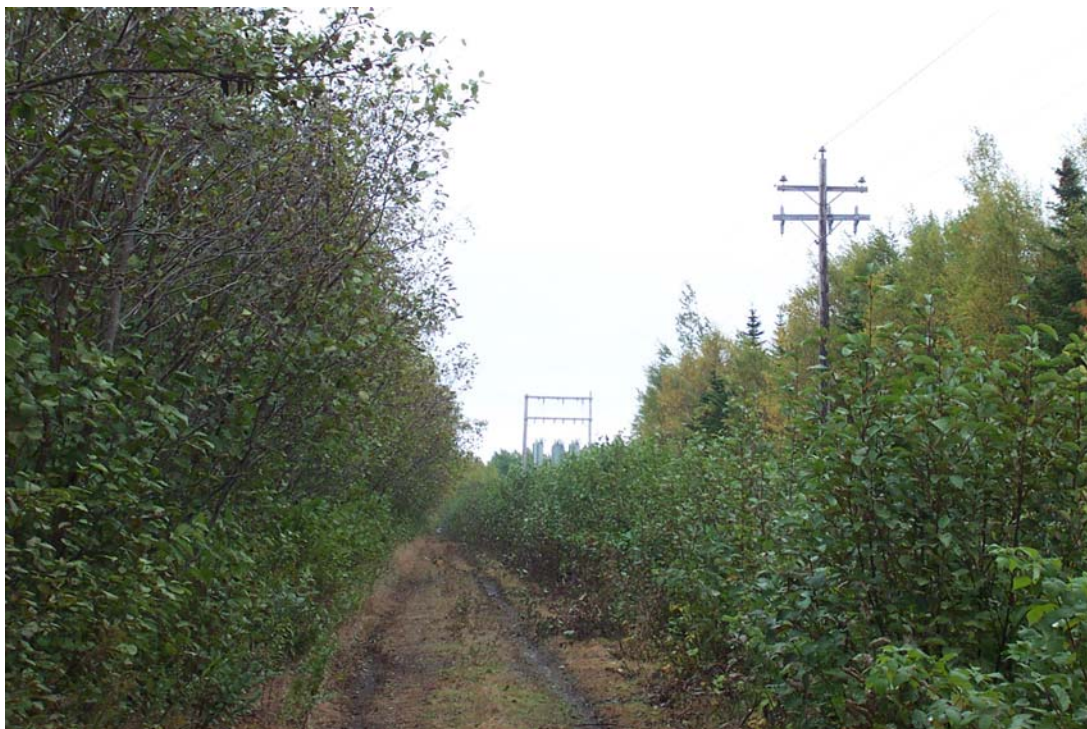
**This is typical of the sections of the feeder that follow the abandoned road.
This location is along Davidsville to the Regulator Structure.
Picture #4**
