**Newfoundland Power Inc.
2006 Capital Budget Application
Filing Contents**

**Volume I
Application**

**Volume II
Supporting Materials**

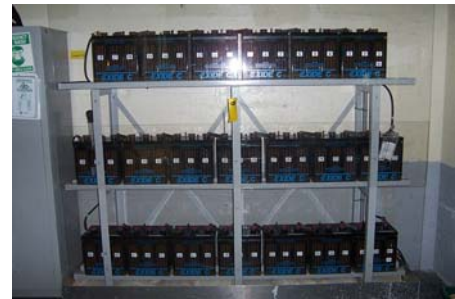
Battery Plant and Charger

A review of maintenance records for the battery bank indicates it has remaining service life. The battery charger was replaced in 2003. It is recommended that both the existing battery bank and charger remain in service.

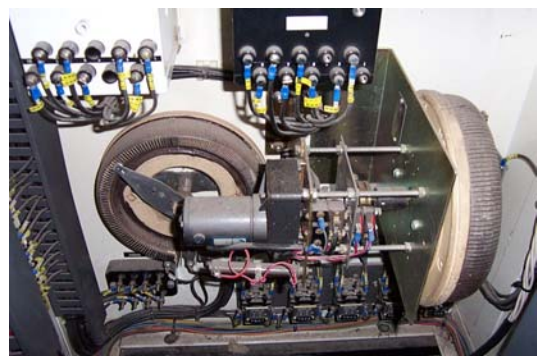
Generators

Unit 1 was rewound in 1970, unit 3 in 1994, and unit 2 in 1986. There are no indications that the generator windings have deteriorated. The addition of continuous partial discharge testing equipment on each generating unit is recommended to monitor the condition of the windings to facilitate scheduled replacement before failure. The integration of the MegAlert stator insulation resistance monitors with the unit control panels is recommended to ensure the units are not started with condensation on the windings which could result in failure.

There is difficulty in regulating voltage on the units, particularly when operating an isolated system during outages to transmission line 3L. Also, the inability to match machine voltage to system voltage has created situations where the units have tripped while attempting to synchronize with the system. Units 1 and 3 have Brown-Boveri model AB2/1 voltage regulators and unit 2 has a Basler model SR-8 voltage regulator. It is recommended that the voltage regulators on all three units be replaced with digital technology to eliminate the voltage regulation problems.

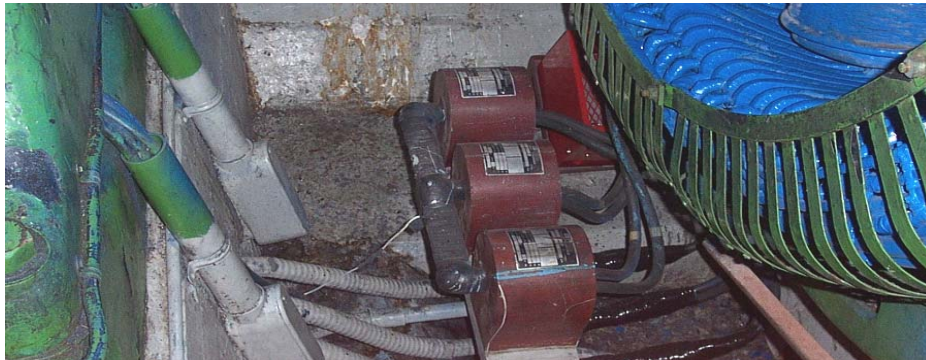
Switchgear

The inspection of the switchgear identified that the bus work and breakers are in good condition and do not need to be replaced. It is recommended that revenue class current and potential transformers be added to the switchgear to provide accurate metering data from these units.

The power cables were installed in 1978 and remain in serviceable condition.

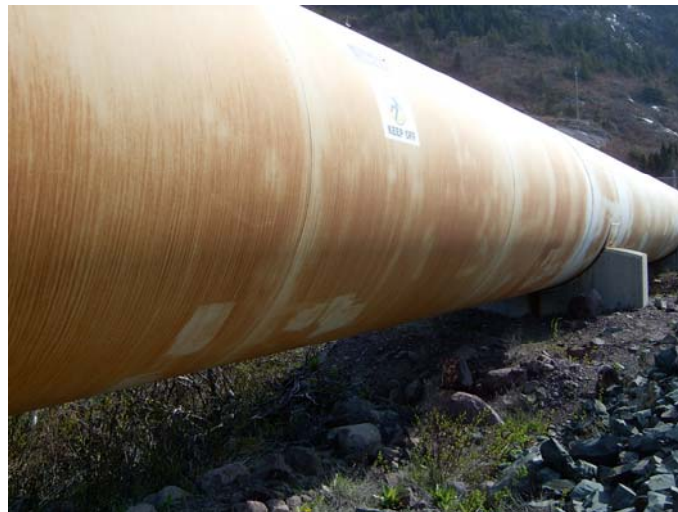
The penstock was replaced in 1999. In 2002 the penstock paint system started to show signs of deterioration and over the last year the level of deterioration has increased. Most of the surface area has significant rust staining indicating that the surface is permeable and not protecting the steel as intended. Water and oxygen are able to penetrate the coating system and are causing the penstock to rust. The entire steel penstock should be recoated.

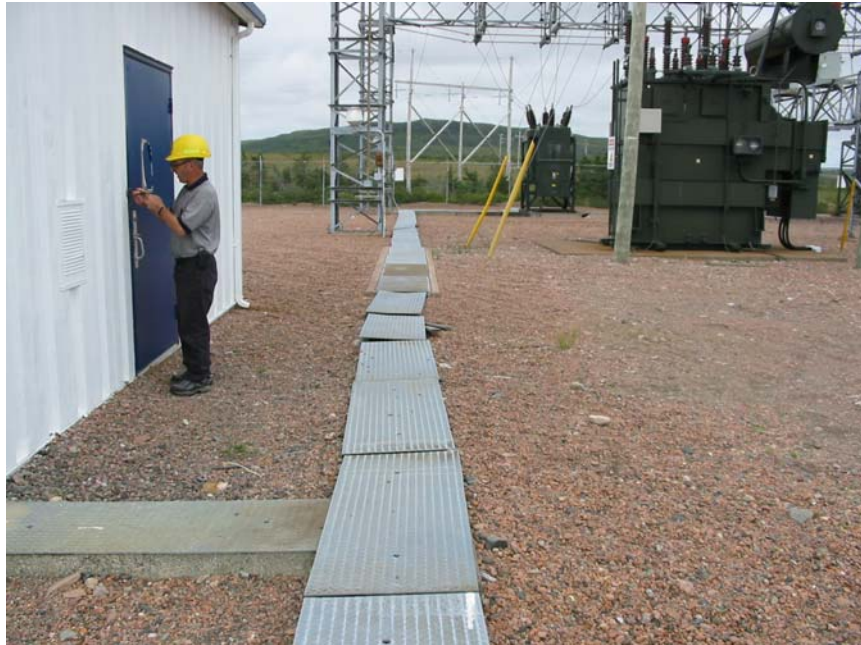
The drainage in the Laurentian Substation is inadequate resulting in frost action which has caused movement of the cable trench. In addition, during wet periods, movement around the yard by vehicles is difficult and damages the yard.

**Picture #1: Laurentian Substation
Shifting of cable trench due to frost heaving.**

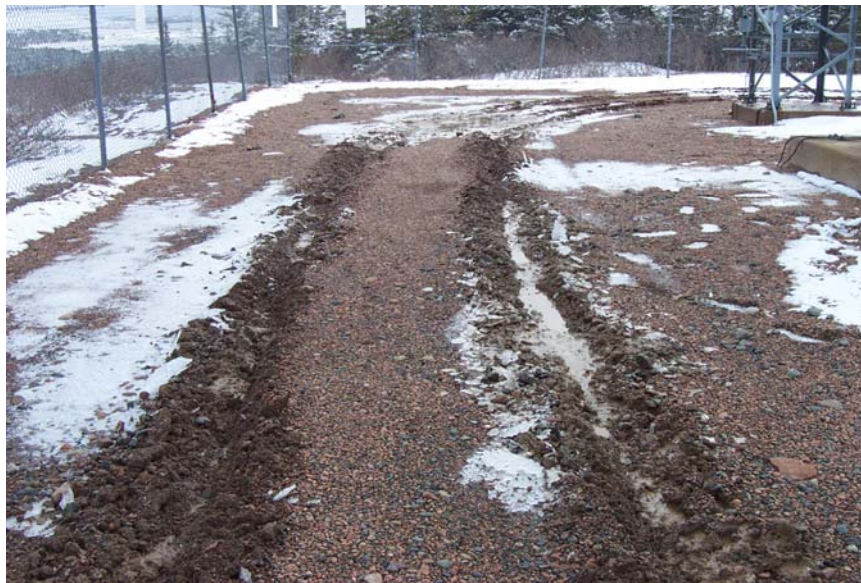
**Picture #2: Laurentian Substation
Damage to crushed stone and sub-grade.**

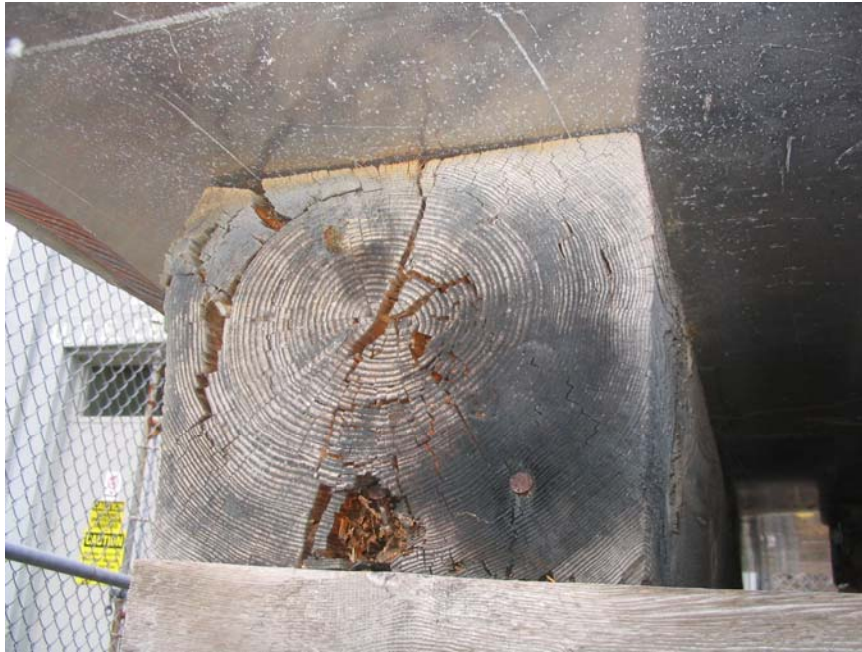
The foundation for the Topsail T1 transformer is approximately fifteen years old, and because it is in close proximity to a water body, it was constructed of untreated timber. Wood rot and splitting of the timber has been identified. Failure of this foundation could lead to an oil spill and failure of the transformer. The timber foundation will be replaced with a concrete foundation.

Picture #3
Topsail T1, rotting timber foundation

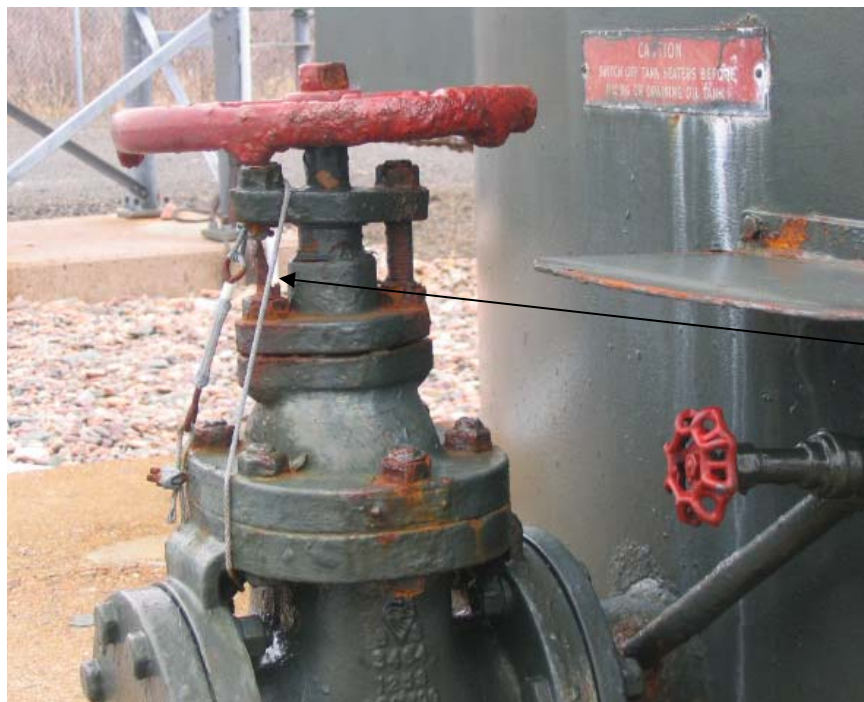
Picture 1
GRH-301L-B

The existing Greenhill substation breakers (for 301L/305L) are bulk oil type units that contain in excess of 12,000 litres of insulating oil. As a result, they represent a significant environmental risk should the units fail and the oil be released. The replacement breakers will be galvanized steel oil-free breakers.

Bolt Rusted Off

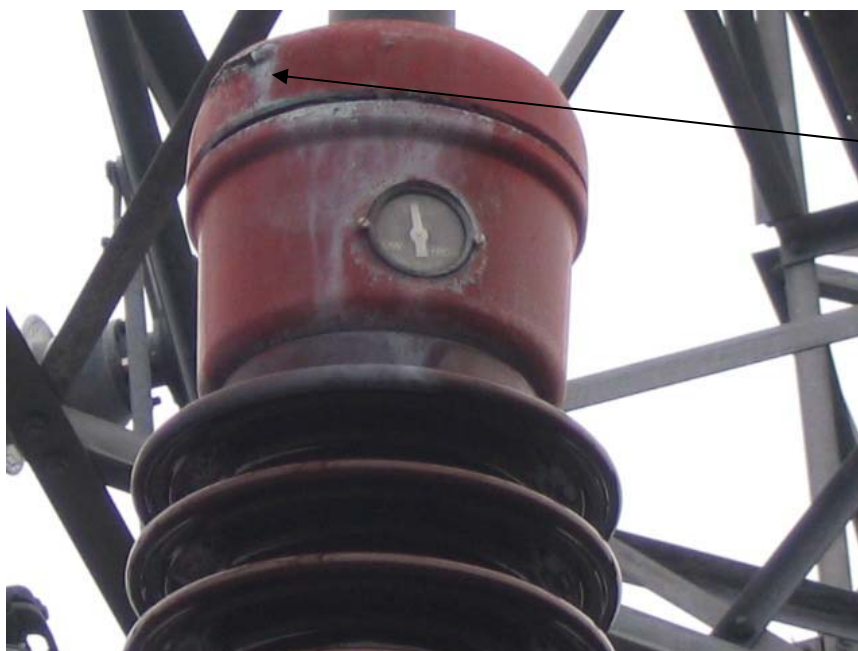
Bushing Rupture

Picture 2
Bushing Deterioration

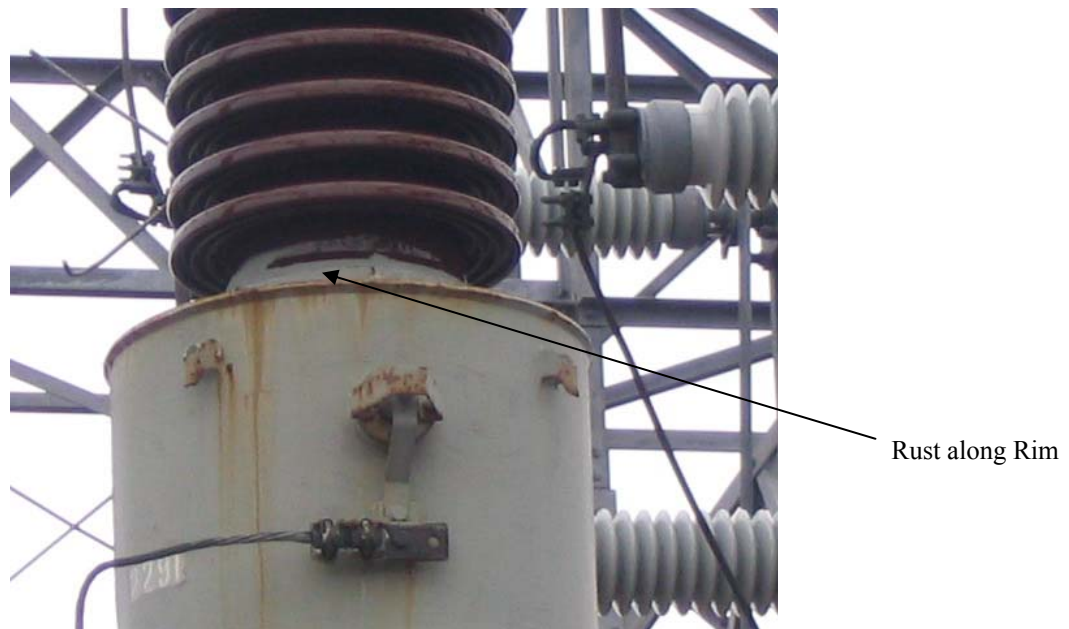
Three 66 kV PTs at the Greenhill Substation require replacement due to rusting and the resulting likelihood of failure of these units due to water ingress into the transformer. Failure of these units would affect the ability of protective relaying to perform properly. Also failure of a potential transformer would cause an outage to all the customers serviced from Greenhill Substation. Picture 3 shows the rusted case on one of the units. A similar PT failed at the Laurentian Substation due to rusting of its top cover which allowed water to enter the PT. A similar PT in the Greenhill Substation has also been replaced due to severe rusting.

Picture 3
Rusting Case of PT at Greenhill Substation

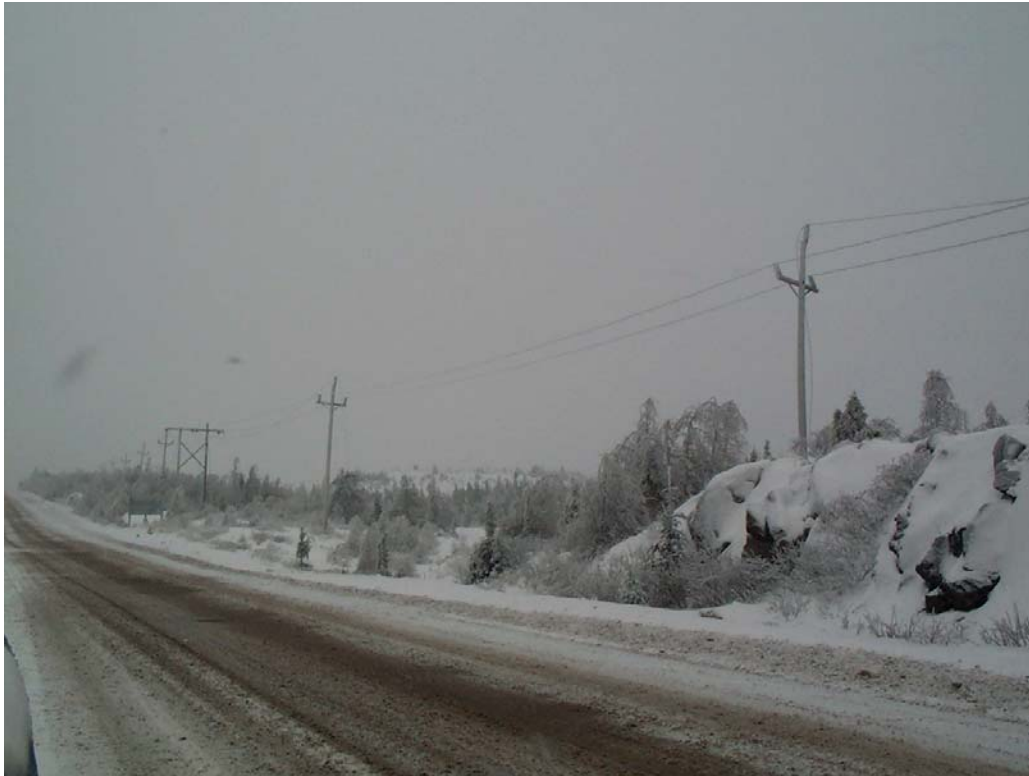
Figure 2 110L Ice Storm Damage December 2003

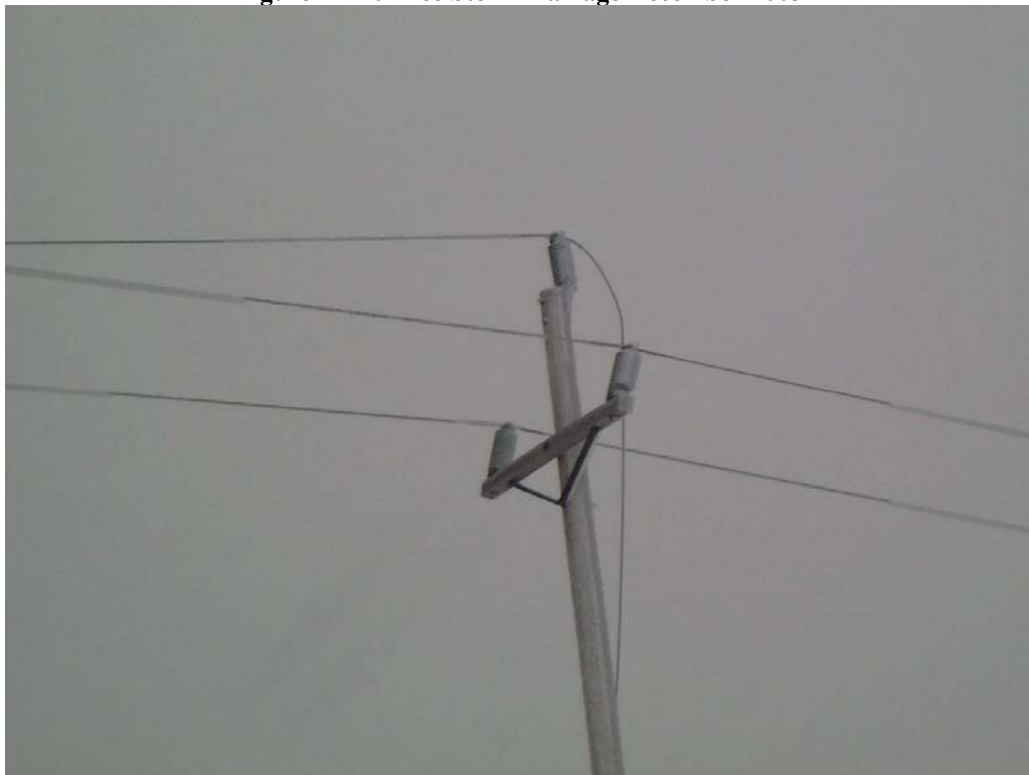
Figure 3 110L Broken conductor - ice build up December, 2003

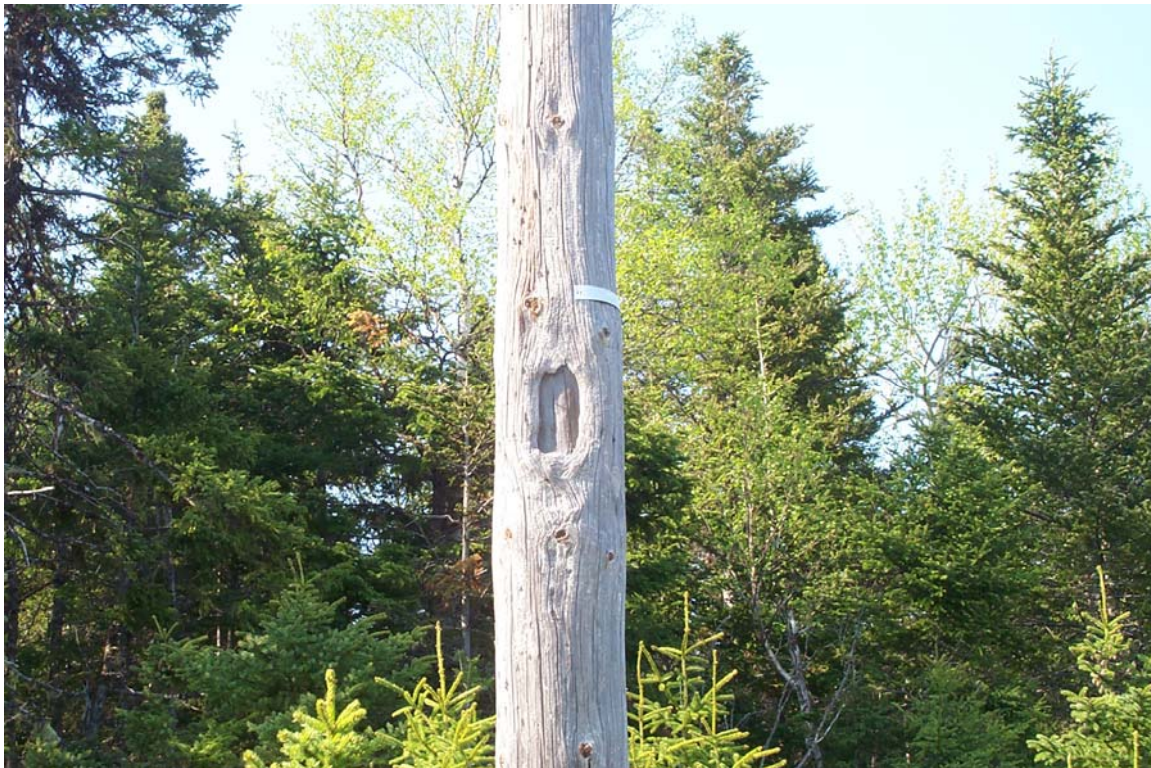
Figure 4 Deteriorated pole 110L

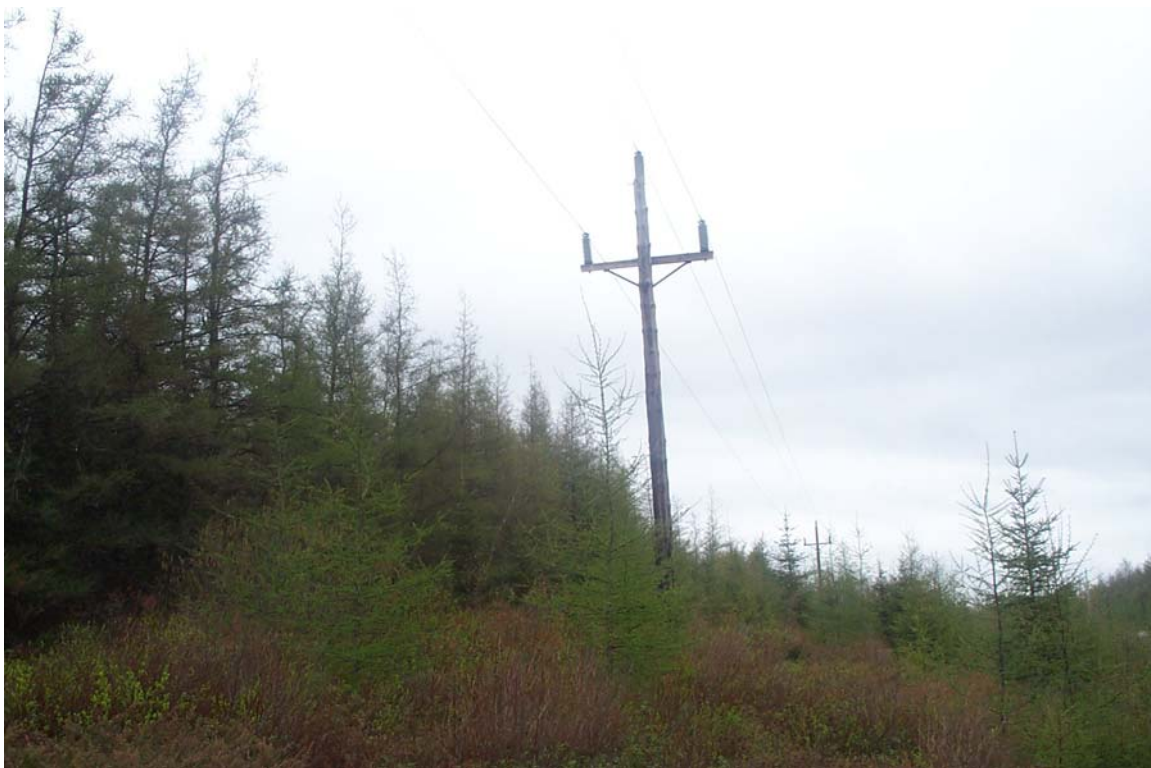
Figure 5 Deteriorated pole 110L

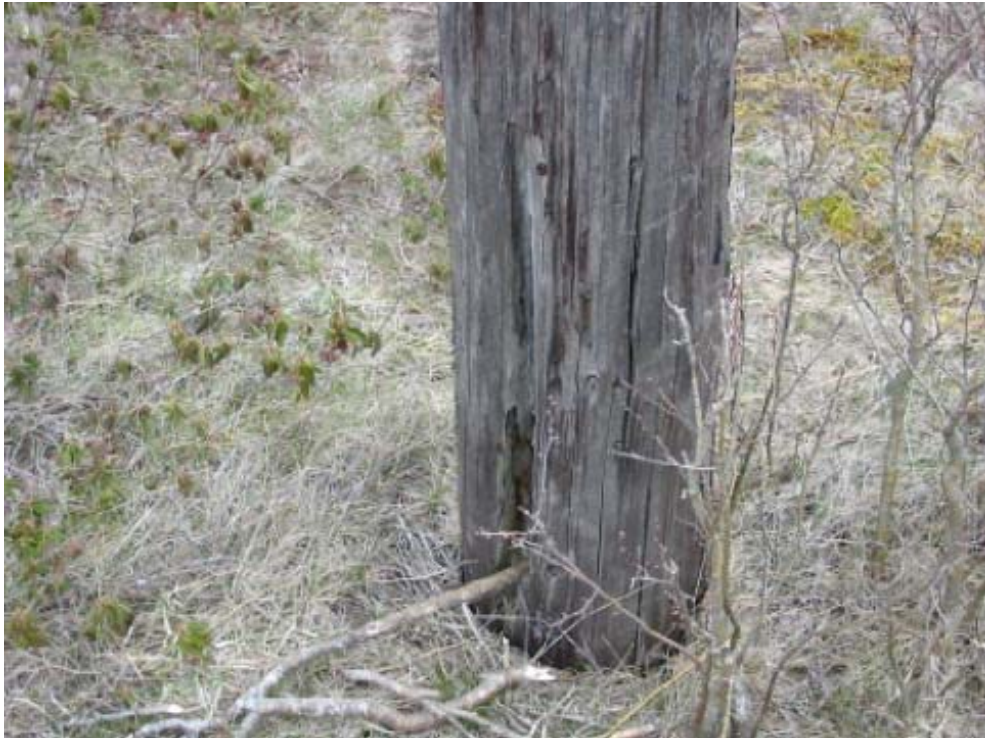
Figure 2 Deteriorated pole 407L

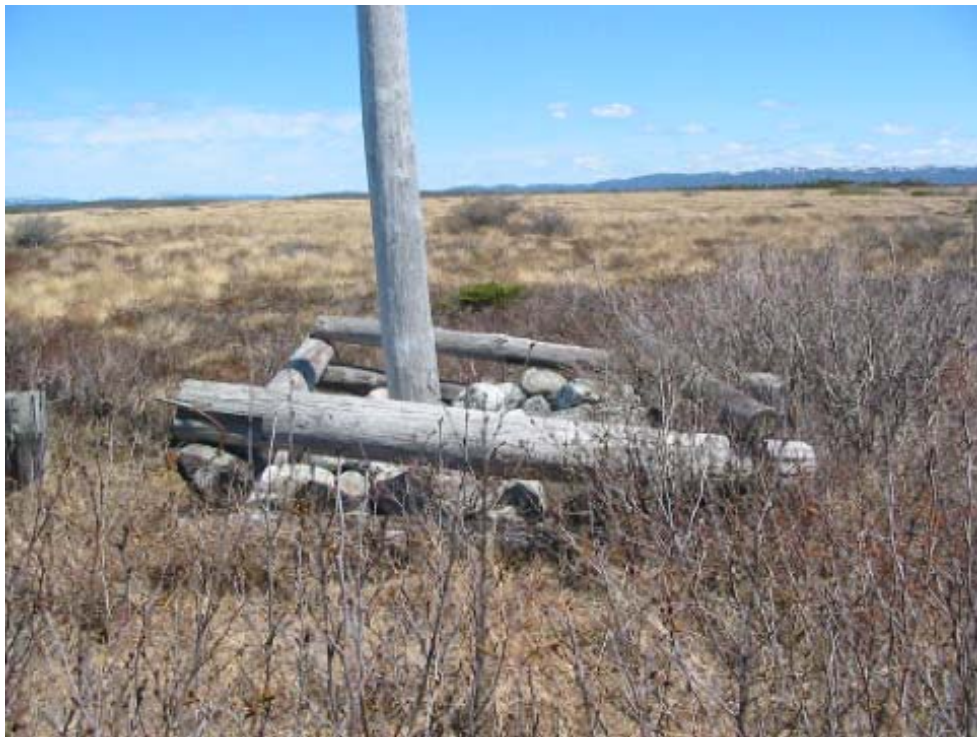
Figure 3 Deteriorated crib 407L

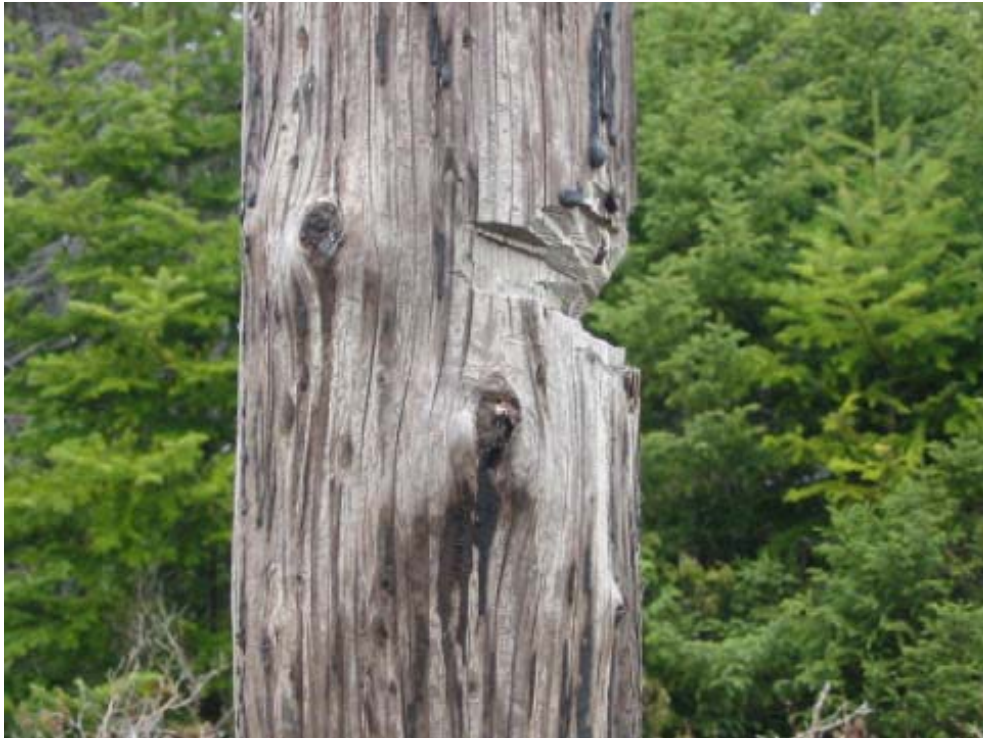
Figure 4 Vandalized pole 407L

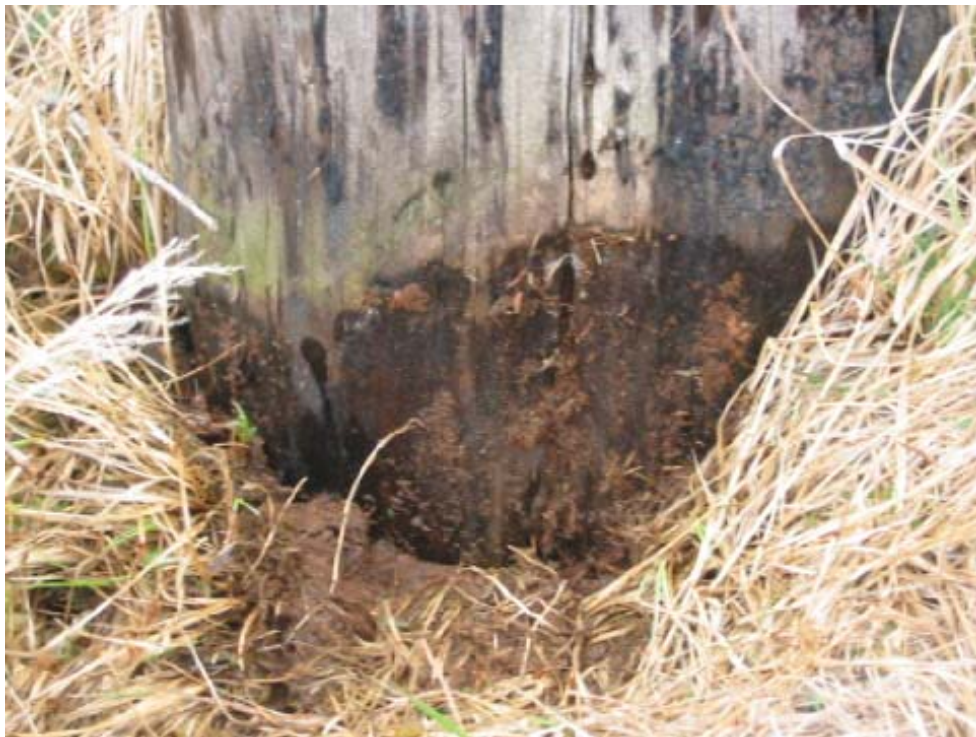
Figure 5 Ground line decay 407L

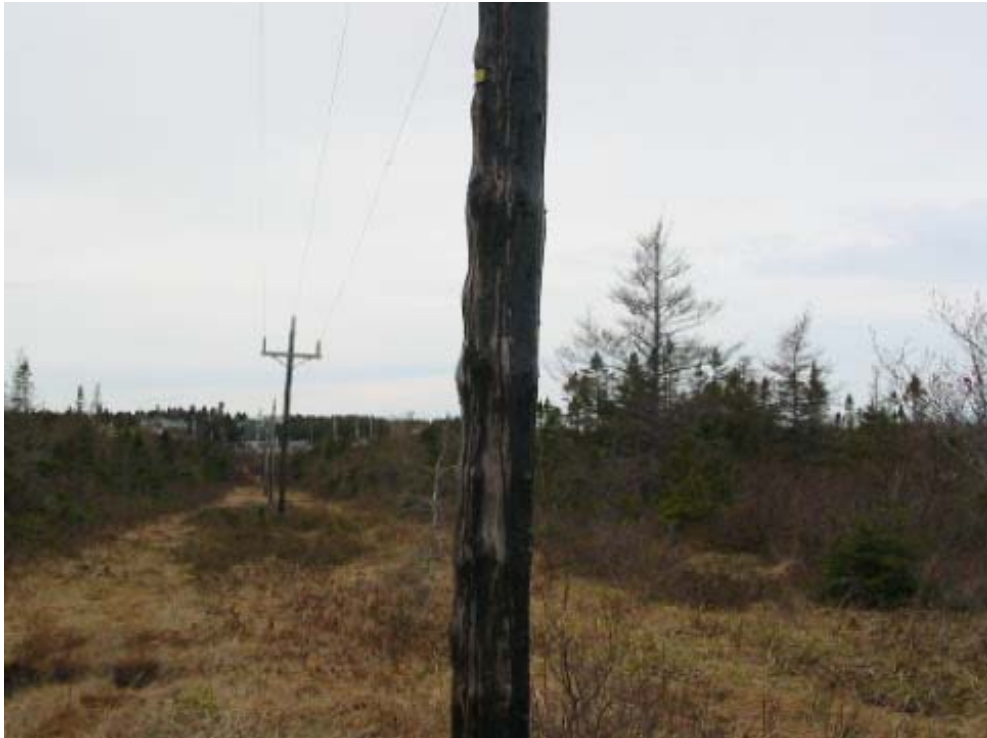
Figure 6 Deteriorated pole 407L

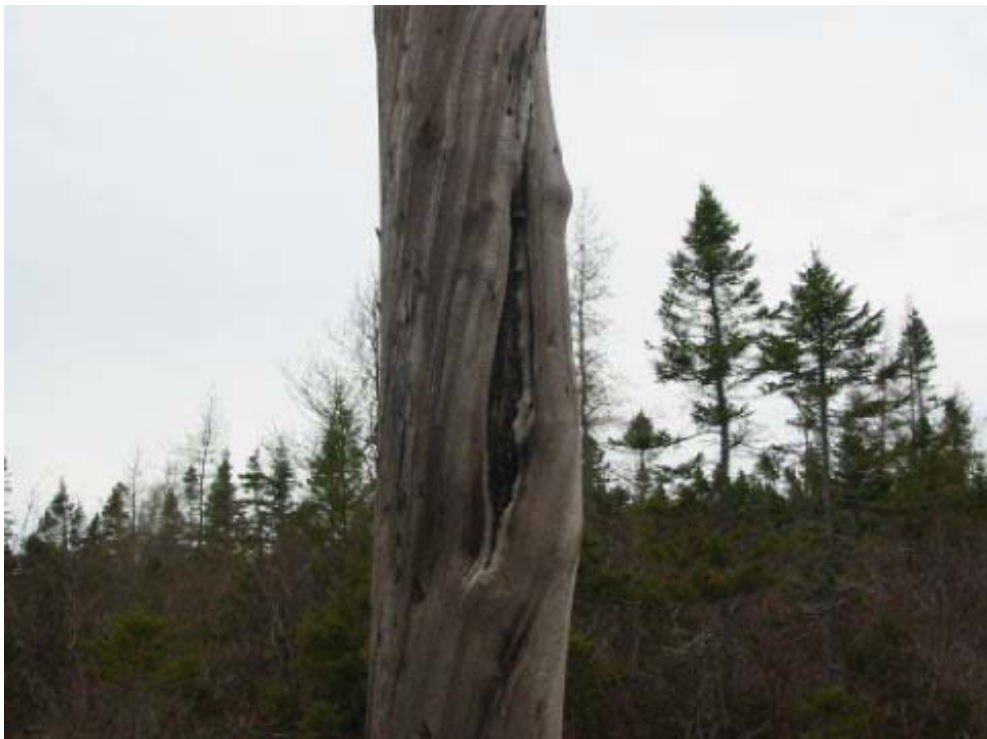
Figure 7 Deteriorated pole 407L

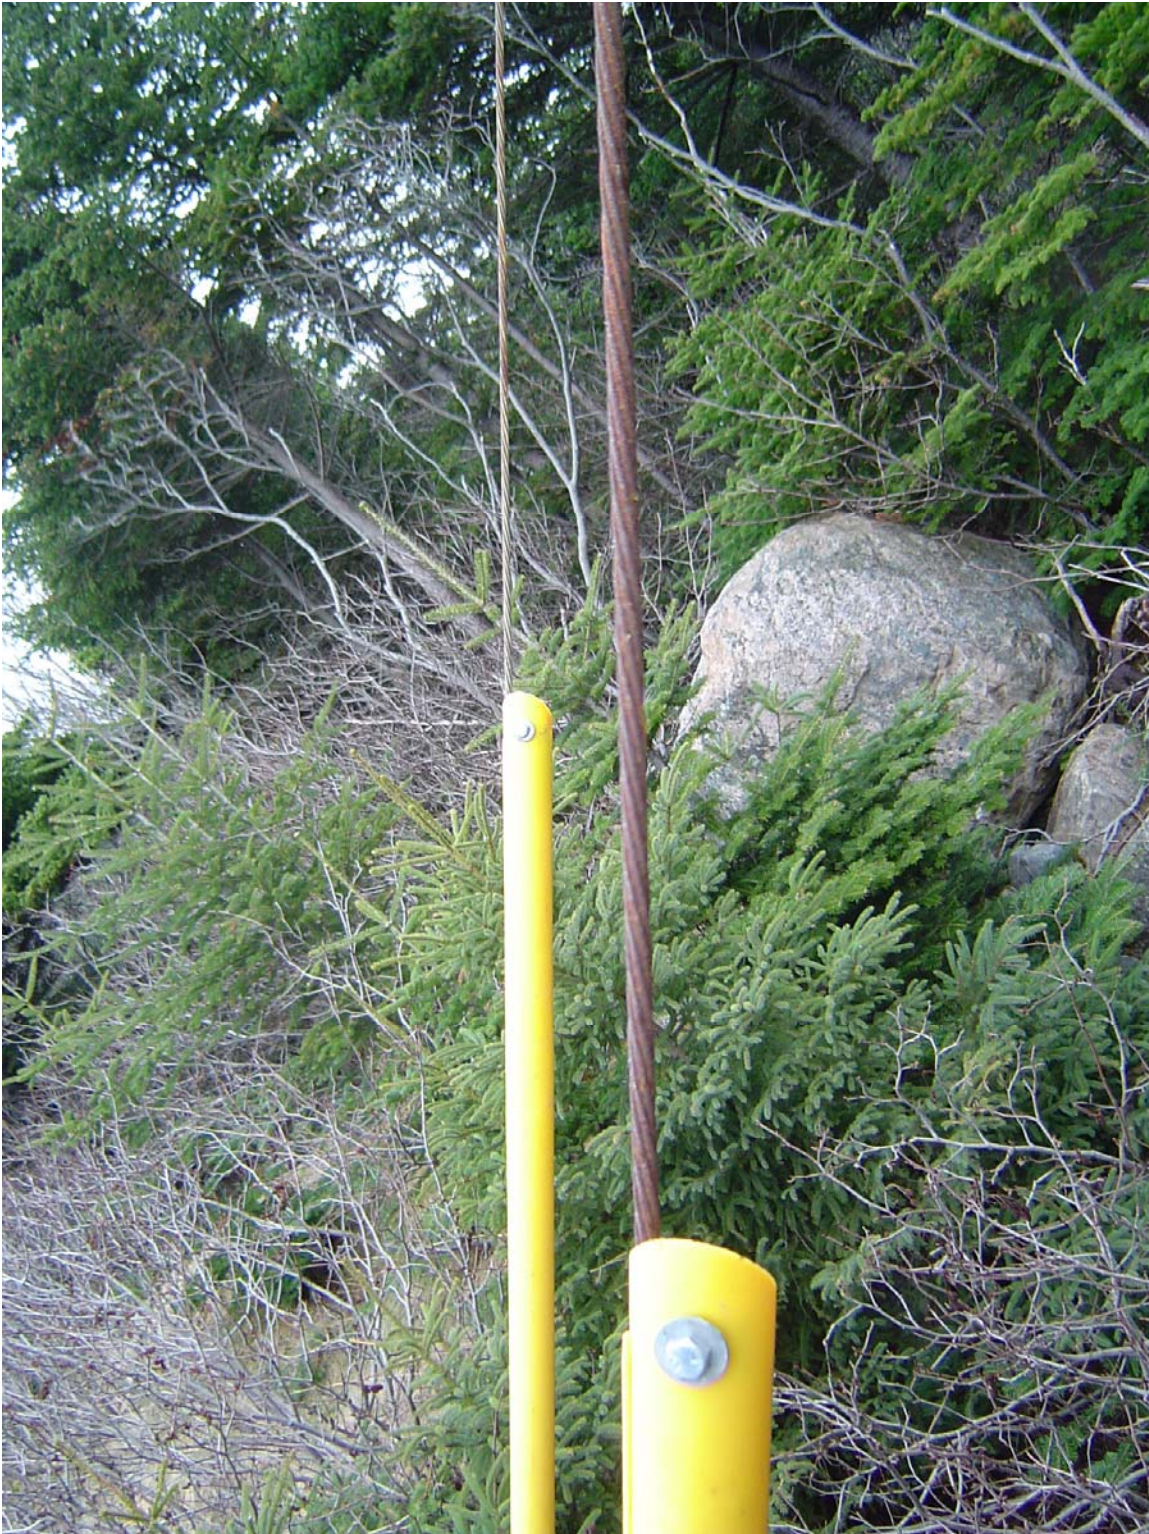
Figure 2 Rusty guy wire 43L

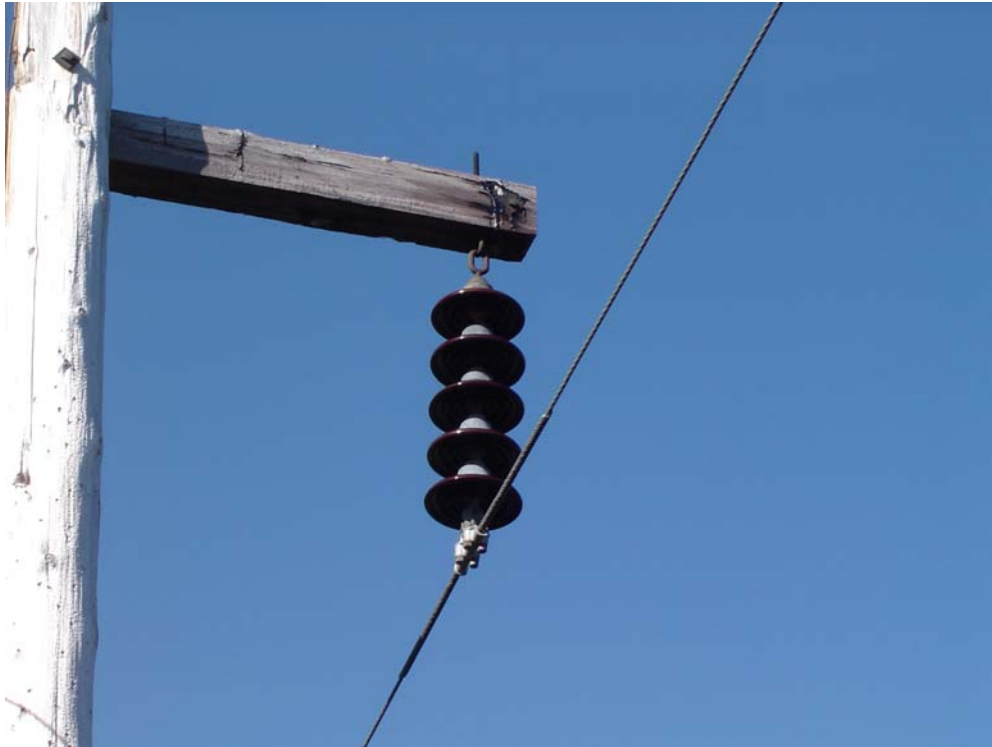
Figure 3 Old insulators 43L

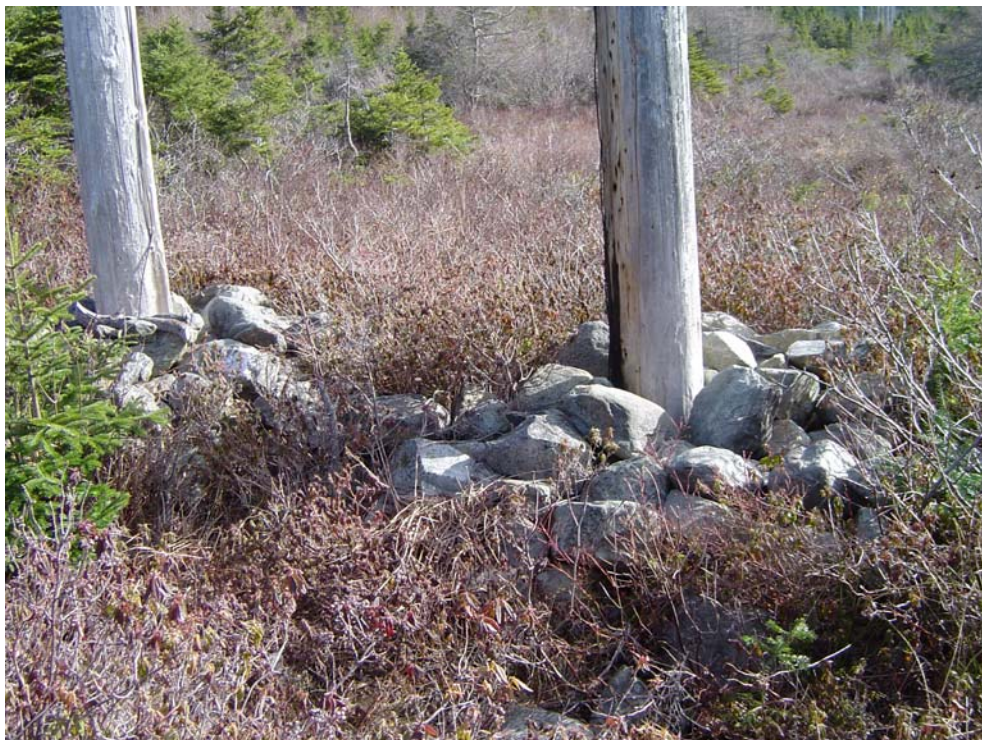
Figure 4 Deteriorated cribs 43L

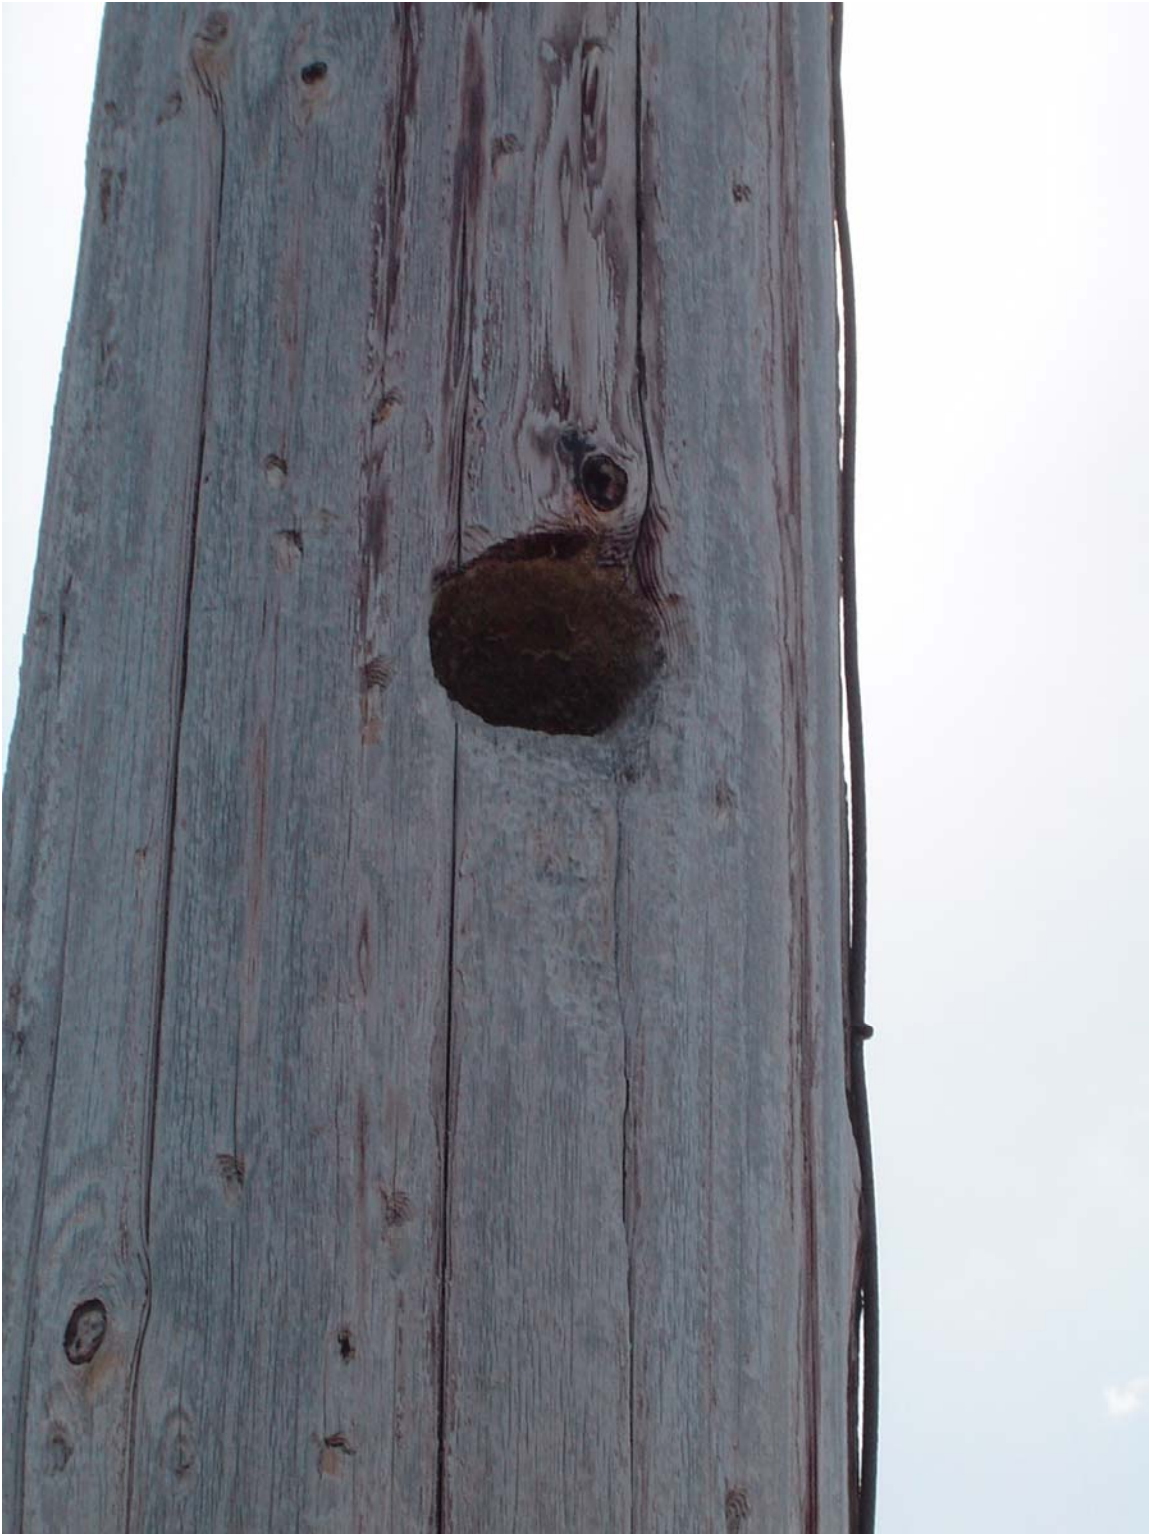
Figure 5 Woodpecker damage 43L

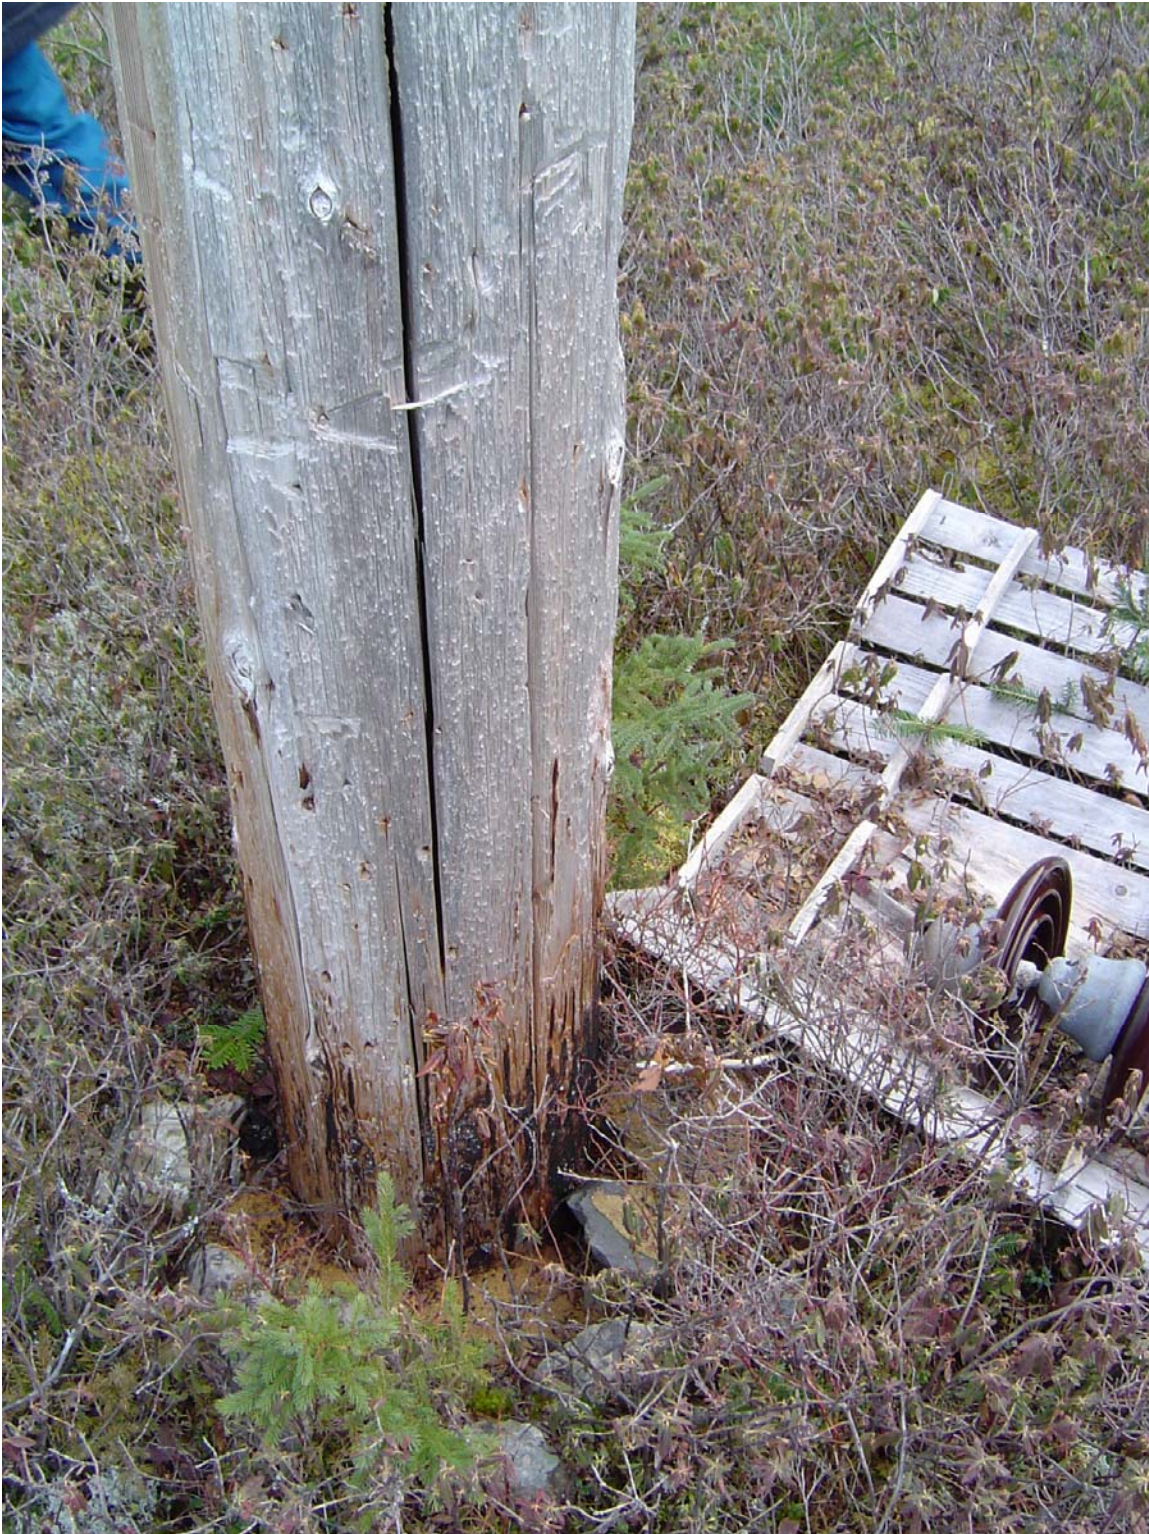
Figure 6 Deteriorated pole (ant damage) 43L

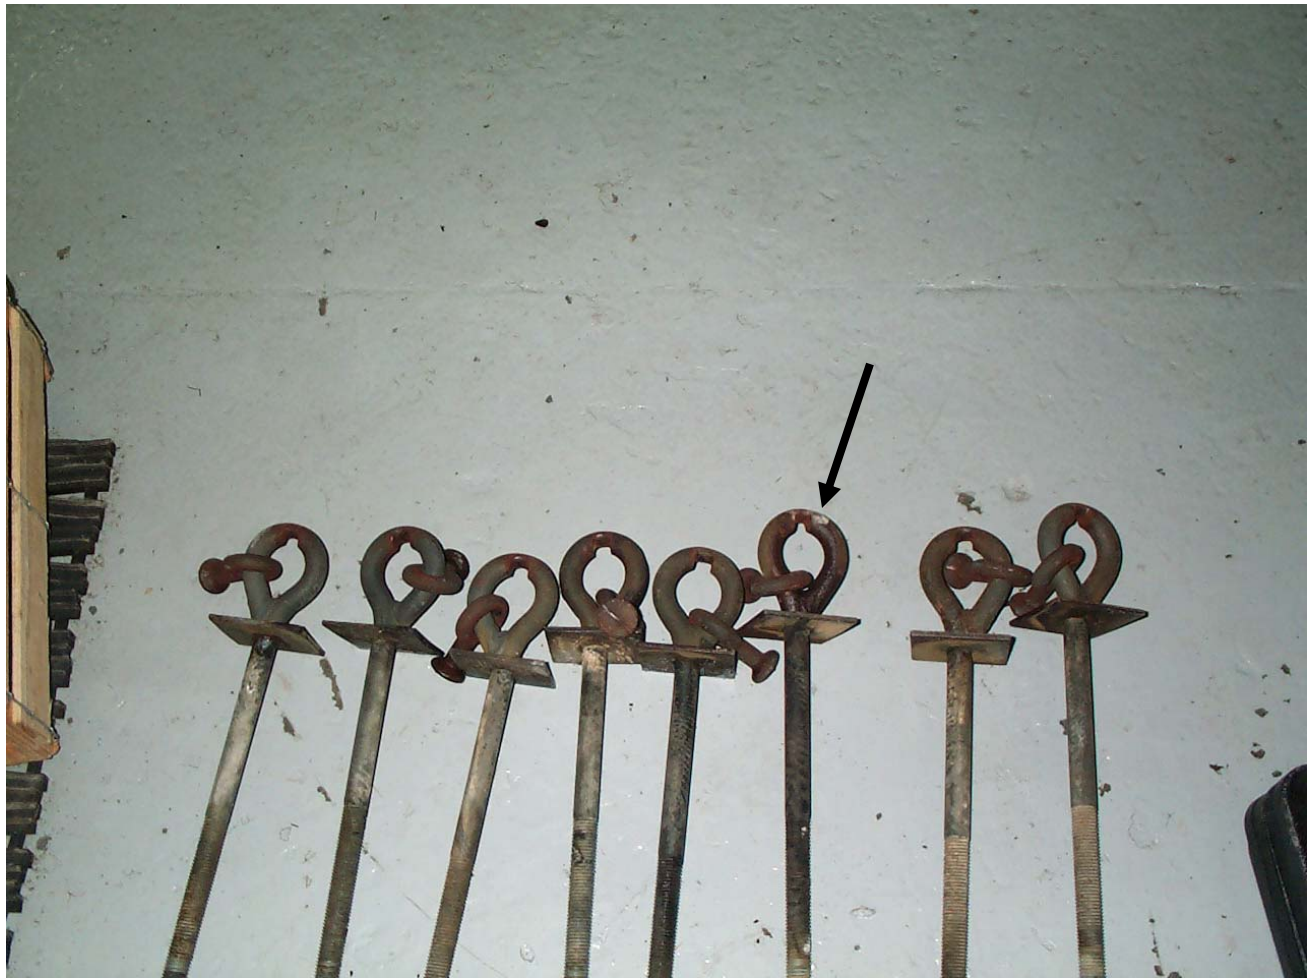
Appendix D

Wear on Ball Link Eye Bolts
