**Newfoundland Power Inc.  
2007 Capital Budget Application  
Filing Contents**

## Rattling Brook Hydro Plant Refurbishment

Prepared by:  
Gary L. Murray, P.Eng.

March 2006

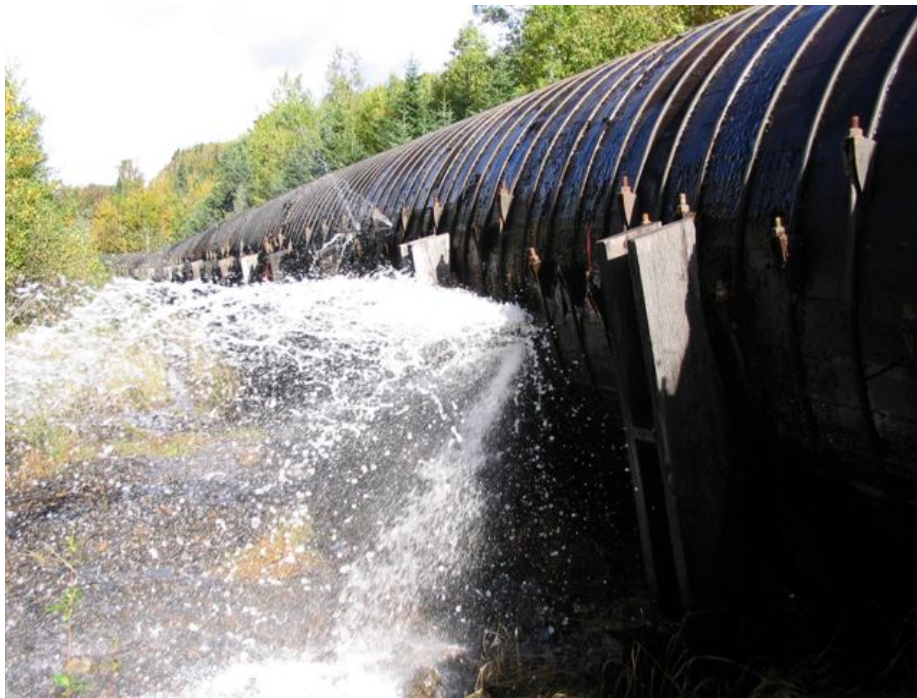
**Figure 1: Water Leakage from Penstock**

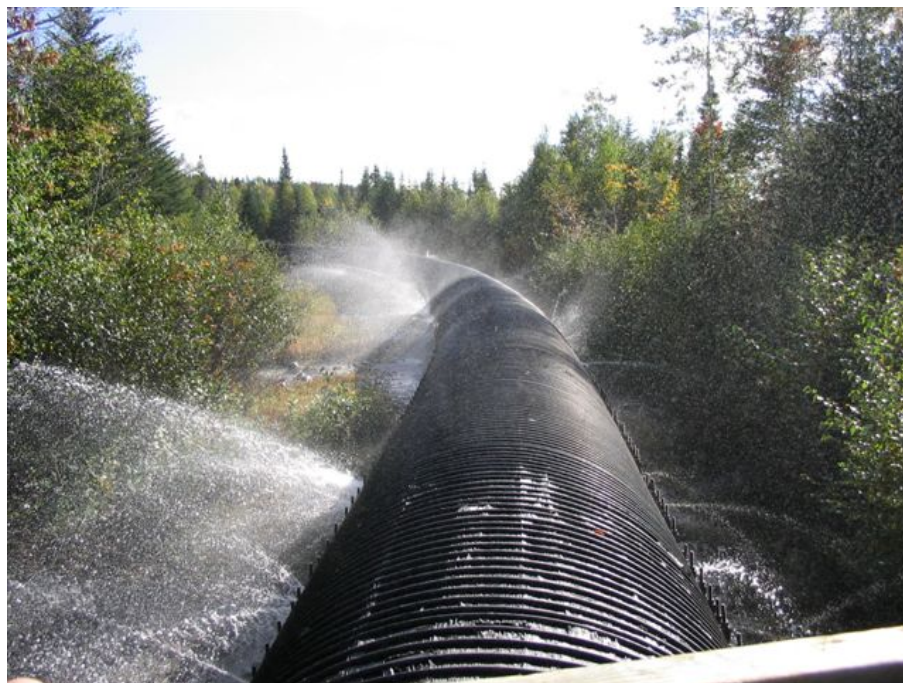
**Figure 2: Water Leakage from Penstock**

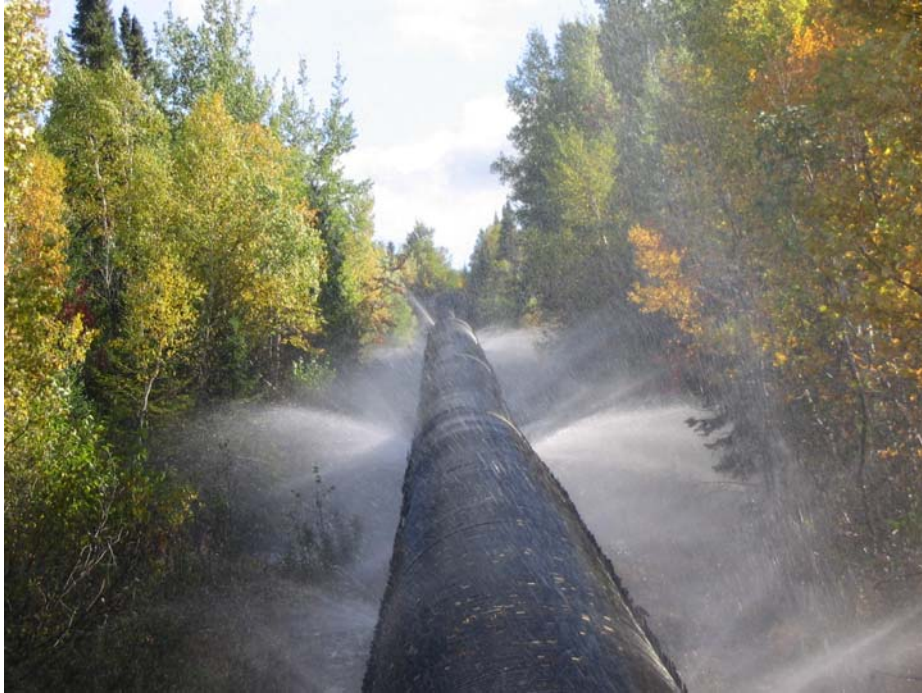
**Figure 3: Water Leakage from Penstock**

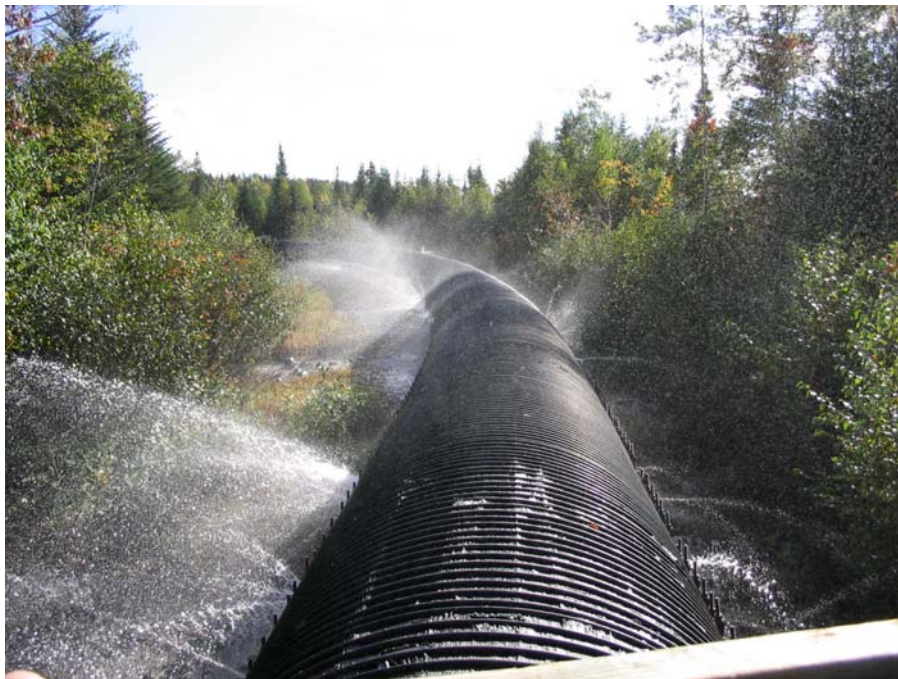
**Figure 4: Water Leakage from Penstock**

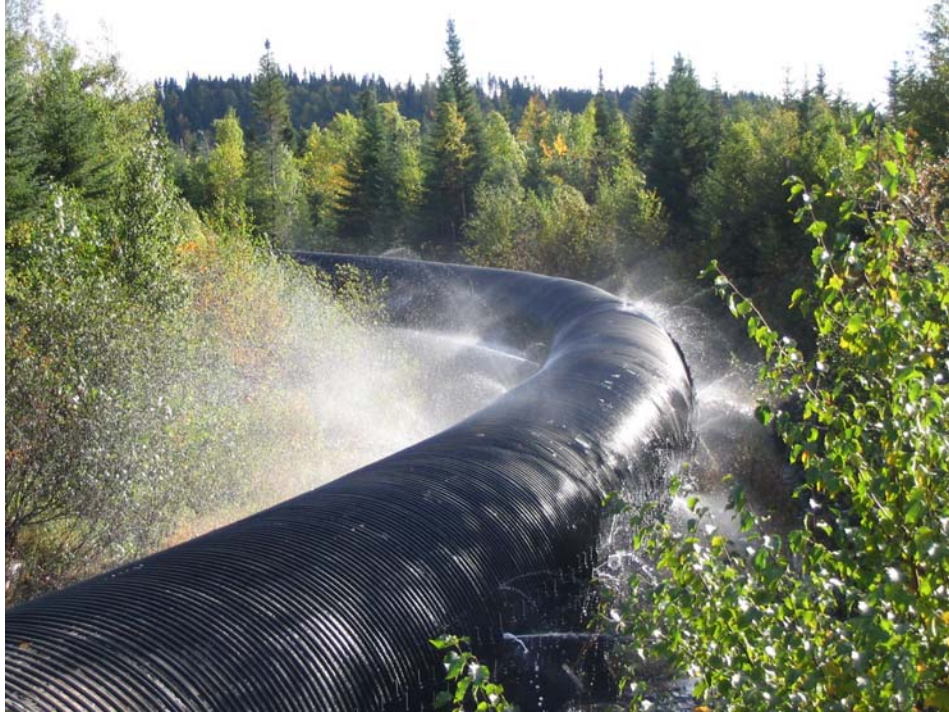
**Figure 5: Water Leakage from Penstock**

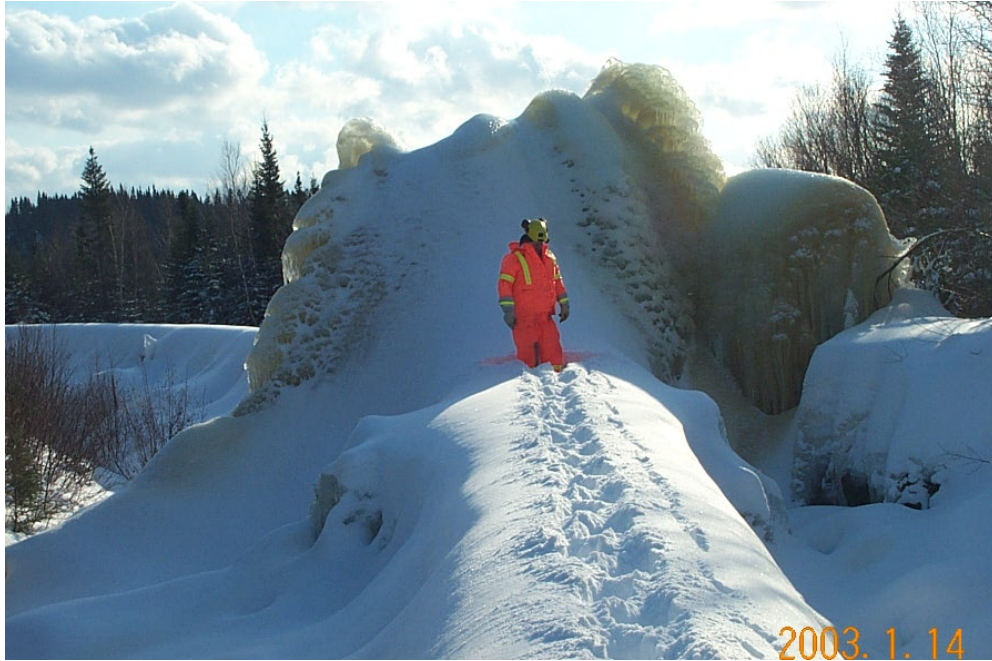
**Figure 8: Ice Build-up on Penstock due to Water Leakage**

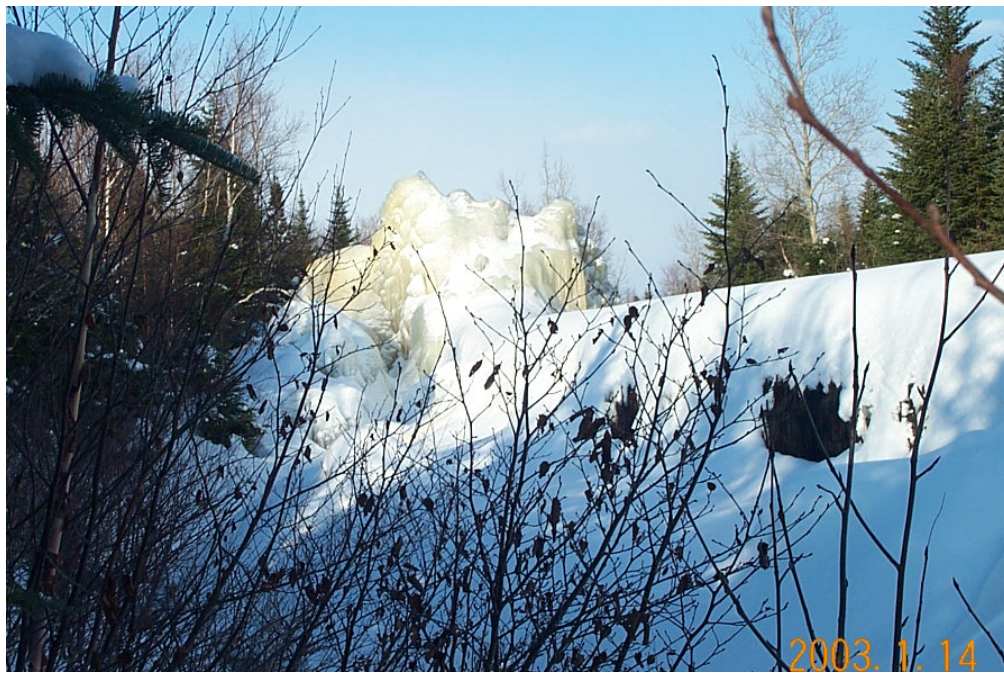
**Figure 9: Ice Build-up on Penstock due to Water Leakage**

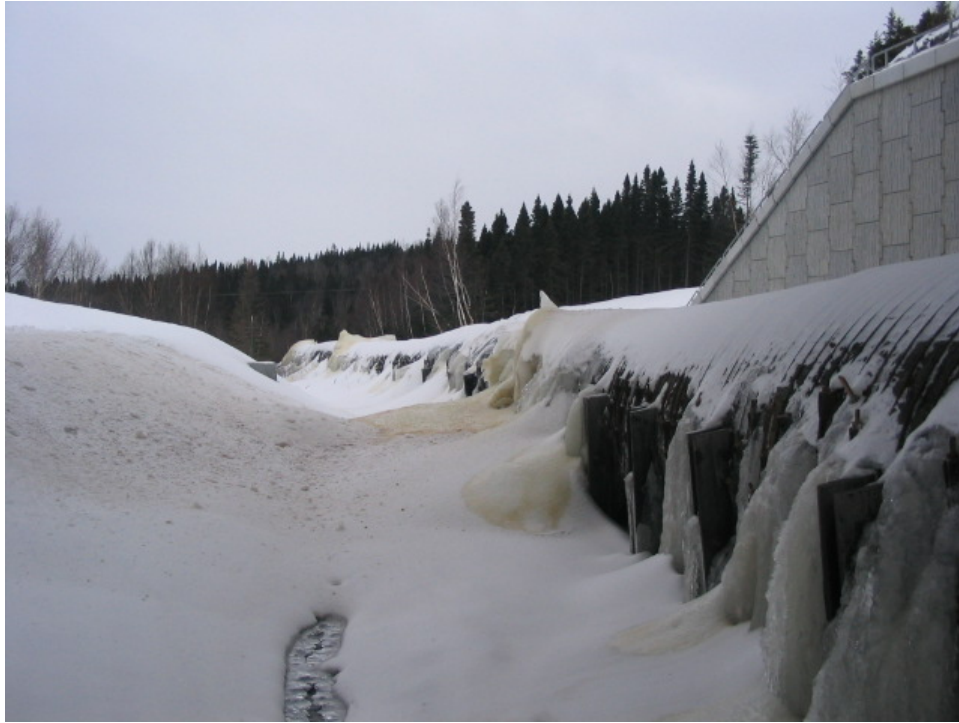
**Figure 10: Ice Forming on Penstock during Winter**

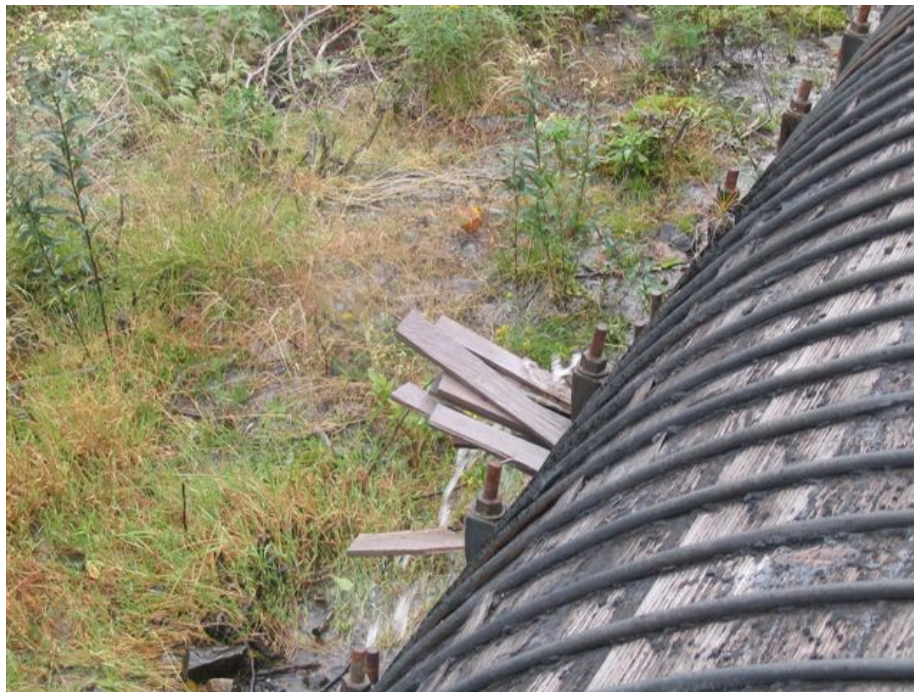
**Figure 15: Repairing Leakage**

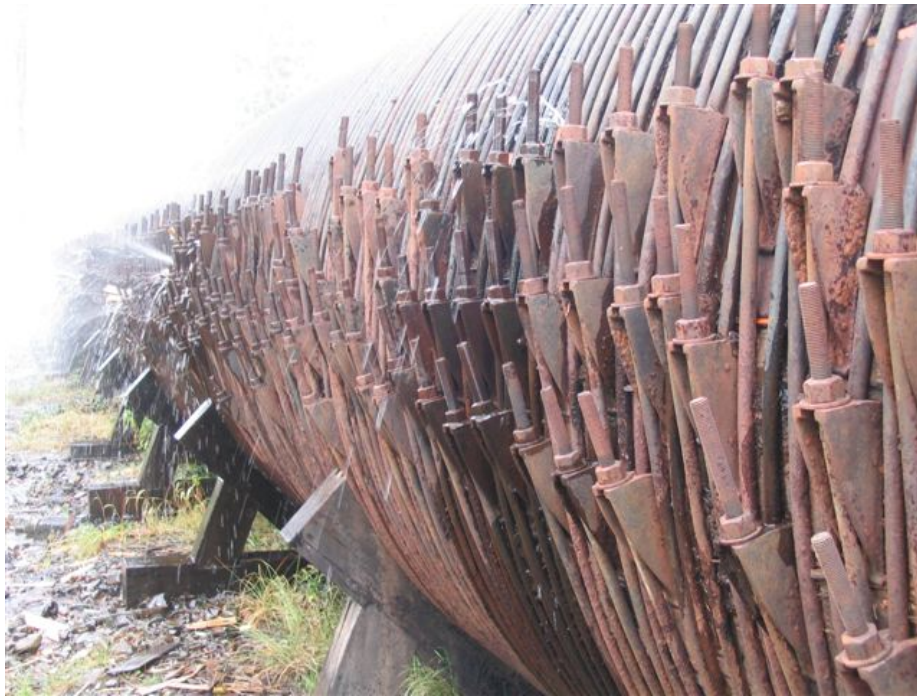
**Figure 16: Leakage at Lower Section of Penstock**

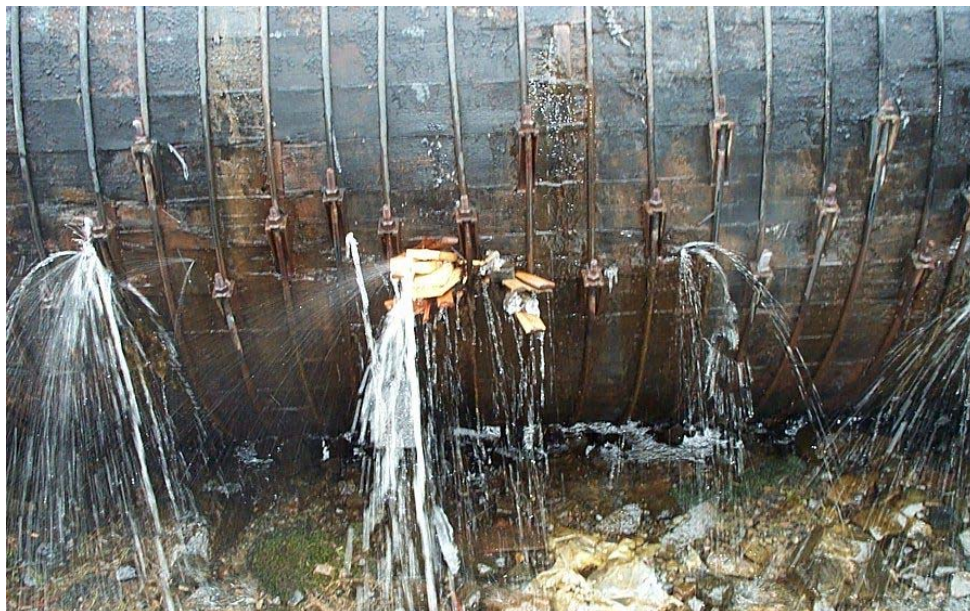
**Figure 17: Leaking Woodstaves**

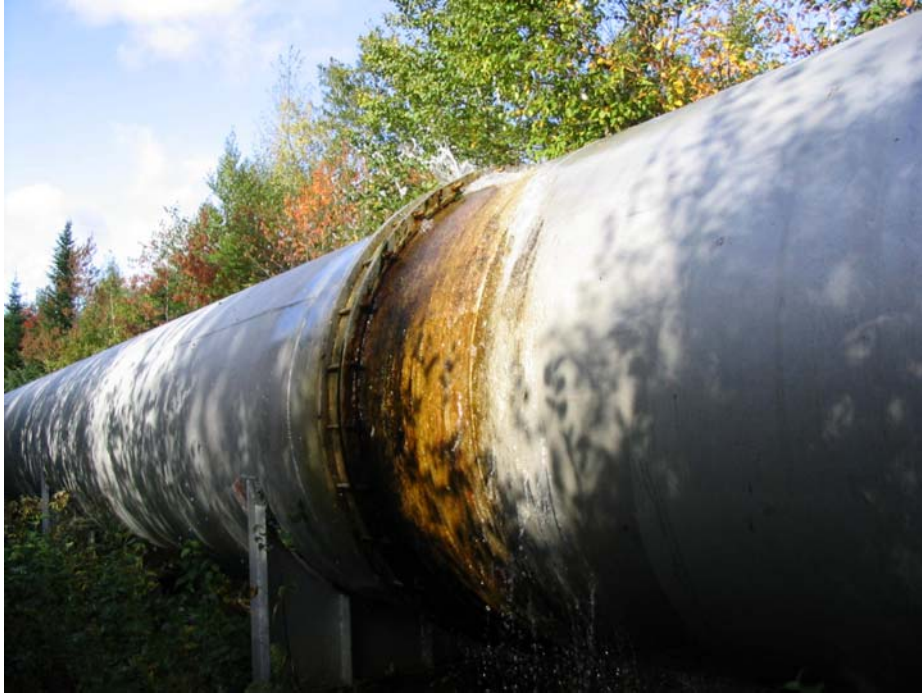
**Figure 18: Leakage at Expansion Joint**

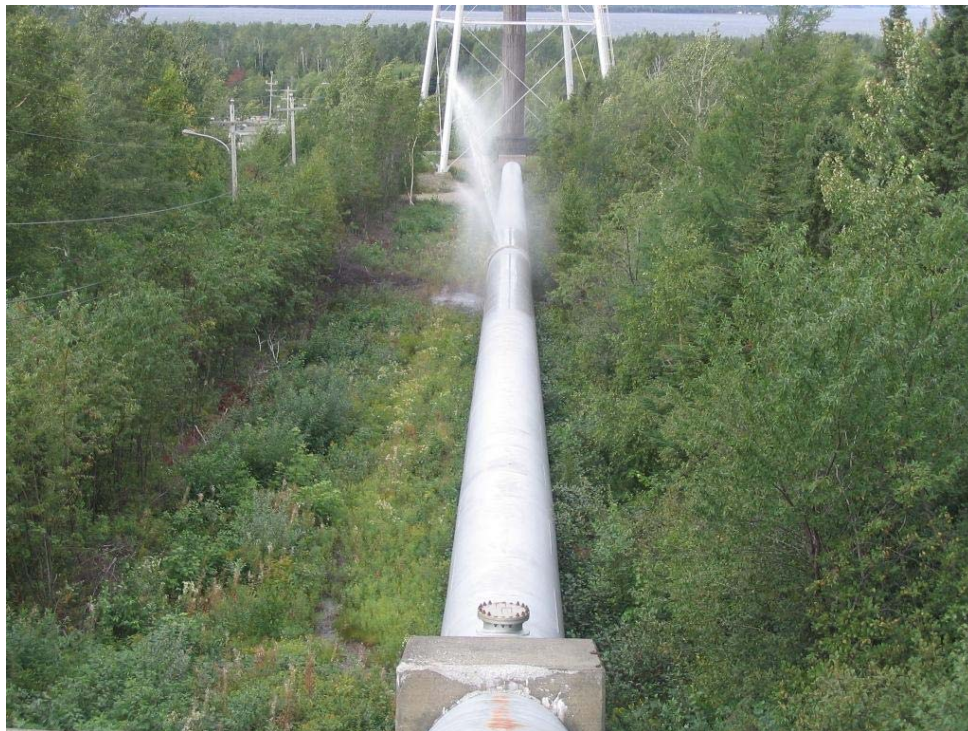
**Figure 19: Leakage at Expansion Joint**

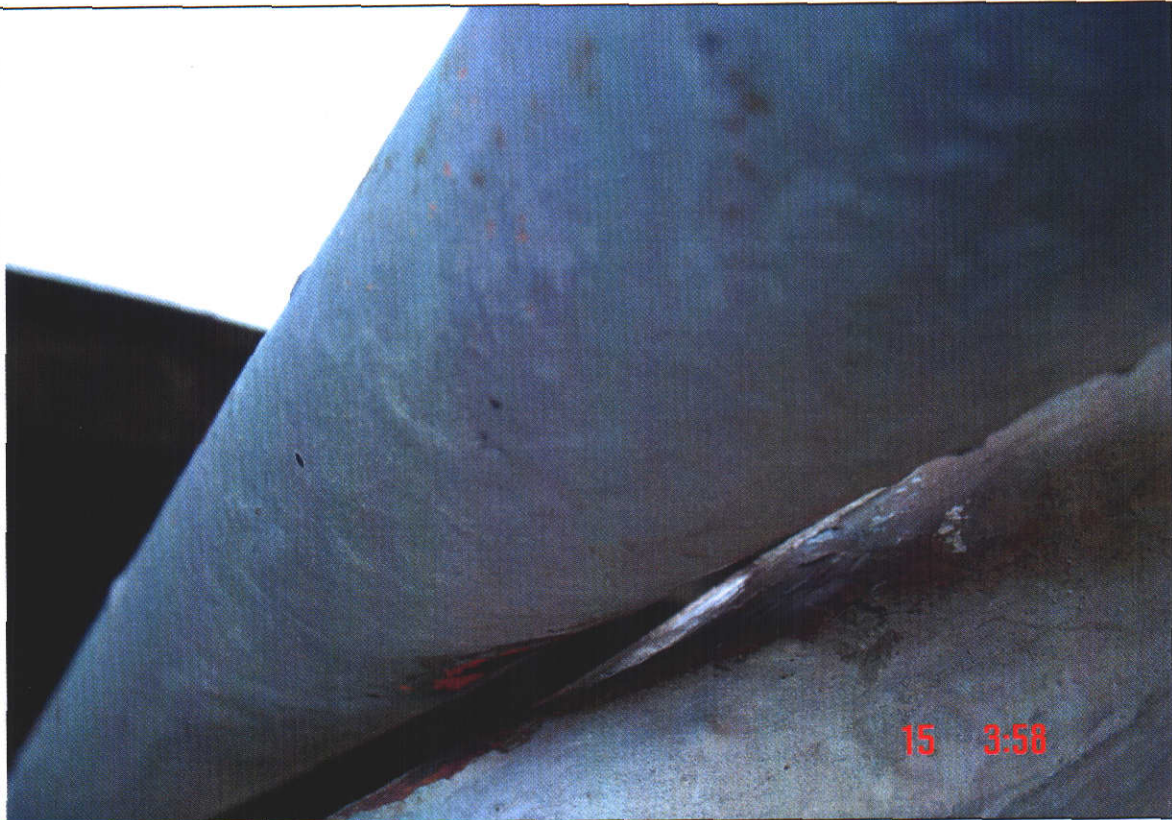
3. Wear of rod bracing.

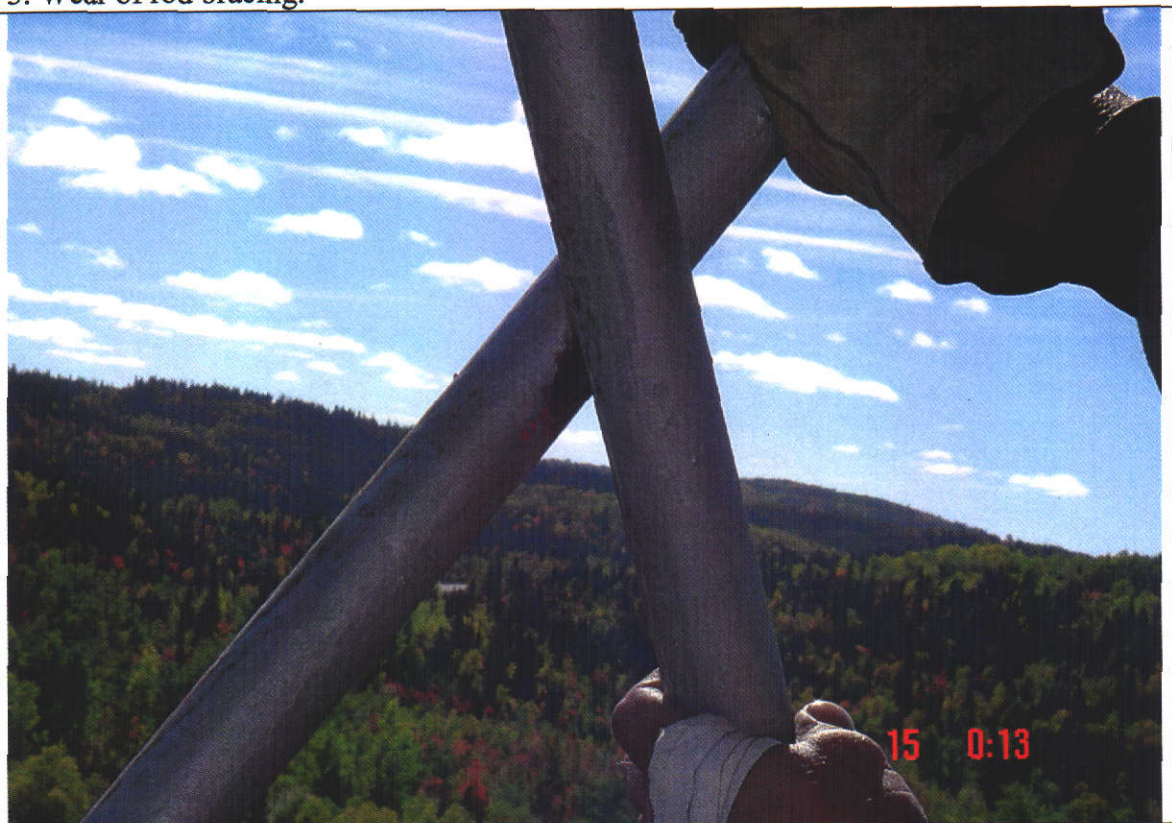
4. Wear of diagonal rod bracing.

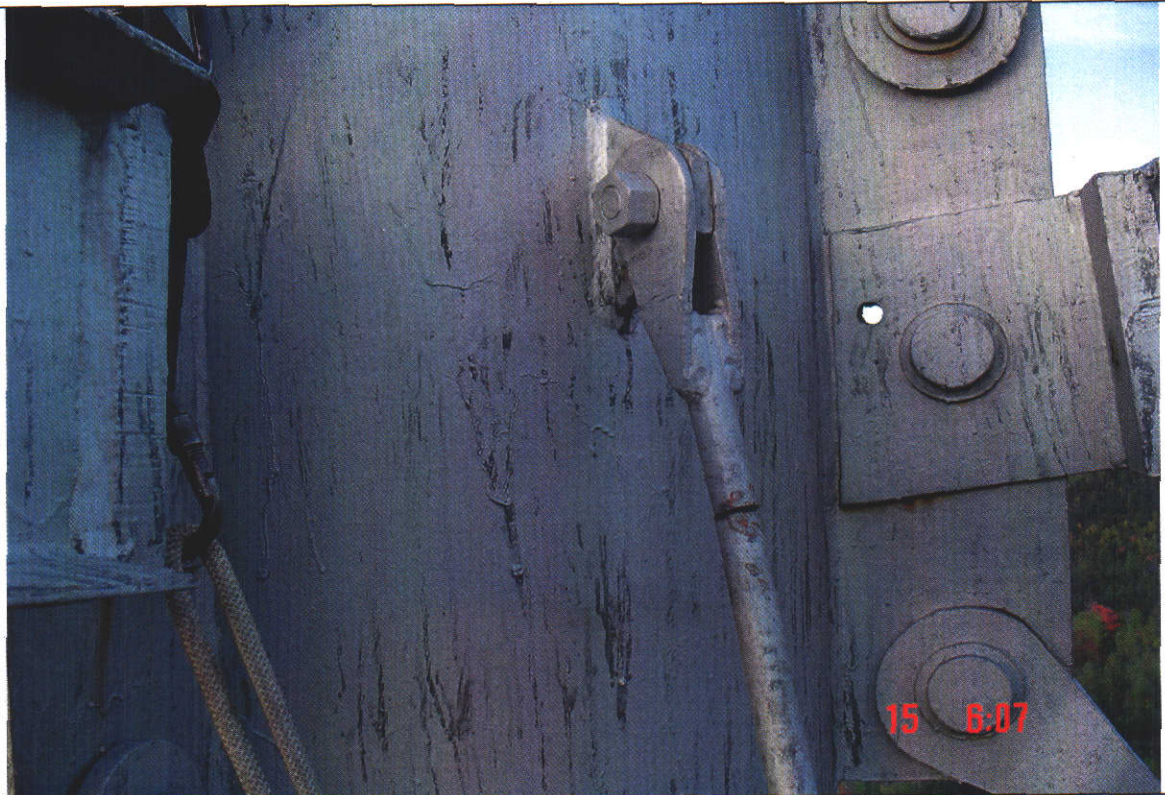
5. External riser stabilizer rod connection to leg #4 at EL.140'.  
Weld failure on connection to riser.

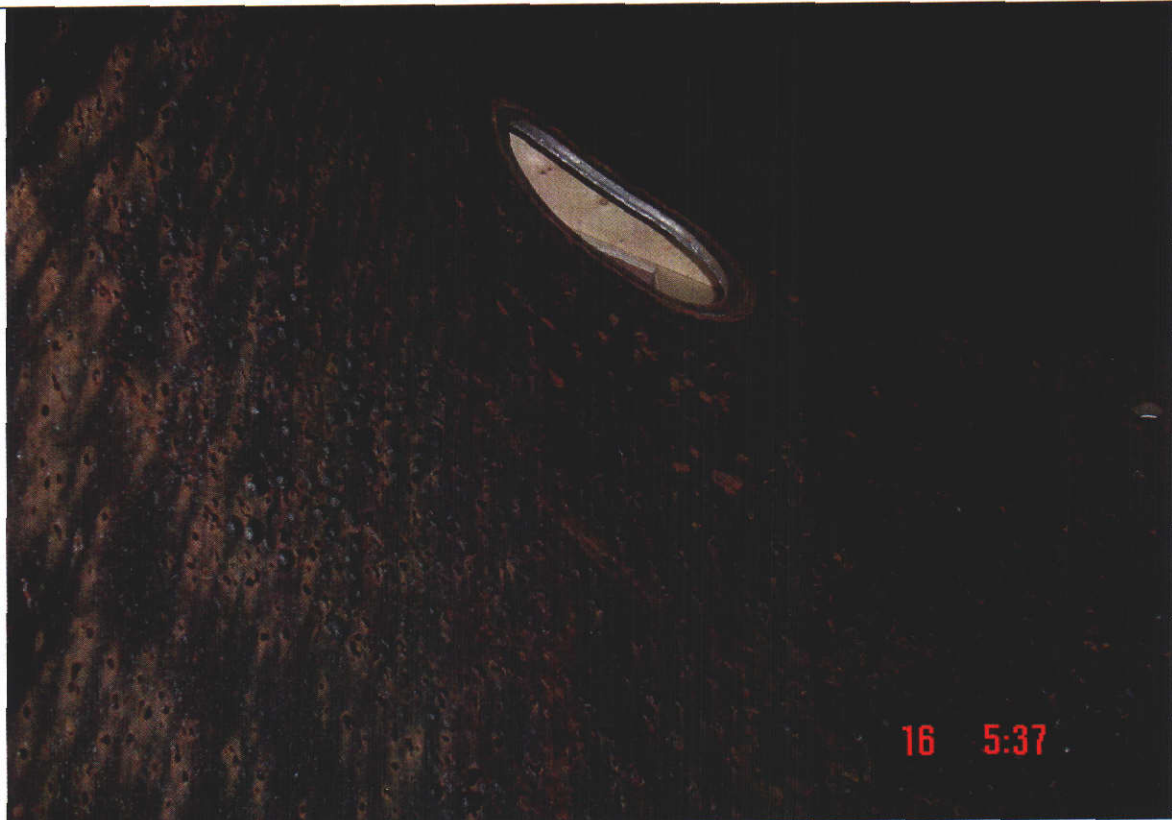
9. Surface corrosion of surge tank tee at access hatch.

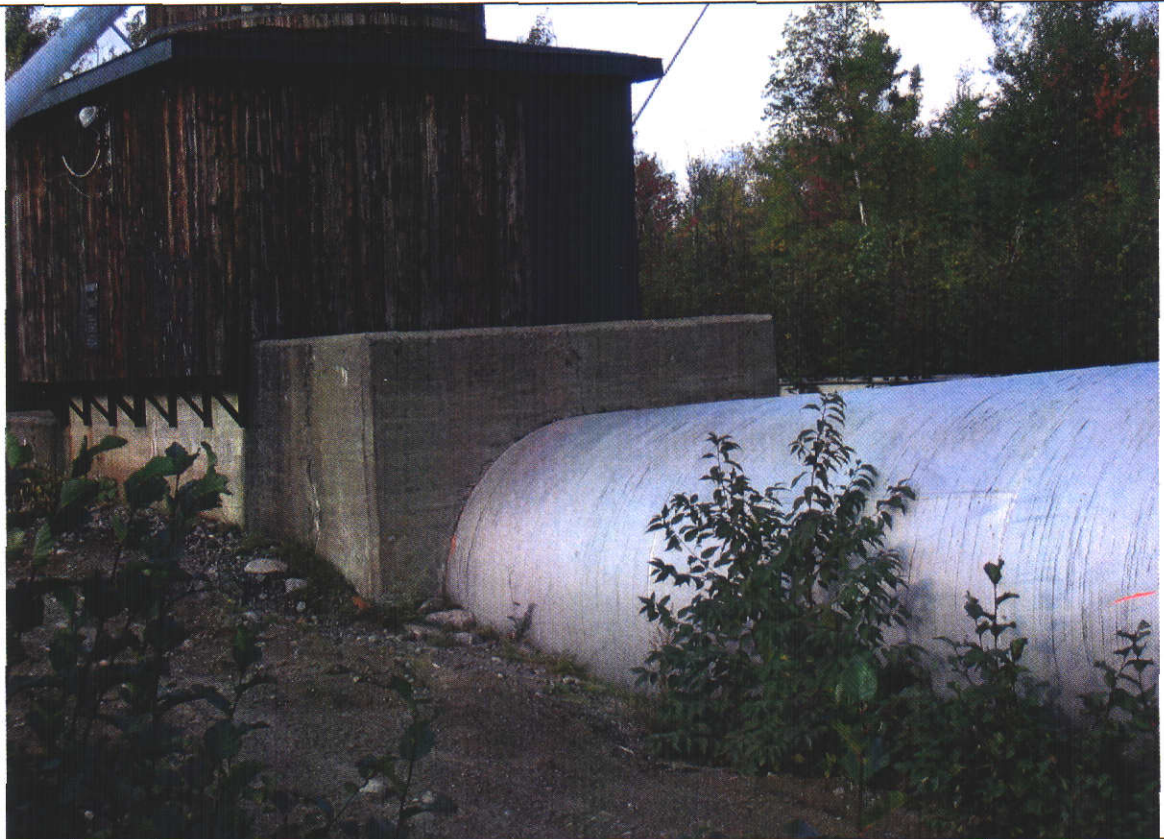
13. Surge tank anchor block with shrinkage crack.

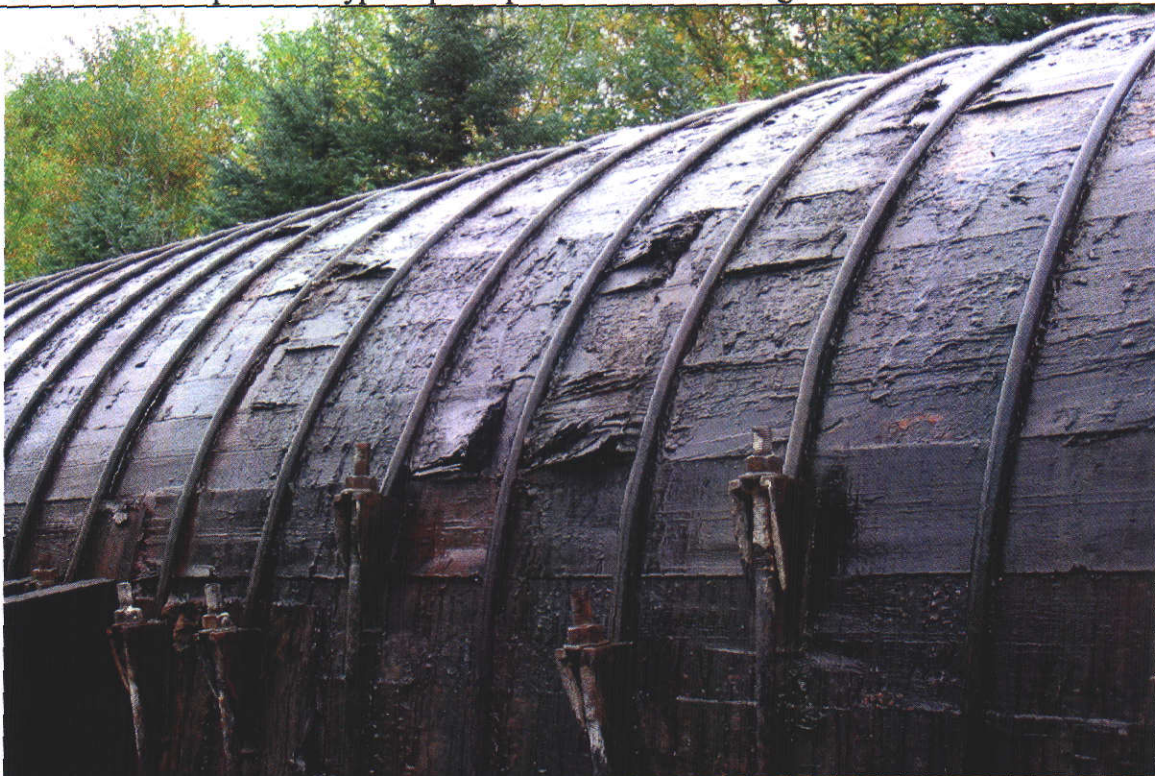
16. Wood stave penstock surface condition.

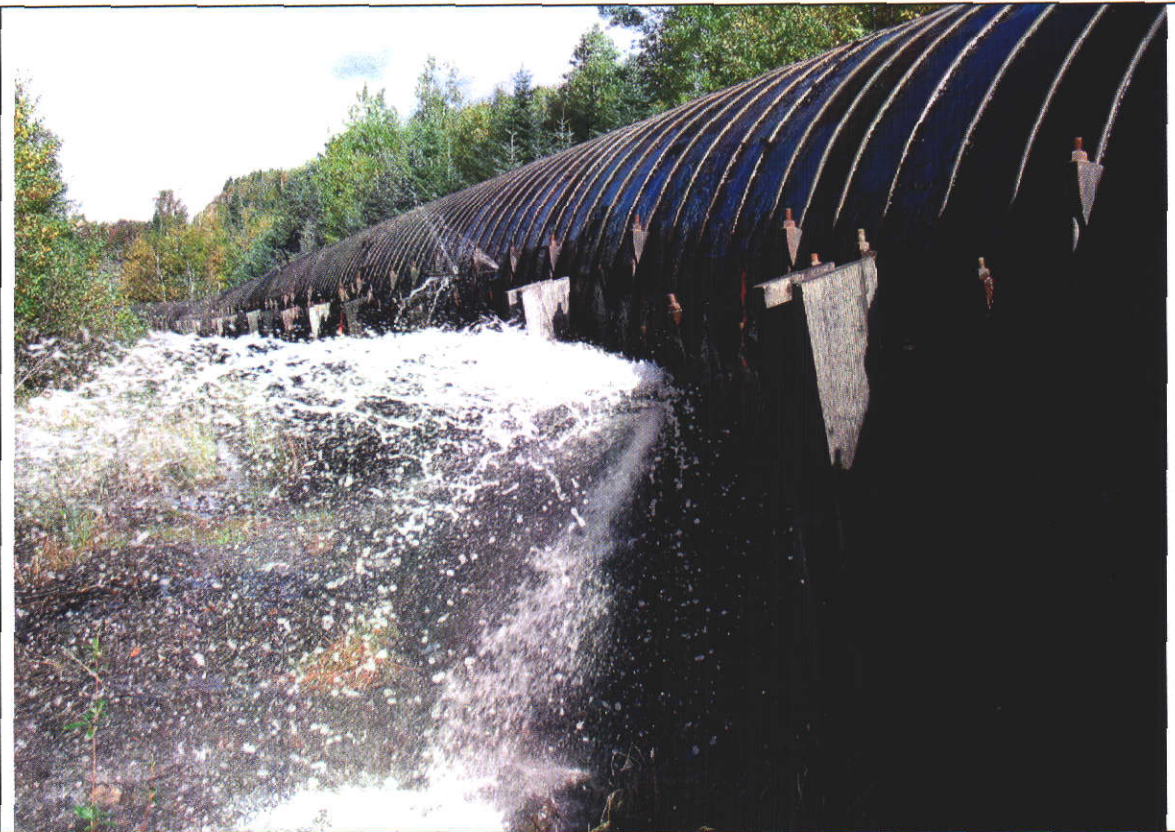
17. Wood stave penstock leakage.

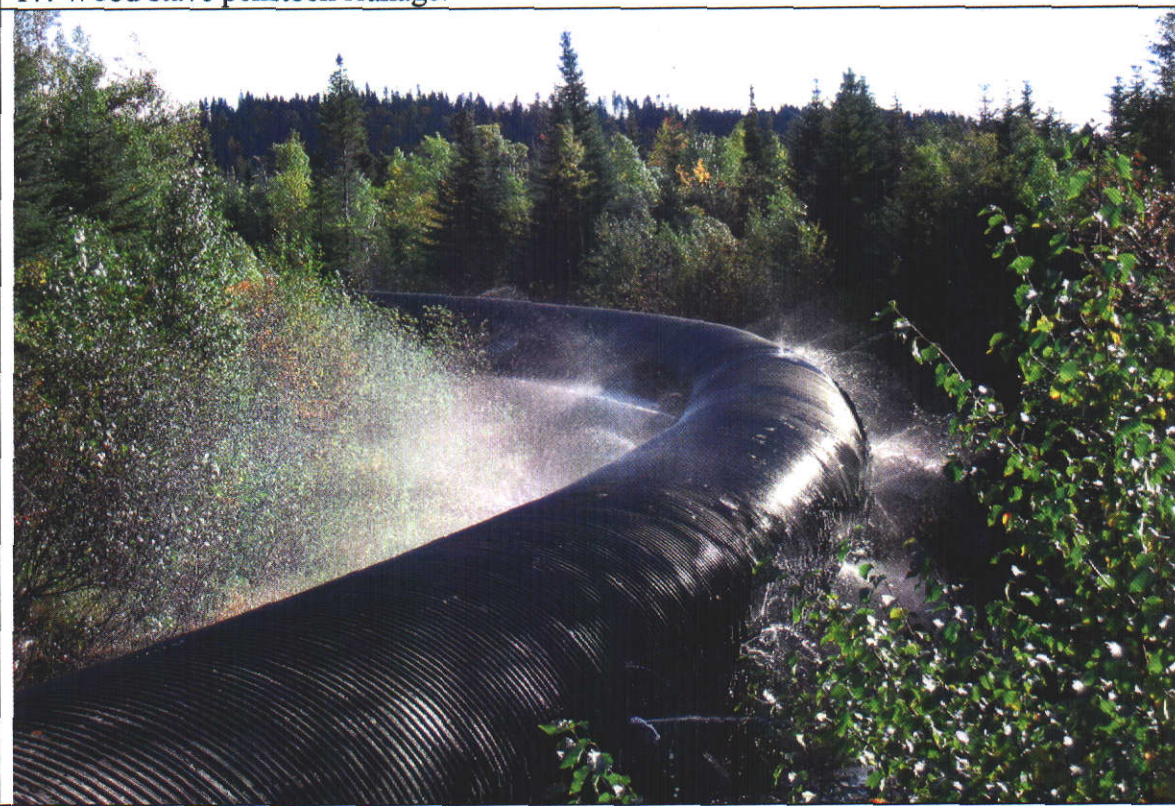
18. Wood stave penstock leakage.

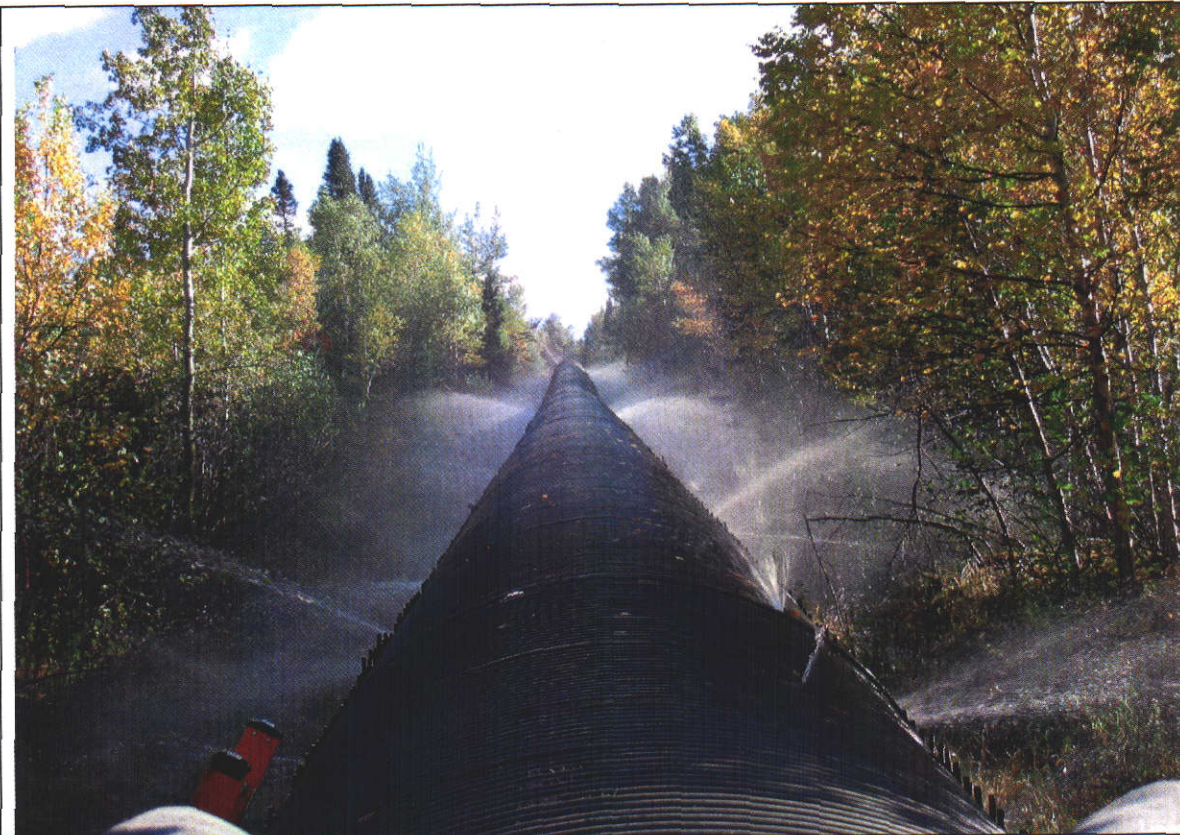
19. Wood stave penstock leakage.

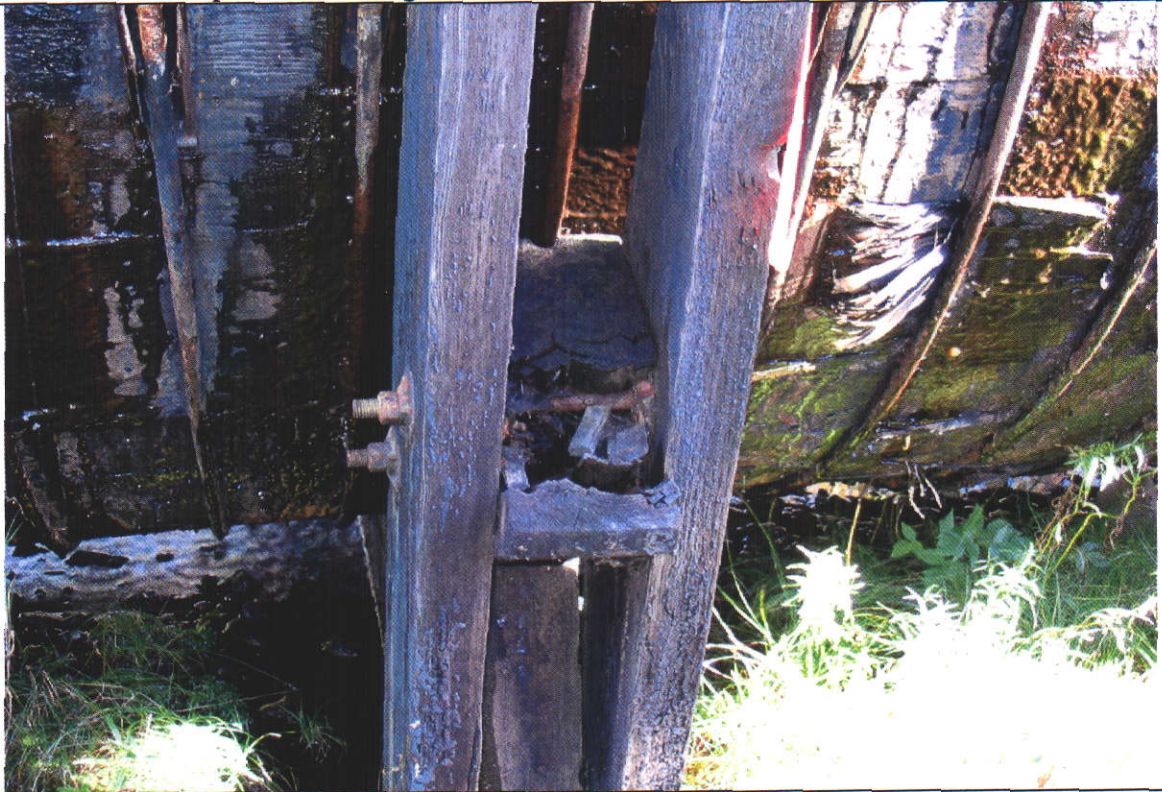
20. Wood stave penstock saddle deterioration.

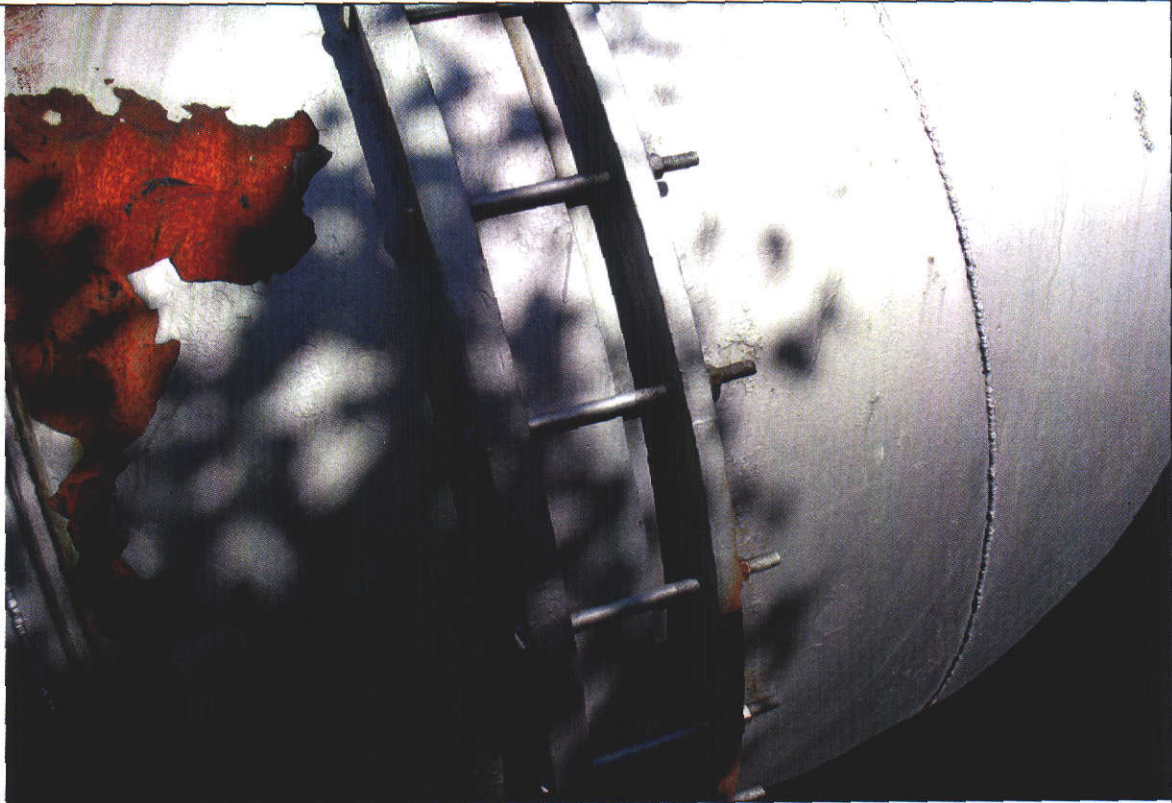
21. Expansion joint #1 paint failure.

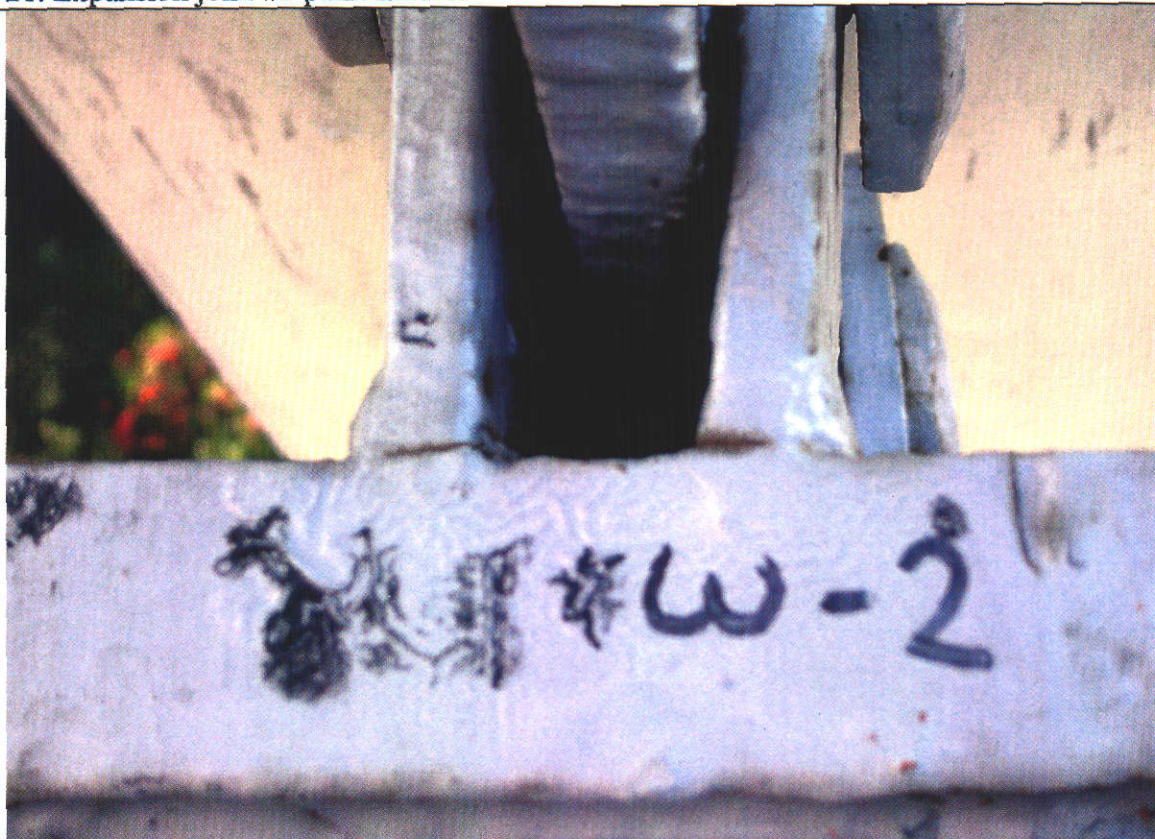
22. Horizontal brace north face at leg #3. Cracks in welds.

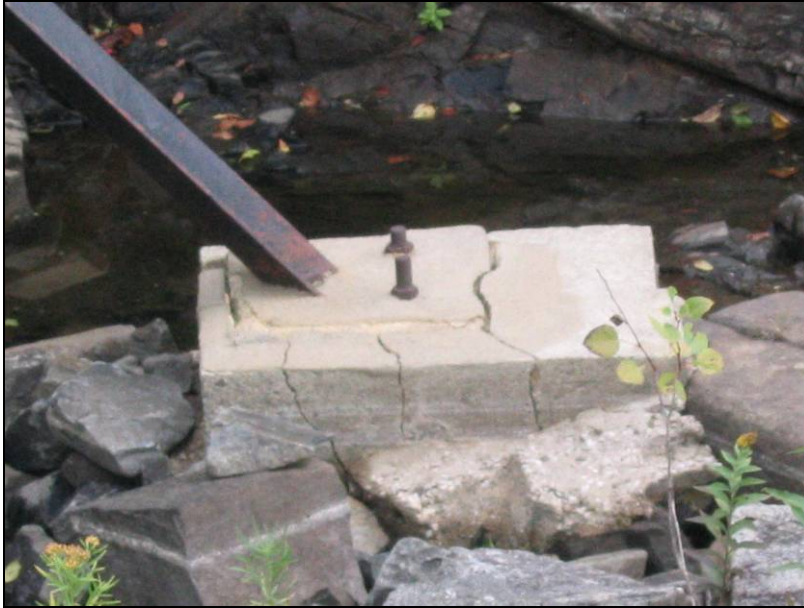
**Figure 3: Fractured Brace Foundation**

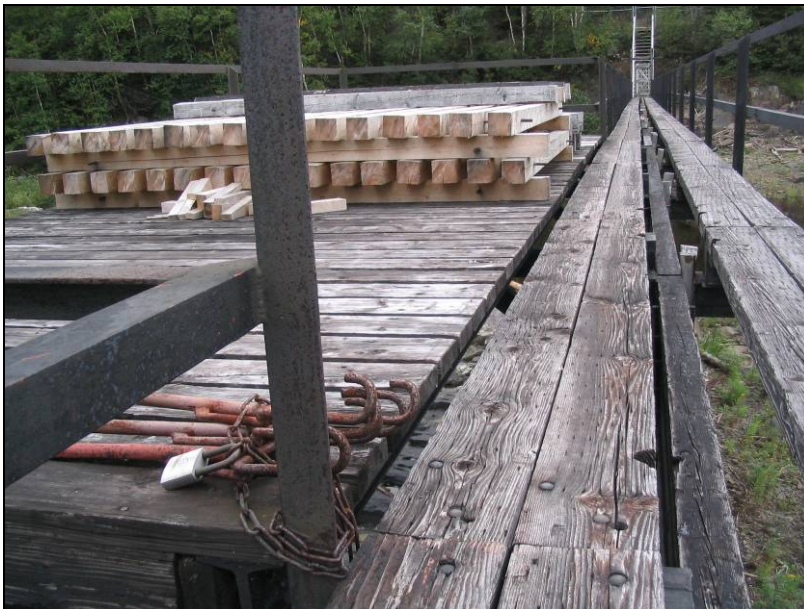
**Figure 4: Deteriorated Walkway Timbers  
& Operation Staff's "Removal" System**

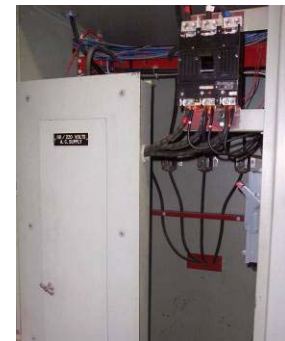
**Figure 1 - AC Distribution**

The existing 120/240V 3-phase AC service panel (figure 1) is located in a cell in the existing switchgear line up. This equipment is original to the plant and replacement breakers are no longer available. With additional loading from the proposed plant upgrading and the addition of new heating and ventilating equipment, this panel will no longer have sufficient capacity. It is preferred to locate the AC panel away from the switchgear line-up to provide ease of access for wiring future circuits.

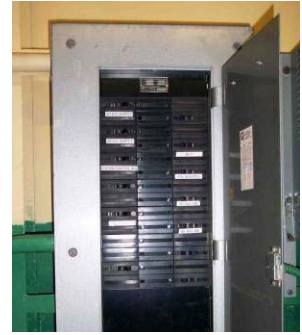
**Figure 2 - DC Distribution**

The DC distribution panel (figure 2) is original to the plant and has no spare breaker positions for additional circuits. Additional breaker positions will be required to accommodate the various electronic components to be included in the governor and unit control panels. Additional DC circuits are also required for the motor actuators associated with the new valves to be installed as part of the plant mechanical upgrade. Due to its age, and lack of spare capacity it is recommended that the DC distribution panel be replaced.

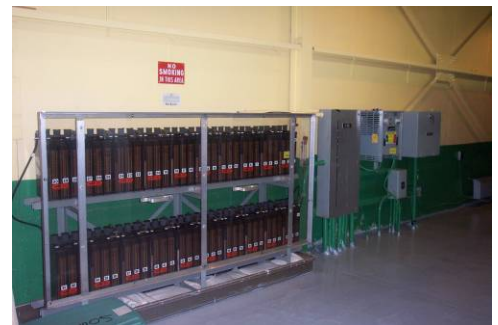
**Figure 3 - Battery Bank**

The battery bank (figure 3) was installed in 1996 and is in good condition. The battery charger is 21 years old and the supply of spare parts has been exhausted. During the inspection its condition was assessed and the charger requires replacement. The battery bank and the charger are located in the same room as the switchgear instead of in a separate battery room. The plant refurbishment will include the construction of a separate battery room to house the battery bank.

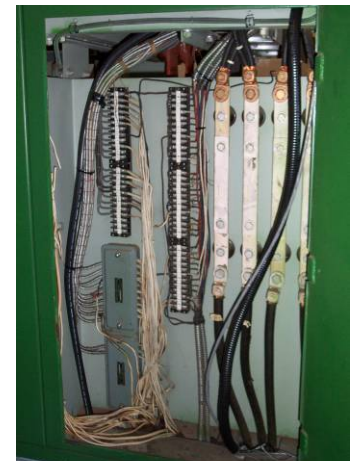
**Figure 4 – Termination Cabinet**

Generator No. 2 and Generator No. 1 were rewound in 2002 and 2004 respectively. No additional work is required on the generator windings. The temperature signals from the resistance temperature devices installed in the stator windings during the rewinds will be monitored by the new control system. The existing terminal blocks in the generation terminal cabinet will be replaced with resistance temperature device terminal blocks.

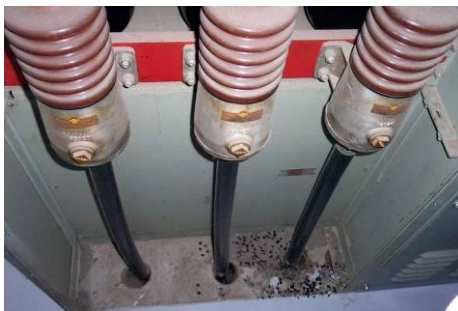
Figure 7 - Unit No. 1 Switchgear  
Cable Terminations

The power cables from the generator termination cabinets to the switchgear are the original 1000 MCM paper insulated lead covered (PILC) cables with pitch filled pothead terminations. PILC cables typically have a long life expectancy. However, these cables are susceptible to stress fractures if the insulation is subjected to movement following years of resting in a fixed position. It will not be possible to relocate these cables to new switchgear cubicles without severely damaging the insulation. Therefore the power cables and terminations will need to be replaced as a result of the planned switchgear replacement.

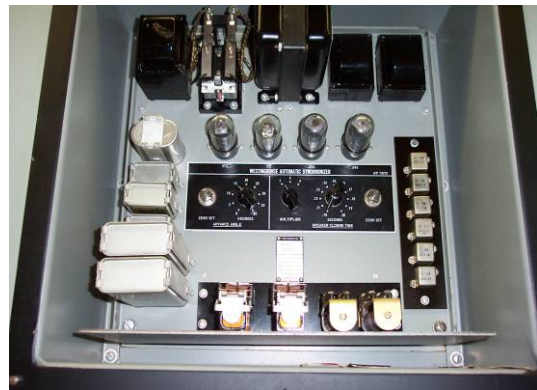
**Figure 9 - Existing Synchronizer**

The synchronizer (figure 9) is original to the plant and is based on vacuum tube technology making parts difficult to obtain. It will be replaced with modern digital synchronizers as part of the upgraded unit control panel.
