**Newfoundland Power Inc.  
2007 Capital Budget Application  
Filing Contents**

## Rattling Brook Hydro Plant Refurbishment

Prepared by:  
Gary L. Murray, P.Eng.

March 2006

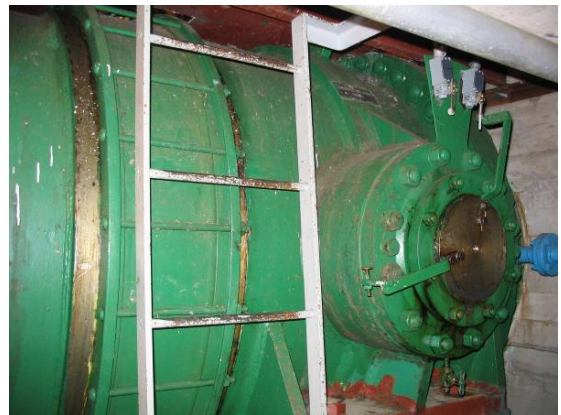
**Figure 1- Main Valve**

The existing main inlet valves have experienced leaks and related problems. Attempts were made to mitigate these issues however none resulted in long term success. The valves currently leak and make it unsafe to access the scroll case without having to dewater the penstock.

During the site visit, a series of pressure and load rejection tests were carried out. These tests were conducted to determine the pressure differential across the butterfly valves. The maximum pressure loss across each valve was measured to be approximately 3 psi. This pressure loss is approximately three times that which would be typical of a modern butterfly valve. Assuming an annual plant production of 76 GWh after plant refurbishment and a cost of energy of \$0.07/kwh, the replacement costs were justifiable.

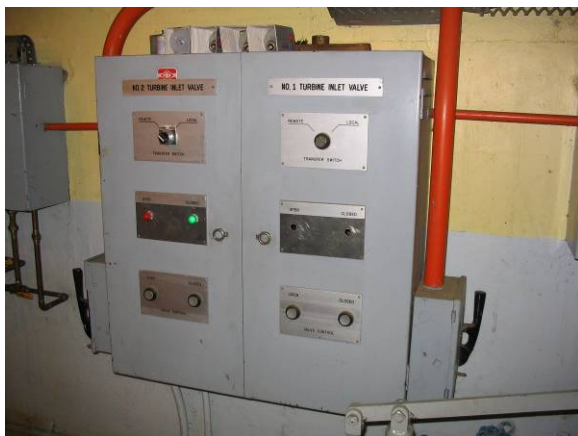
Figure 5 - Valve Control Panel (exterior)

The control panel for the valves has been modified since its initial installation however the controls for both units are obsolete. The controls for unit no. 2 have only the “main valve closed” indicator light currently operational. The controls for unit no. 1 are original equipment and no indicator lights are working. This control panel will be replaced.

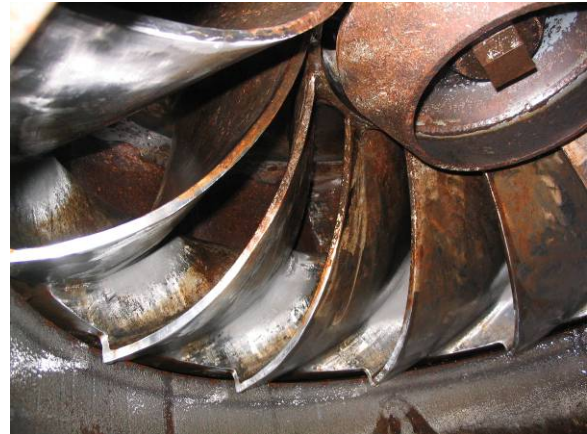
**Figure 8 – Turbine Blades Unit No. 1**

All but two wicket gates are in good condition. These two gates are located near the 2<sup>nd</sup> and 3<sup>rd</sup> stay vanes, counting from the area near the scroll case access hatch. These gates will be repaired as a temporary measure until the unit is overhauled in about 2012.

Heal-to-toe clearance between the gates is currently less than 0.002", on the five gates that were measured. There is less than 0.0015" between the top surfaces of the gates and the upper facing plate and approximately 0.015" to 0.018" between the bottom surfaces of the gates and the lower facing plate. Overall, clearances are approximately equal on all gates and there is minimal leakage through the gates into the draft tube area. There has been no change in the wicket gate clearances since the 1998 inspection report.

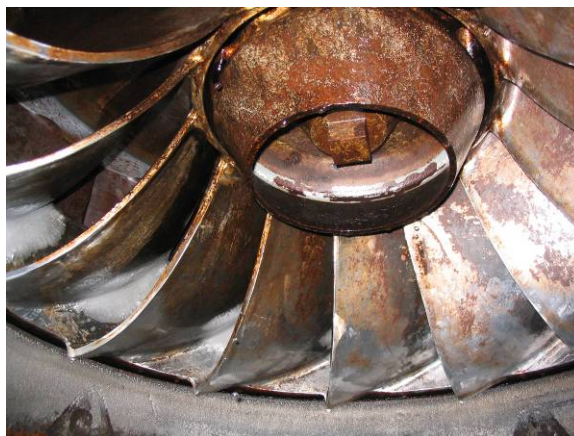
Figure 9 – Turbine Blades Unit 2

All wicket gates, but one, are in good condition. Like on unit no. 1, this gate is located near the 2<sup>nd</sup> and 3<sup>rd</sup> stay vanes, counting from the area near the scroll case access hatch. These gates will be repaired as a temporary measure until the unit is overhauled in 2013.

Heal-to-toe clearance between the gates is less than 0.002" on the five gates that were measured. There is less than 0.0015" between the top surfaces of the gates and the upper facing plate and approximately 0.015" to 0.020" between the bottom surfaces of the gates and the lower facing plate. Overall, clearances are approximately equal on all gates and there is very little leakage through the gates into the draft tube area. There has been no change in the wicket gate clearances since the 1998 report.

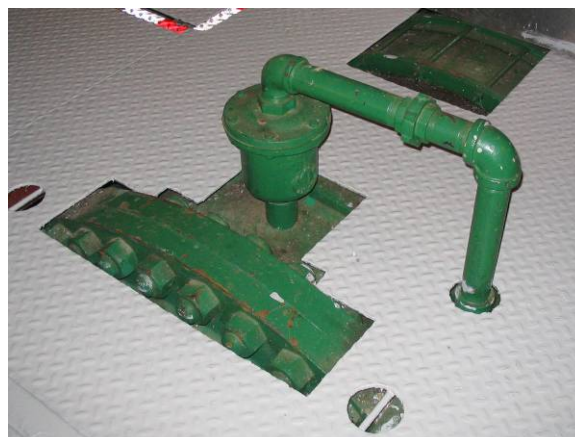
Figure 10 – Scroll Case Air Vent

The scroll case air vent valve on this unit is original equipment (figure 10). Given the age and condition of this equipment, and the fact that identical equipment on unit no. 1 of the same vintage has already required replacement, this valve will be replaced.

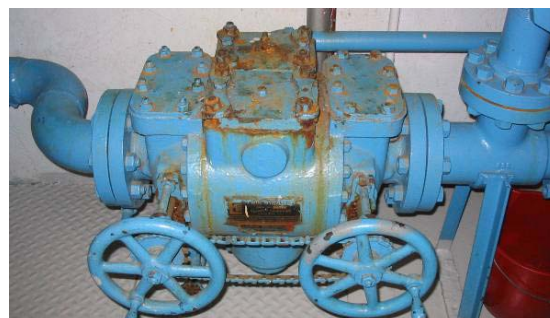
**Figure 14 – Twin Strainer**

The existing twin strainer (figure 14) is original 1958 vintage equipment and has caused problems in recent years. It supplies both bearing cooling water systems as well as other water systems that are no longer in use.

To clean the existing strainer, as is periodically required, both hydro units must be shut down. This strainer will be replaced.

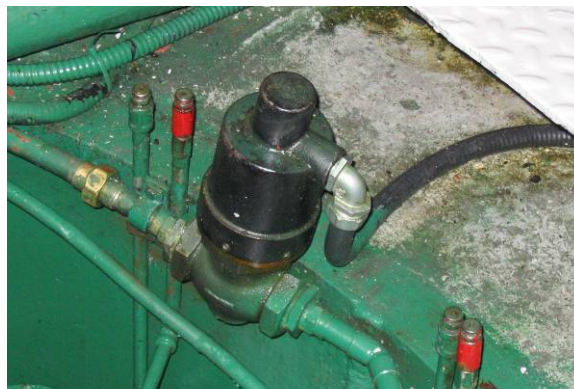
**Figure 15 – Solenoid Valve**

There are solenoid valves (figure 15) and flow meters on the cooling water lines for each bearing and oil level switches on each bearing oil reservoir. This system is designed to control the flow of cooling water when the generator is operating. In addition it monitors the oil level in the bearing oil reservoir. By closely monitoring water flow and oil levels, the system can detect if water is leaking into the bearing reservoir and can stop the flow of water, preventing the release of oil into the environment.

The solenoid valves were installed on unit no. 1 in 2000 and at that time some of the original bearing cooling water piping was replaced with new copper piping. Similar work was carried out on unit no. 2 at the same time. Experience has shown that the service life of this particular make and model of solenoid valve is limited and therefore all the cooling water solenoid valves will be replaced with more robust equipment.

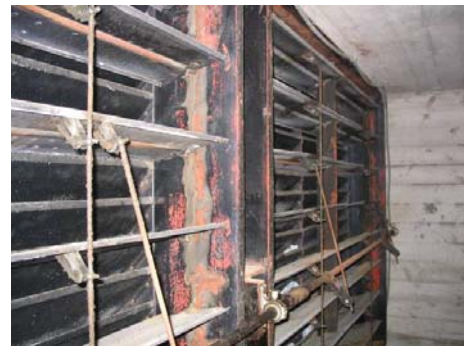
Figure 18– Air Inlet Dampers

The six air inlet dampers (figure 18) each have 9 inch horizontal, parallel blades in a 6 inch deep frame. The inside of each frame opening measures approximately 80½ inches long by 66 inches high. These dampers are badly corroded and require replacement.

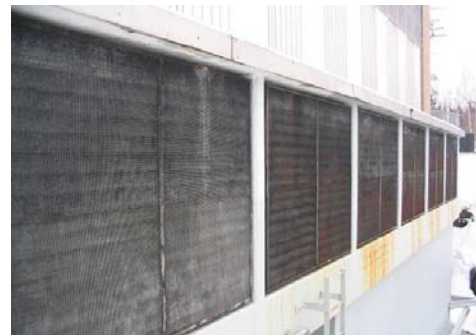
Figure 19 – Exterior Louvers

The six fixed louvers (figure 19) are located immediately outside air inlet dampers within the same building openings. As such, the overall dimensions of each louver match that of the air inlet dampers. Each louver has 9 inch horizontal, parallel blades in a 6 inch deep frame. The louvers also have an exterior bird screen with ¼ inch openings. This equipment is badly corroded and requires replacement.
