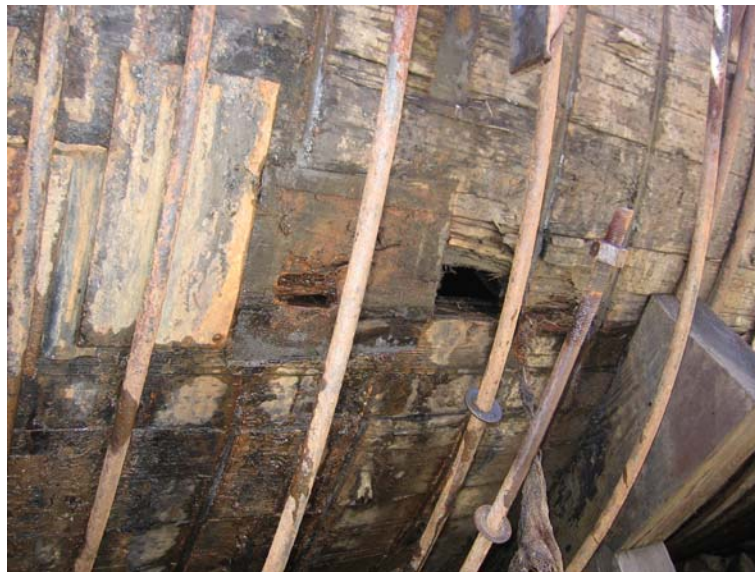
18 For example, the area depicted in Figure 1 shows a hole that caused a major leak in the
19 penstock in April 2006. The hole developed in an area of the penstock that was covered
20 by numerous steel plates. The hole developed immediately adjacent to one such steel
21 plate.

22
23
24 **Figure 1 – Major Leak Downstream of TCH Bridge**
