2
3 **Rattling Brook Hydro Plant Refurbishment (Clustered) - \$18,242,000**

4 **PUB 10.0 NP**

Maintenance Logs for Rattling Brook Plant
2003 to 2006

2005 Dam Safety Inspection Report

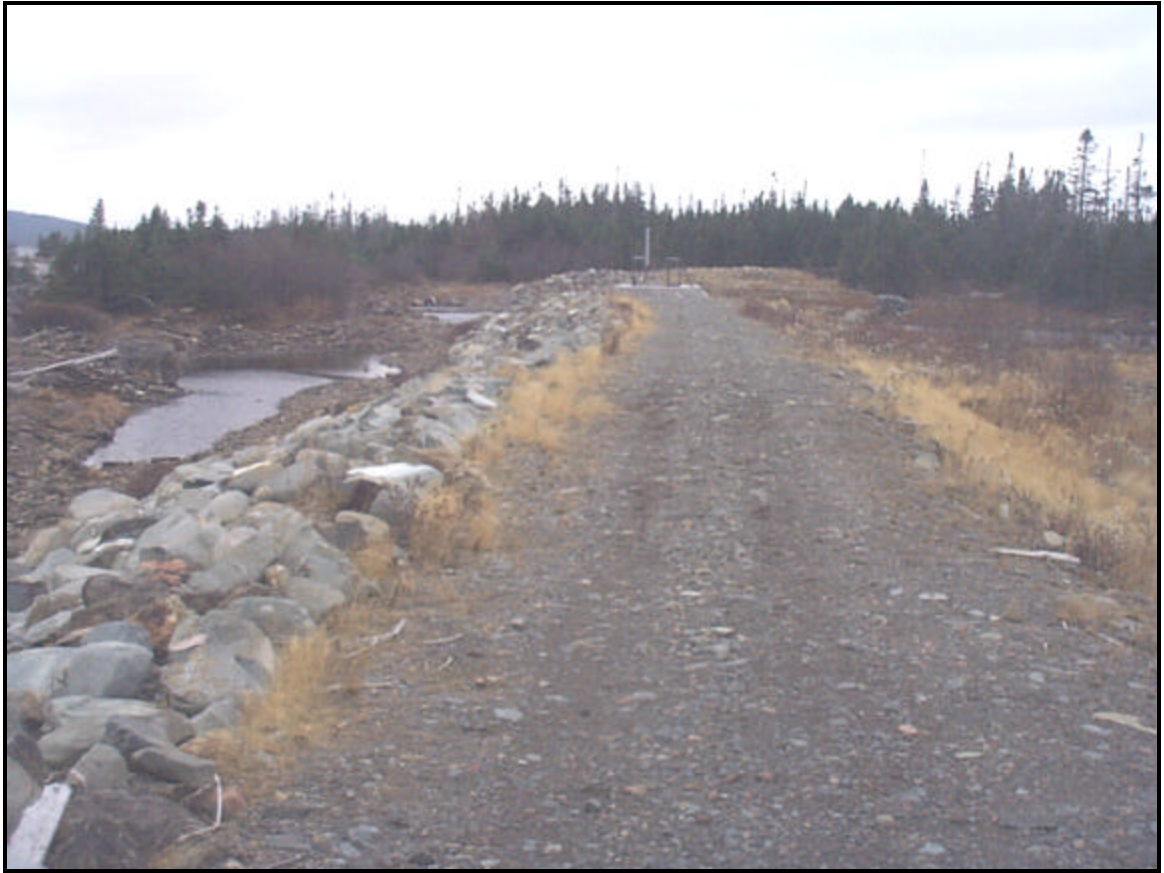
The embankment section of the dam is in good condition.

The outlet structure is deteriorated and in need of rehabilitation.

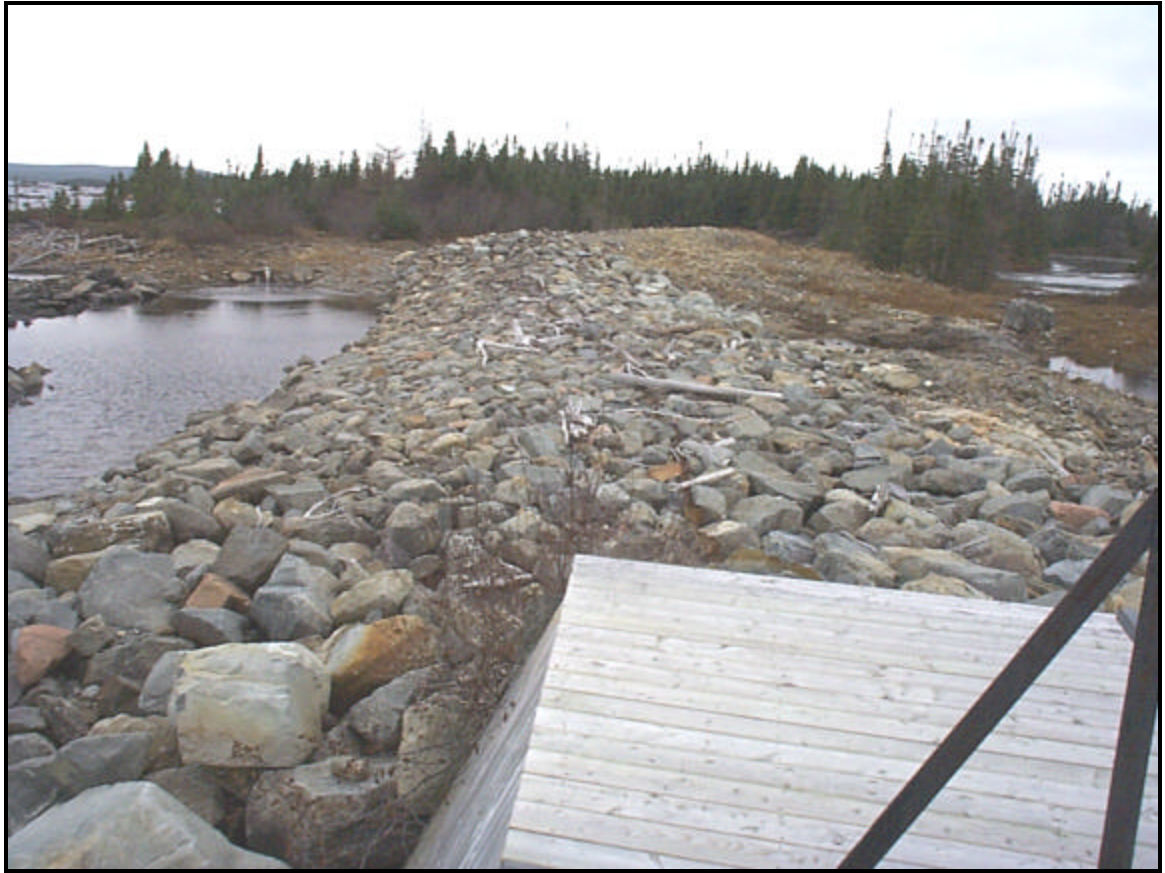
ROCKFILL OVERFLOW SPILLWAY

Overall good condition

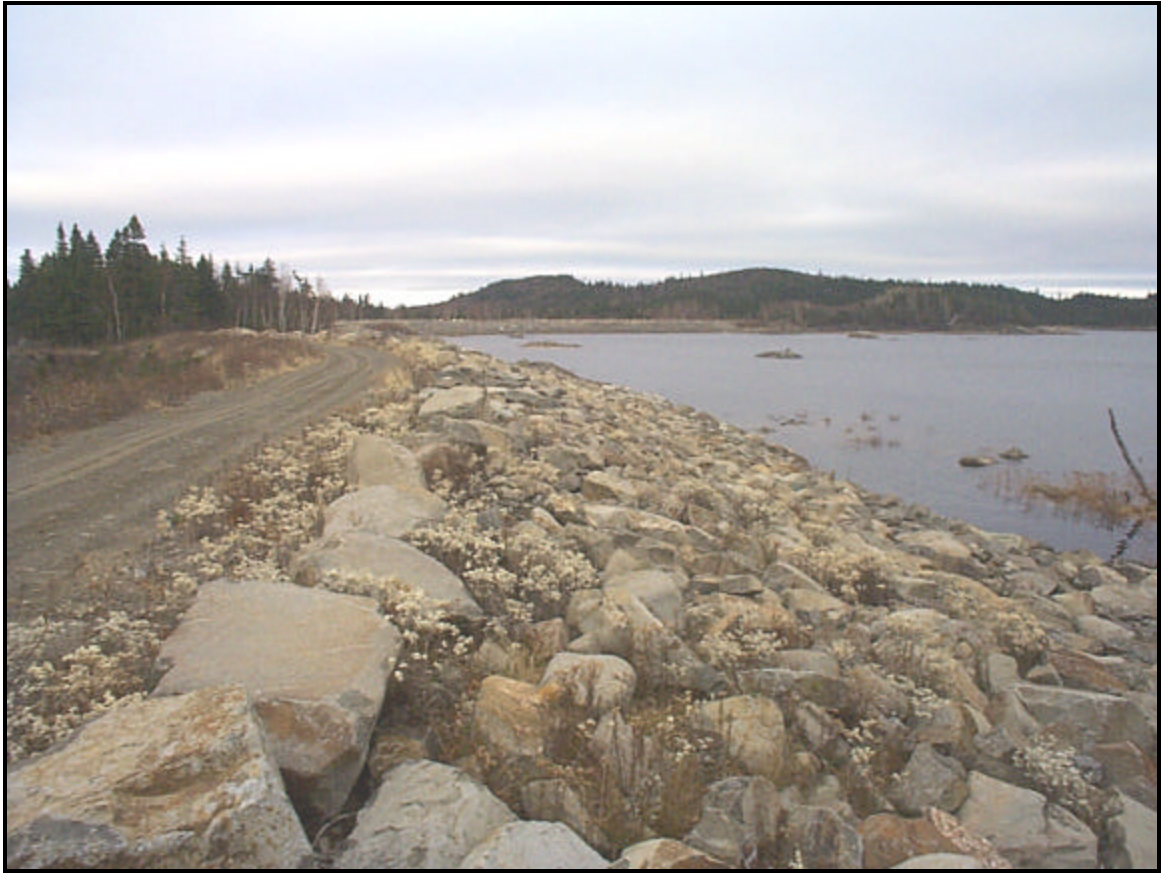
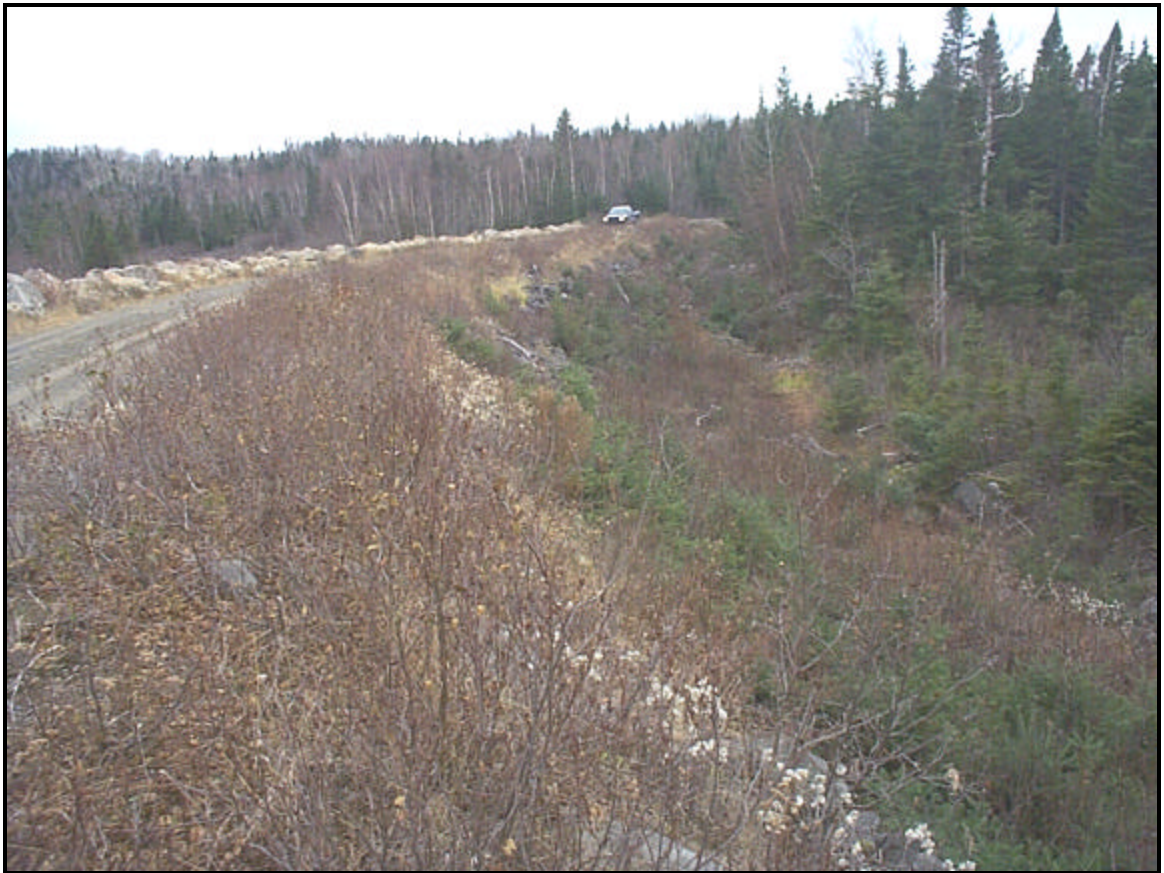
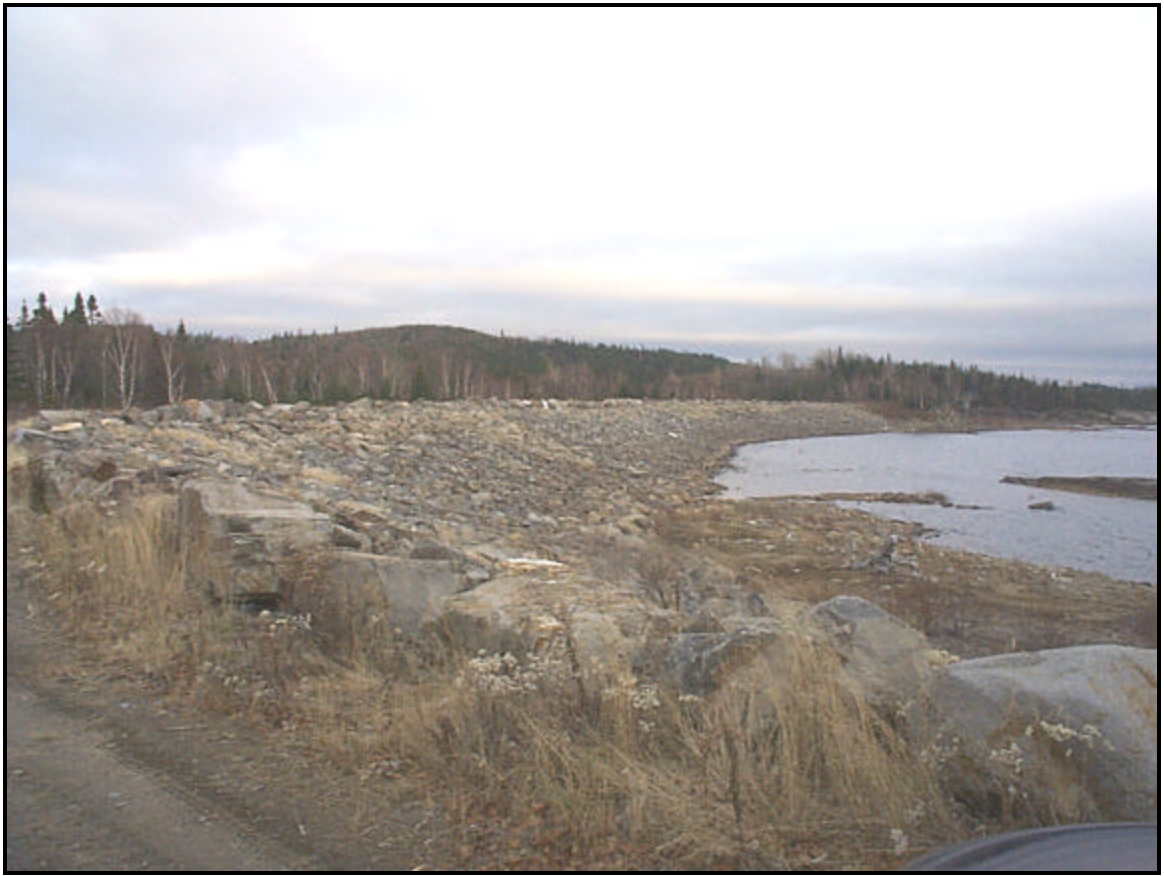
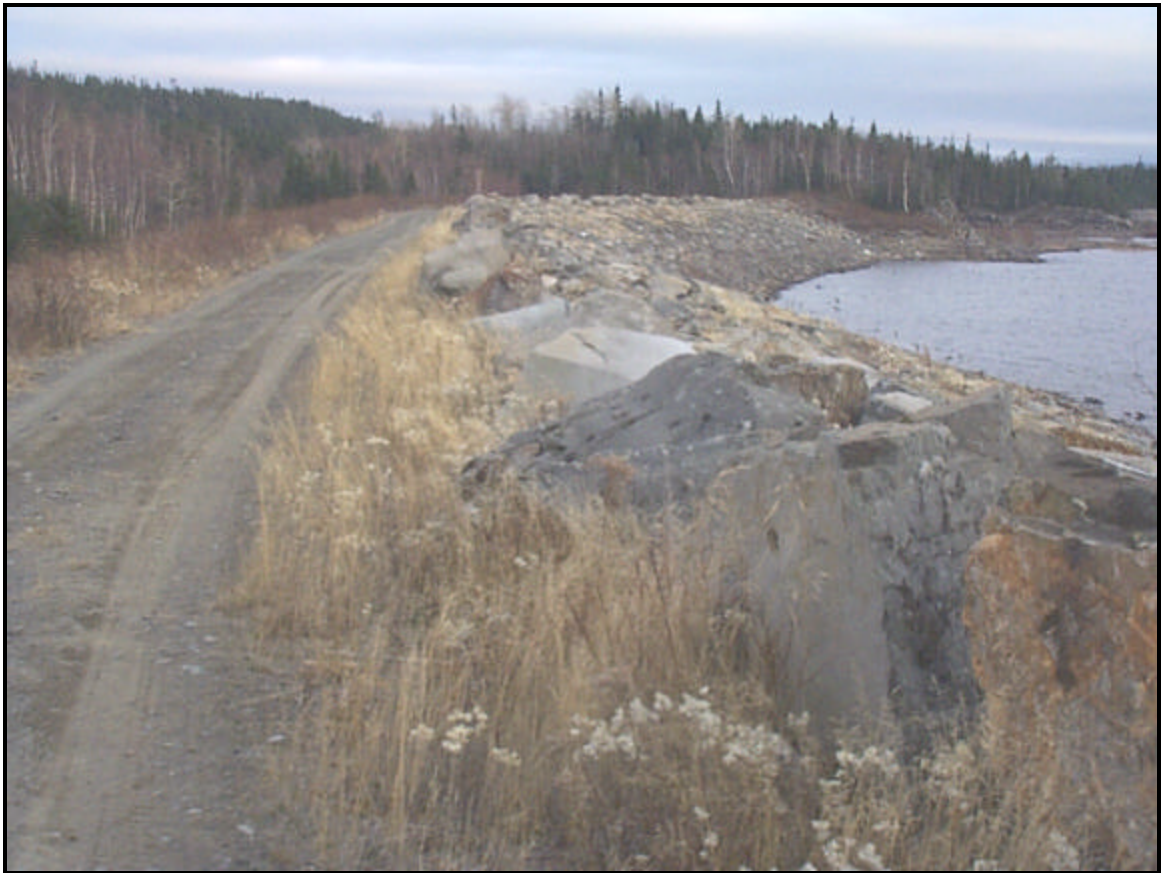
EMBANKMENT DAM

Overall good condition, with exception of vegetation maintenance required on d/s slope.

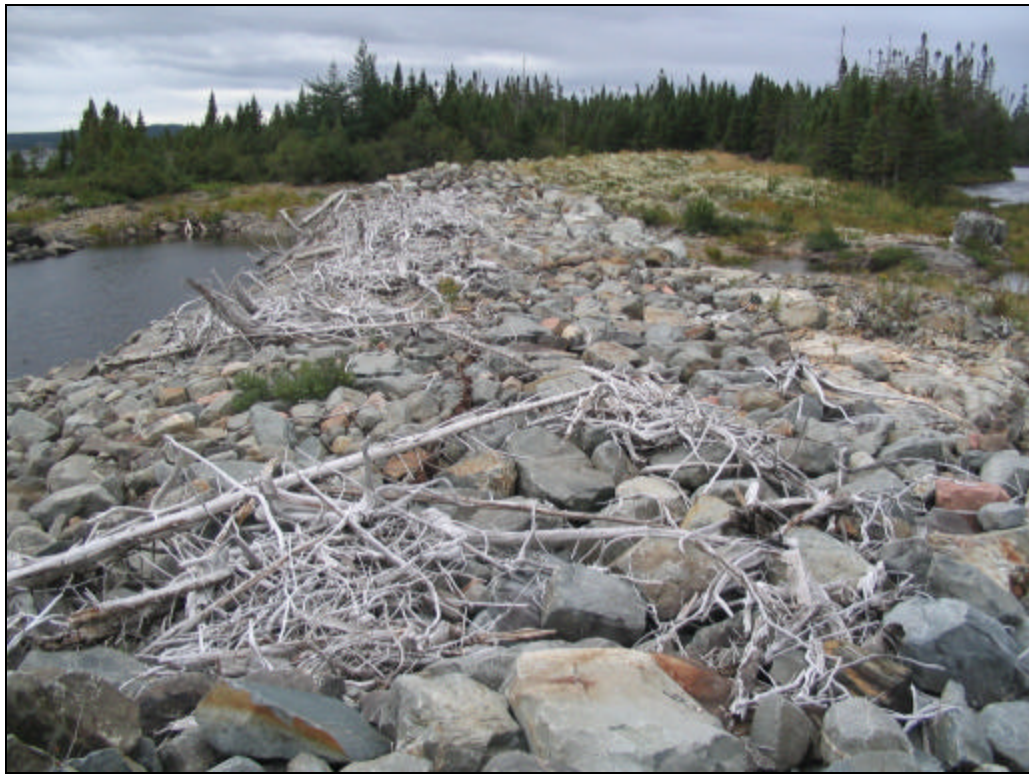
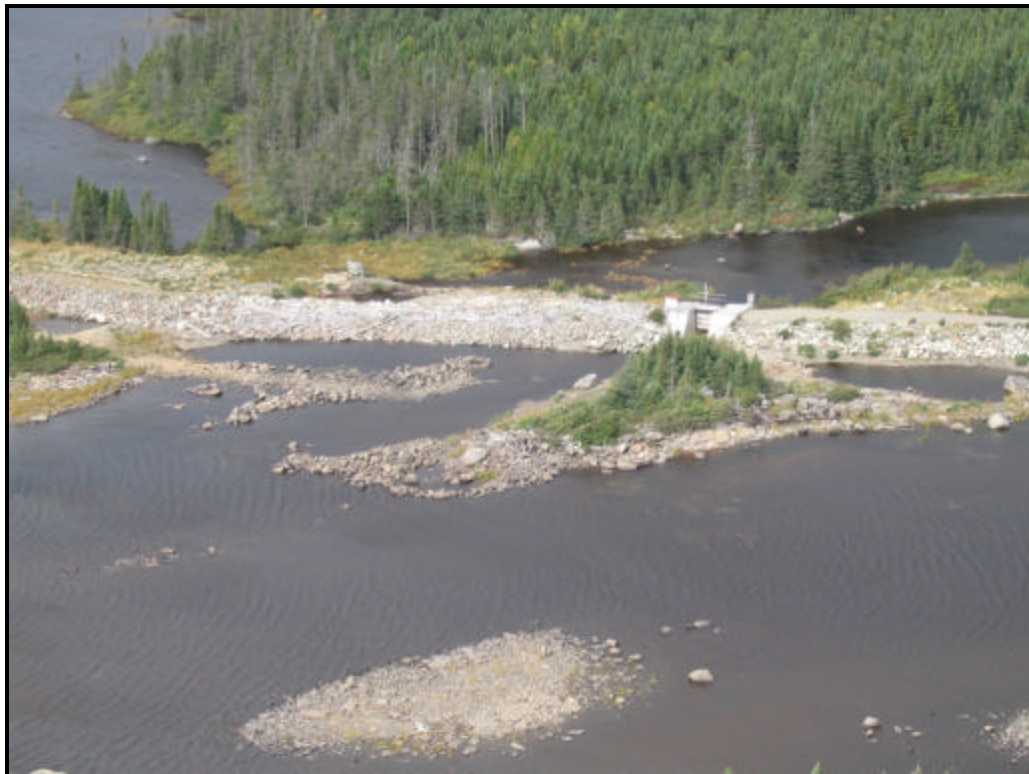
ROCKFILL OVERFLOW SPILLWAY

Overall good condition.

Driftwood should be cleared from spillway crest.

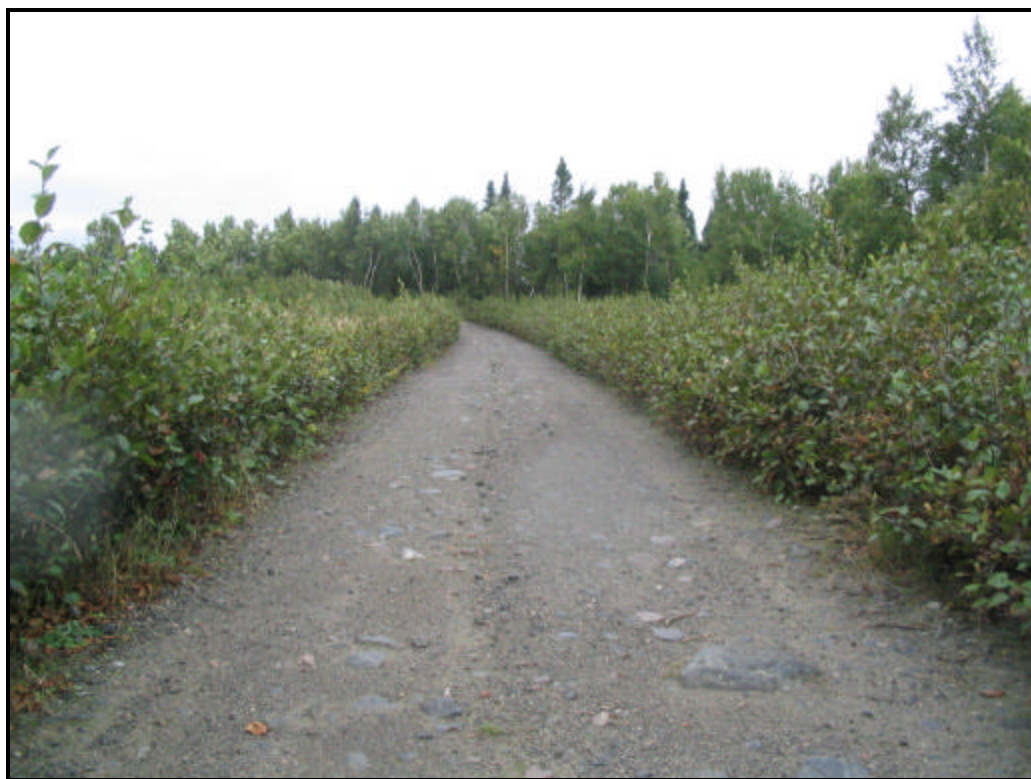
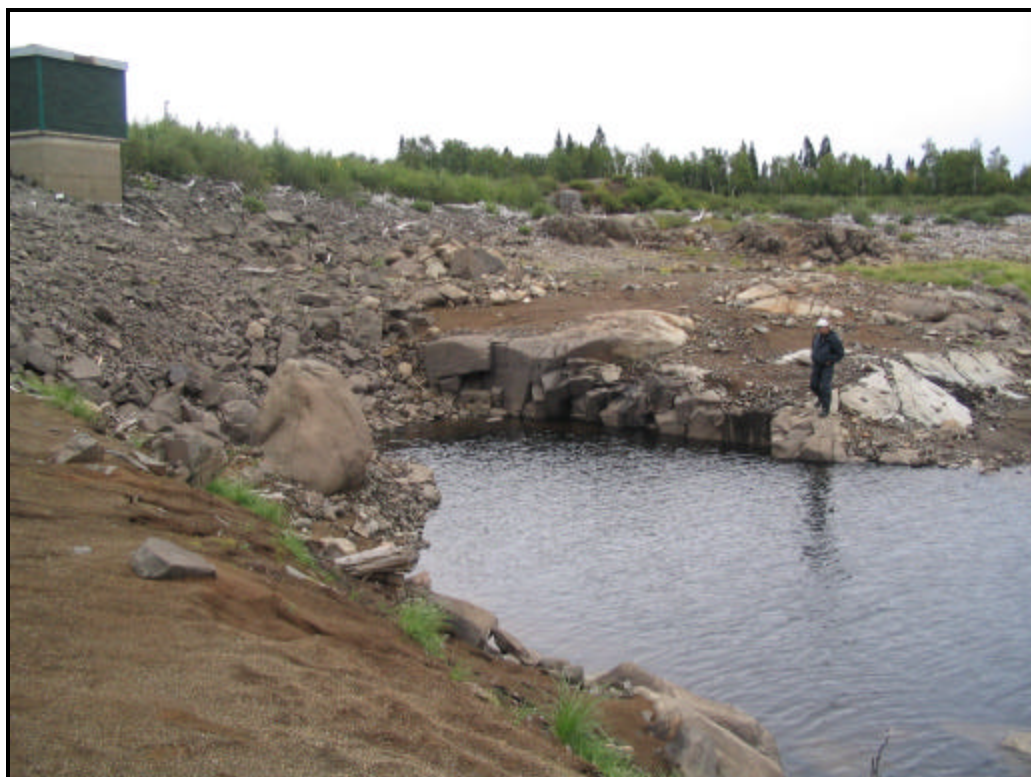
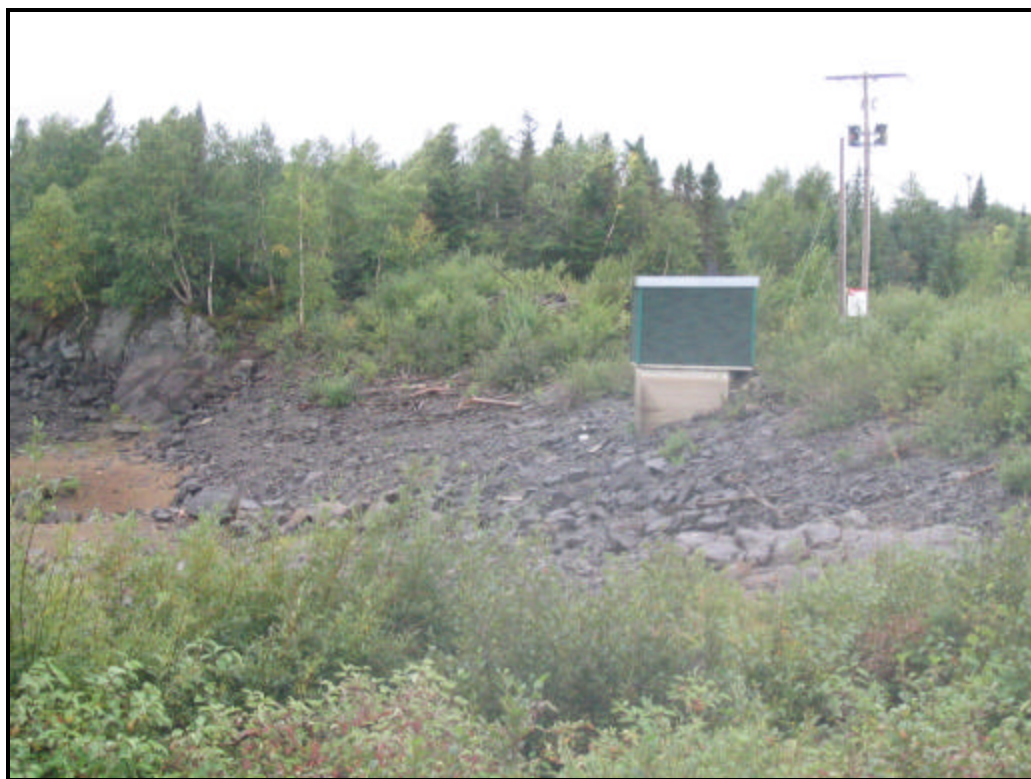
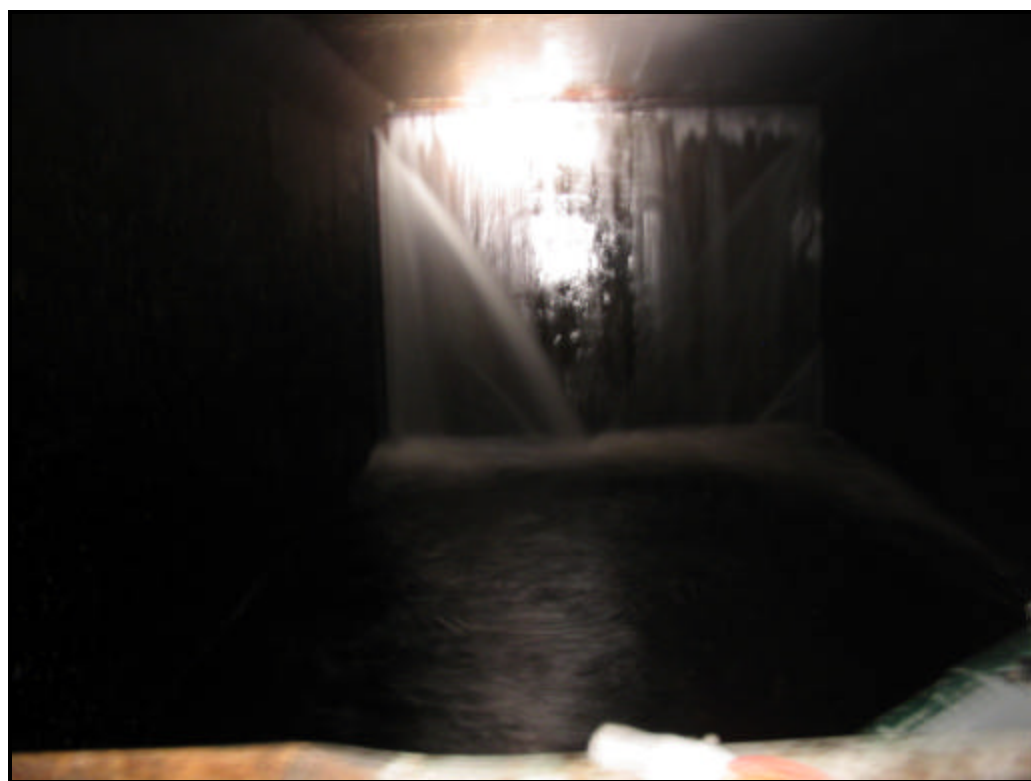
EMBANKMENT DAM

A detailed inspection of the d/s dam slope was not possible due to extreme amount of vegetation growth.

(Note: Vegetation clearing is scheduled to be completed at this site later in Fall/2005)

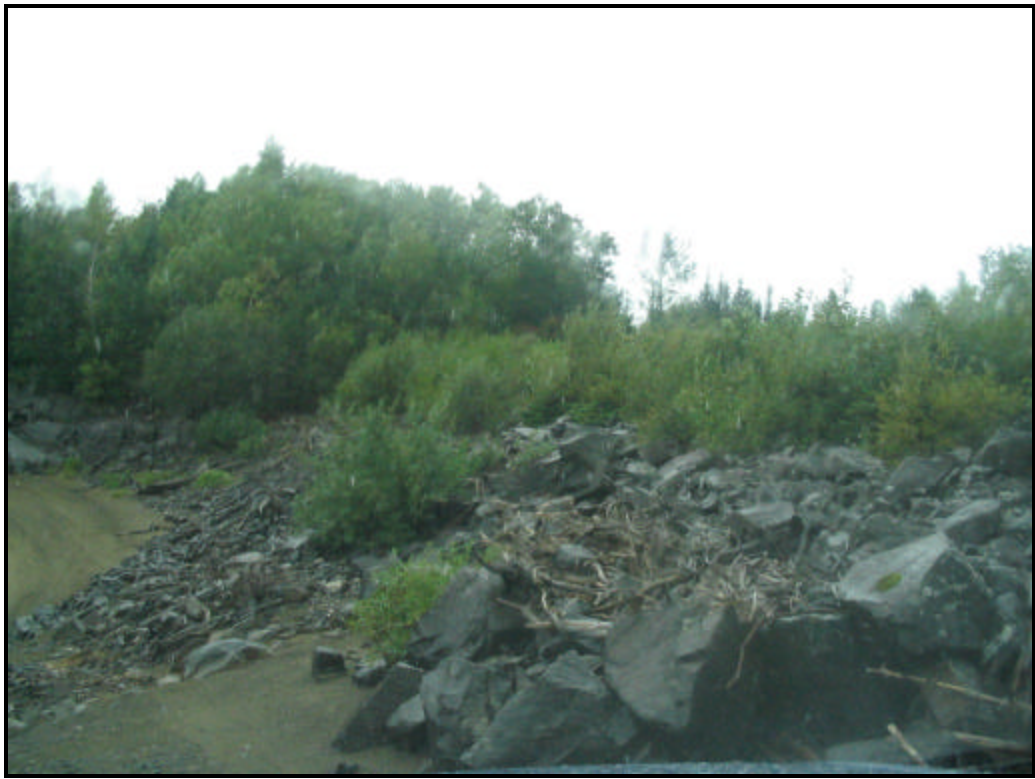
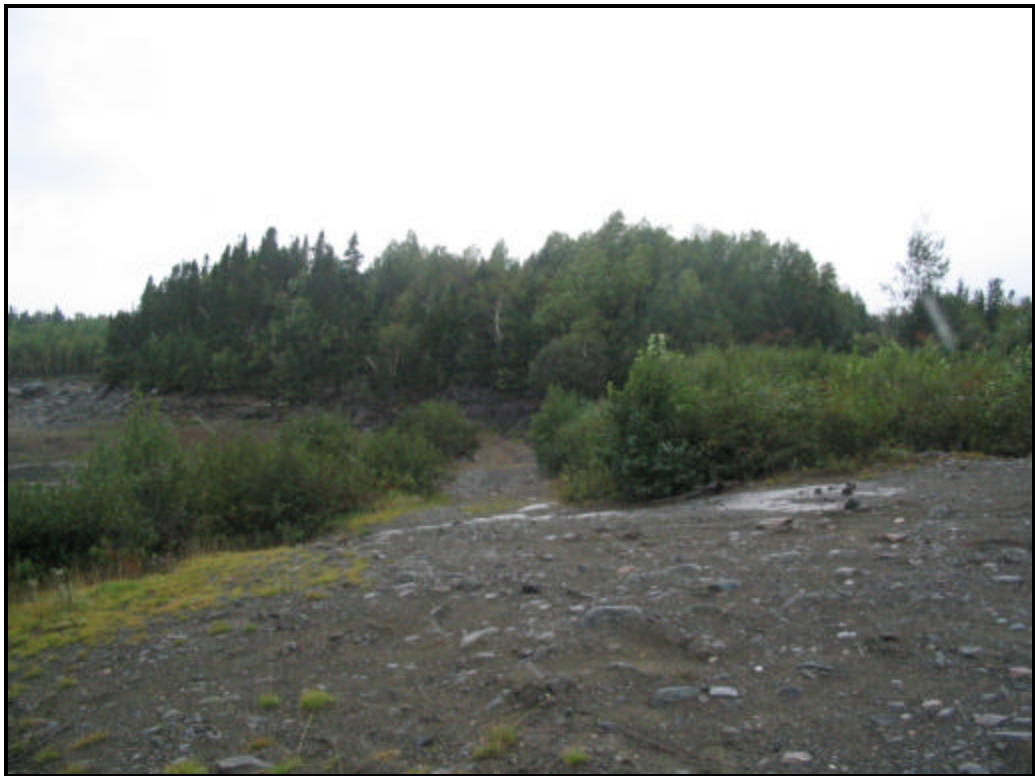
EMBANKMENT DAM

Vegetation growth prevents completing a thorough inspection.

(Note: Vegetation clearing is scheduled to be completed at this site later in Fall/2005)
