**Re: An Application by Newfoundland and Labrador Hydro (Hydro) pursuant to Subsection 41(3) of the Act for the approval of the replacement of a circuit breaker, insulators, synchronous condenser shaft seals and resistance rings, and level 2 condition assessments of the synchronous condensers, at the Wabush Terminal Station**

### **Voith 2015 SC1 and SC2 Annual Inspection Report and Recommendations**

## Synchronous Condenser Inspection Report and Recommendations

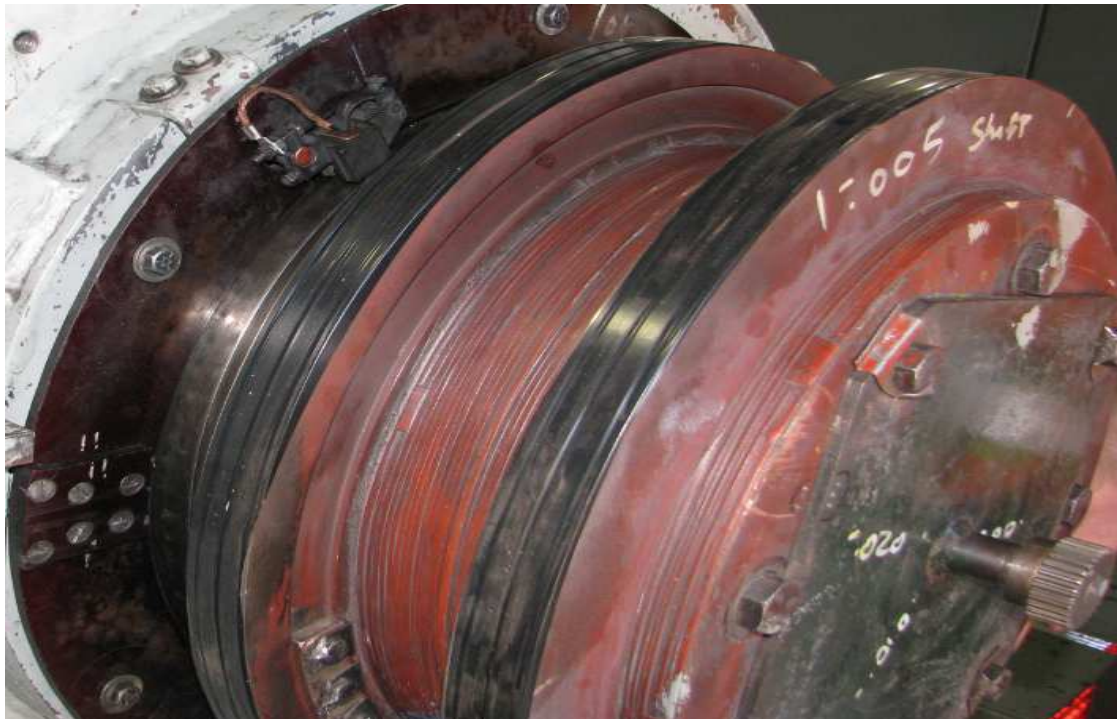
The collector rings are typically found to be in acceptable condition, with no excessive wear or out of round condition found. During this year's inspection of the SC1 collector ring, a cracked insulating washer for the connection bolt on the collector ring was replaced.

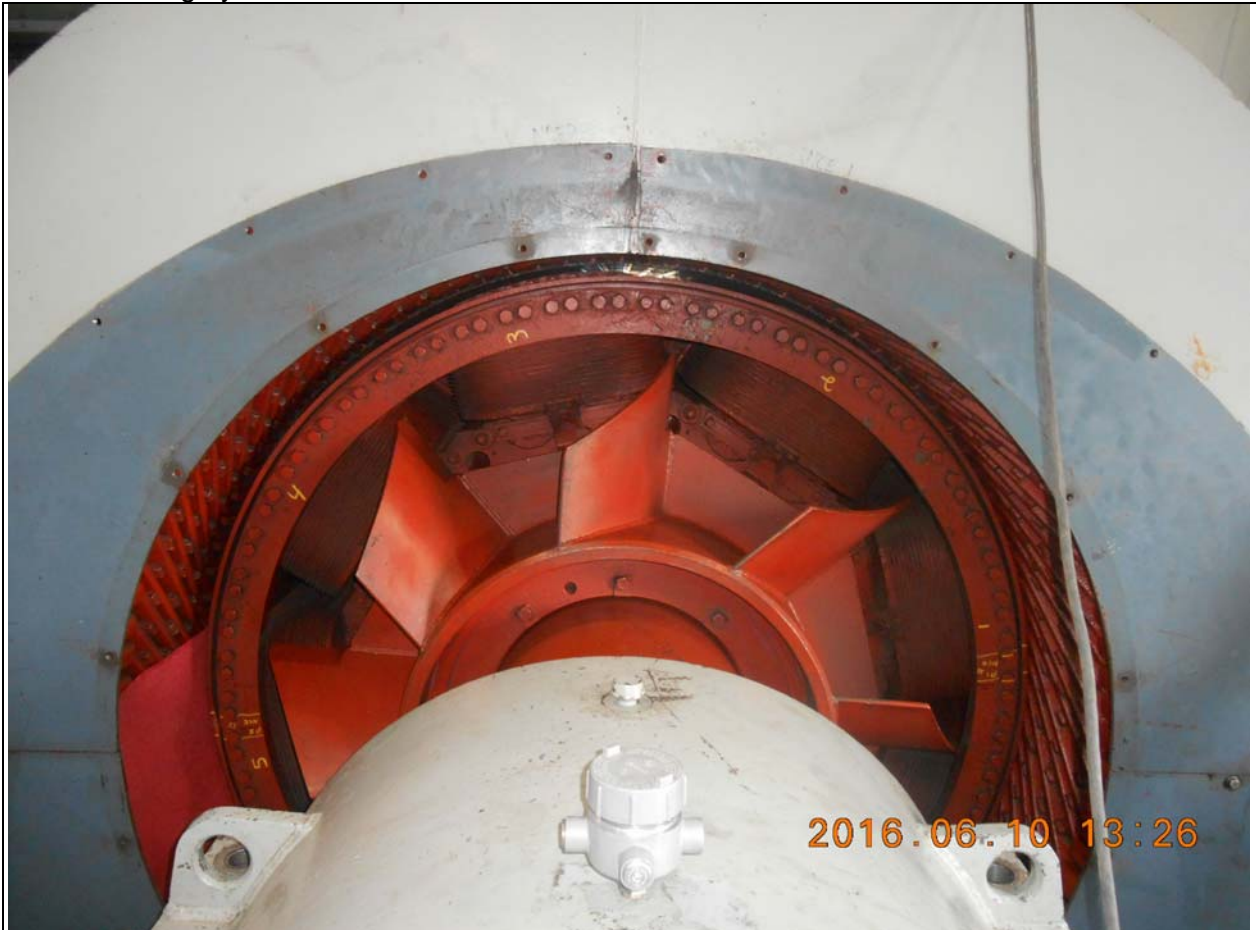
Unit SC1 is in serviceable condition, with no findings that would curtail its operation within normal parameters. Internally, the Stator winding end turns and Rotor poles are covered in a light film of oil and dirt. This does not affect unit performance significantly but does affect the insulation integrity over the life of the unit.

Fig. 2: Overview of Non-Collector End - Light Dirt on Stator Winding End Turns and Rotor Poles

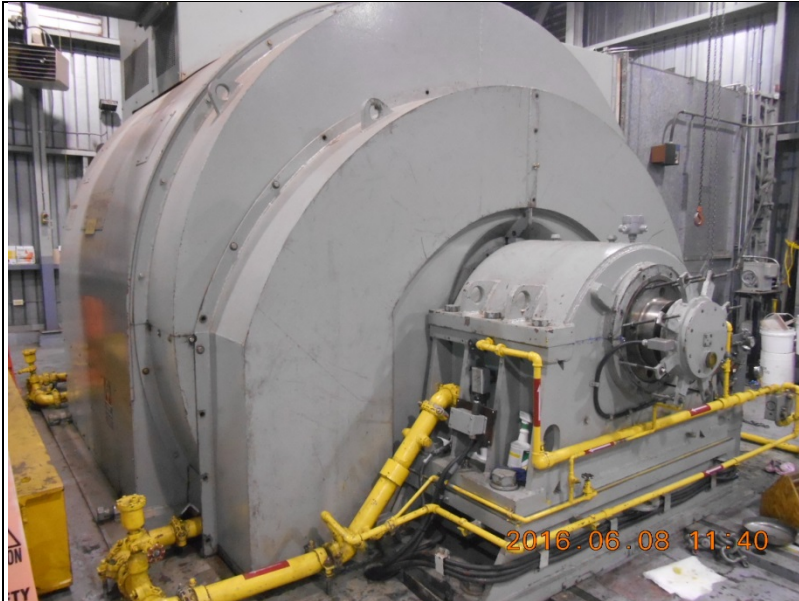
Fig. 4: The oil film appears to be a result of small leaks in the external oil piping. There are a number of oil absorbing pads placed on the outside of the bearing pedestal and around the unit.

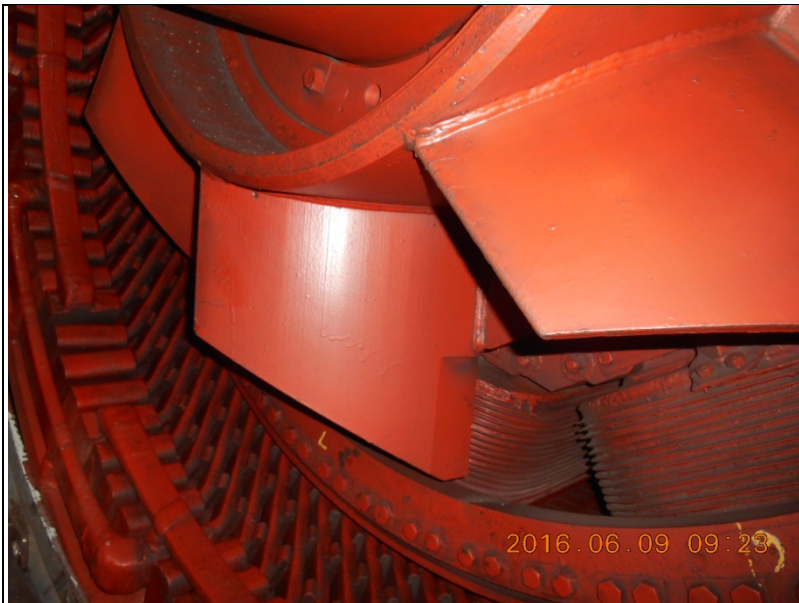
Annual inspections of the stator windings have revealed light contamination of some oil and dust on the end turns and coil extensions. All blocking at the coil extensions is intact with no signs of movement.

Fig. 5: Stator end turn and coil extension condition

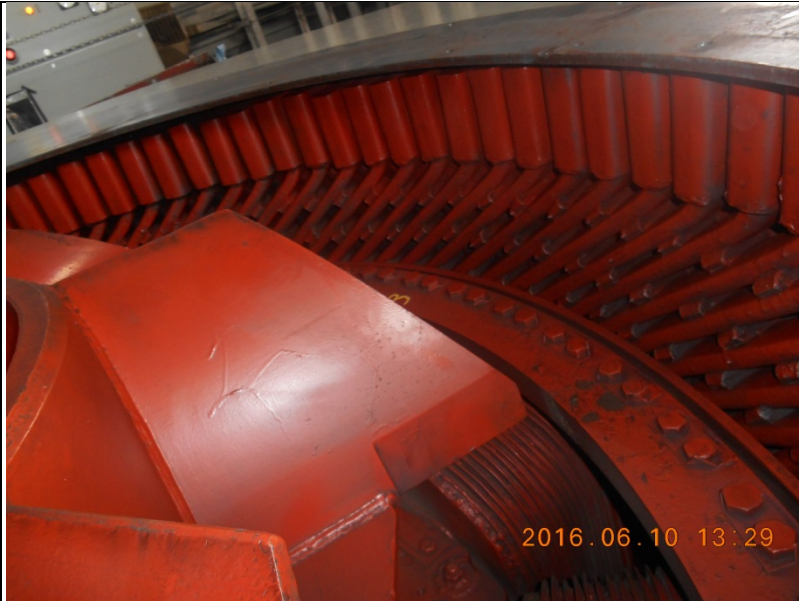
Fig. 6: Stator end turn and coil extension condition

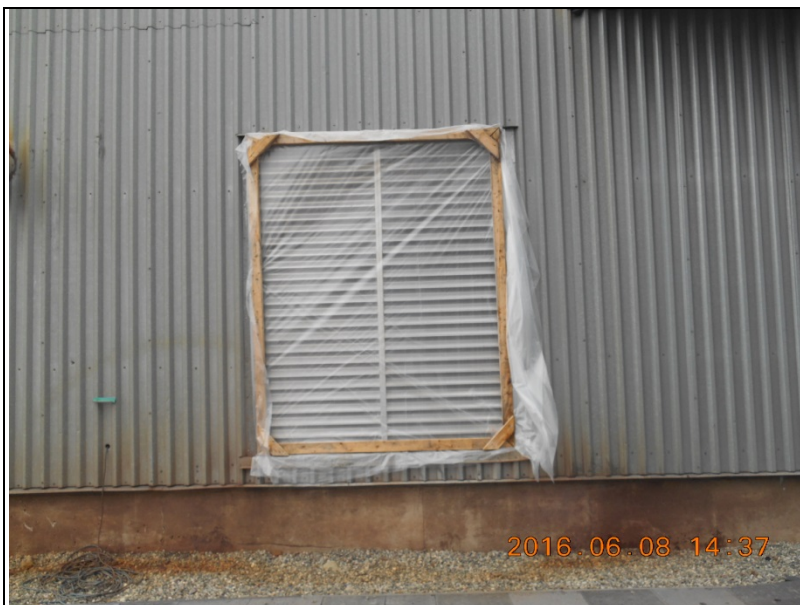
This frame is installed after shutdown and lockout of the unit to reduce the moisture accumulation in the stator windings. The frame does not fully cover the louvres and should be re-made for a better fit with heavier gauge poly-plastic.

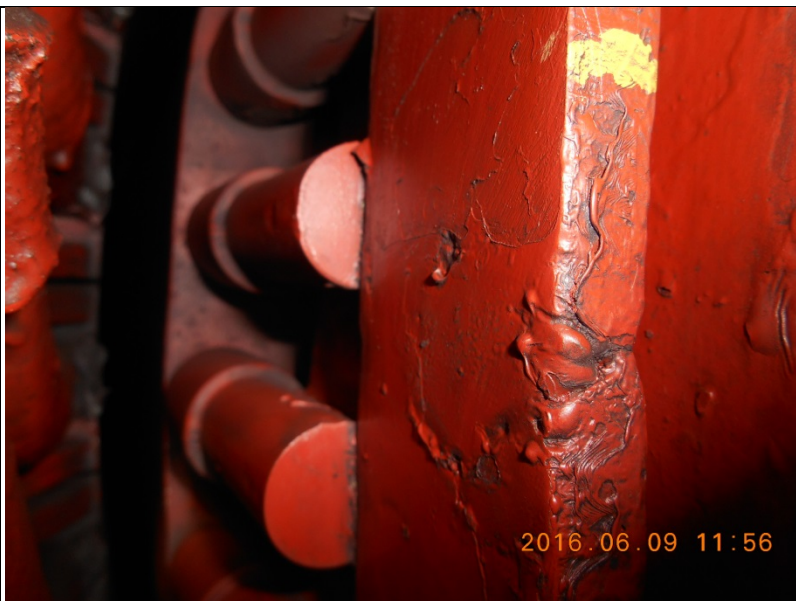
This is a photo of the outer circumference of the damper winding. It appears this area may have been repaired previously.

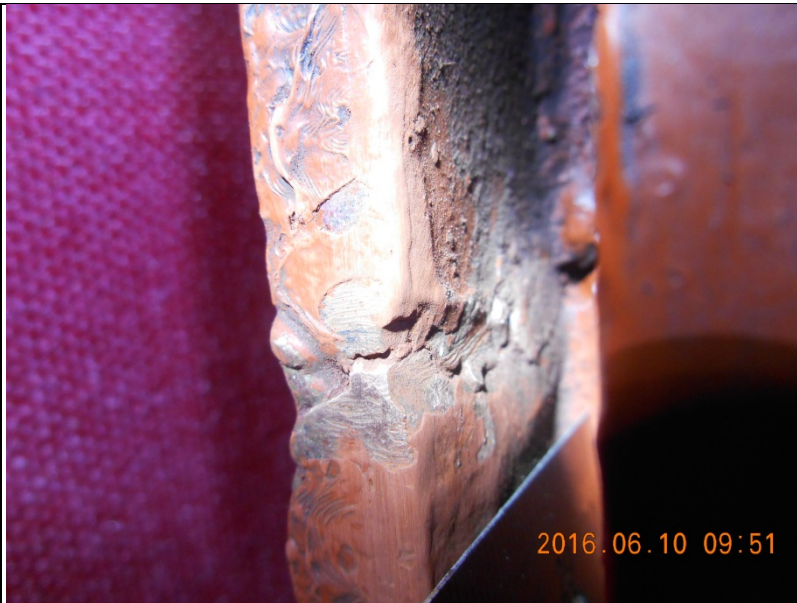
Fig. 13: NCRE Damper winding - Paint removed to investigate the area.

The paint was removed in this area to reveal the existing weld repair. The 'crack' is actually the overlap of the weld, and appears visually to be intact.

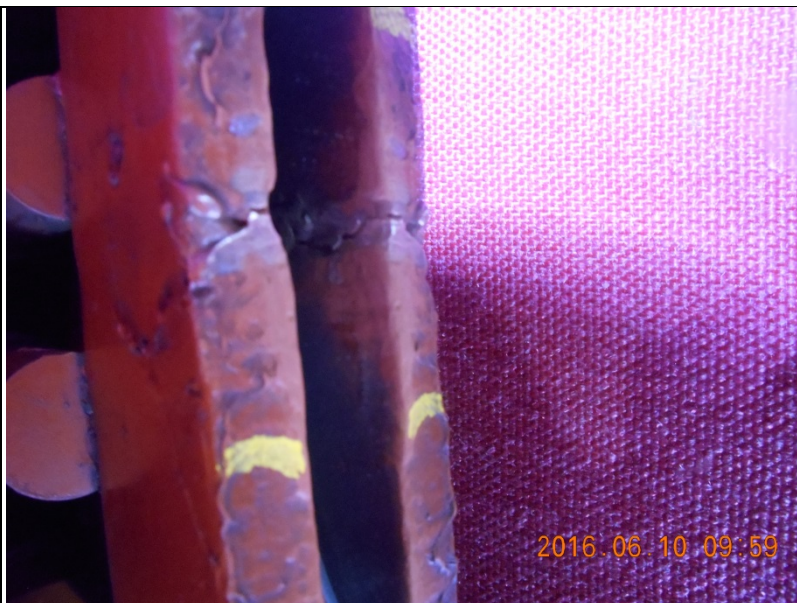
Second photo of the area using a mirror to show more of the weld repair.

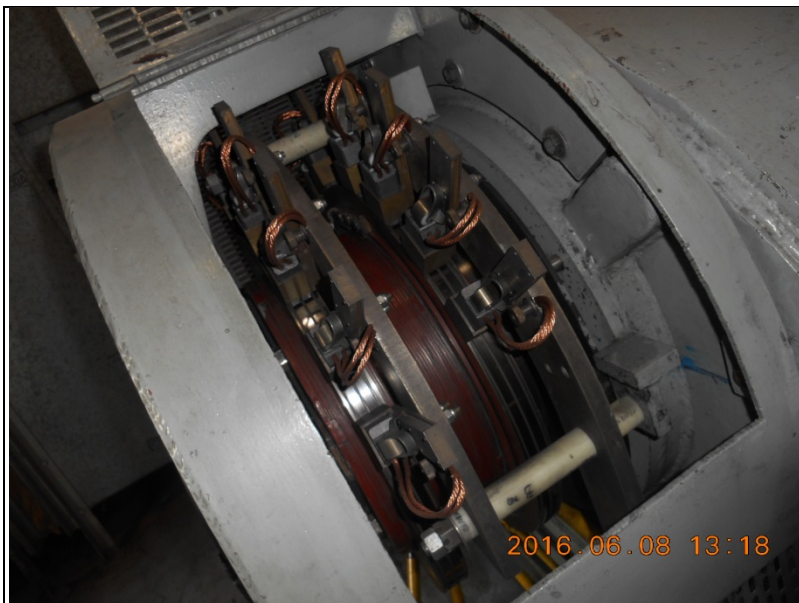
The brush rigging assembly is in good condition. All brushes appear to be in good condition and spring tension on the retainers is an average of 3.5lbs which is sufficient for proper brush pressure. The minimum spring pressure is 3lbs.

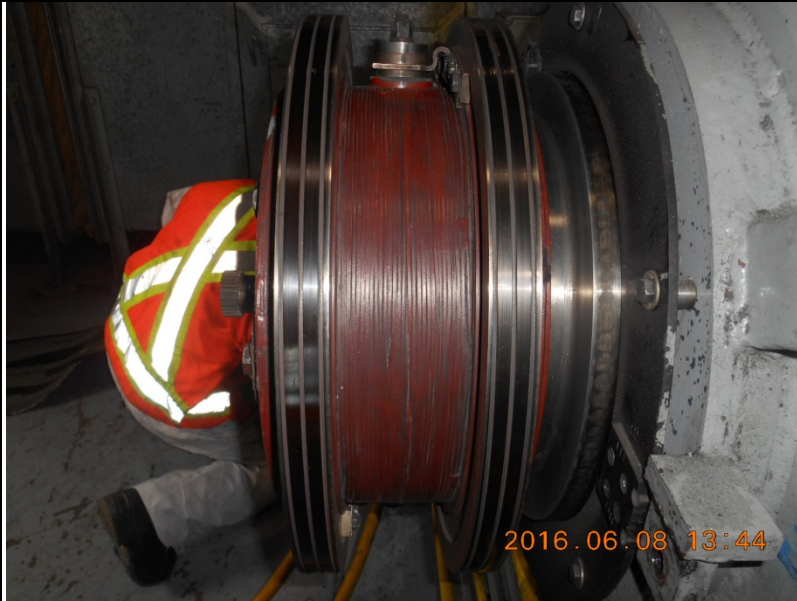
Fig. 16: Collector Rings

The collector rings are in good condition with no evidence of burnishing or physical damage. The bore copper studs are tight.

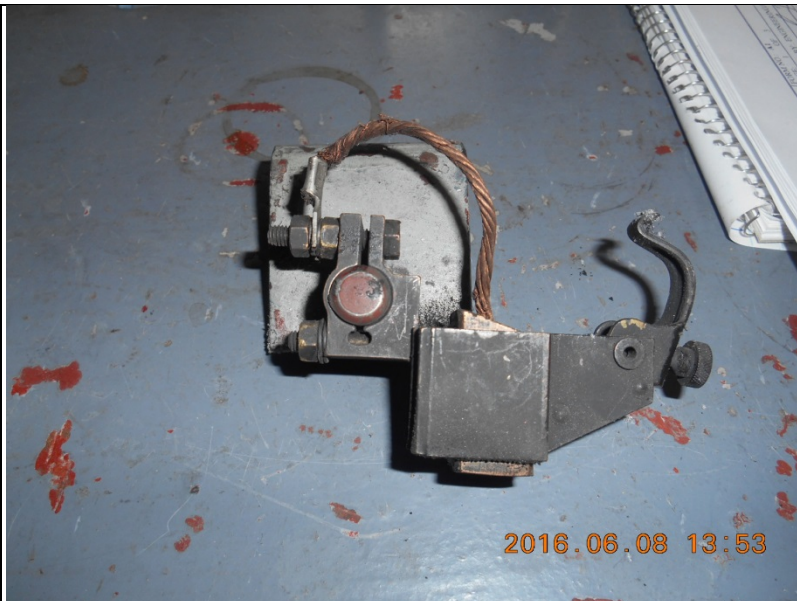
The ground brush assembly is in good condition and the brush itself does not require replacement at this time. The brush will likely need to be replaced at the next inspection interval.

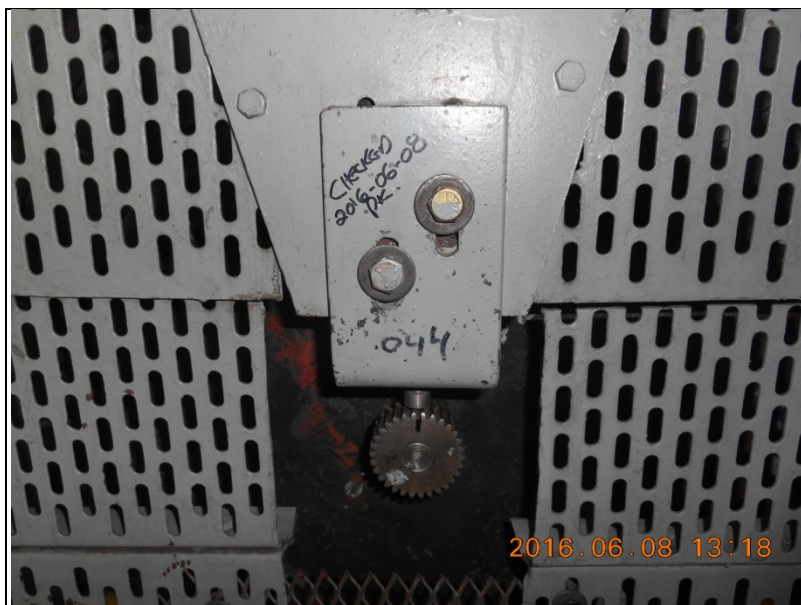
Speed probe measurement was found to be 0.044" before removal of the guards.

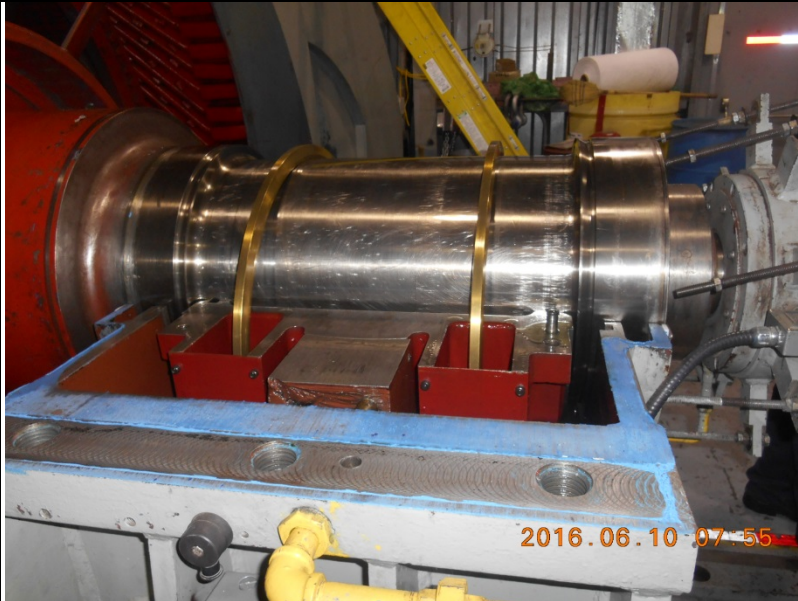
Fig. 19: NCRE Journal and Oil Rings

NCRE Bearing upper half removed. The journal is in good condition with only light scratches observed. The oil rings are in serviceable condition, with no raised spots on the punch marks as was found during the 2015 inspections

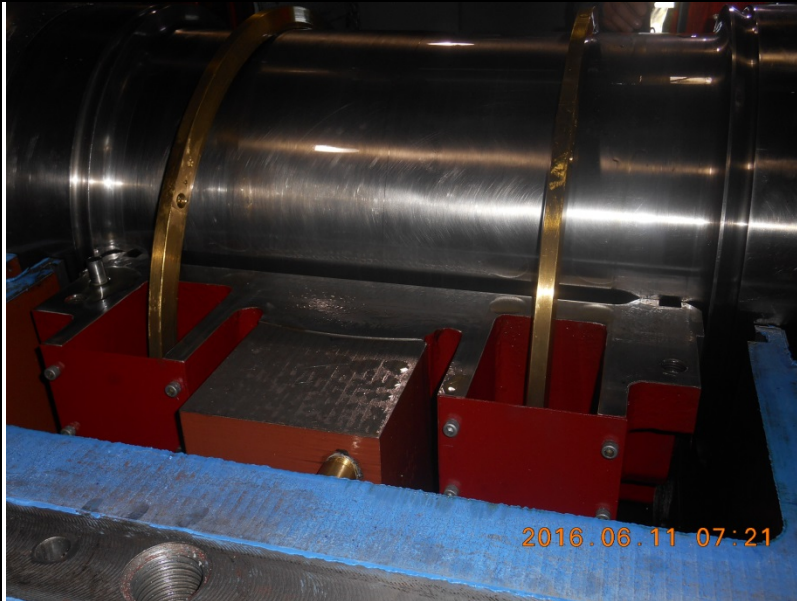
Fig. 21: CRE Journal and Oil Rings

The CRE journal was found to be in good condition with only light surface scratches. The punch marks on the oil rings are flush with no high-spots.

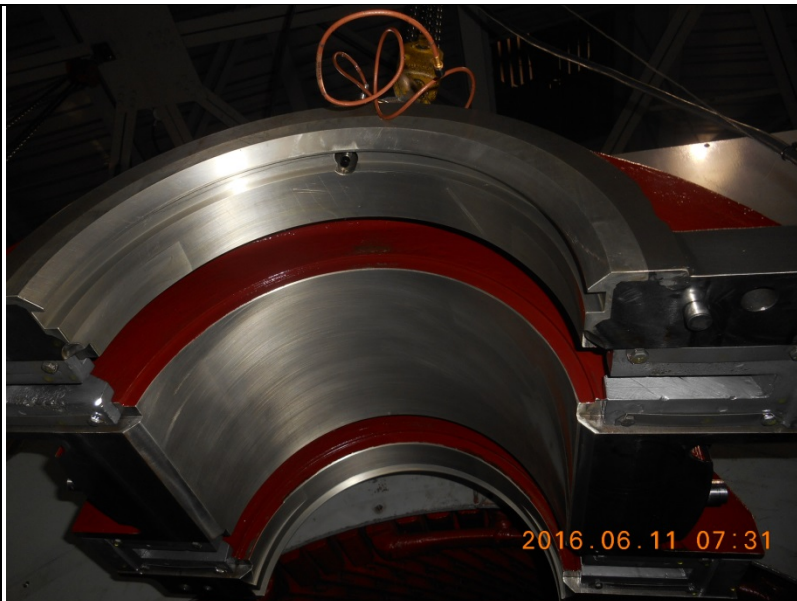
The CRE upper half bearing was found to be in good condition. There are some light scratches on the outboard side of the bearing surface.

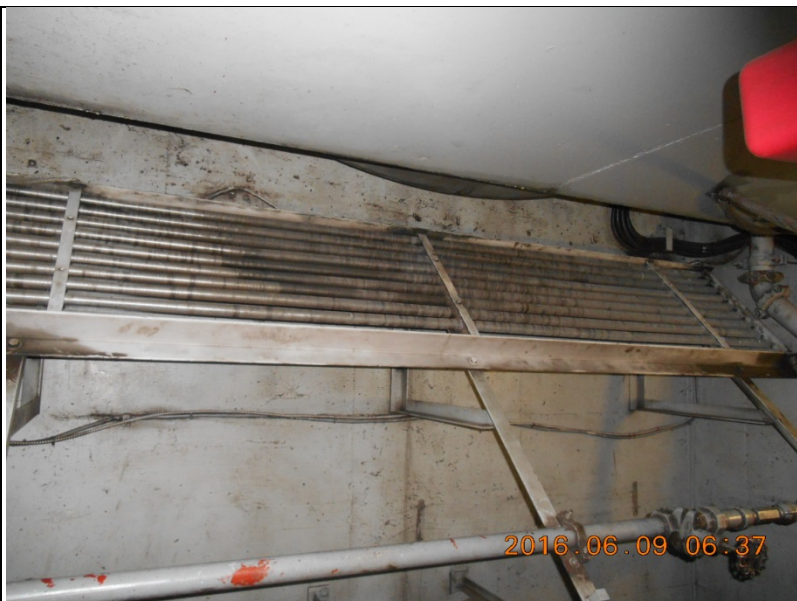
The oil coolers appear to be in good condition. Some fins are bent. Both coolers have a film of oil and dirt.

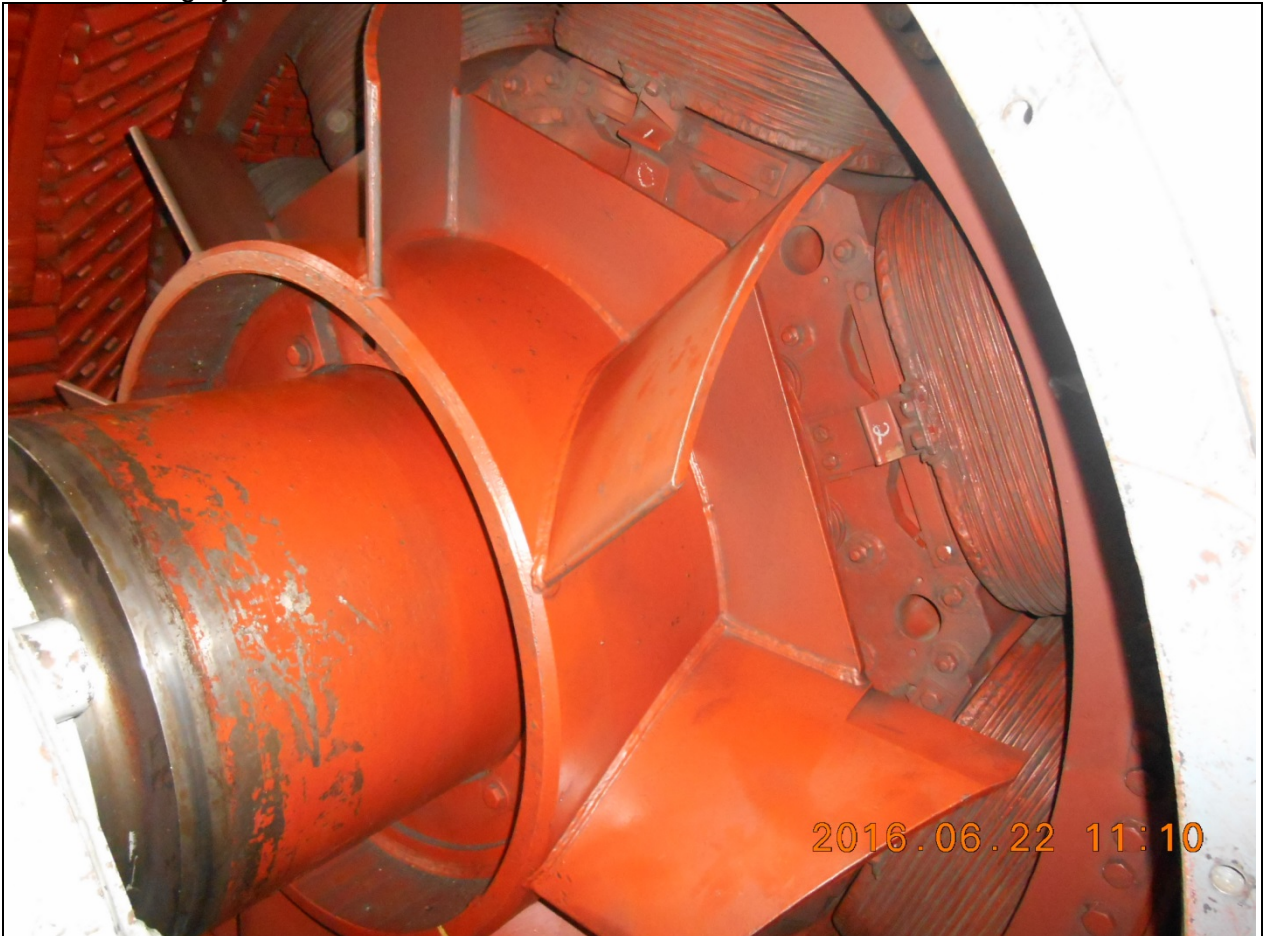
Unit SC2 is in serviceable condition, with no findings that would curtail its operation within normal parameters. Internally, the Stator winding end turns and Rotor poles are covered in a light film of oil and dirt. This does not affect unit performance significantly but does affect the insulation integrity over the life of the unit.

Fig. 2: Overview of Collector End - Light Dirt on Stator Winding End Turns and Rotor Poles

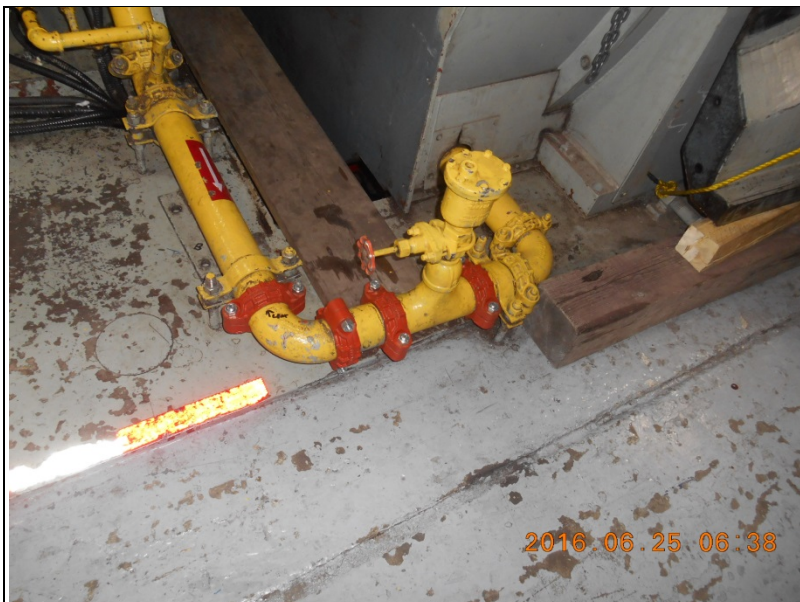
There were a number of leaks in the Collector End 3" pedestal drain, which is constructed using sections of pipe and Victaulic couplings. Nalcor purchased new coupling assemblies and grommets that were installed during the outage.

The three couplings downstream of the first four seen in this photo were also replaced after the customer identified a second leak from this area.

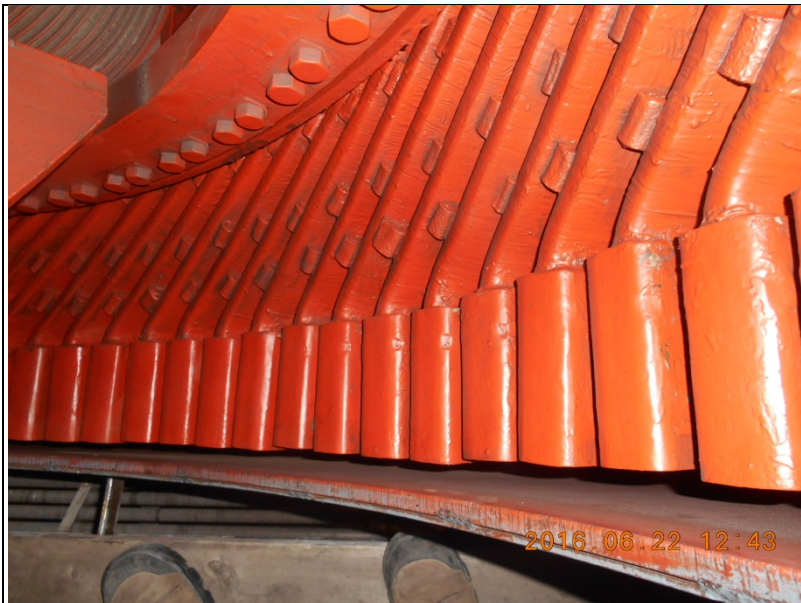
Annual inspections of the stator windings have revealed light contamination of some oil and dust on the end turns and coil extensions. All blocking at the coil extensions is intact with no signs of movement.

Fig. 4: Stator end turn and coil extension condition

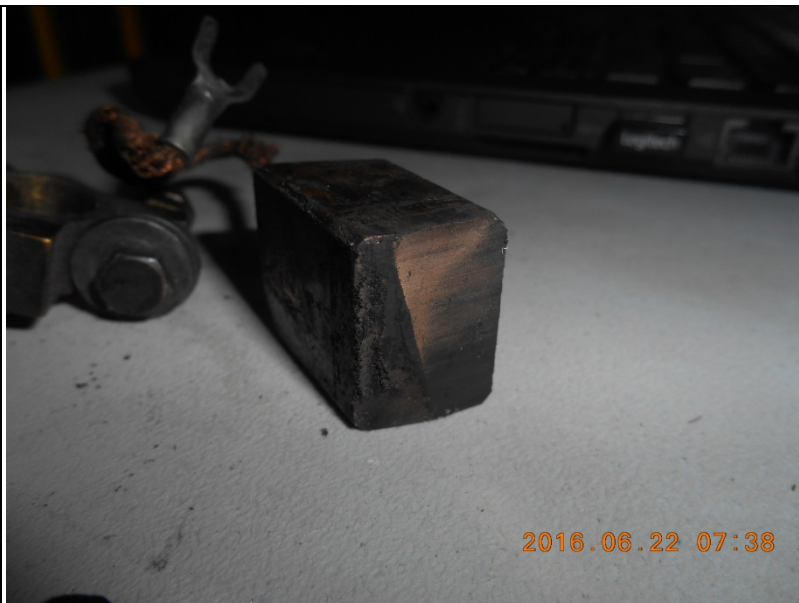
The ground brush assembly is in good condition. The brush itself requires replacement at this time. A new brush was taken from stock.

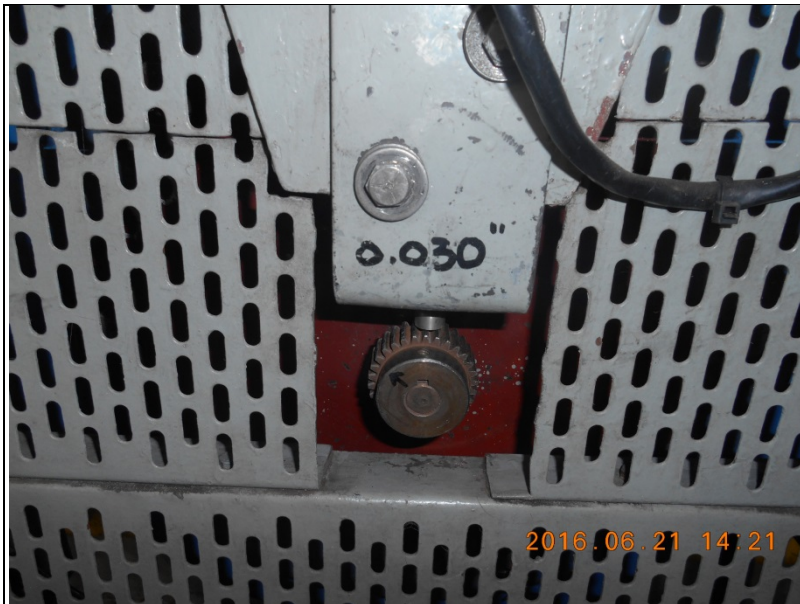
Speed probe measurement was found to be 0.030" before removal of the guards. With the hi-lift system running, the gap measures .021" in the same position and .028" when the shaft was manually rotated 180 degrees.

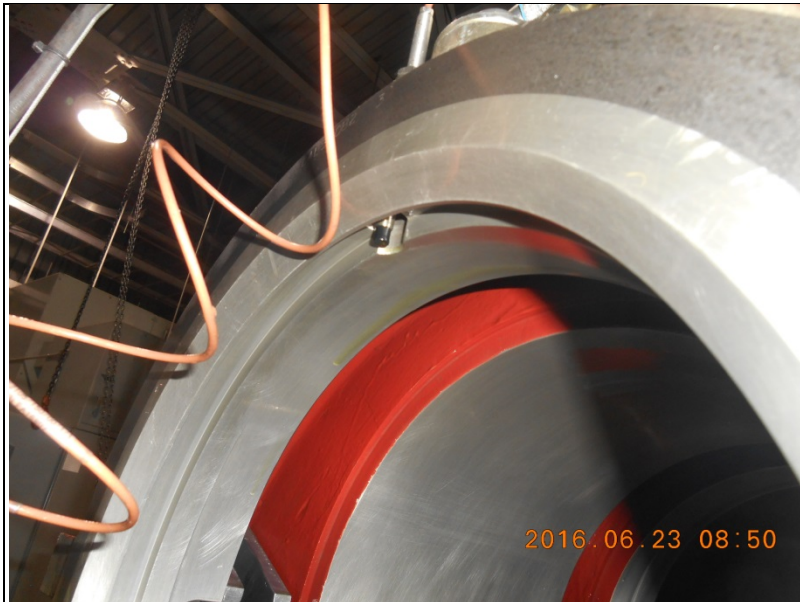
The speed probe was found to be loose and had turned to the point it was making contact with the shaft. It was backed out and the jam nut re-tightened.

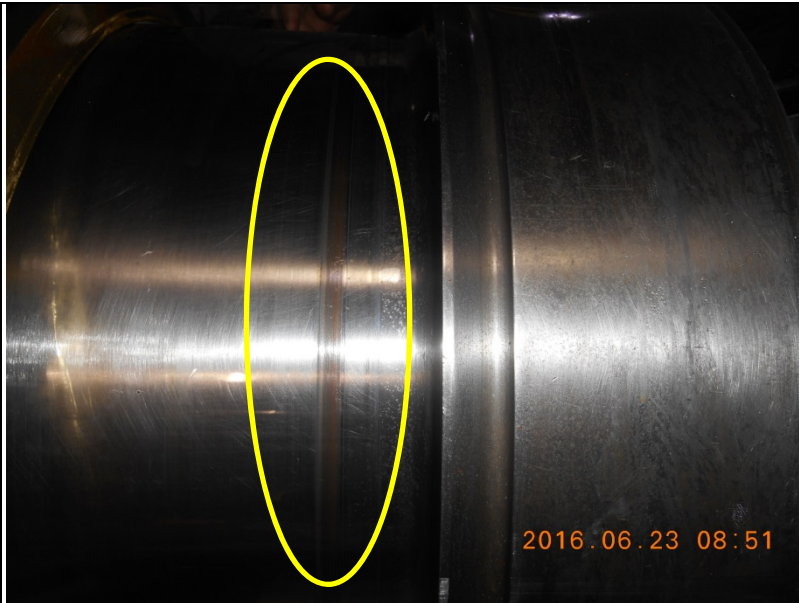
The mark in the center of this photo is the result of the speed probe making contact with the shaft. No damage occurred.

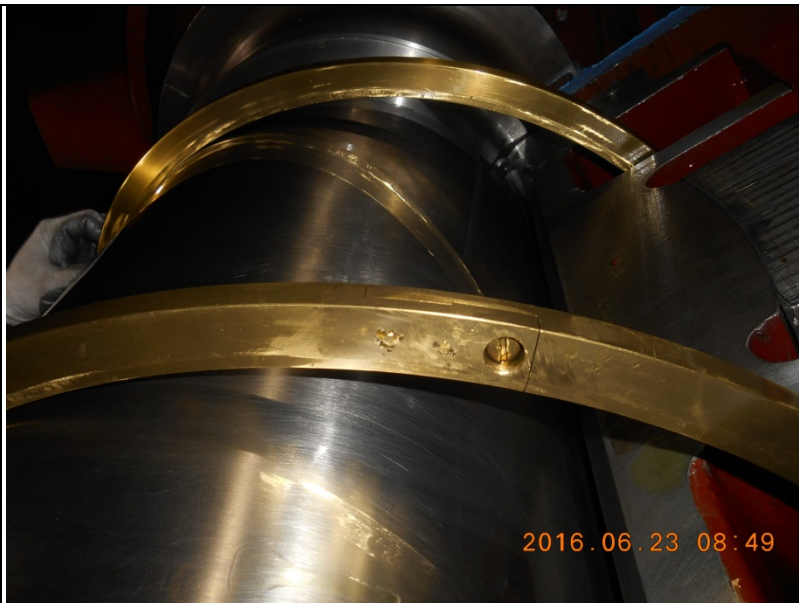
The NCRE oil rings appear worn with rub marks noted around the circumference. Removal and installation of the rings required additional peening to retain the connecting screws.

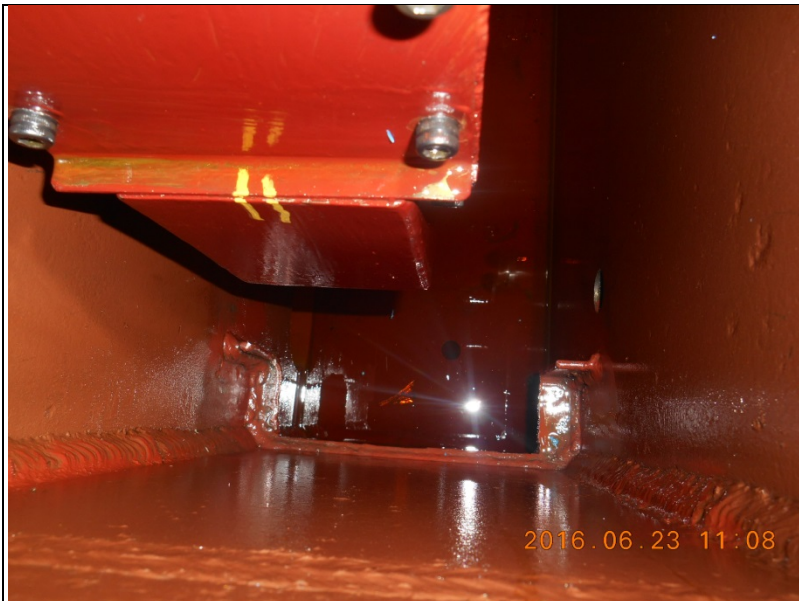
Babbitt found in the bottom of the collector end bearing pedestal sump

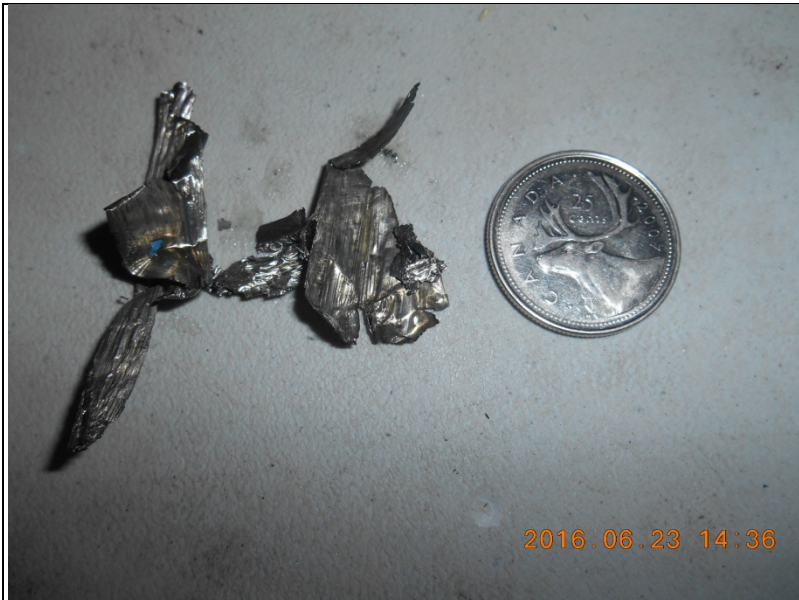
Total quantity of babbitt found in the sump, buside a quarter for comparison

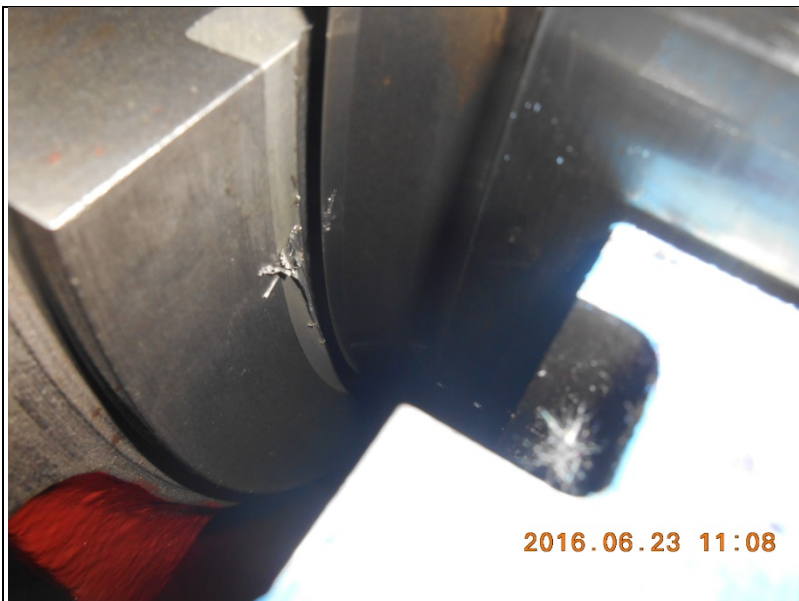
Source of the babbitt where the shaft vertical face has made contact with the bearing.

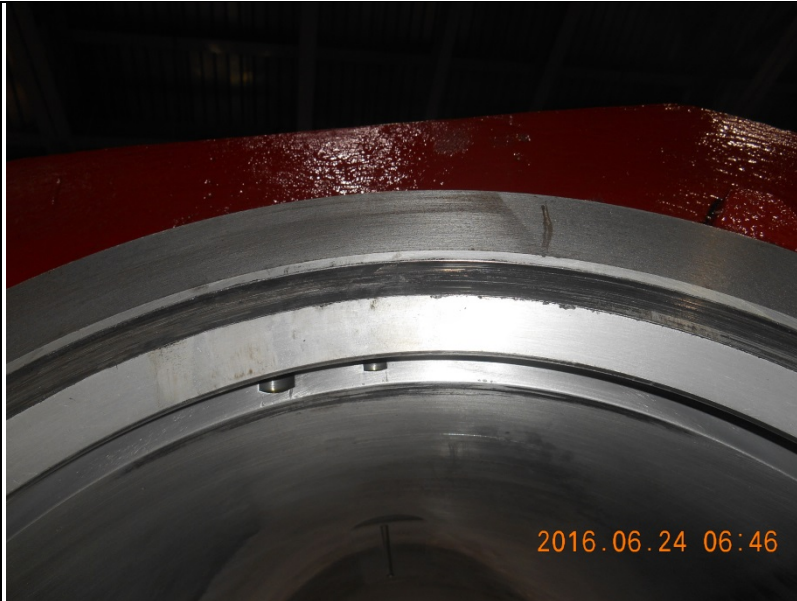
Photo of the damage to the outboard face of the lower half bearing

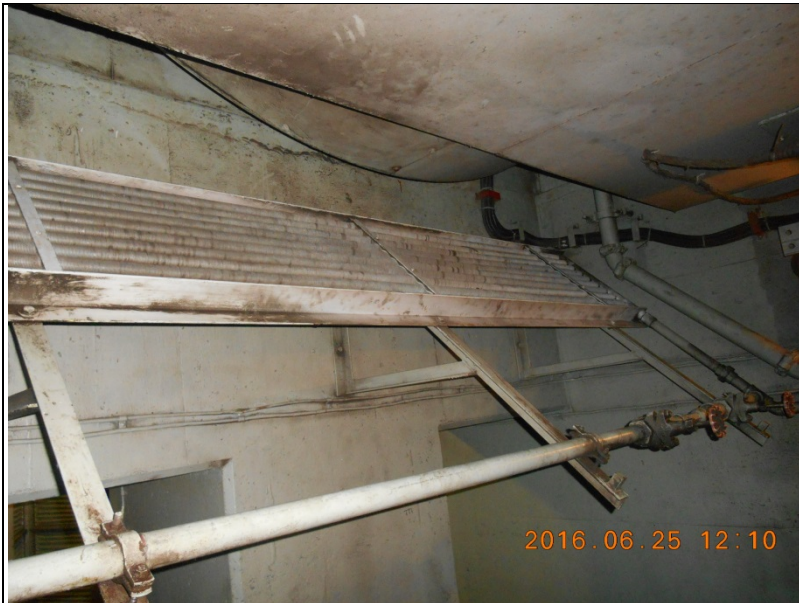
The oil coolers appear to be in good condition. Some fins are bent. Both coolers have a film of oil and dirt.
