Re: An Application by Newfoundland and Labrador Hydro (Hydro) for approval of capital expenditures to complete a Level 2 condition assessment on Penstocks 1 and 2, and a report on Penstocks 1, 2, and 3 at the Bay d'Espoir Hydroelectric Generating Station

Condition Assessment – Powerhouse 1 Penstocks
Bay d’Espoir Hydroelectric Generating Station

Engineering Report
Mechanical Engineering
Refurbishment and Failure Investigation Final Report

H356043-00000-240-230-0003

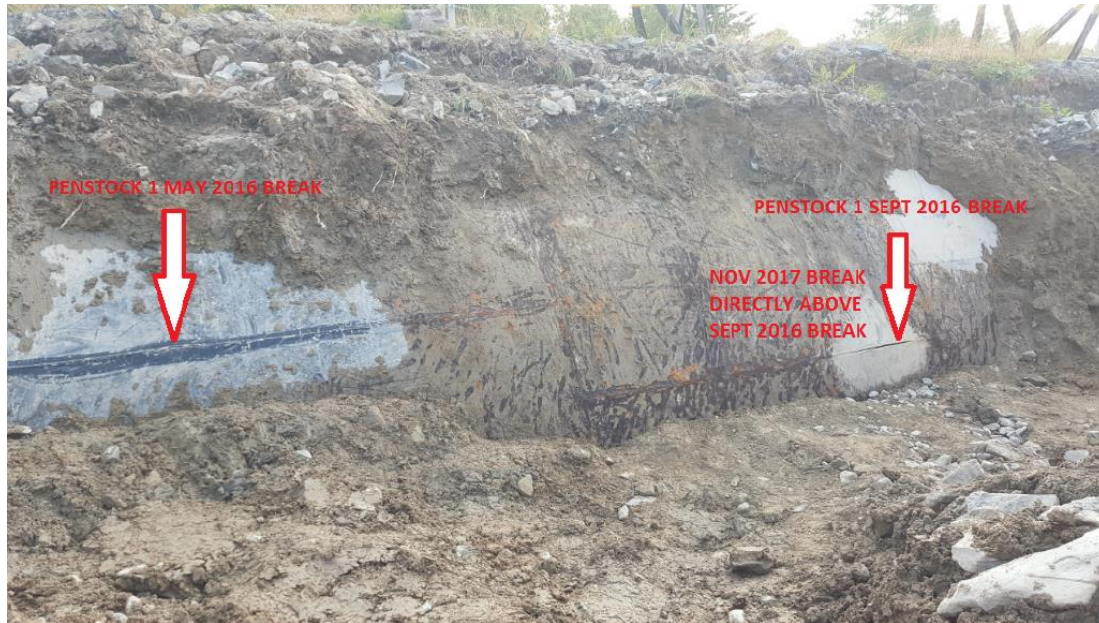
Figure 2: Rupture locations on Penstock 1 Bay d'Espoir

- 10 • May 2016: Rupture in penstock wall. Unplanned outage for two weeks.
- 11 • September 2016: Rupture in penstock wall slightly upstream of the May 2016
- 12 failure. Unplanned outage for ten weeks.
- 13 • November 2017: Rupture in penstock wall directly above the September 2016
- 14 failure. Unplanned outage for five weeks.

16 The location of the penstock ruptures have been in close proximity to each other as seen in
17 Figure 2.

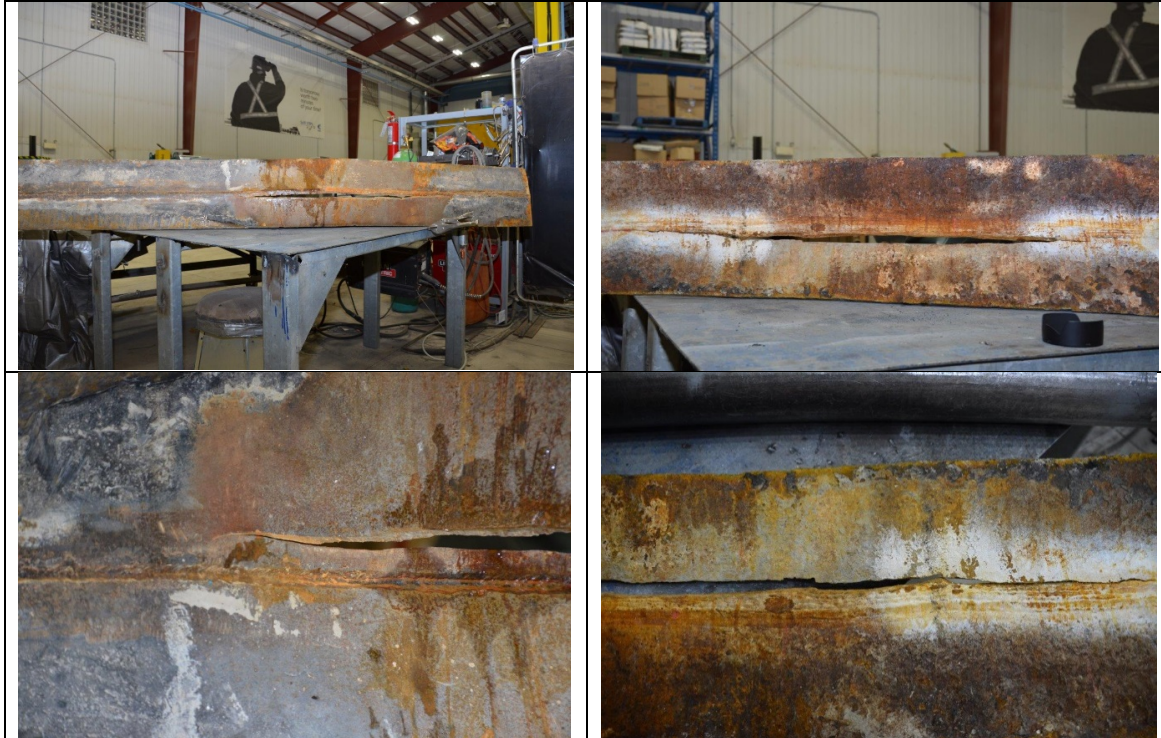
Figure 4-1: Close-up View of the Rupture in Can 35 (in the Laboratory for Material Tests)

A third rupture of Penstock No. 1 at Bay d'Espoir (BDE) occurred on November 4, 2017. The rupture occurred in the form of a 2' long crack just below the crack that was refurbished 14 months earlier (September 2016) in Can 35.

Initial visual inspection of the fracture surface showed (Figure 4-1) that the crack was approximately 43 inches long and propagated along the toe of the weld for a large portion of the seam and veered into the base metal along one end. During sample removal, the crack continued to propagate parallel to the weld. This would indicate large residual stresses being present within the weld joint. Figure 8-1 maps out different areas of a weld cross section for clarity with regards to the metallurgical summary.

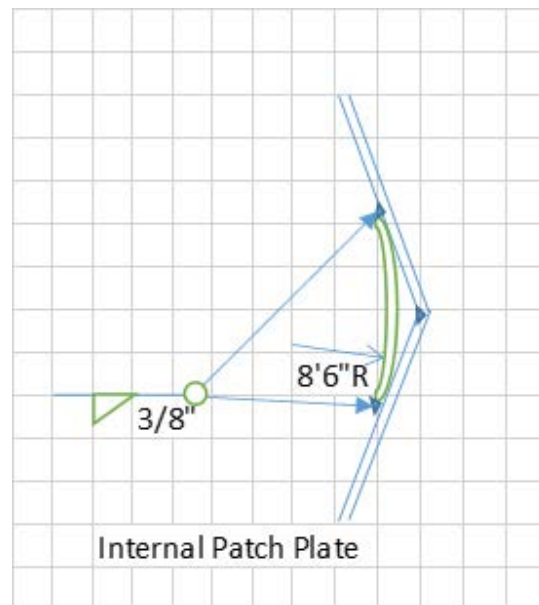
Figure 5-1: Refurbishment of Internal Longitudinal Seams

For the 29 longitudinal seams in other cans with defects or cracks, existing weld metal was removed from inside of the penstock and rewelded. Prior to the installation of the reinforcing plates the excess weld reinforcement on the longitudinal welds was ground flush to reduce the stress concentration at the welds and allowing the reinforcing plates to sit tighter to the existing plate surface. In each case a 22" wide 9' long rolled patch plate (8'6" radius, 1/2" thick) was welded in place on the inside of the refurbished longitudinal welds, as shown schematically in Figure 5-1 below. Figure 5-1 also shows peaking at the weld.

Hatch designed the refurbishment of the ruptured penstock can. It involved removal of a 2' wide 9' long longitudinal strip of the penstock can with the crack in the middle (Figure 4-1) and inserting a 1/2" thick pre-rolled (8'6" radius) plate (CSA G40.21 350WT-CAT 4, which is superior to existing) and welding it in place according to the procedure provided by Hatch. For safety, the longitudinal weld in Can 34, repaired originally in May 2016, was also removed and replaced by inserting another 1/2" thick pre-rolled plate. To reinforce the new refurbished area and the one from May 2016, spliced reinforcing plates (8'6" radius, 1/2" thick) were welded on the exterior of cans 33, 34, 35 and 36 (see Hatch drawing 352666-D-M-0001.1, rev B).

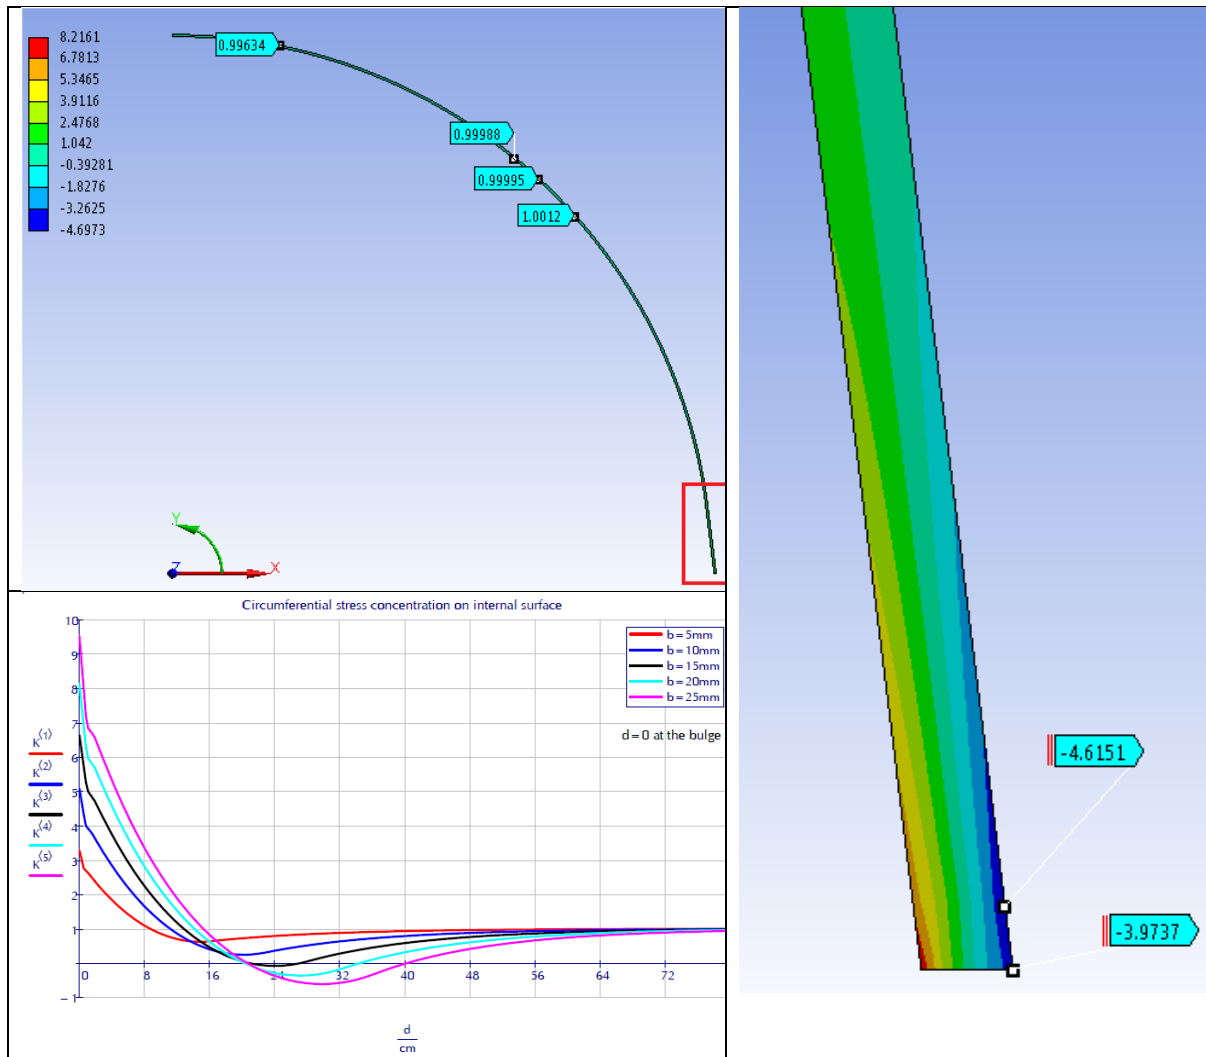
Figure 7-3: Influence of Non-Circular Geometry at Longitudinal Welds Under Pressure

- As would be expected, the maximum stresses occur when the penstock is under dynamic pressure and subject to a load rejection. The highest measured stress was on the inside in the vicinity of the longitudinal weld seams in Can 65. Stresses in the order of 280 MPa [above the yield strength of 30 ksi (206 MPa) but below the ultimate tensile strength of 55 ksi (380 MPa)] were measured in the ASTM A285 Gr. C section with the penstock full and during a load rejection. The measured values suggest that the operational stresses were 25% less than the ultimate strength and 37% above the yield strength of ASTM A285 Gr. C. The high stress is attributed to the penstock peaking at the longitudinal weld caused by the lack of rolling radius of the two mating edges.

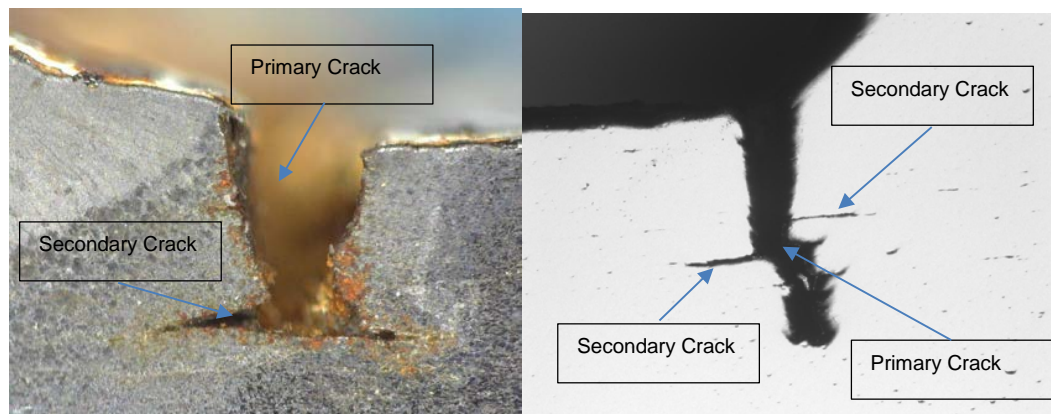
Figure 8-2: Primary Cracks (Vertical) and Secondary Cracks (Horizontal)

Two different types of cracks were discovered through macro examination and are shown in Figure 8-2. The primary cracks (through thickness) generally propagate from the toe of the weld through the heat affected zone (HAZ). All observed crack micro examinations had pearlitic structures which is a desirable trait and would indicate that the cracks were not caused by brittle structures. There is evidence of bending and high tensile loading when analyzing the micro photographs. Several of the samples had secondary cracking (interplanar) present. The secondary cracks appear to follow sulphide inclusions that are present within the base material and can likely be attributed to the presence of said inclusions. It seems unlikely the secondary cracking is the primary cause of the rupture but could have accelerated the failure.

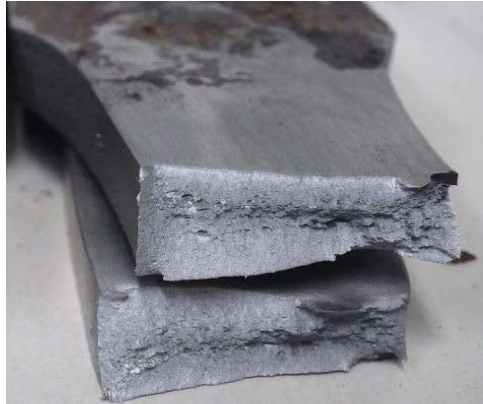
Figure 8-3: Ductile Failure Tensile Tests Penstock No. 1

Further to the visual, macro, micro and chemical analysis, a set of mechanical testing was completed. The testing consisted of tensile testing for the base metal and the weld metal. The tensile samples failed within the base metal and were also ductile in nature (similar to the results determined in the 2016 investigation). The tensile test in Figure 8-3 shows an extensive reduction in area and significant cupping which is typical of a ductile failure. This testing is further evidence that brittle fracture was not involved and that the material and weld metal is ductile, which is preferred practice for design of steel structures.

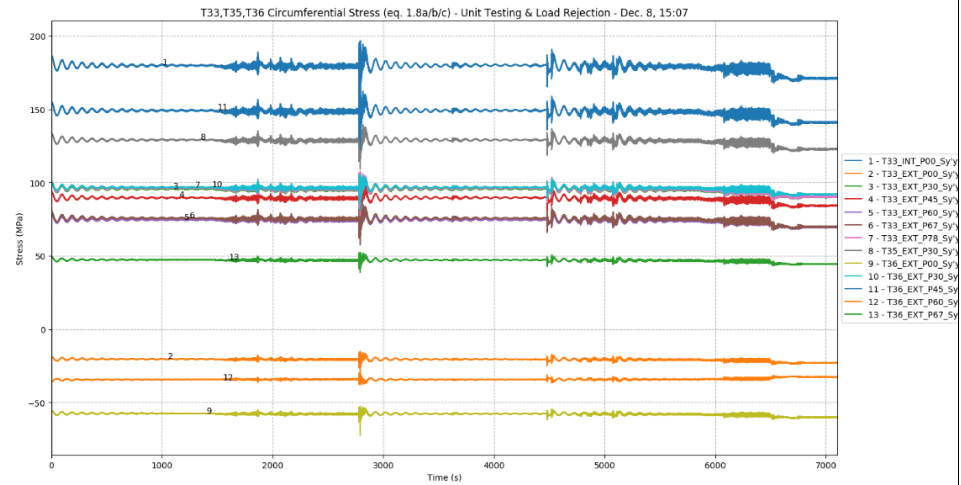
Figure 8-5: Circumferential Stresses in Penstock at Can 33 - Rough Zone and Load Rejection

- A load rejection results in pressure rise of 10% at the powerhouse (259 psi+26 psi). The corresponding pressure waves up the penstock cause fluctuations in pressure at Can 33 of the order of $\pm 17\%$ (± 6.8 psi) in the area where the rupture occurred (Figure 8-4). The corresponding fluctuation in the maximum stress is 280 ± 25 MPa during load rejection (Figure 8-5). Load rejection occurs between 1500 and 3500 seconds and the peak was at approximately 2700 seconds.
- The fluctuations in maximum stress during rough zone operation are of the order of ± 7 MPa (1.0 ksi) and ± 5 MPa (0.7 ksi) with two units and one unit in the rough zone, respectively (Figures 8-5 and 8-6). This is interesting as it was not anticipated that the rough zone operations would result in significant stress fluctuations in the penstock. Rough zone occurs from approximately 4500 seconds onward.

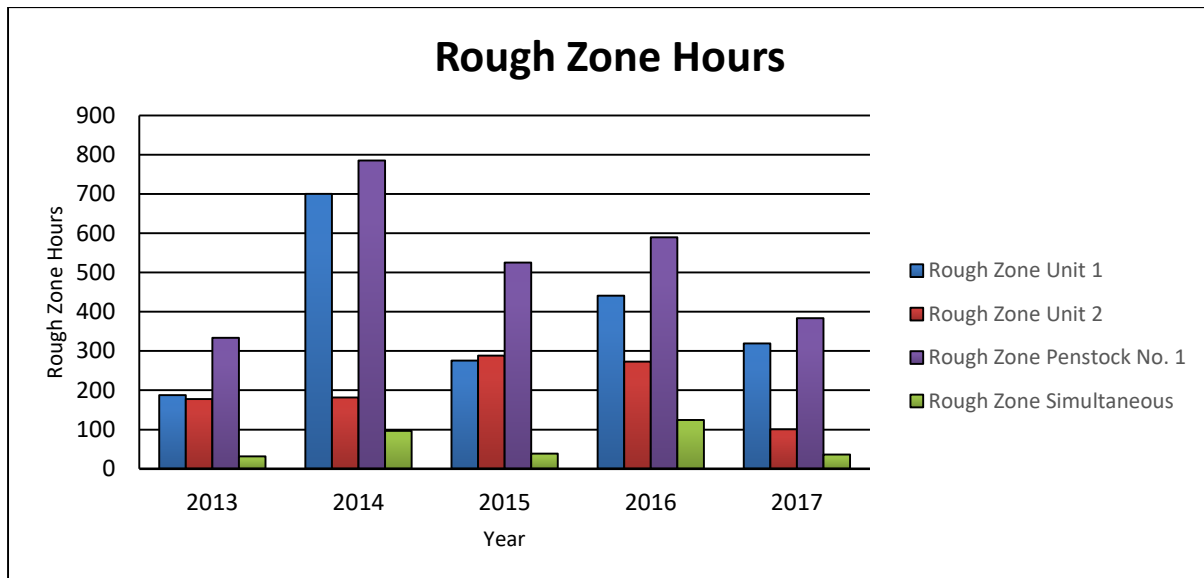
Figure 8-7: Rough Zone Trends

Analyzing the data and approximating the total hydraulic rough zone time shows that over the last five years Penstock No. 1 averaged more than 400 hours in the hydraulic rough zone per year, with a peak of over 800 hours in 2014. It should be noted that 2016 and 2017 had significant down time for repairs and the duration of rough zone operation was reduced as a result.

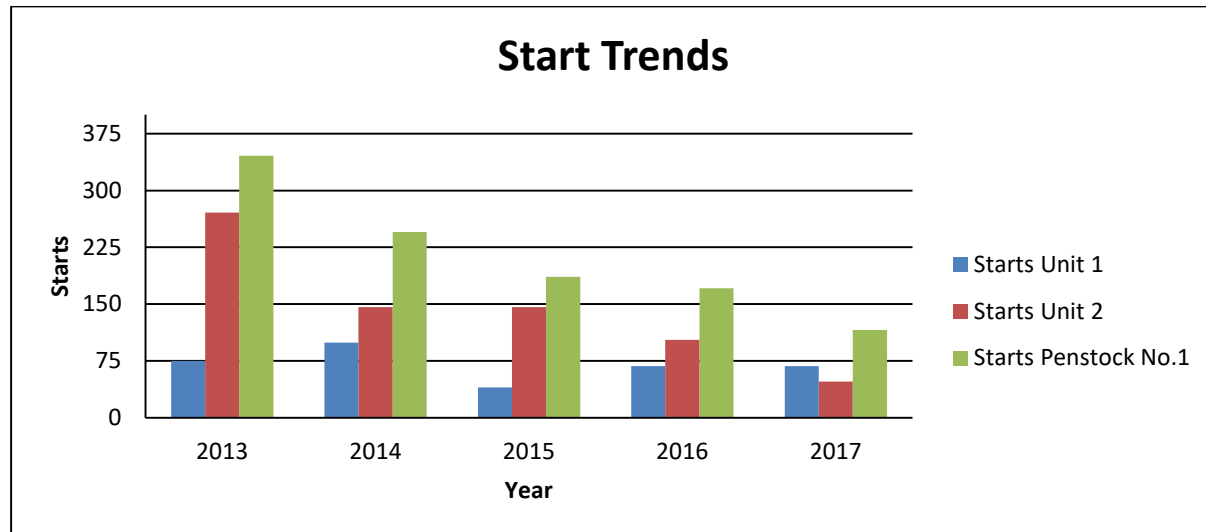
Figure 8-8: Start Trends

Newfoundland and Labrador Hydro provided the last five years of operational data to Hatch for analysis. The operational data provided shows decreasing amounts of starts/stops for each unit over the five years analyzed, and high hourly time spent within the rough zone (between 25 to 40 MW based on the measured test results). In general, eliminating unnecessary starts/stops is a common recommendation to increase the life of a hydraulic turbine. However, in this instance operating the units at low loads to meet the power demand resulted in these units spending an increased amount of time operating in the rough zone. The amount of time spent within the rough zone over the last five years is shown in Figure 8-7, and the number of annual starts/stops is shown in Figure 8-8.
