EXTERIOR PRECAST CONCRETE PANEL ASSESSMENT

HYDRO PLACE
500 Columbus Drive, St. John's, NL A1B 4K7

NEWFOUNDLAND LABRADOR HYDRO

REPORT > ORIGINAL > FINAL
Rev. C01 > Internal ref. 632109-0001-t-44-rep-000-0001

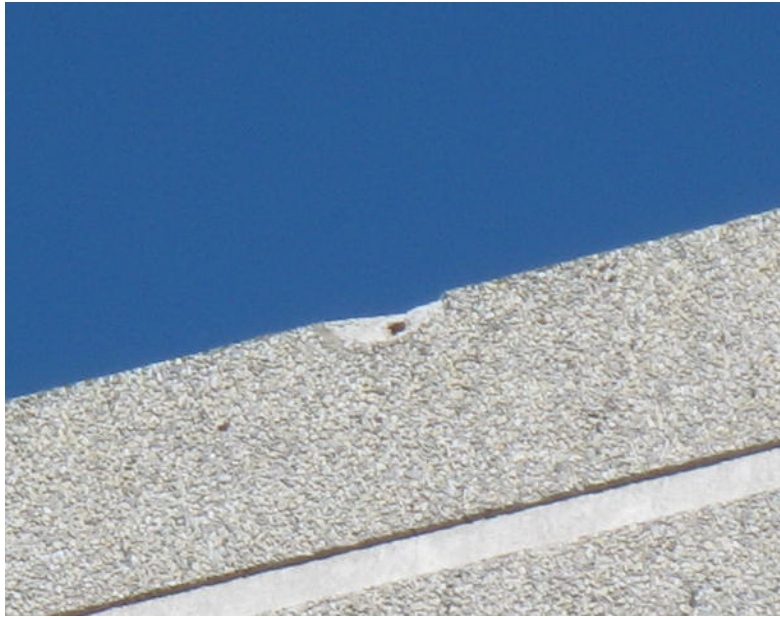
Photo 1: Spall at top of panel.

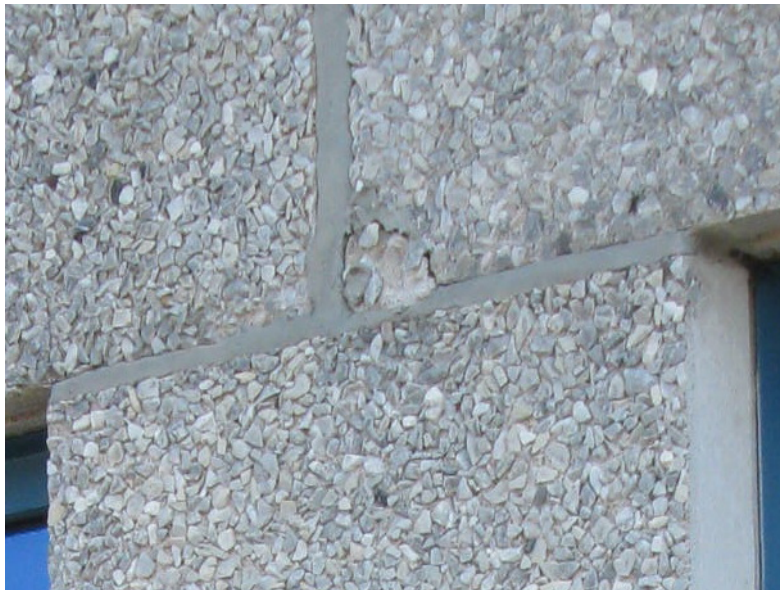
Photo 2: Spall and repair at lower left corner of panel.

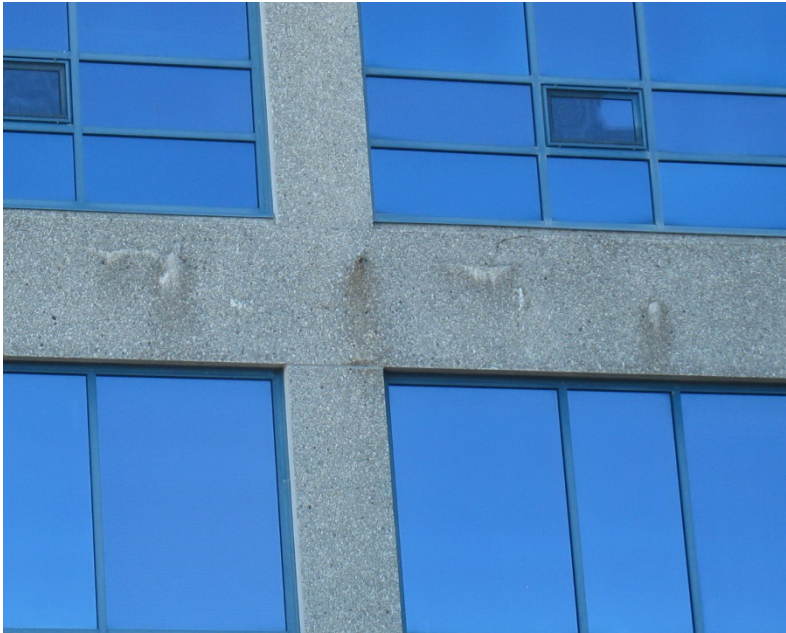
Some minor cracks are visible on the face of two (2) separate panels. Water migration around the cracks has led to the formation of efflorescence crystals which are visible from the exterior (Photo 3 and 4). Also, cracks at the top of a panel at another location are visible but efflorescence crystals have not formed (Photo 5). Efflorescence (white crystal deposits) is crusty, white, water-soluble salt deposits which are leached to the surface of concrete as water evaporates through it.

Photo 3: Minor cracks and efflorescence crystal formation.

2. Those panels showing signs of efflorescence be treated with an applicable solvent to remove existing efflorescent crystals and then treated with a sealer to inhibit future development of efflorescence. This is often done by the use of toluene or xenol to remove the crystals followed by an acrylic sealer. This will restore the appearance of the panel to original, but the efflorescence may reoccur. Another option is the direct application of an acid gel such as Spray-Lock which will remove the efflorescence for a longer period. Refer to the Spray-Lock Data Sheets in Appendix C of this report for more information.
3. All cases where panels are out of normal tolerance should be examined – each on its own merits, and a decision made as to whether to accept and stabilize if it is determined that all possible movement has stopped, or replaced or reinforced if there remains some

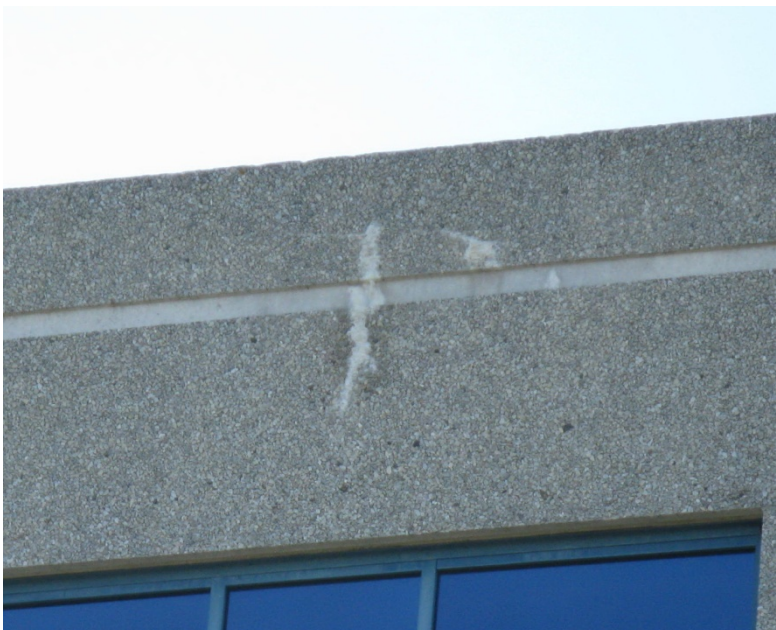
Photo 4: Minor cracks and efflorescence crystal formation.

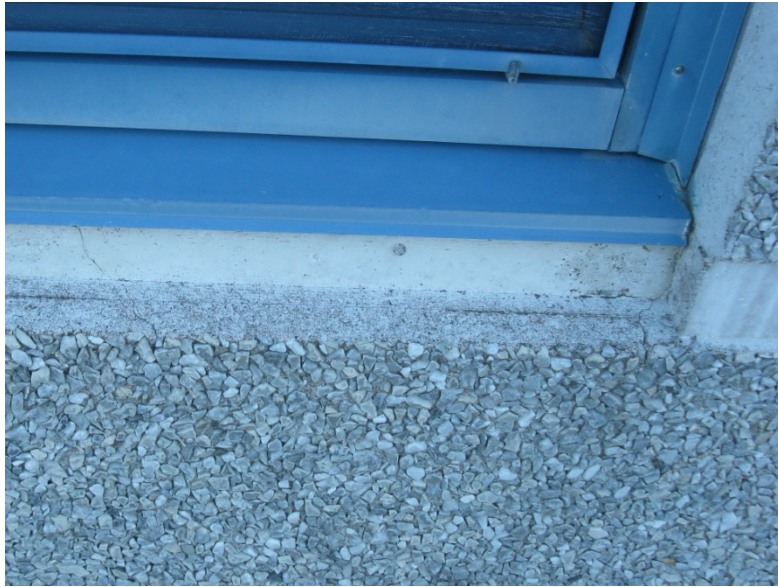
Photo 5: Minor cracks in panel.

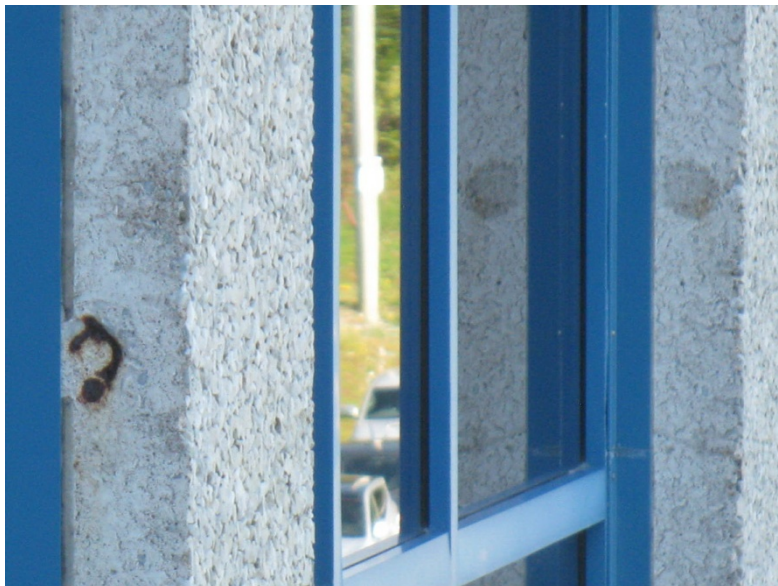
The ends of steel reinforcing/lift anchors are exposed at the sides of various panels and rust is visible (Photo 6 and 7). Patching with mortar to cover these exposed ends appears to have been done during the installation of the panels but some of the patching has disintegrated and/or fallen off. This does not appear to affect the structural integrity of the affected panels and can be considered to be more of an aesthetics issue at this time. However, over time the rusting may cause some minor spalling on exposed surfaces. At one (1) location the end of a section of steel is exposed on the face of a panel (Photo 8) and at another location, a horizontal section of steel rebar reinforcing is exposed at the top of a panel. The rebar may not have been properly placed during the manufacturing process which did not permit the minimum concrete cover typically required (Photo 9).

Photo 6: Exposed end of reinforcing/lift anchor and typical mortar repair beyond.

4. The life of the panels themselves may be extended through the application of a surface gel sealer such as Spray-Lock providing it is shown that the PH of the existing concrete is compatible for this application. This would be spray applied over the exterior surface and would provide long term protection to the exposed concrete that holds the stones on the panels in place. It is noted that Spray-Lock can also stop and eliminate efflorescence if the concrete PH falls within certain limits.
5. That the cause of major stains be addressed and rectified and affected panels treated with an applicable cleanser to remove stains.
6. That non-shrink grout or flexible caulking be applied to exposed ends of anchors/lift devices, reinforcing, and steel framing.

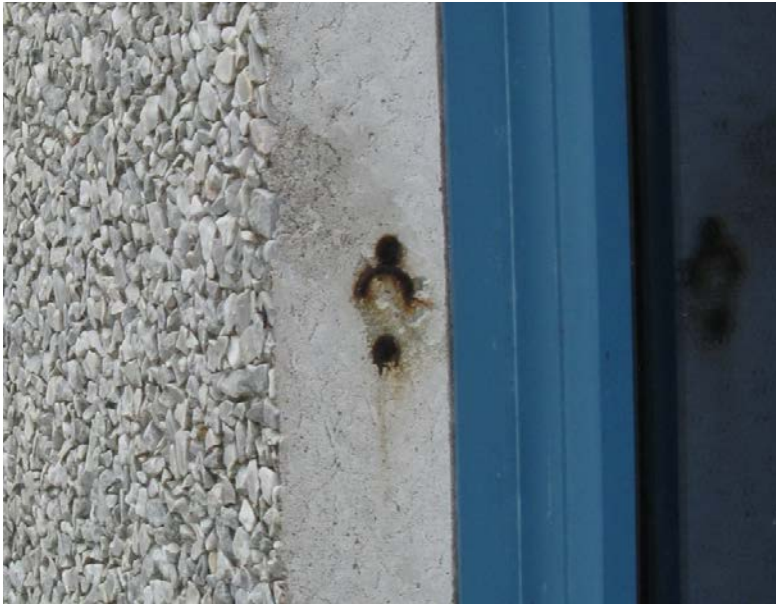
Photo 7: Exposed end of reinforcing/lift anchor.

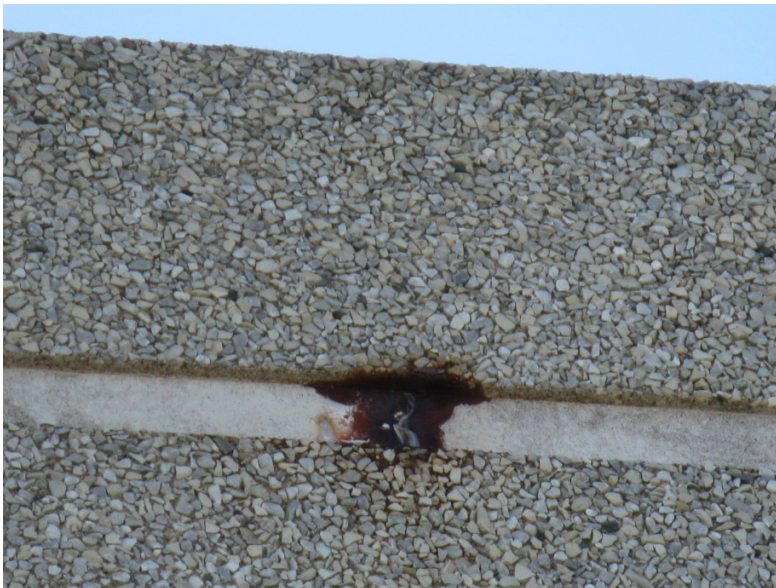
Photo 8: Exposed end of steel section.

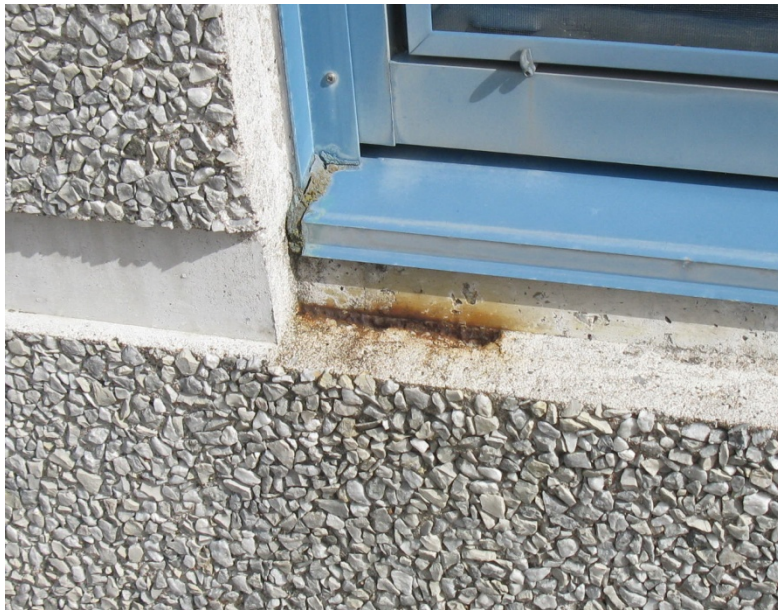
Photo 9: Exposed steel rebar reinforcing.

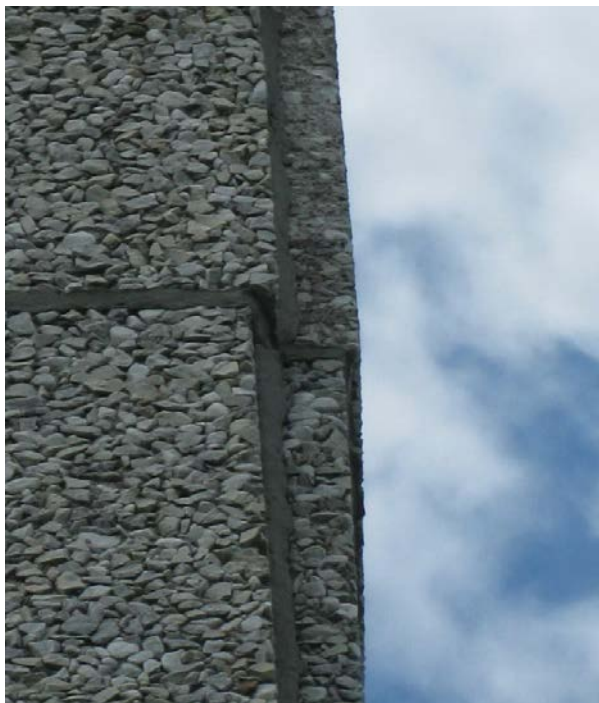
Misalignment of horizontal and vertical panels is visible in few locations (Photo 10) and may be attributed to allowable installation tolerances during the construction of the building. However, at one location on the South Elevation there appears to be a significant variation in the width of a panel joint from top to bottom which suggests there may be a issue with regard to movement (Photo 11 and 12). The panels in this area require further investigation.

Photo 10: Misalignment of panels.

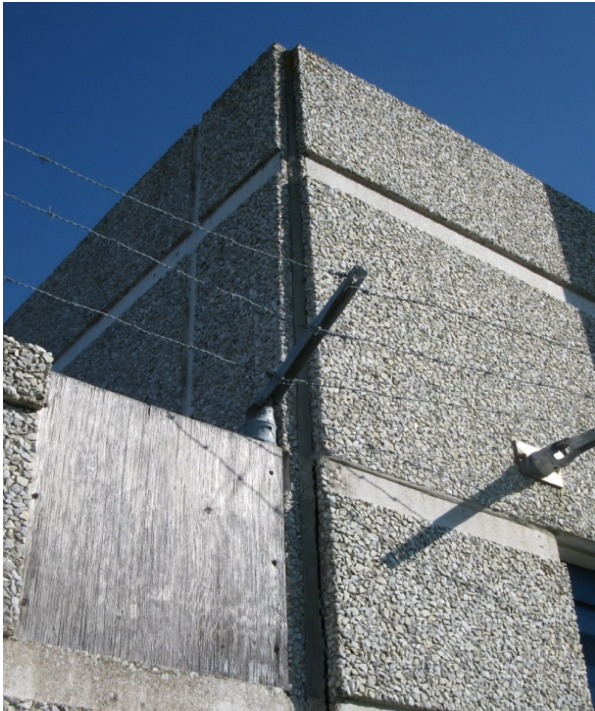
Photo 11: Width of joint varies from top to bottom of wall.

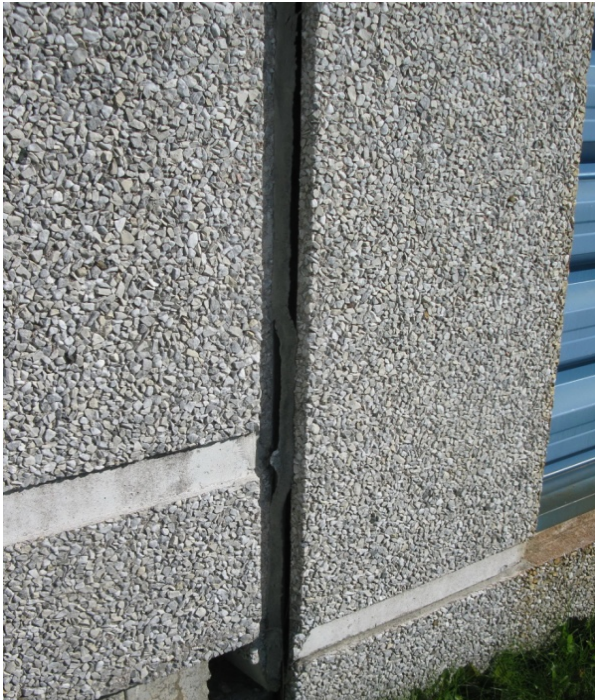
Photo 12: Width of joint varies from top to bottom of wall.

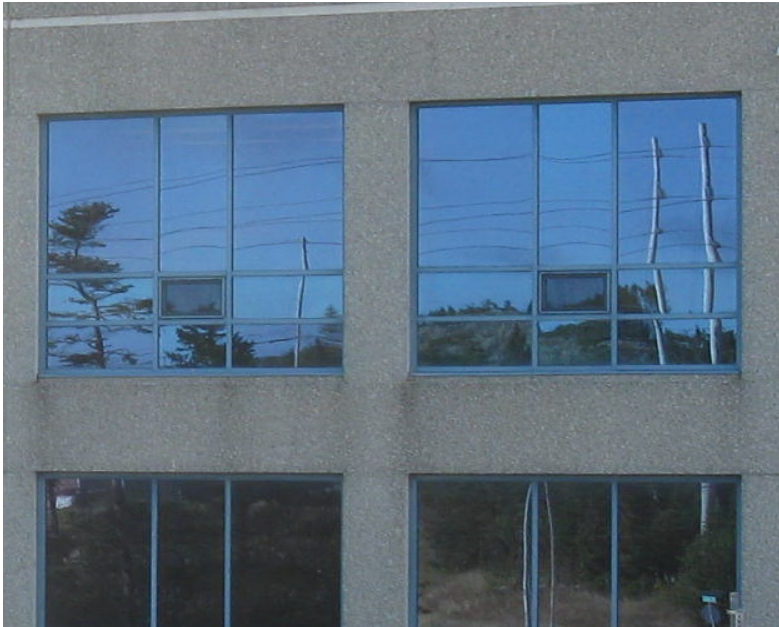
Stains from various sources are visible on the surface of some panels. Stains that occur as a result of water runoff from adjacent window sills can be found on all sides of the building (Photo 13). Staining from water runoff has occurred around some of the mechanical system louvres as well. Some rust stains are visible around sleeves for building service equipment such fire protection standpipes, light fixtures, external alarms and around exposed anchors where equipment and or signage has been removed (Photo 14 and 15). The staining does not affect the structural integrity of the panels and is more of an aesthetic issue.

Photo 13: Water runoff stains adjacent to windows.

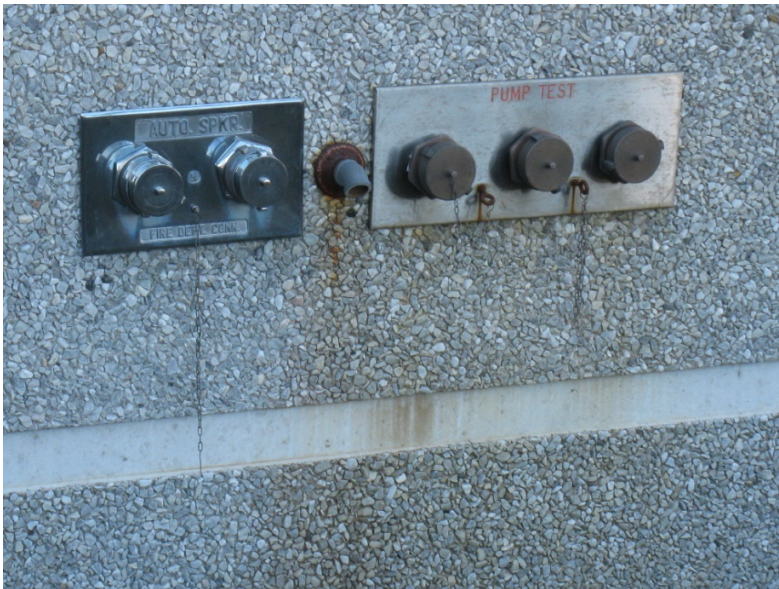
Photo 14: Stains/rust around building service equipment.

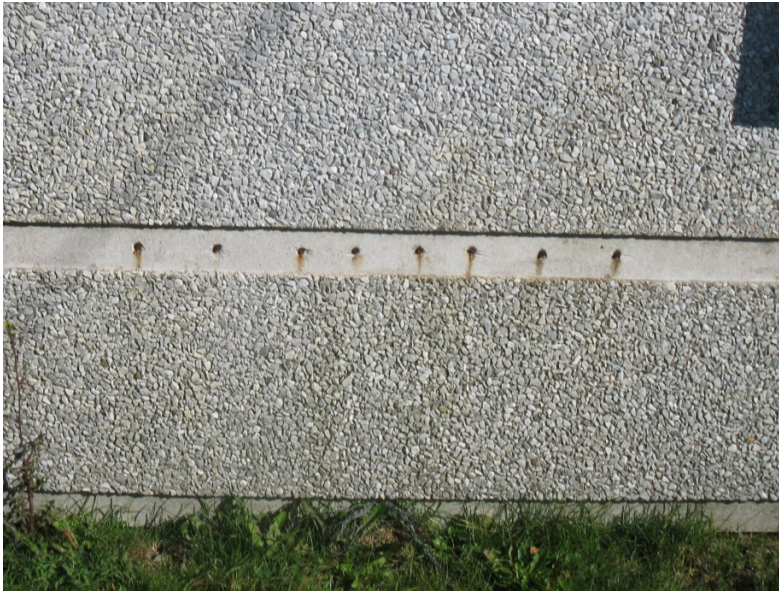
Photo 15: Rust at exposed anchors.

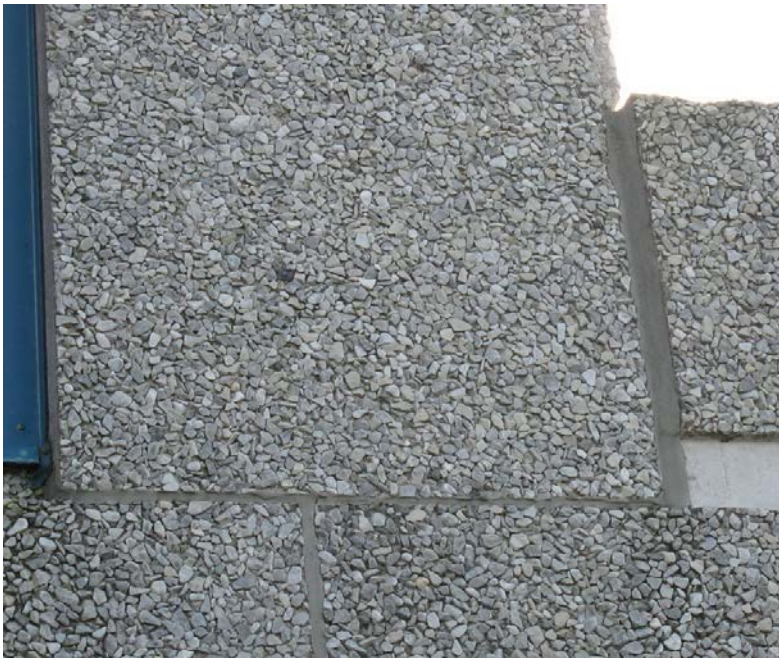
Typical joint widths observed on site are approximately 13mm ± but vary from 6mm to 50mm ± depending on location (Photo 16). At some locations joint width appears to have increased

Photo 16: Various joint widths.

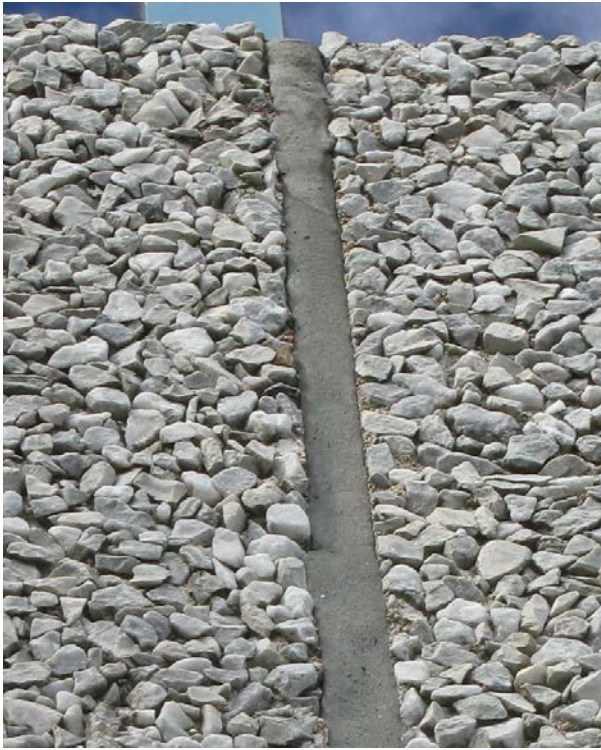
Photo 17: Joint sealant in fair but aged condition.

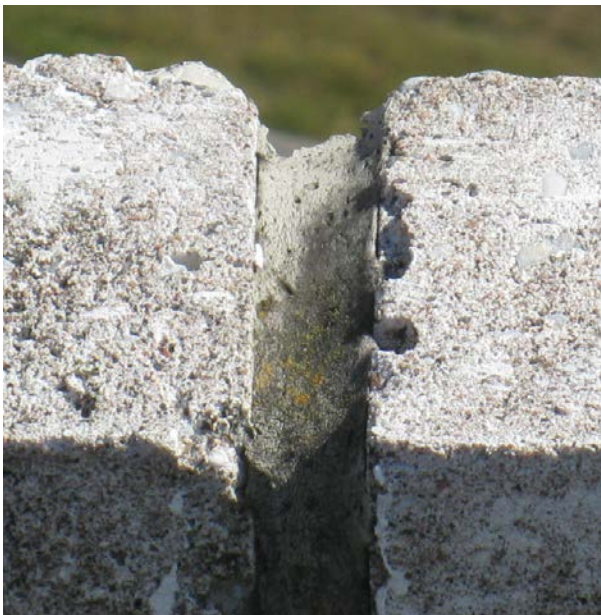
Photo 18: Joint sealant in fair but aged condition.

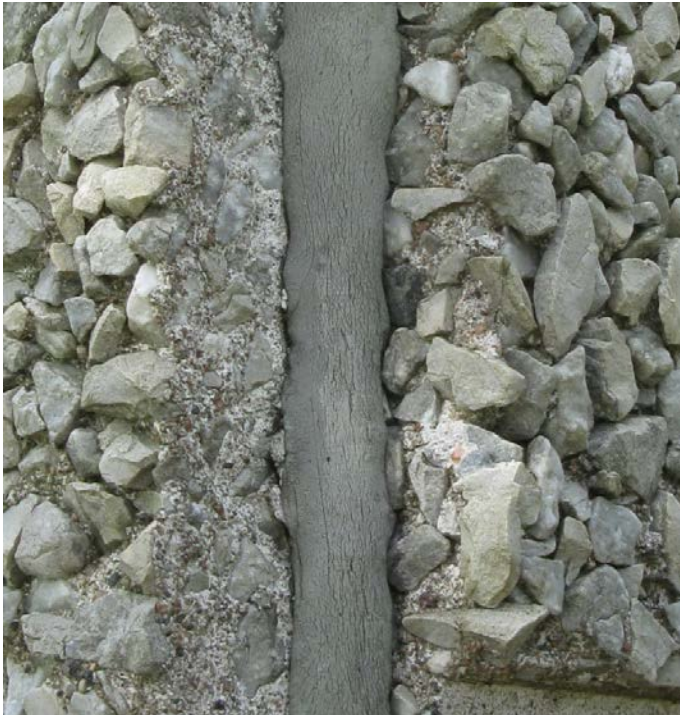
Hairline cracks and small fissures are visible on the surface of the sealant in other locations which indicates a portion of the sealant has dried out and become brittle (Photo 19 and 20). Sealant at some locations has partially detached from the precast panels on one side and in some cases on both sides of the joint (Photo 21 and 22). Complete detachment has occurred in some locations with sagging sealant and exposed foam rod backing visible in the joints which may be a result of panel shrinkage. Sealant at a number of locations is a lighter colour and appears to be new which suggests that repairs have been previously completed.

Photo 19: Hairline cracks in sealant.

1. That all of the joints between panels be revisited, and treated according to their existing state or condition – (A) where completely missing, put in new foam backer rod, treat the surfaces to be sealed, and apply a new latest technology or state of art sealant, (B) where pulled away on one side, sealant removed, surface cleaned and treated and replaced with new, (C) where still in service, surface cleaned, and re-parged with a compatible new sealant.

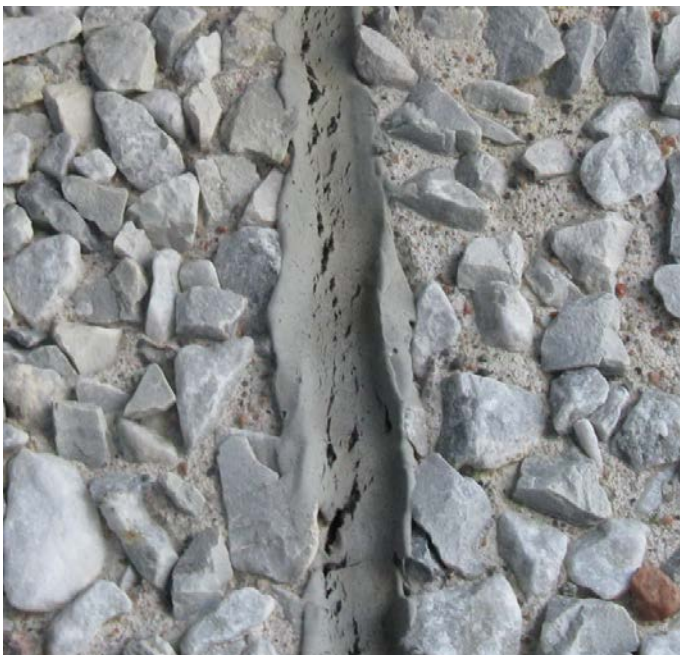
Photo 20: Fissures in sealant.

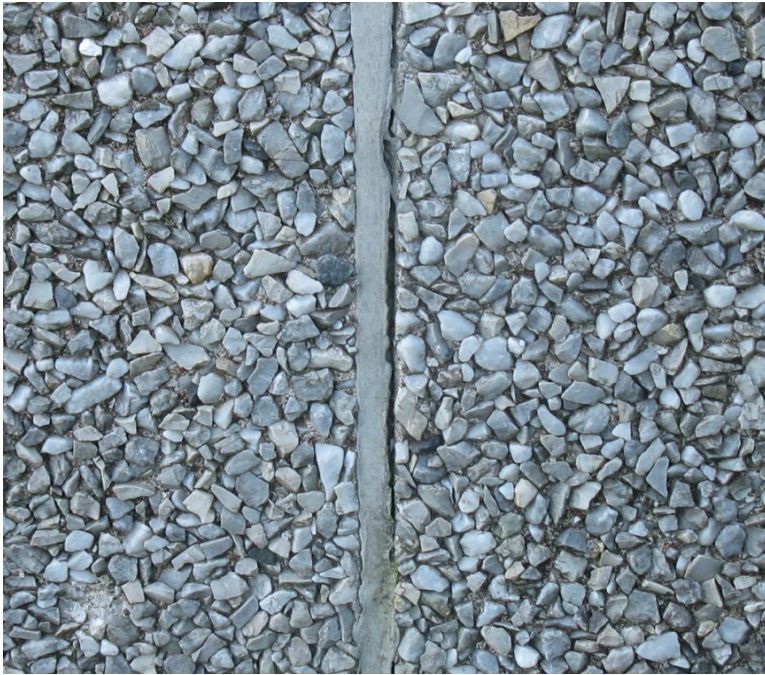
Photo 21: Sealant partially detached on one side of joint.

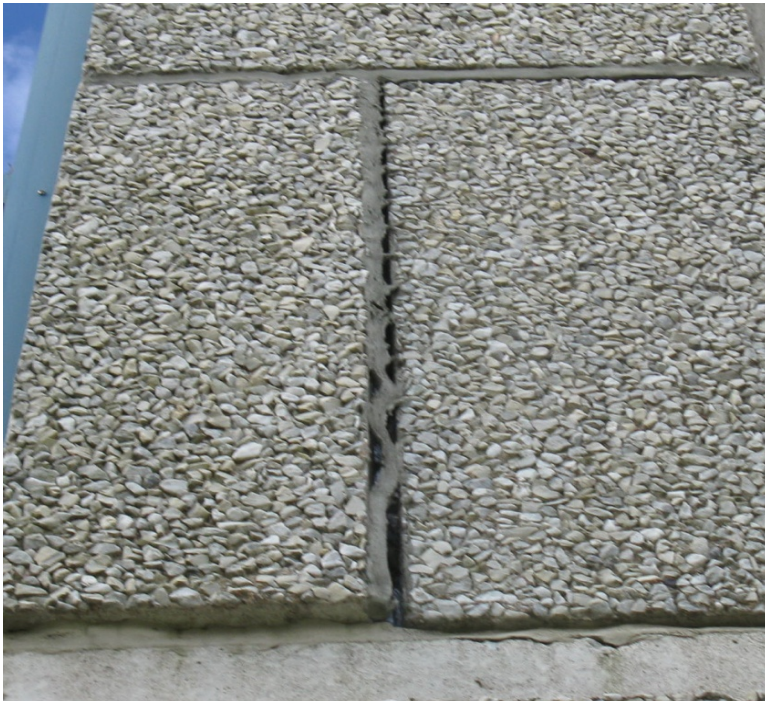
Photo 22: Sealant detached on both sides of joint.

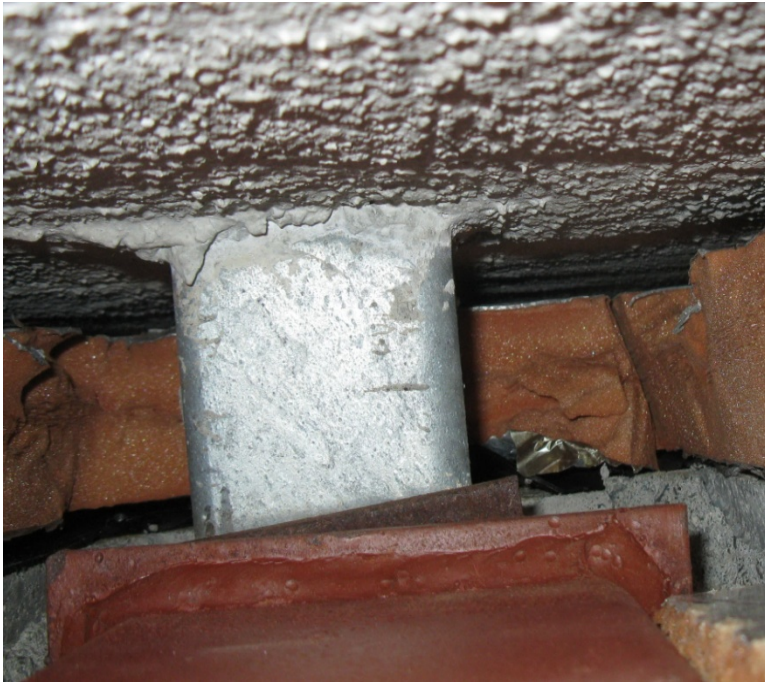
Photo 23: Hollow structural steel panel support.

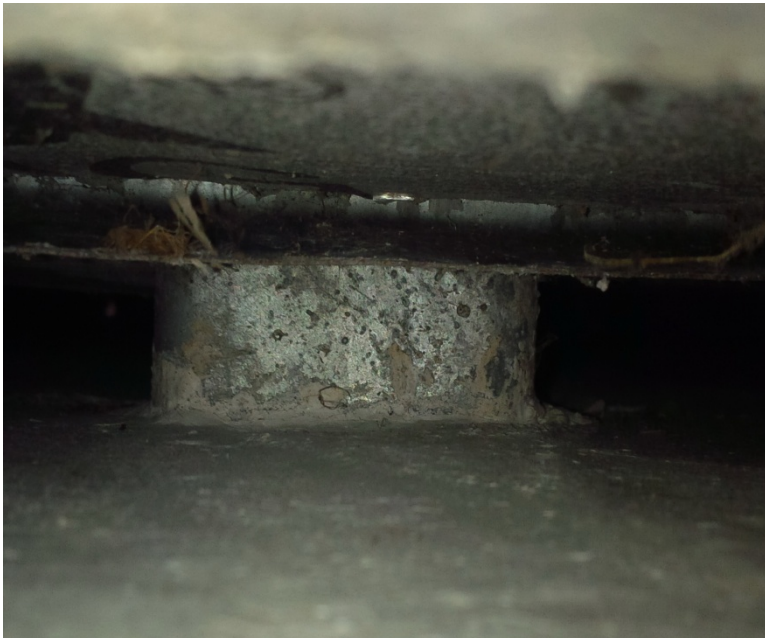
Photo 24: Hollow structural steel panel support.

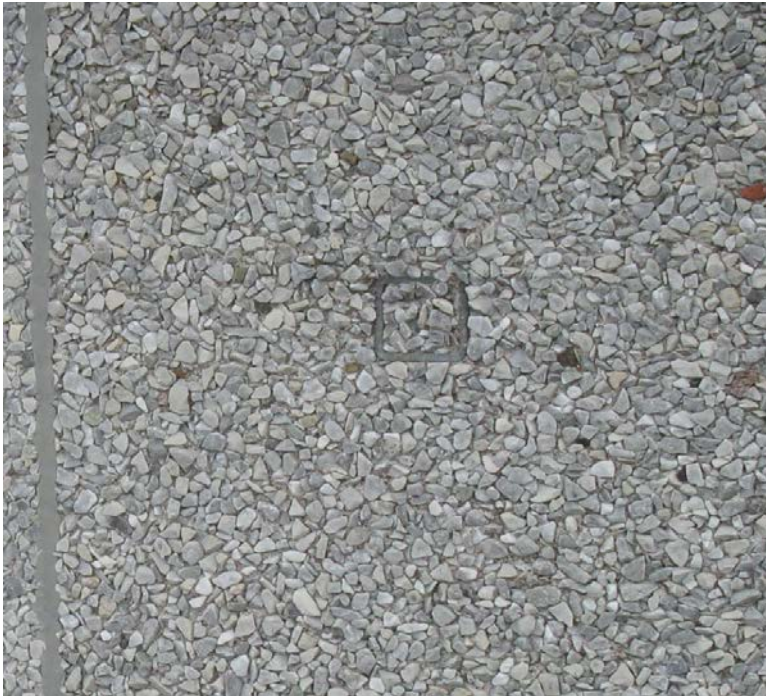
Photo 25: Visible panel support at exterior.

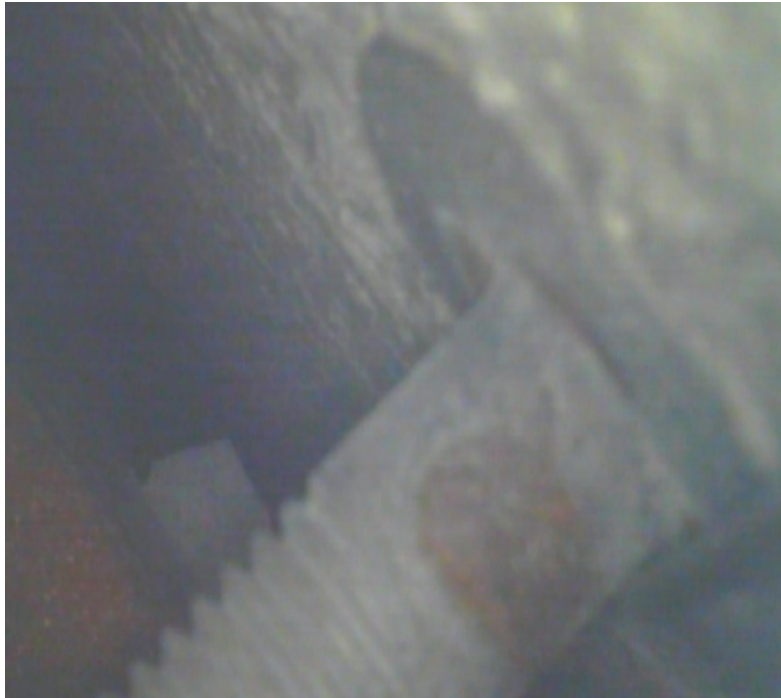
The second anchoring system was only evident at the third floor penthouse. It consisted of using fairly large diameter bolts (Photo 26 and 27). Narrow width precast panels located mainly between windows are supported at the bottom with galvanized steel support angles (Photo 28).

Photo 27: Large diameter panel support bolt.

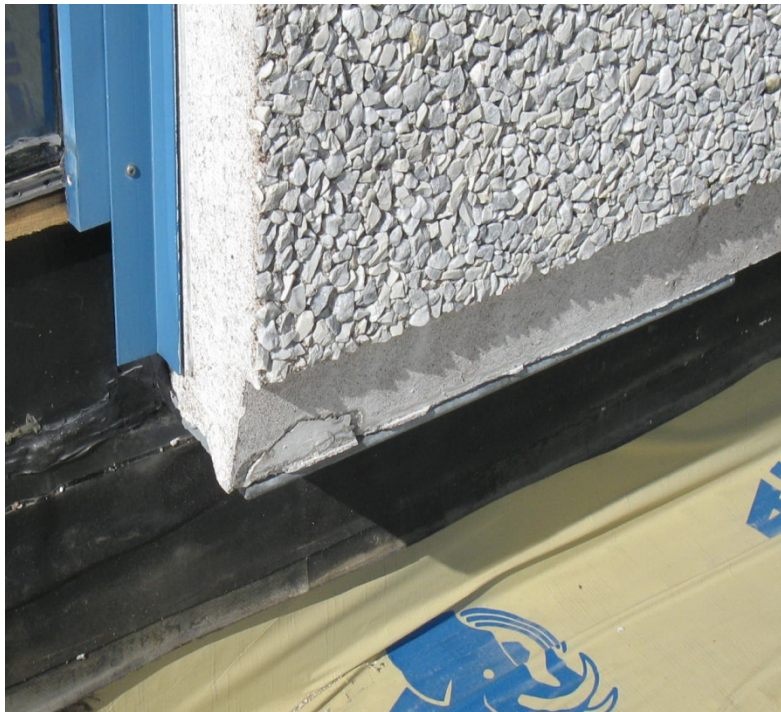
Photo 28: Galvanized steel angle at panel bottom.

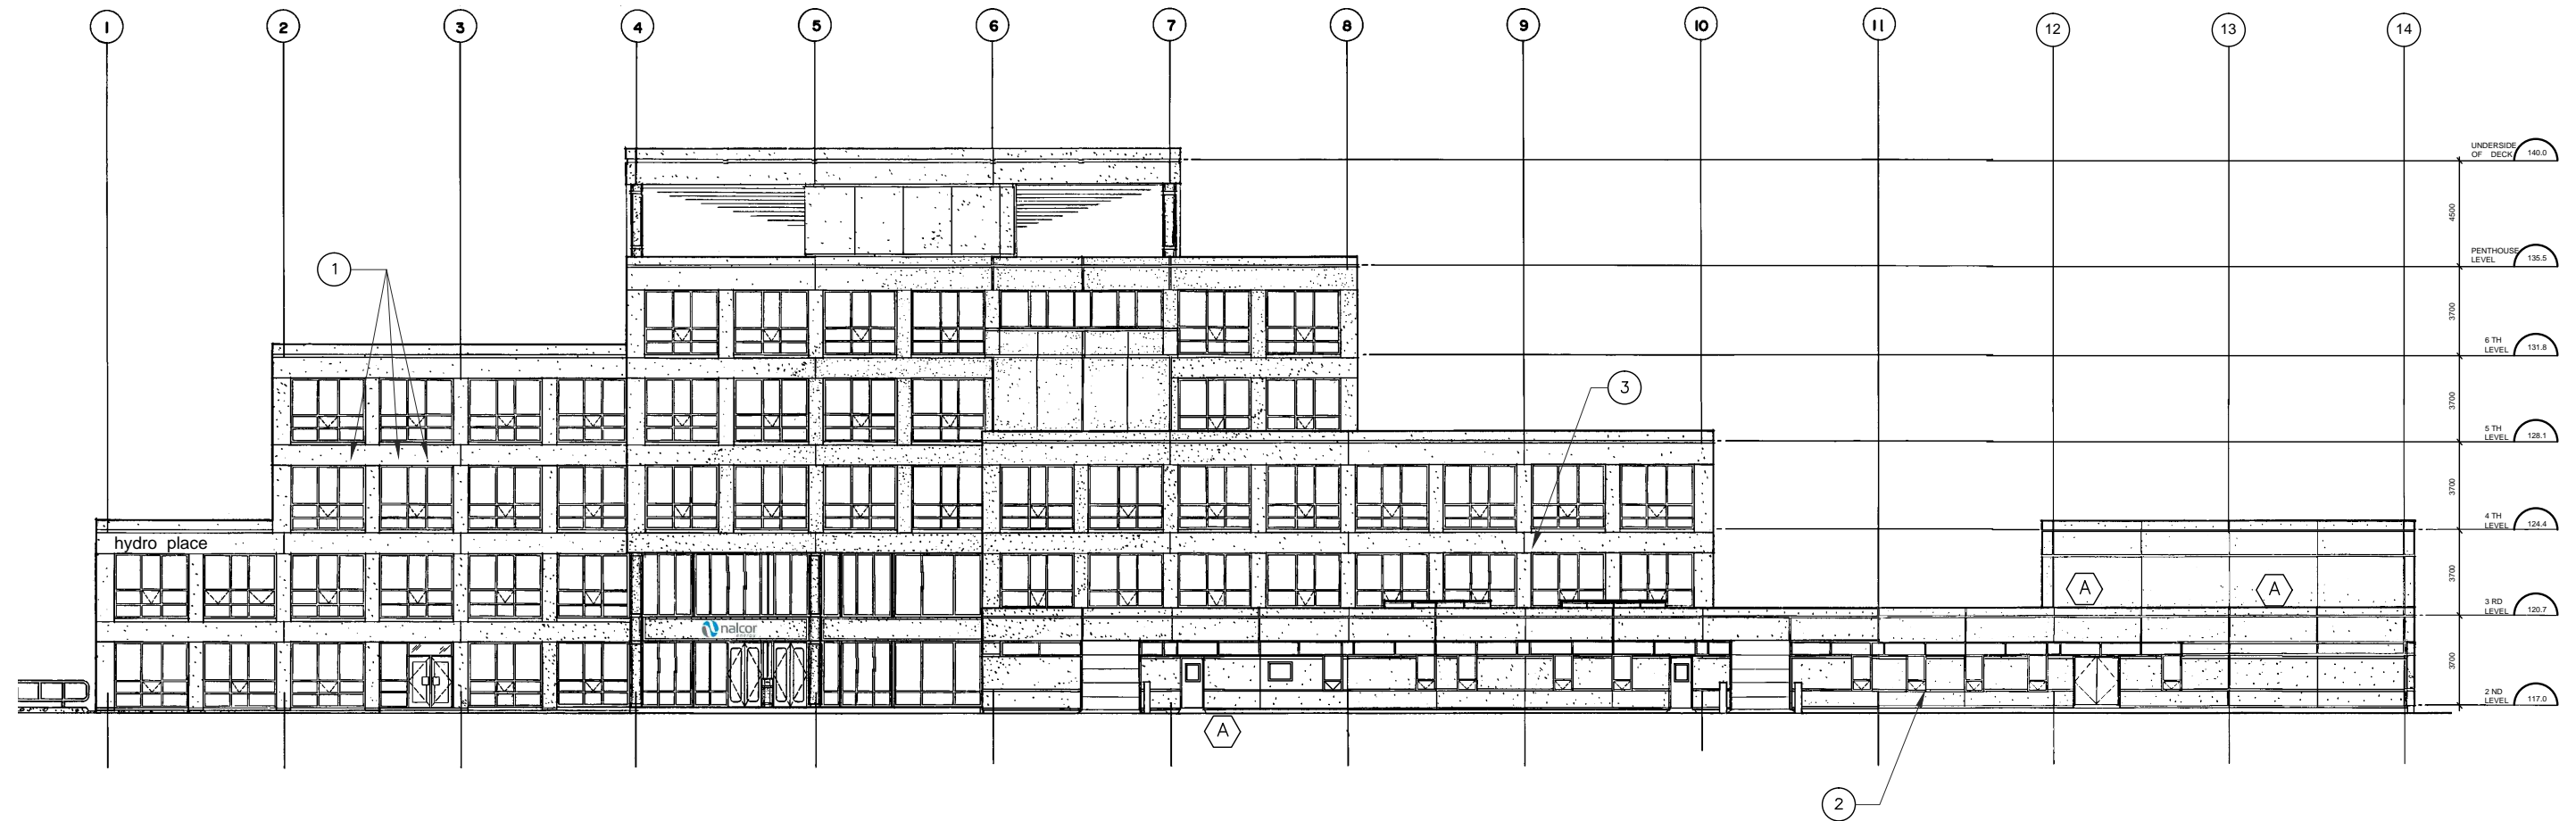
WEST ELEVATION

- ① EFFLORESCENCE CRYSTALS AND MINOR CRACKS.
- ② MINOR CRACKS.
- ③ MINOR SPALL.
- ④ EXPOSED END OF STEEL ON FACE OF PANEL.

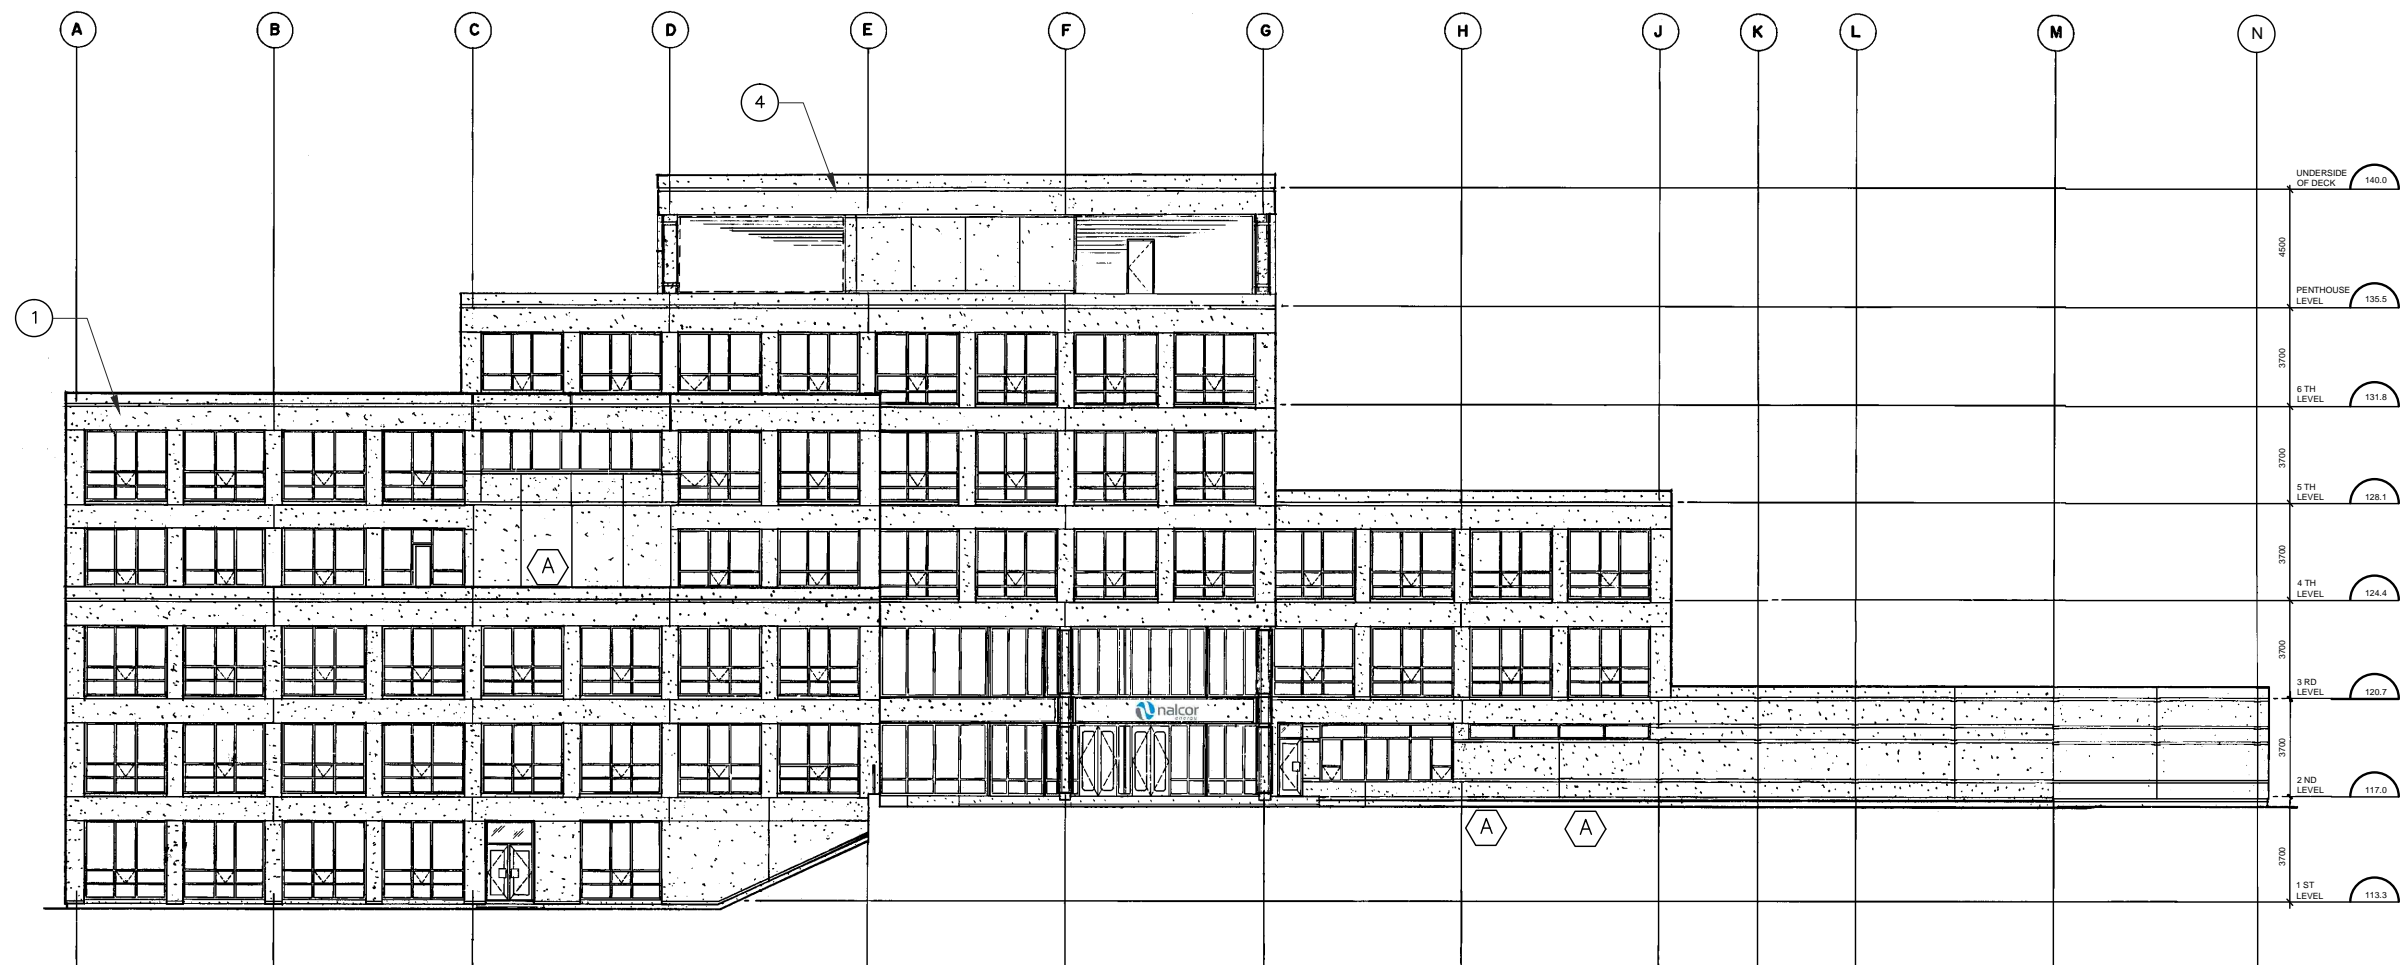
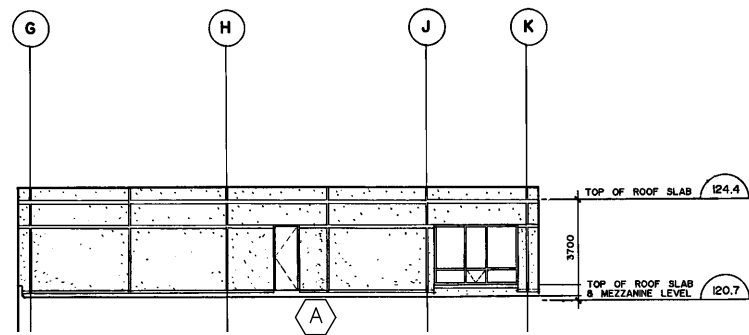
NORTH ELEVATION

- ① EFFLORESCENCE CRYSTALS AND MINOR CRACKS.
- ② MINOR CRACKS.
- ③ MINOR SPALL.
- ④ EXPOSED END OF STEEL ON FACE OF PANEL.

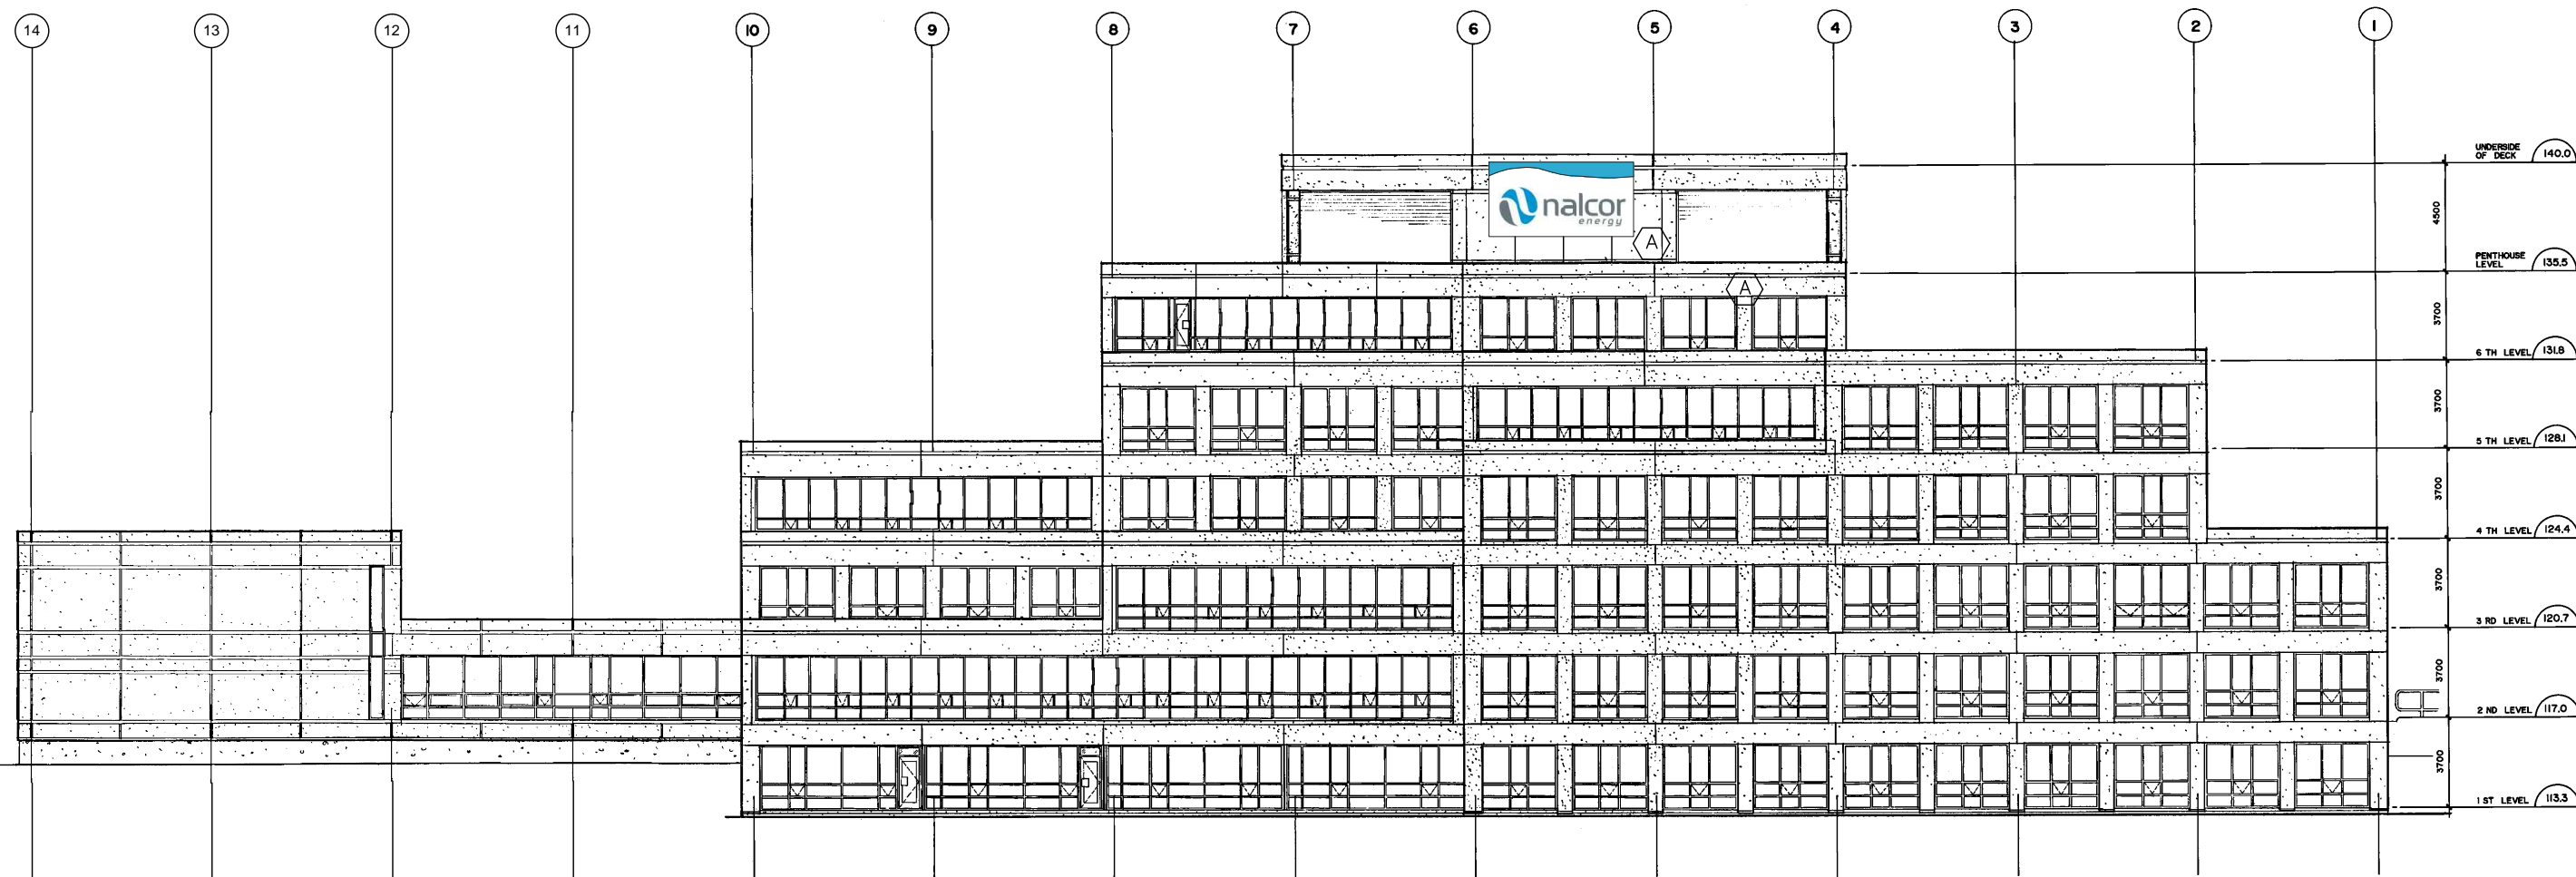
EAST ELEVATION

- ① EFFLORESCENCE CRYSTALS AND MINOR CRACKS.
- ② MINOR CRACKS.
- ③ MINOR SPALL.
- ④ EXPOSED END OF STEEL ON FACE OF PANEL.
