EXTERIOR PRECAST CONCRETE PANEL ASSESSMENT

HYDRO PLACE
500 Columbus Drive, St. John's, NL A1B 4K7

NEWFOUNDLAND LABRADOR HYDRO

REPORT > ORIGINAL > FINAL
Rev. C01 > Internal ref. 632109-0001-t-44-rep-000-0001

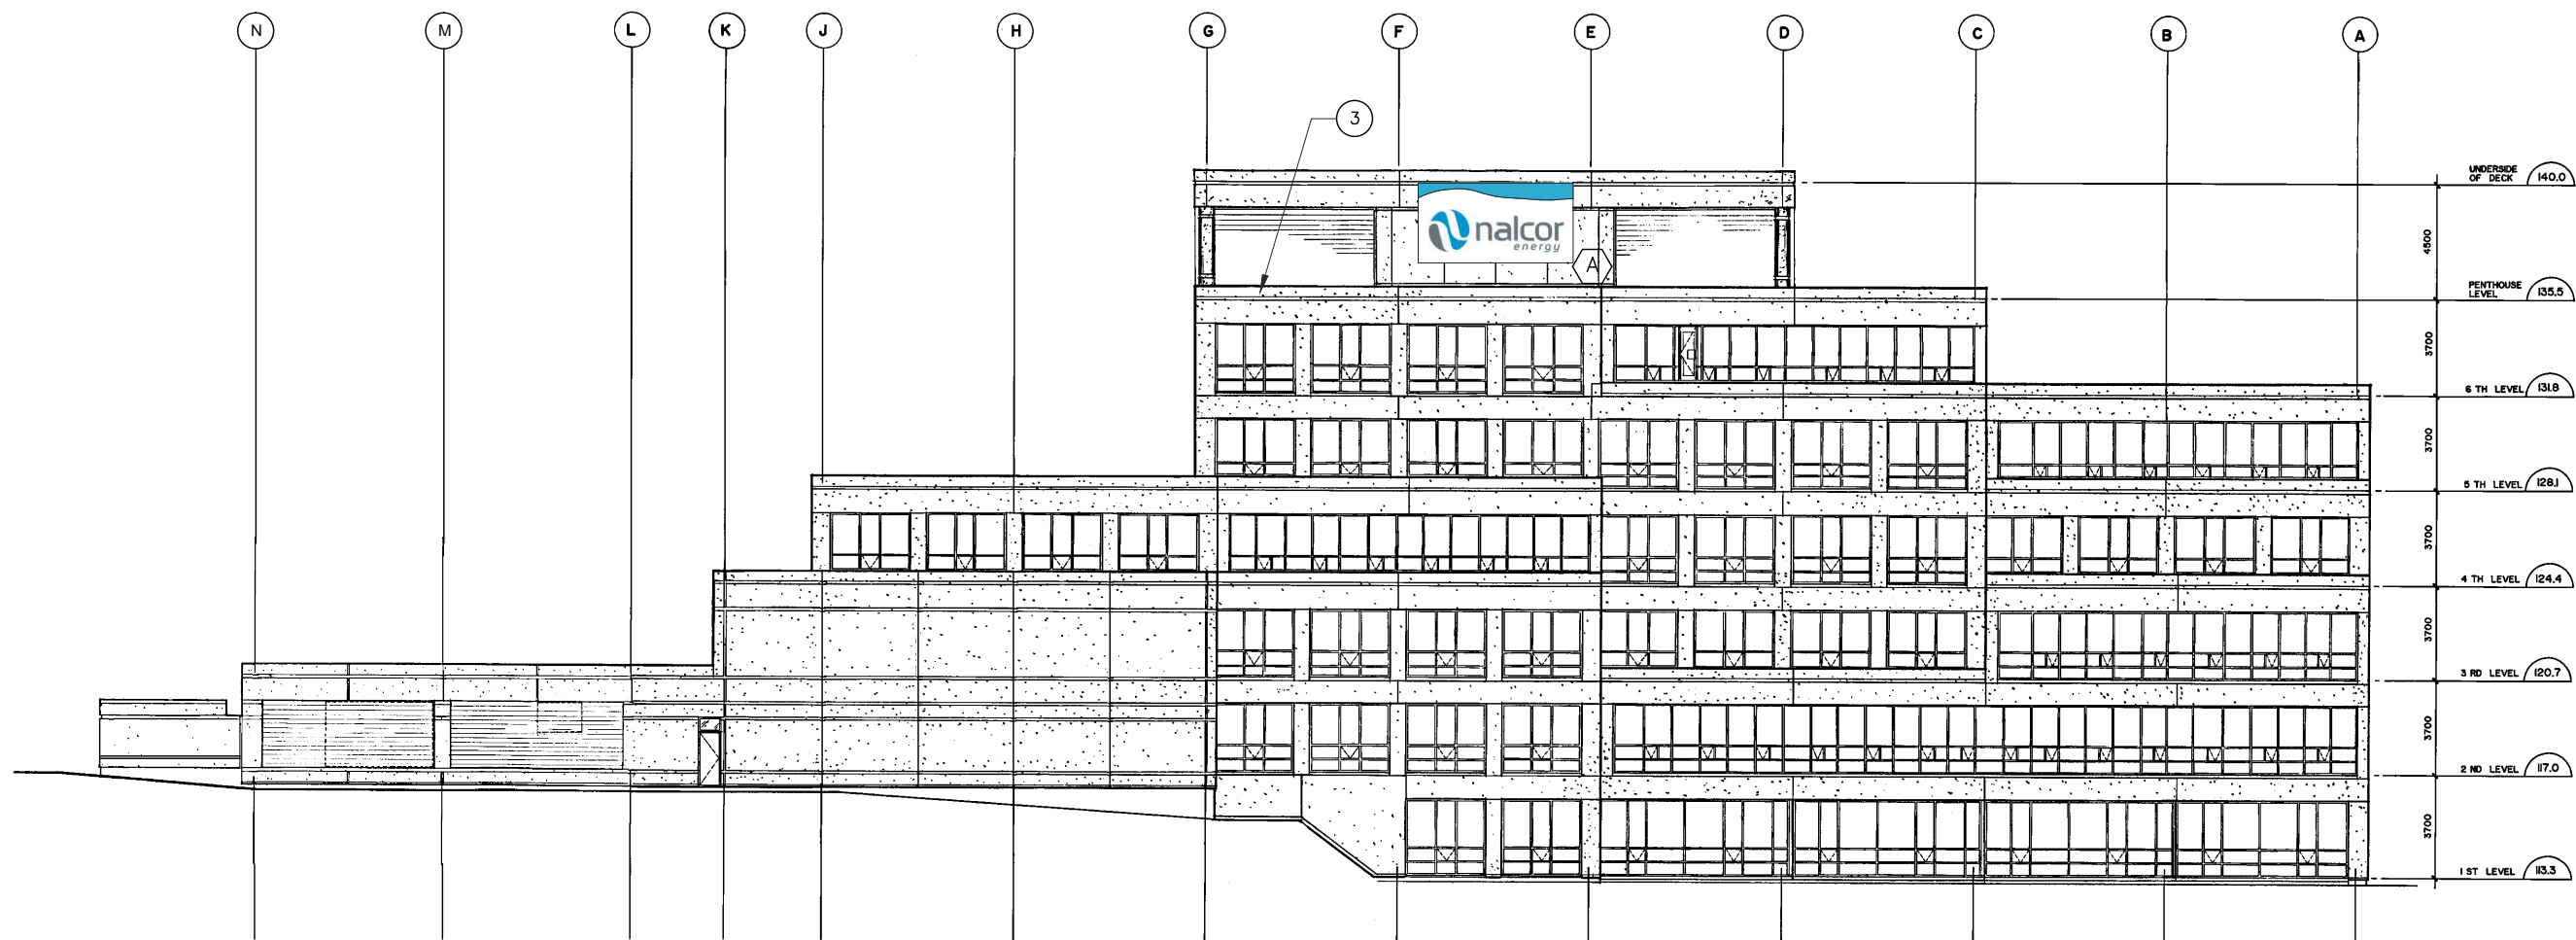
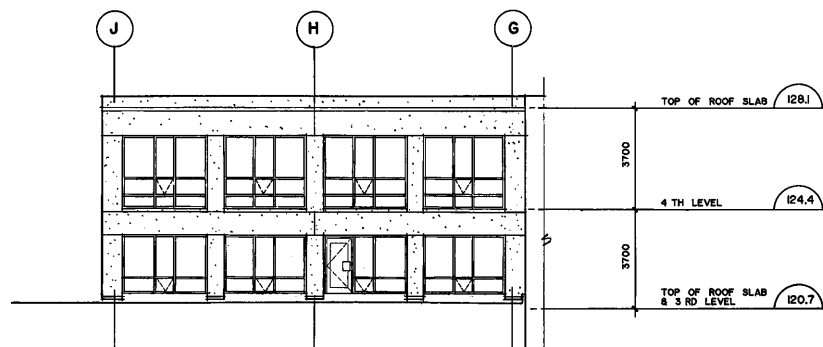
SOUTH ELEVATION

- ① EFFLORESCENCE CRYSTALS AND MINOR CRACKS.
- ② MINOR CRACKS.
- ③ MINOR SPALL.
- ④ EXPOSED END OF STEEL ON FACE OF PANEL.
