1   **Re: D-85, Replace Radio Tower, Ebbegunbaeg, \$179,000**

## STRUCTURAL ASSESSMENT

### EXISTING 30m KNOCK-DOWN SELF-SUPPORT TOWER

Ebbegunbaeg, NL

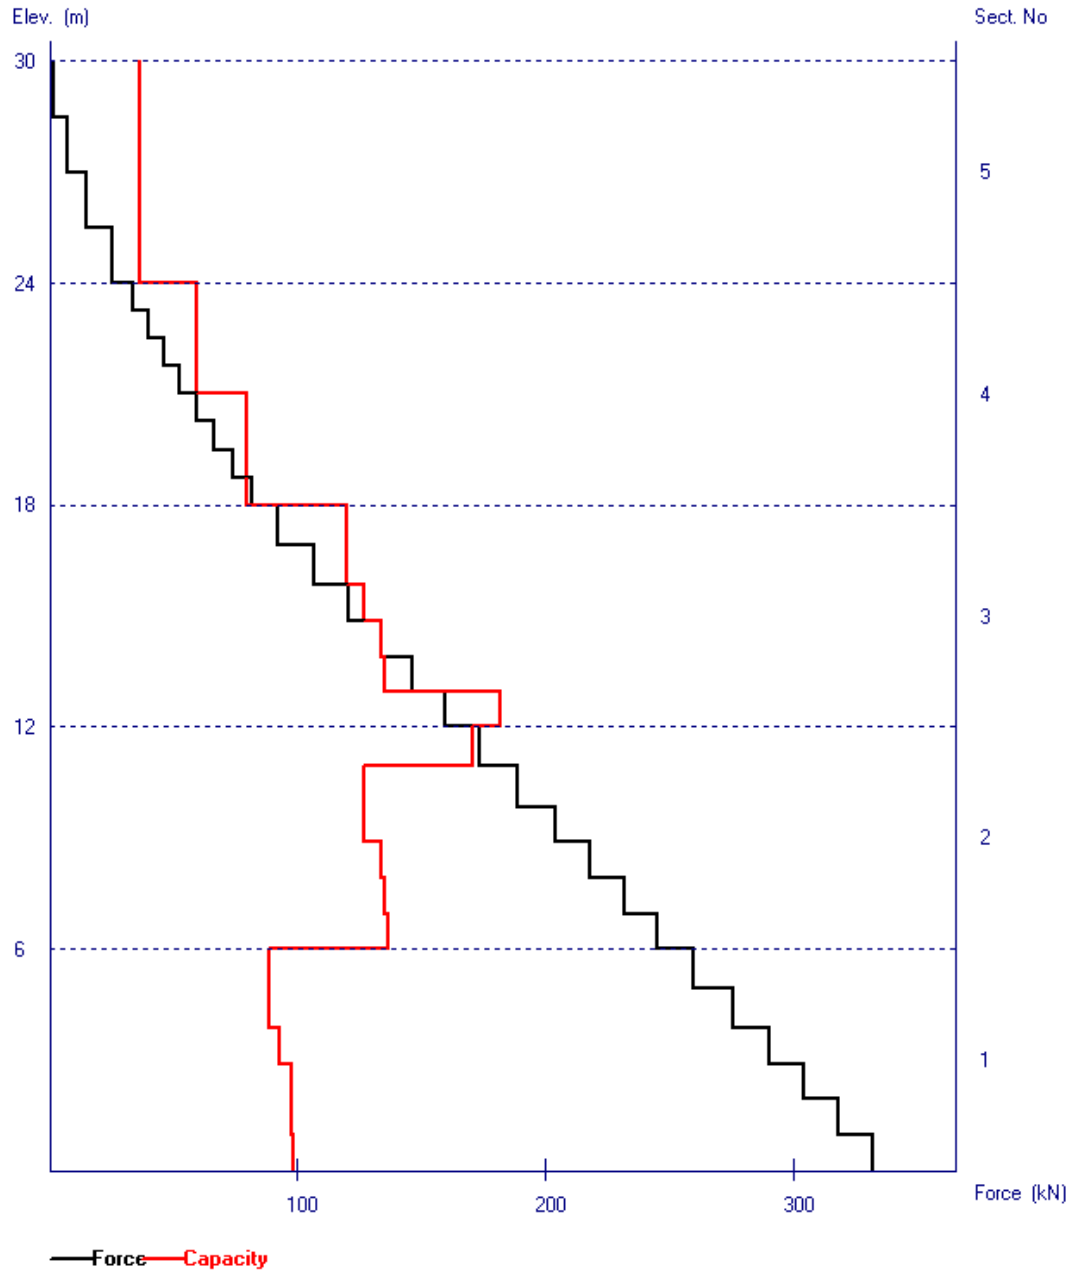
**Leg Load Compression Diagram**  
**Max. Envelope (All Loading Cases)**

- TOWER LEGS: **OVERLOADS 338% Utilization**
- TOWER DIAGONALS: **OVERLOADS 105% Utilization**
- TOWER HORIZONTALS: **NO OVERLOADS 3% Utilization**

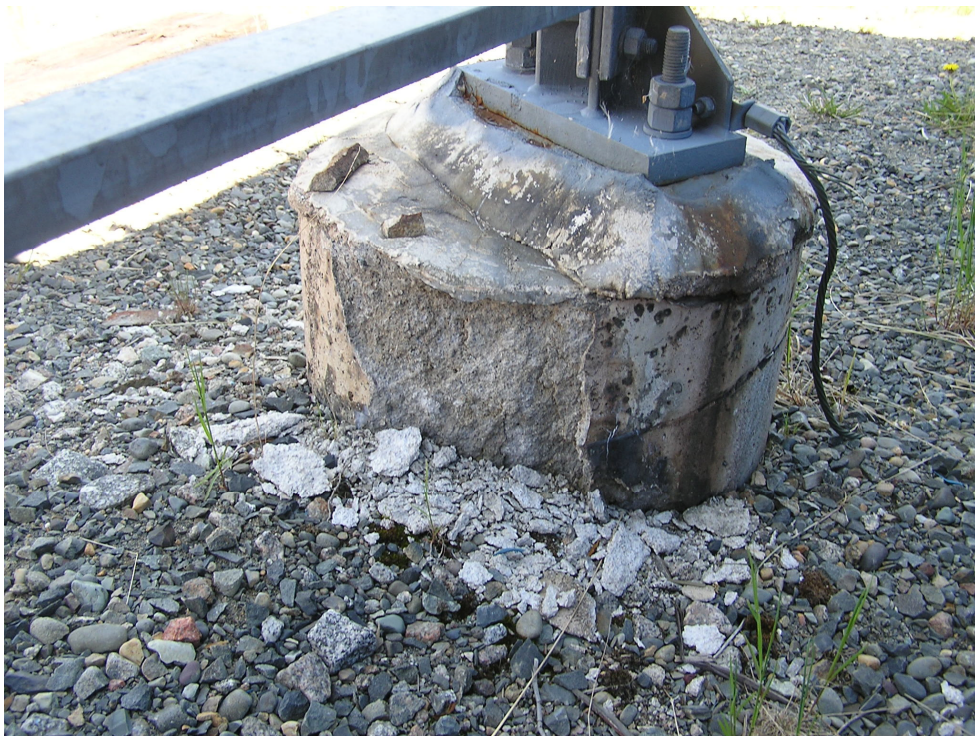
The analysis considered all existing loading for the Ebbegunbaeg tower. The EBB tower exhibits tower leg overloads over 300% and minor diagonal overloads. In addition to leg overloads the existing condition of the tower foundation is deteriorated and requires structural repairs (See Appendix C, Photos #3 & #4). As a result of the extensive leg overloads and deteriorated tower foundations we recommend a full replacement of this tower. As a temporary cautionary measure we recommend installing signage indicating that the tower does not meet CSA-S37-01 requirement and should not be climbed during icing or high wind conditions.

Photo #3: Deteriorated Foundation

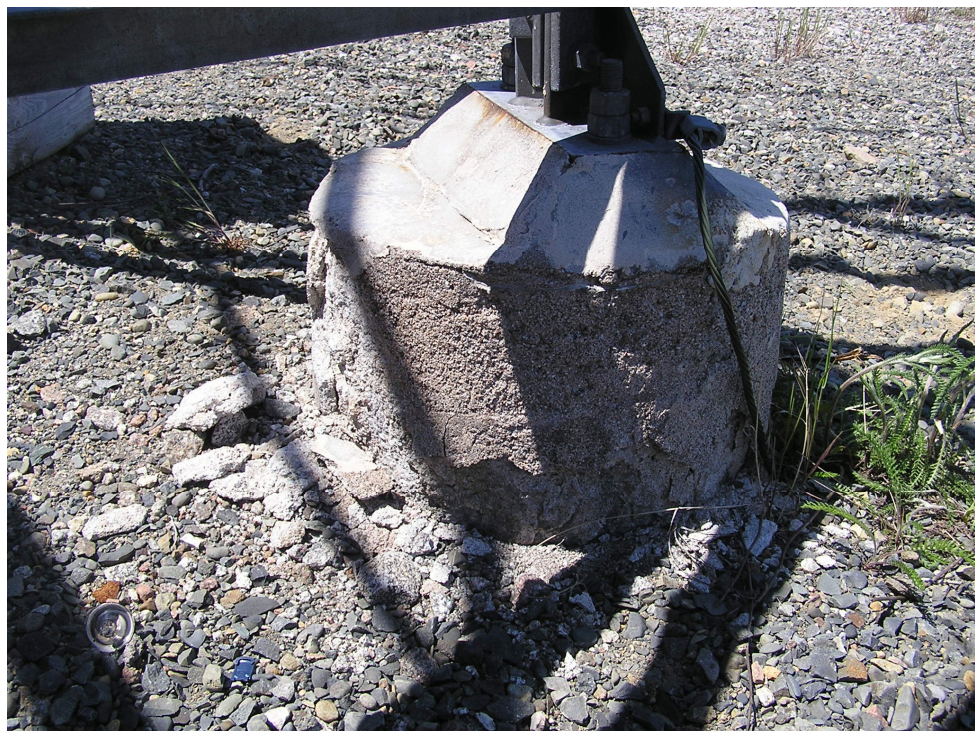
Photo #4: Deteriorated Foundation
