1 **Q. Re: Report by Trina Cormier, B. Eng., “Rocky Pond Hydro Plant Refurbishment”**
2 **(Section 1.2, p. 3) - Does NP have recent photographs of the area of the March 8,**
3 **2008 substantial leak showing the post-repair condition of that area of the**
4 **penstock?**

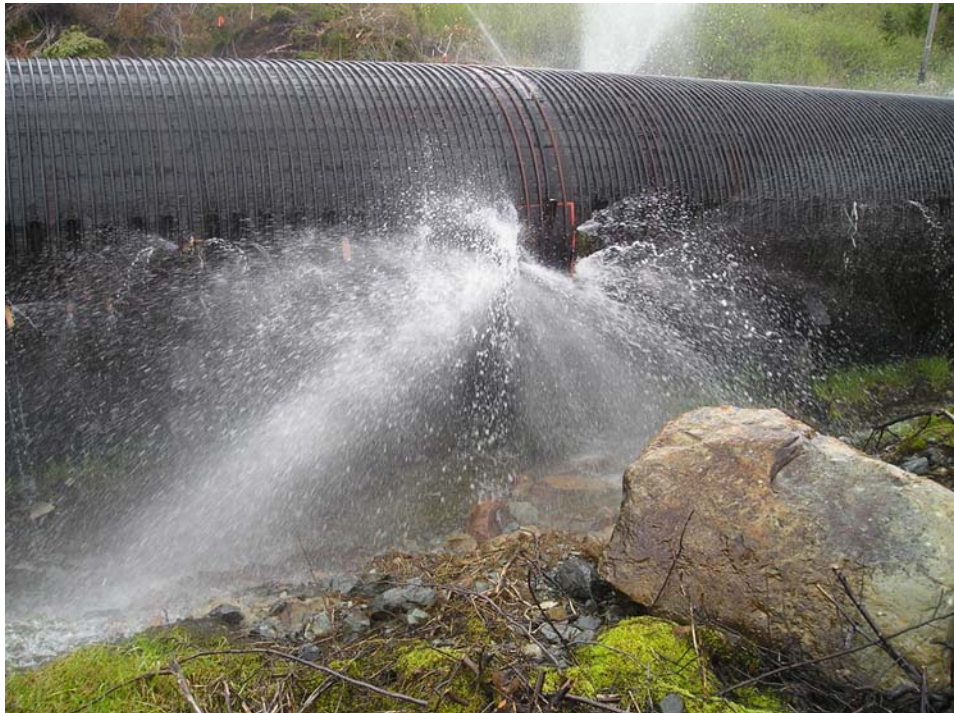
5
6 **A.** Figure 1 shows the post-repair condition of the area of the penstock where the March 8,
7 2008 substantial leak developed. As depicted by the photograph there are leaks that have
8 developed in areas immediately adjacent to the area since the repair was made.
9

10
12
14
16
18
20
22
24
26
28
30
32
34
36
38
40
42
44
46
48
50
51 **Figure 1 – Post-Repair Area of March 8 Major Leak**
52 **(Photo: July 13th, 2008)**

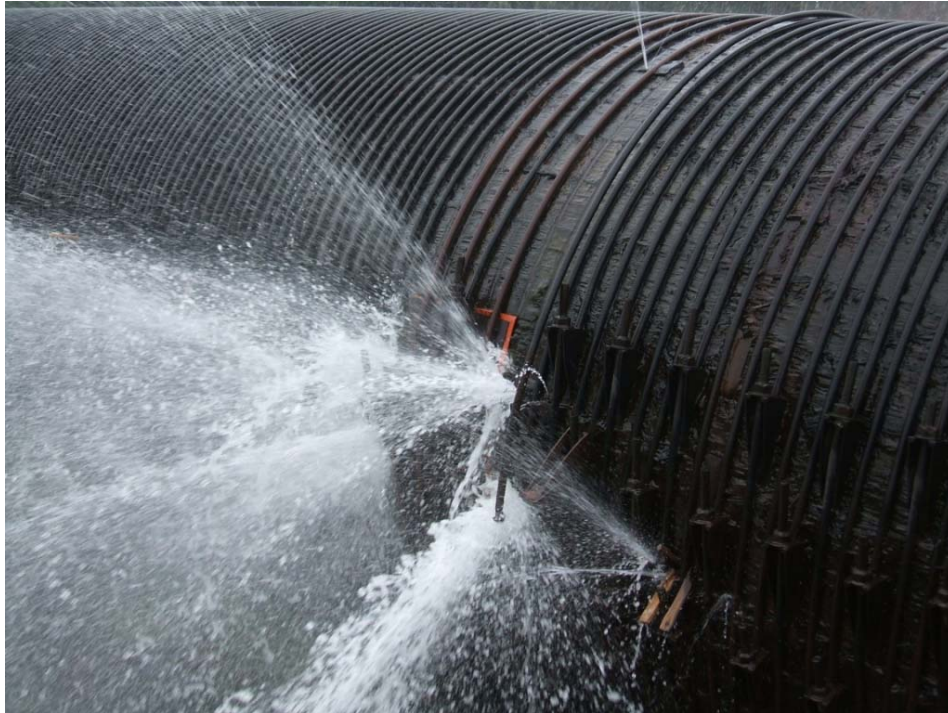
Figure 2 – Metal Patch Covering Area of March 8 Major Leak
(Photo: August 12th, 2008)

Figure 2 shows the area of the penstock where the March 8, 2008 substantial leak was repaired by placing a metal plate and gasket under the steel bands on the wood stave surface. At the centre of the picture a corner of the red gasket material is visible.
