2
3 **Heart's Content Seal Cove Pond Improvements. Please provide a copy of any dam**
4 **safety inspection reports in respect of this structure since 2006.**

2006 Dam Safety Inspection Report
Heart's Content Development

TIMBER-CRIB DAM

Structure :	<u>Seal Cove Pond Dam</u>	Date/Time :	<u>Jan 10, 2007</u>
Inspected by :	<u>G. Murray, B. Titford, G. Squires</u>	Water Level :	<u></u>
Weather :	<u>Overcast, 2°C</u>	Releases :	<u></u>

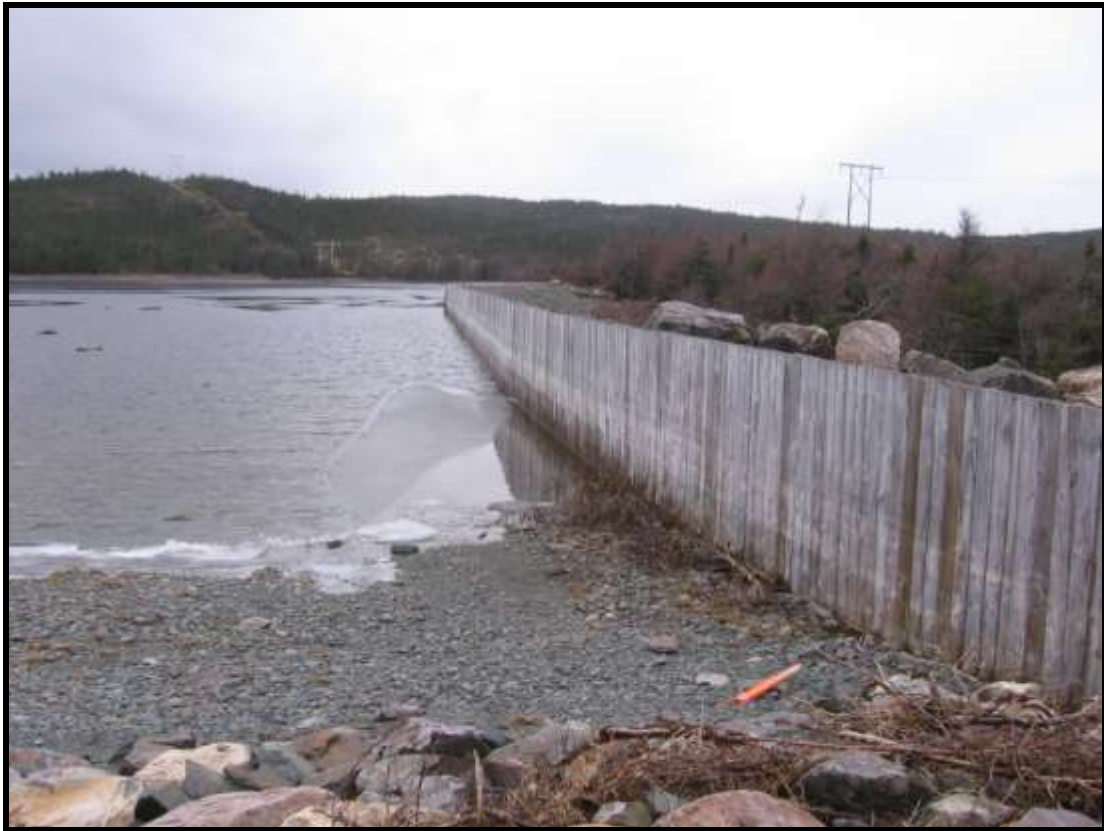
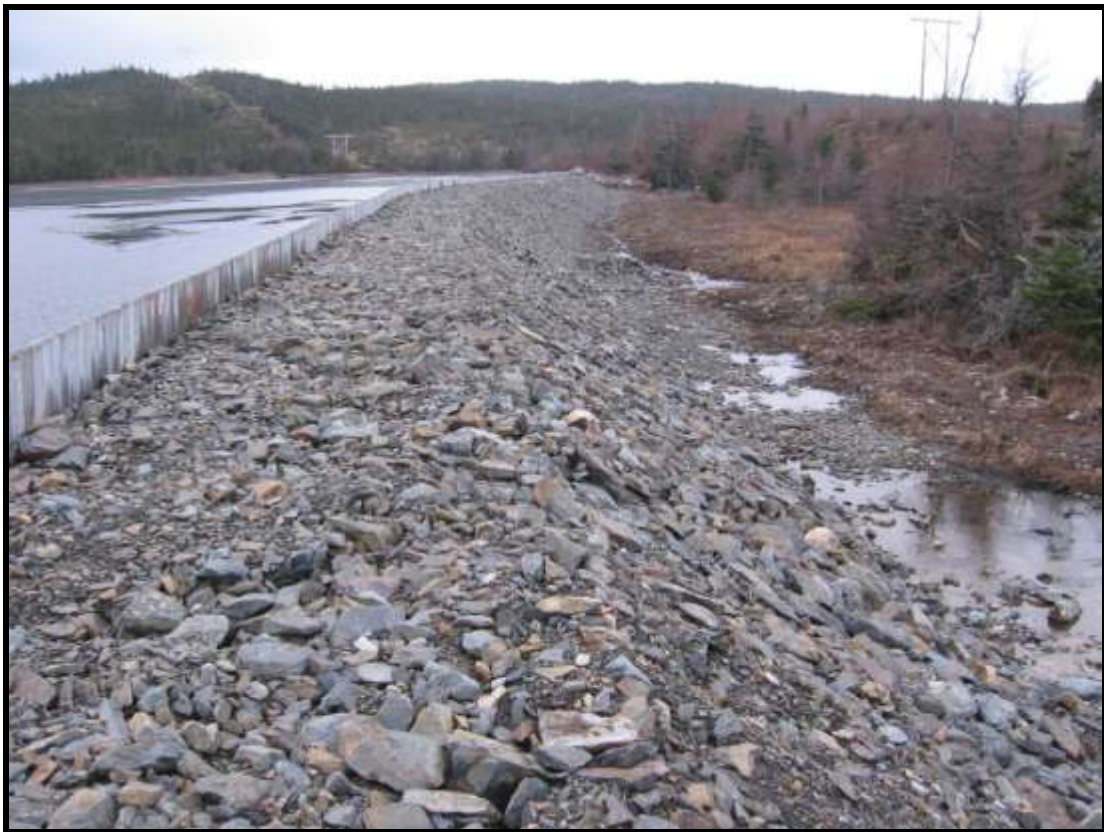
Rock fill cover in good condition. Unable to inspect timber structure.

Fair to good condition. Some misalignment (as previously reported).

Rock fill placed over D/S timber crib section during 2006.

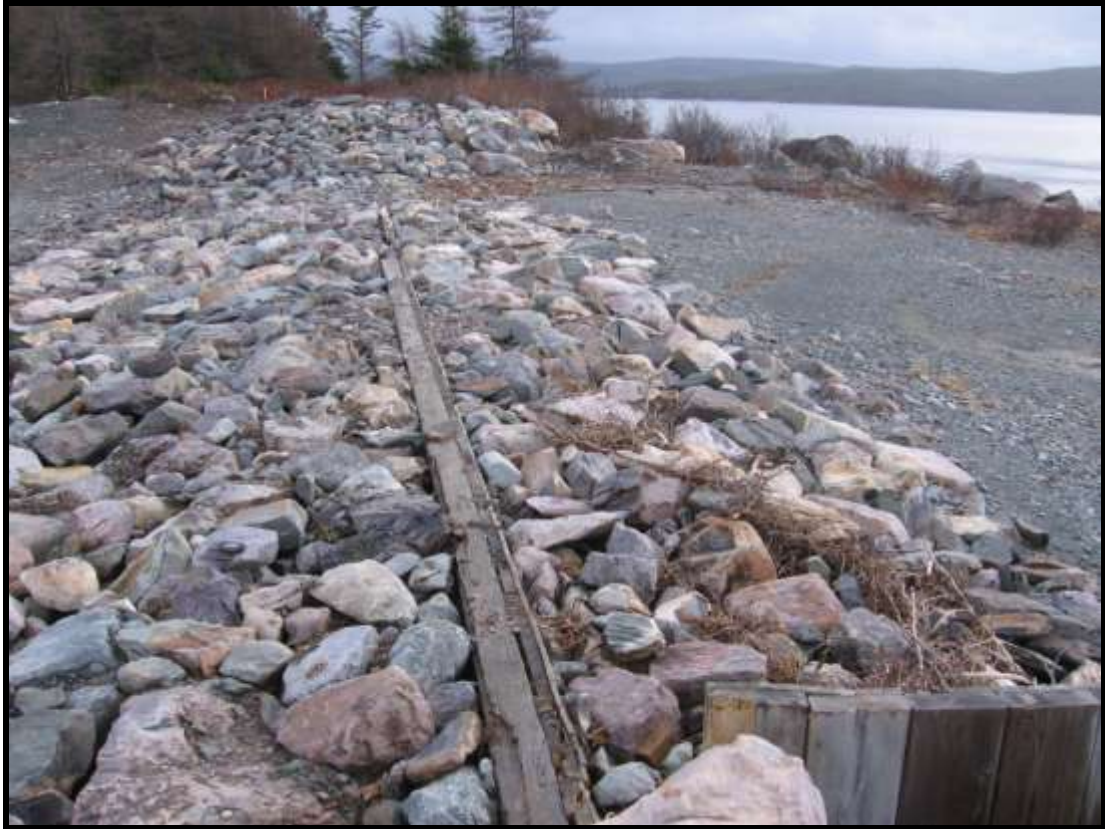
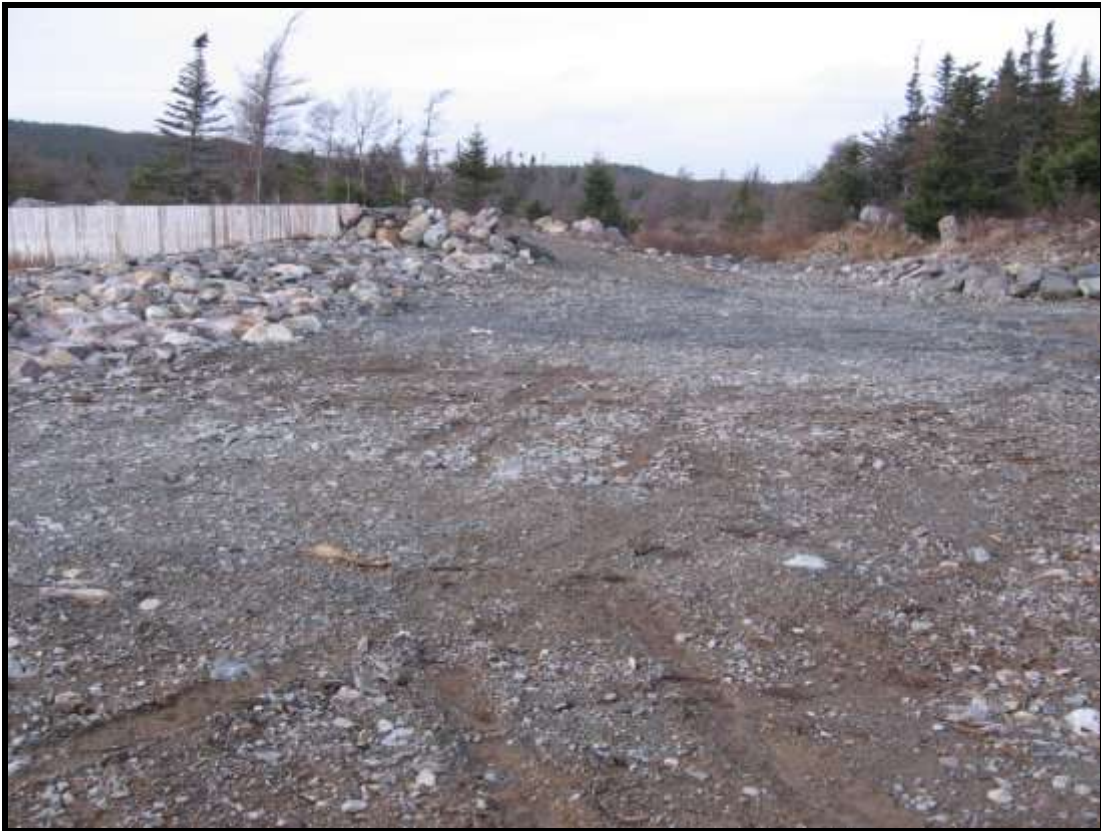
Good condition

No obstructions evident.

No obstructions

Timber crib apron and abutment removed and replaced with rock fill structure since last report.

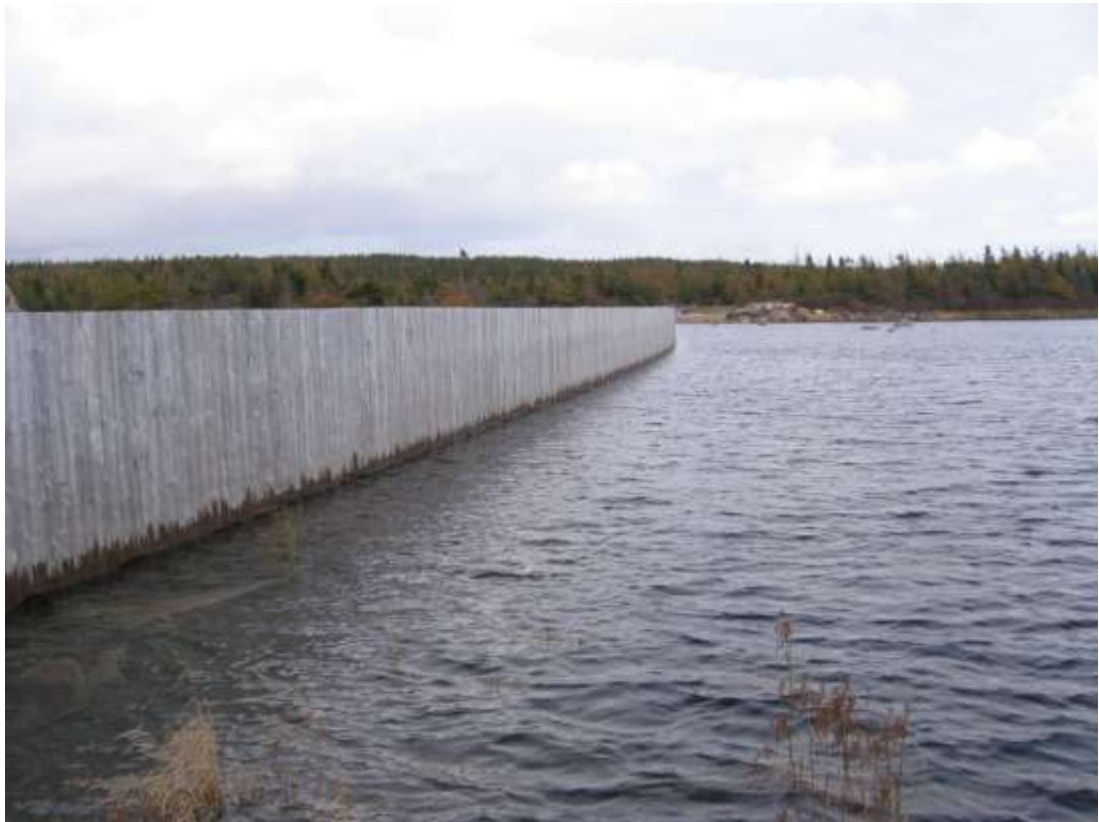
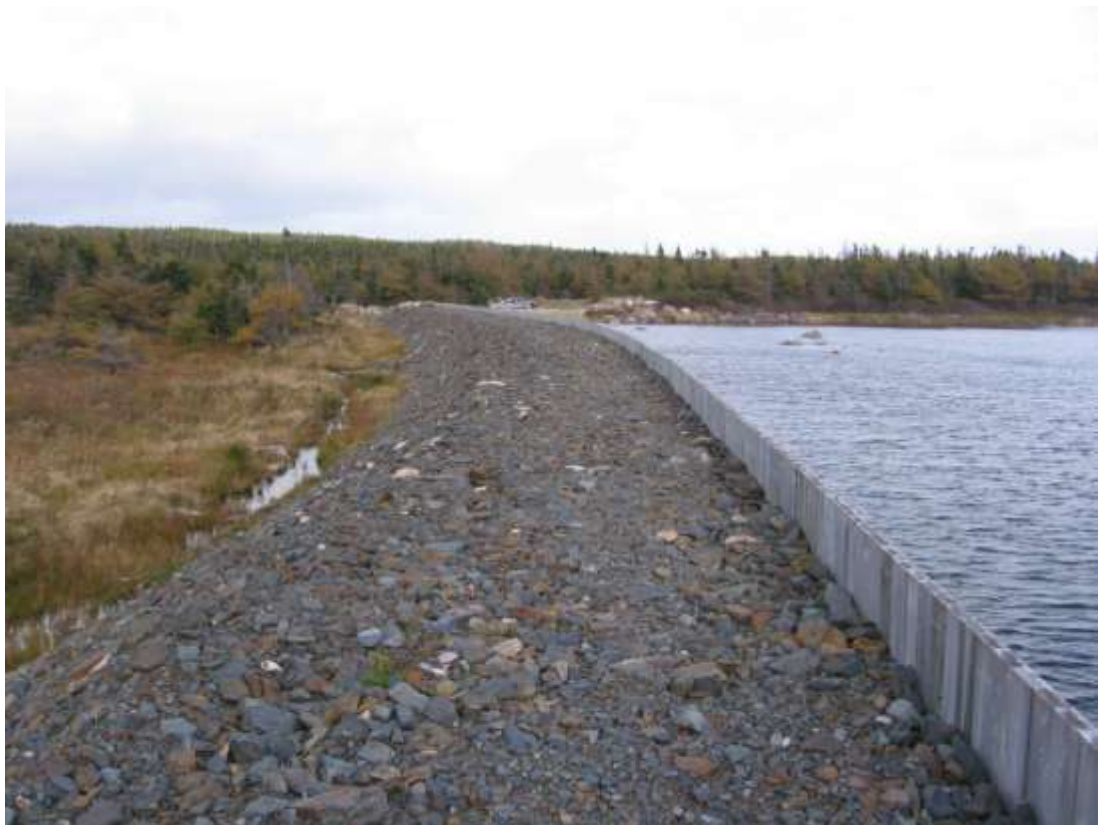
Rockfill cover in good condition. Unable to inspect timber structure under rockfill

Upstream face is deteriorating at and below water line and at attachment to timber crib. Also some misalignment along upstream face.

Rock fill placed over D/S timber crib section during 2006 to stabilize structure. Deterioration of timbers under rockfill is likely to continue. Leakage noted along the downstream toe is also expected to increase due to the deteriorated condition of the upstream face

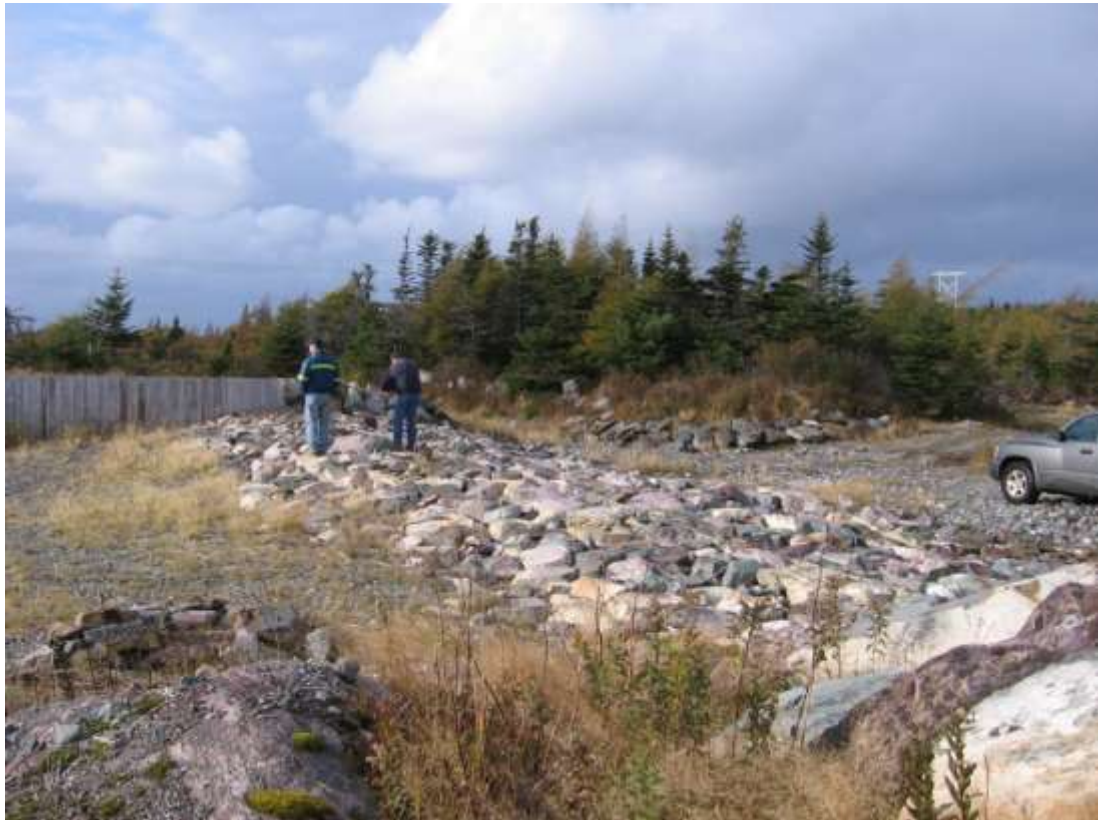
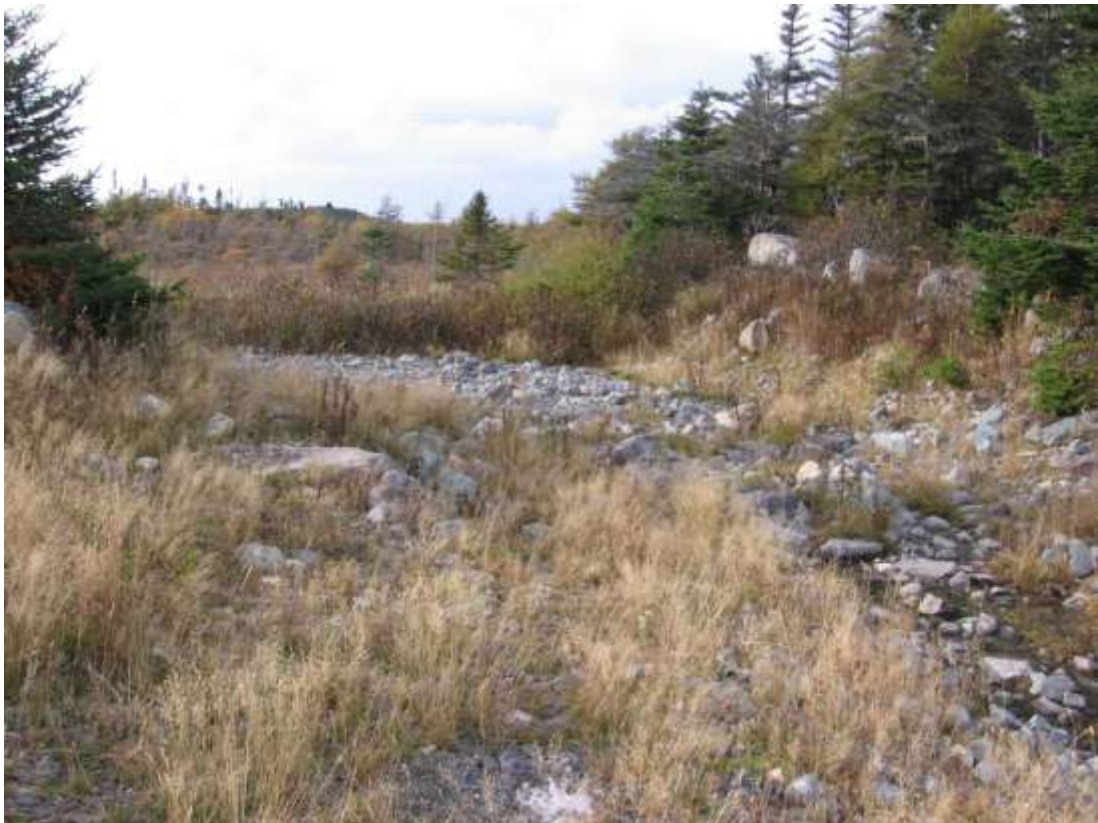
Spillway crest appears low near right abutment.

Minor debris at crest near left abutment.
