Q. Re 2011 Facility Rehabilitation - p. 2 - 3 of 100 - Tab 1.1

Heart's Content Seal Cove Pond Improvements. Does NP have any recent photos of the existing rock filled timber crib dam referred to at p. 1 of the report at Tab 1.1?

**Photographs of the
Rock Filled Timber Crib Dam
Heart's Content Seal Cove Pond**

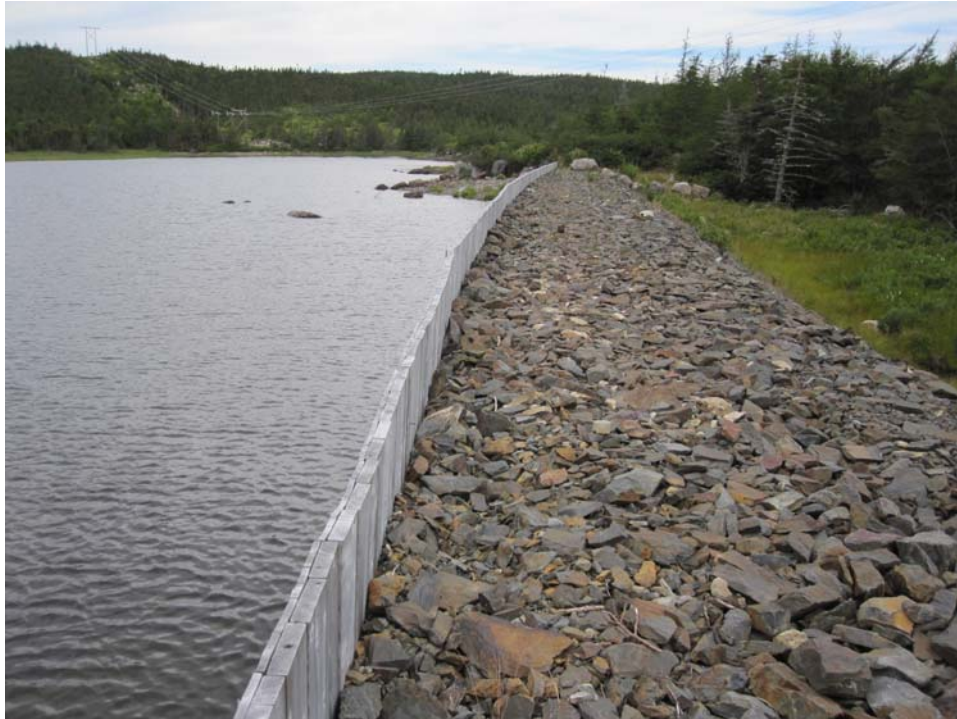
Figure 1

2010 picture showing the rock fill downstream of the dam, placed there in 2006 to increase the stability of the structure

In 2006, Heart's Content Seal Cove Pond Dam had rock fill added downstream of the timber crib dam structure. This remedial work was done to stabilize the structure. It also extended the life of the dam.

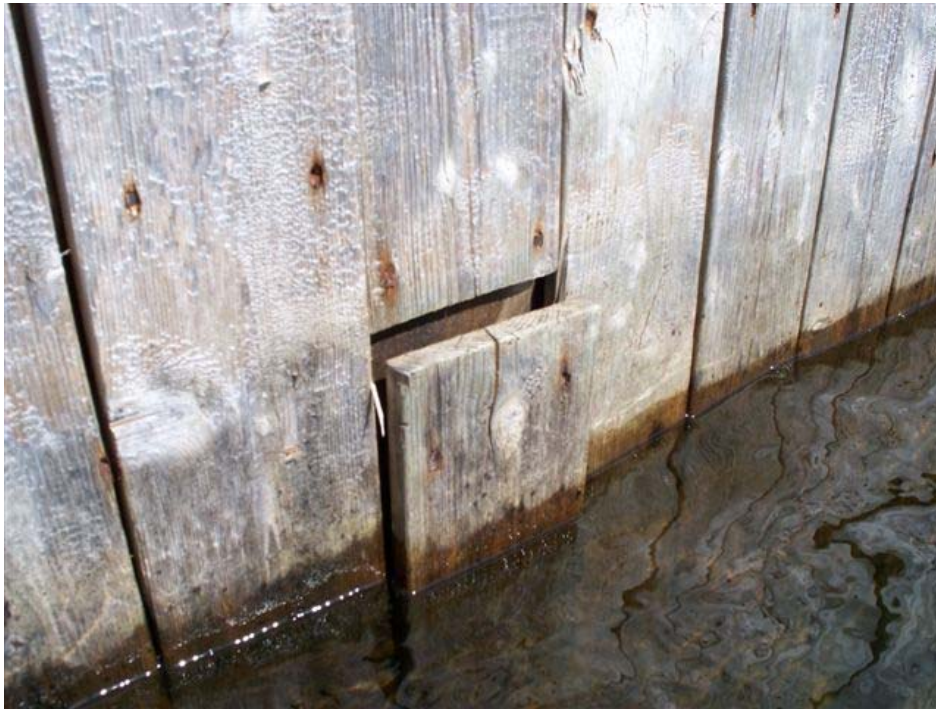
Figure 2

Figures 1, 2 and 3 are photographs taken in August 2010. Figures 2 and Figure 3 show the separation of the dam face from the timber structure caused by the deteriorated condition of the underlying timber crib structure. This deterioration threatens the continued stability of the structure.

2010 picture showing face board pulling away from timber cribbing at the waterline

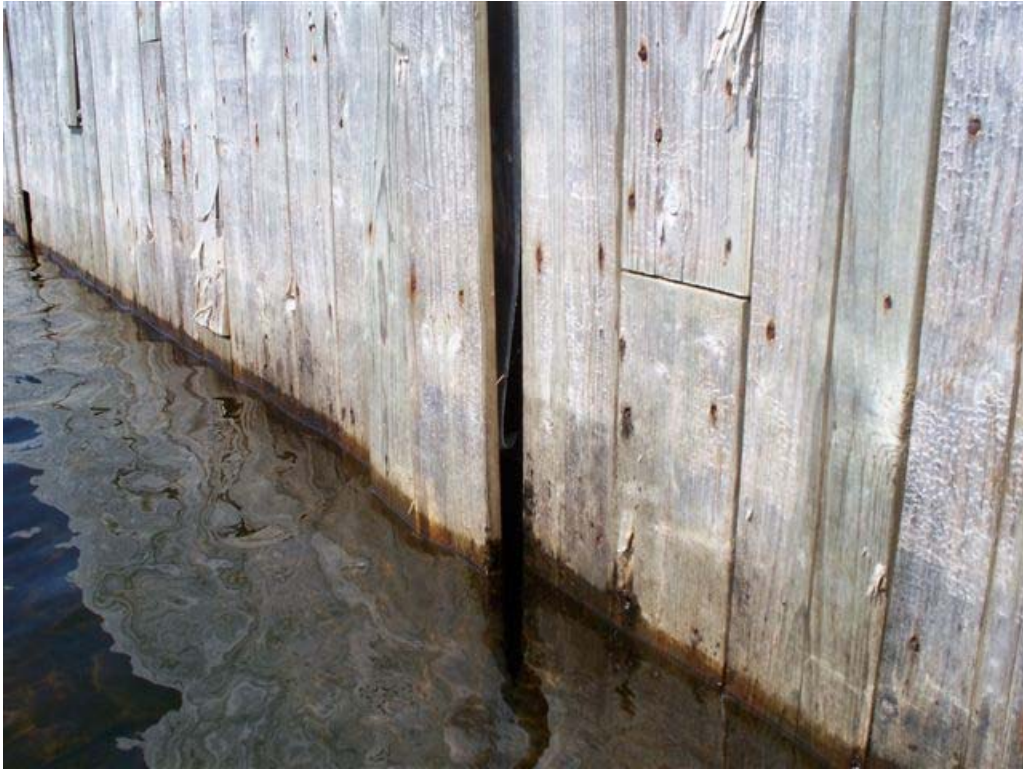
Figure 3
2010 picture showing face board separated from timber cribbing

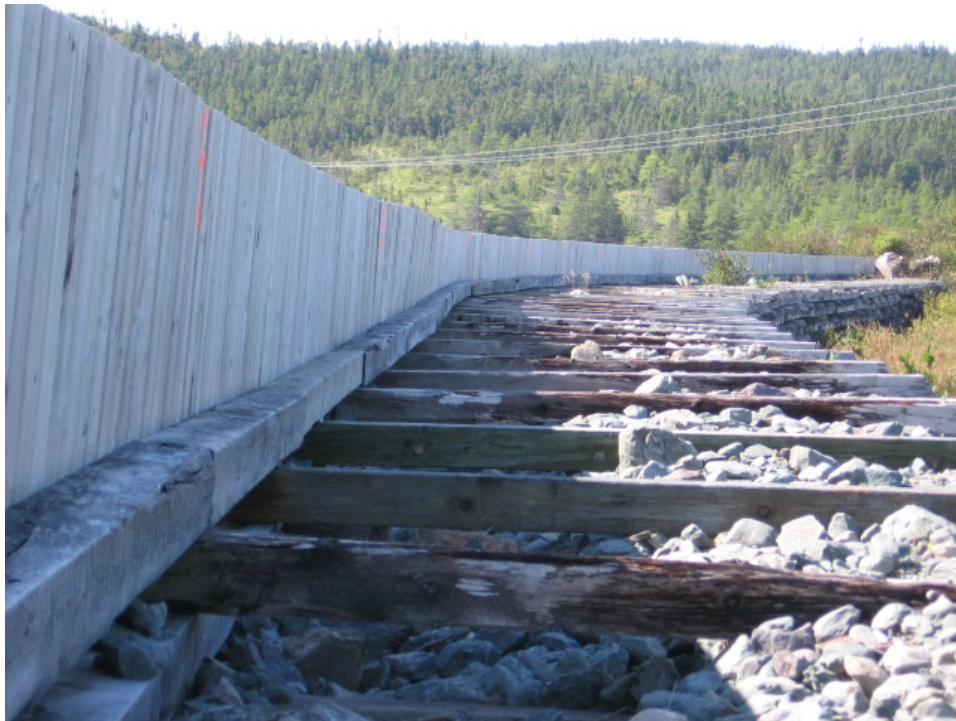
Figures 4, 5 and 6 are photographs taken in September 2006 showing the deterioration of the timber crib dam structure prior to being covered by rock fill in that year. Figure 7 shows an excavator covering the timber crib dam structure with rockfill downstream of the dam. The rockfill used to provide stability to the dam in 2006 will remain following the work in 2011.

Figure 4
Cribbing prior to 2006 rehabilitation showing extent of deterioration of wood structure

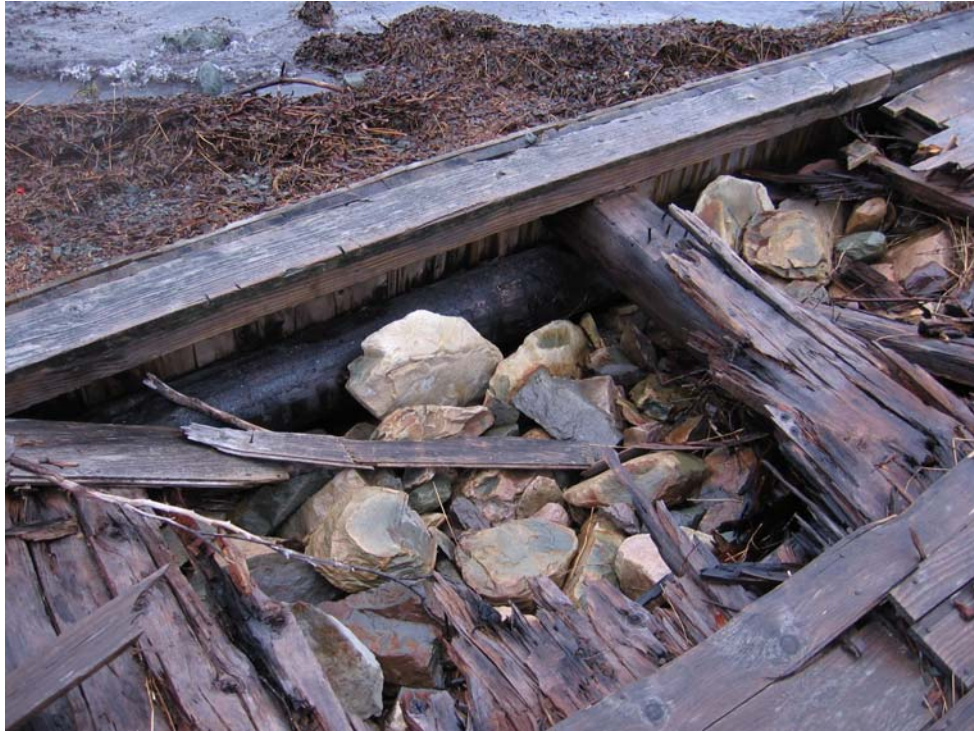
Figure 5
Where dam face meets cribbing (Photo taken prior to 2006 rehabilitation)

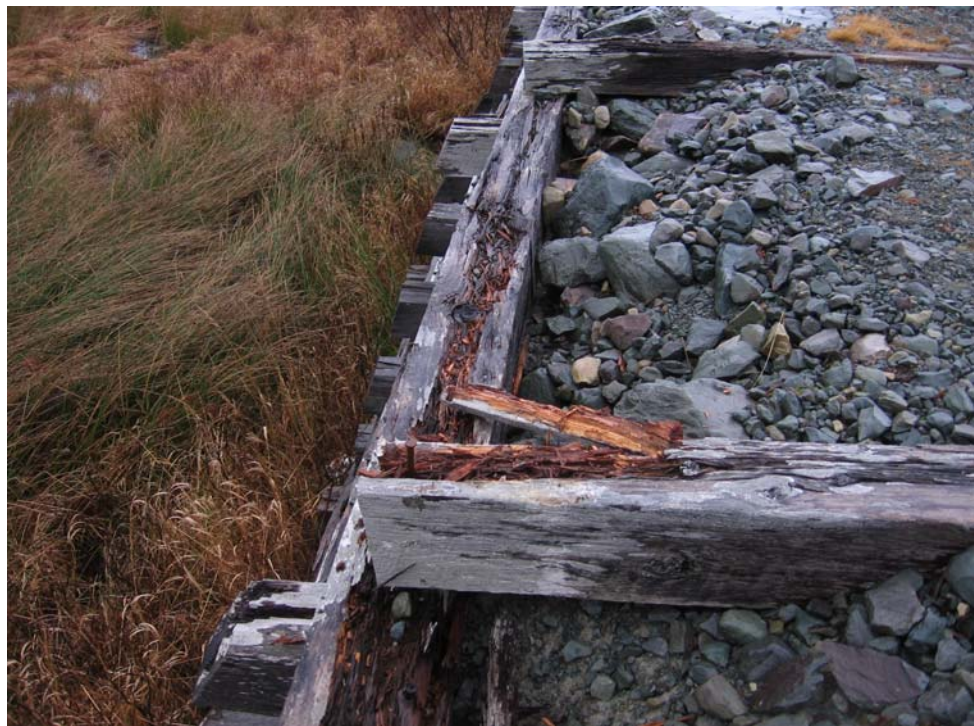
Figure 6
Extensive wood rot evident on timbers (Photo taken prior to 2006 rehabilitation)

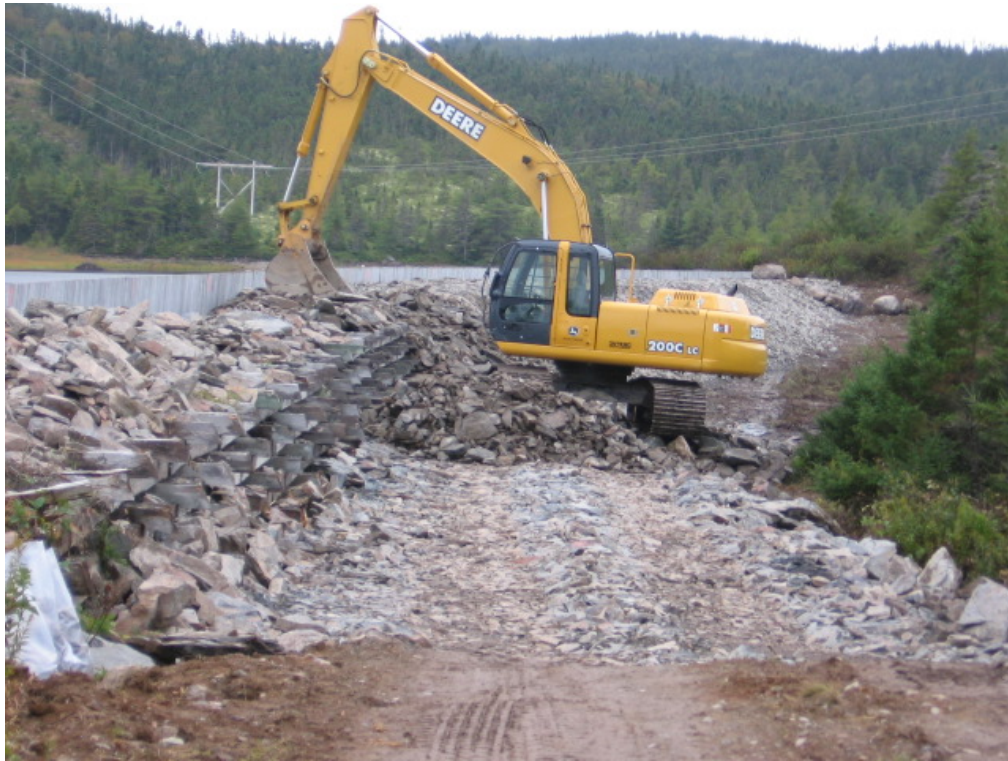
Figure 7

Seal Cove Pond Spillway 2006 rehabilitation, rock fill being placed downstream of dam
