**Undertaking 78**

**Re: Investigation and Hearing into Supply Issues and Power Outages on the Island Interconnected System**

**DESIGN STUDY AND FAILURE INVESTIGATION FOR AUTO  
TRANSFORMER**

**SERIAL # 289147**

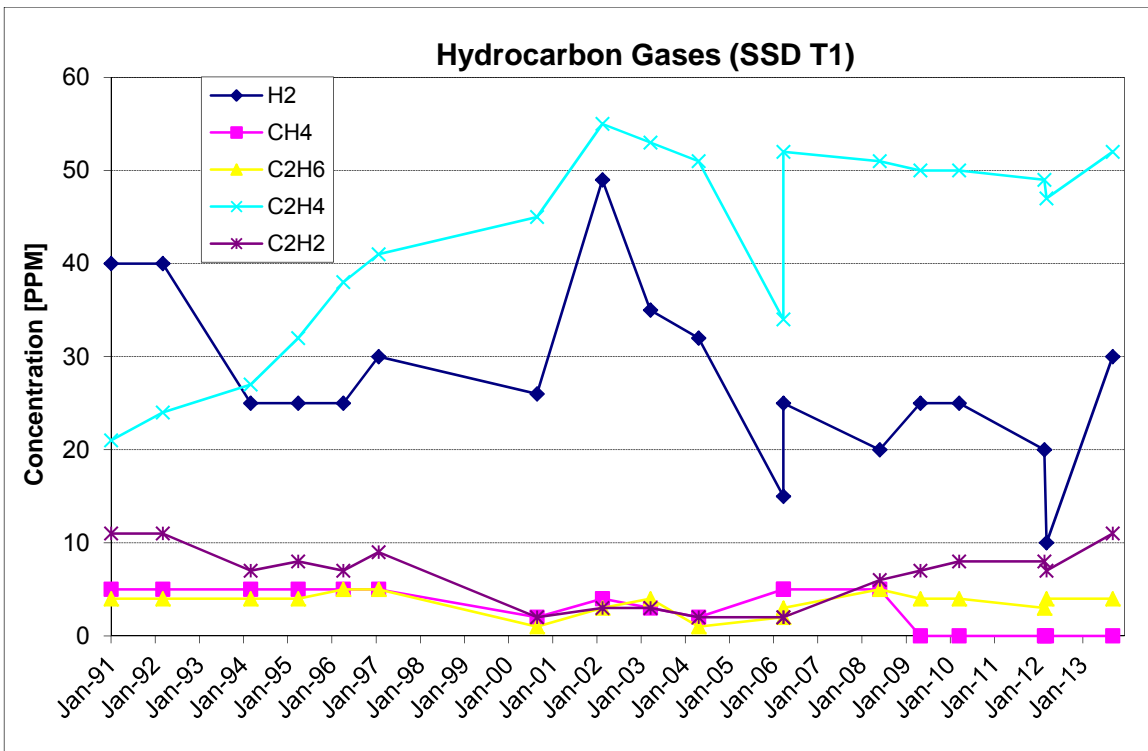
Figure 2 - Hydrocarbon Gas Concentrations

- The concentration of Acetylene (C<sub>2</sub>H<sub>2</sub>) has been above IEEE C57.104-2008 guide condition level 2 since 1991. The level went up and down since then but was almost stable around the 10ppm. This could be oil leaking from LTC diverter compartment.

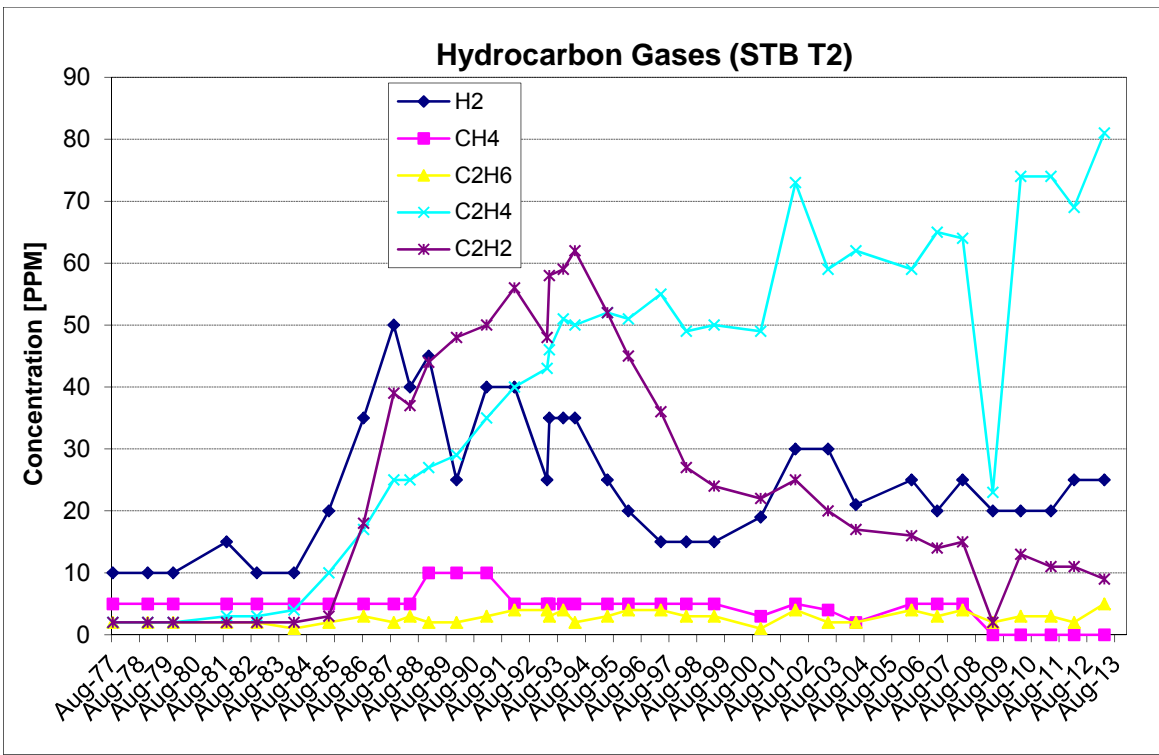
Figure 13 - Hydrocarbon Gas Concentrations

- The transformer has consistently shown high concentrations (>20 ppm) of Acetylene (C<sub>2</sub>H<sub>2</sub>) since 1986, which is far above the IEEE C57.104-2008 guide condition level 2. The high concentration of C<sub>2</sub>H<sub>2</sub> indicates that possible high energy arcing occurred somewhere inside the transformer. The other reason could be oil leaking from LTC diverter compartment. The Acetylene levels are about 10ppm for few years now. This needs to be monitored closely. Any sudden increase of Acetylene needs to be investigated.

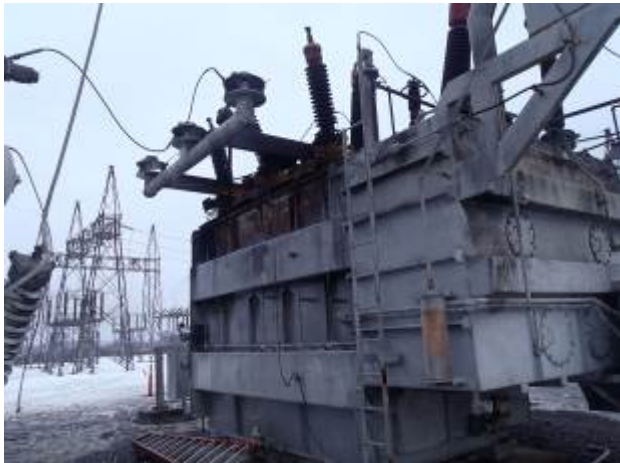
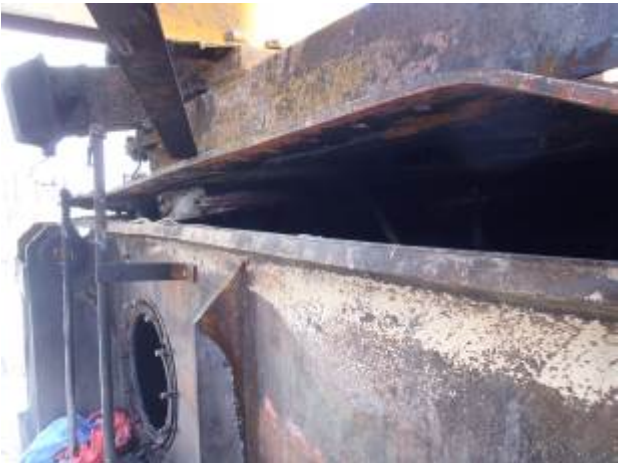
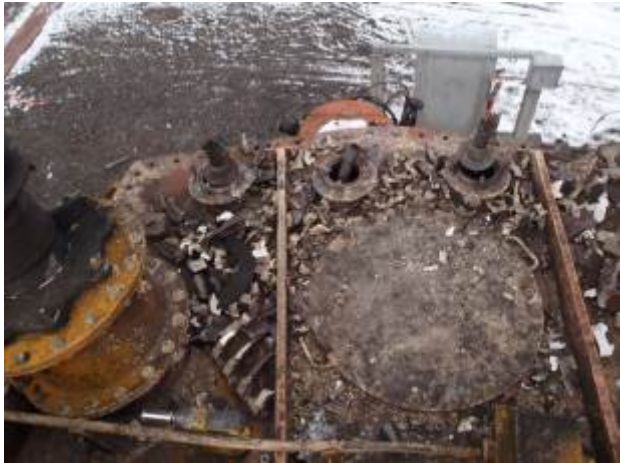
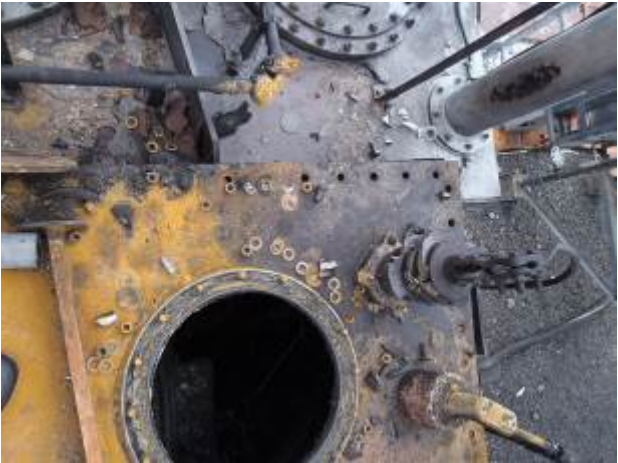
**Photo 1** – Cover Open & Broken Bolts

**Photo 2** – Cover Open & Broken Bolts

**Photo 3** – Cover Open & Broken Bolts

**Photo 4** – Cover Open & Broken Bolts

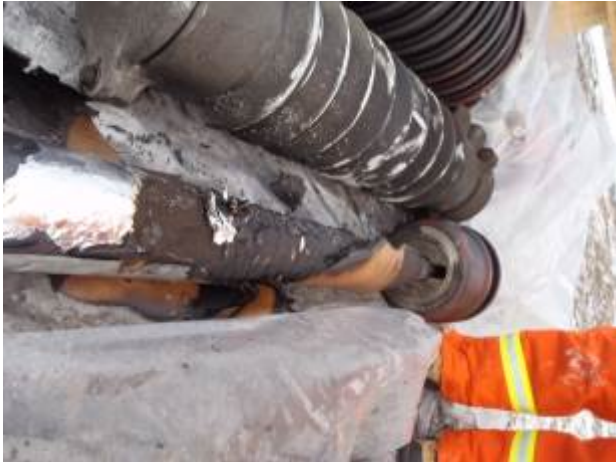
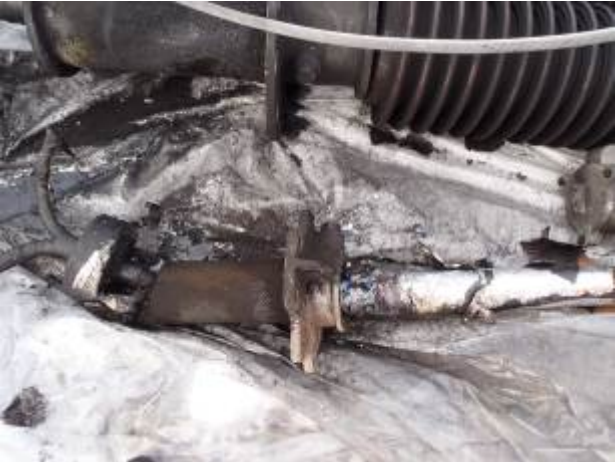
**Photo 5 – LV2 Bushing**

**Photo 6 – LV2 Bushing**

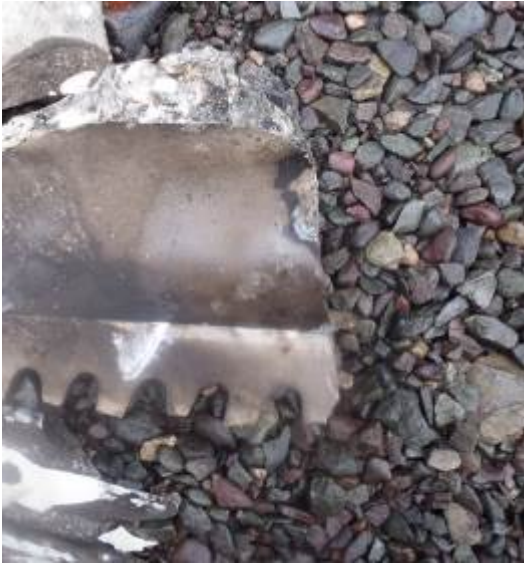
**Photo 7 – LV2 Bushing Porcelain**

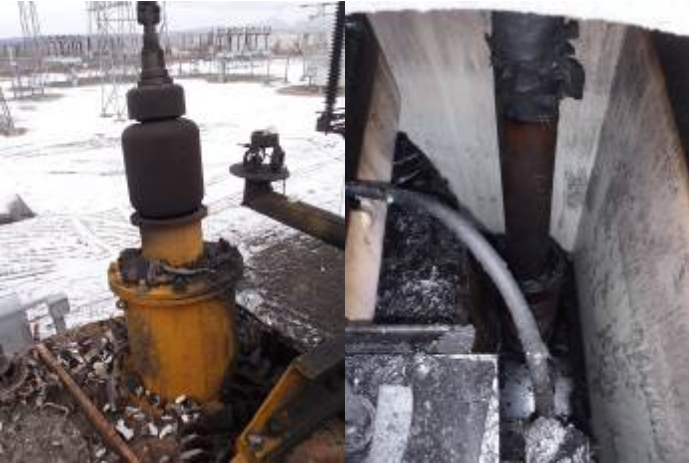
**Photo 8 – HV1 Bushing Porcelain**

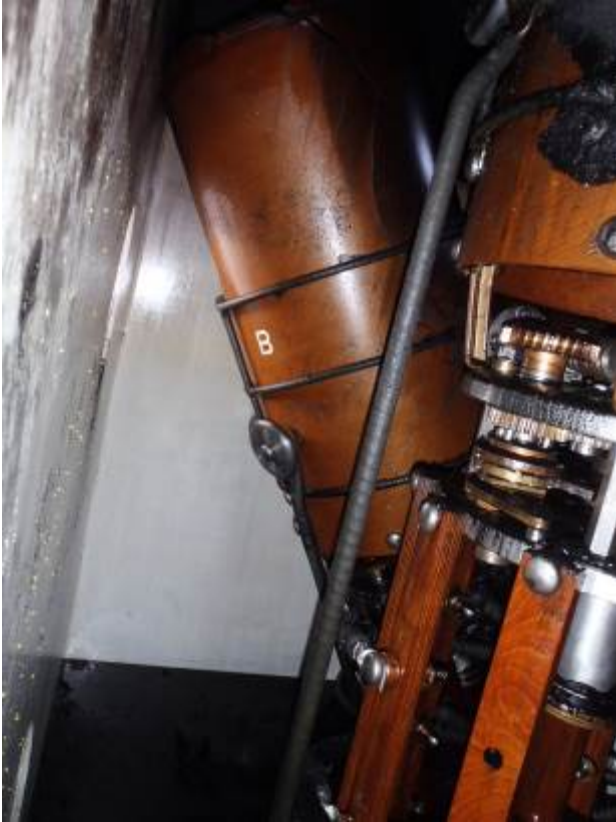
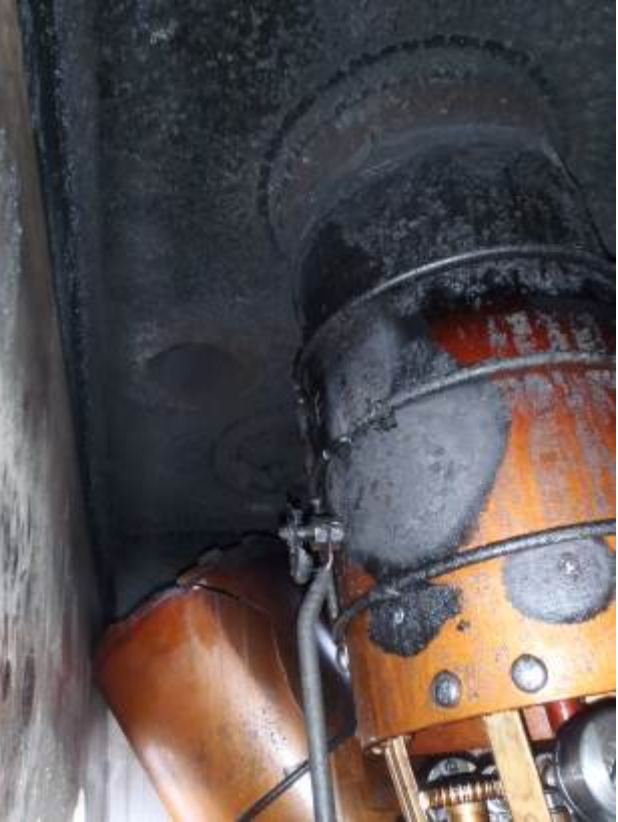
**Photo 9** – LTC Compartment (Phases 2 & 3)    **Photo 10** – LTC Compartment (Phases 2 & 3)

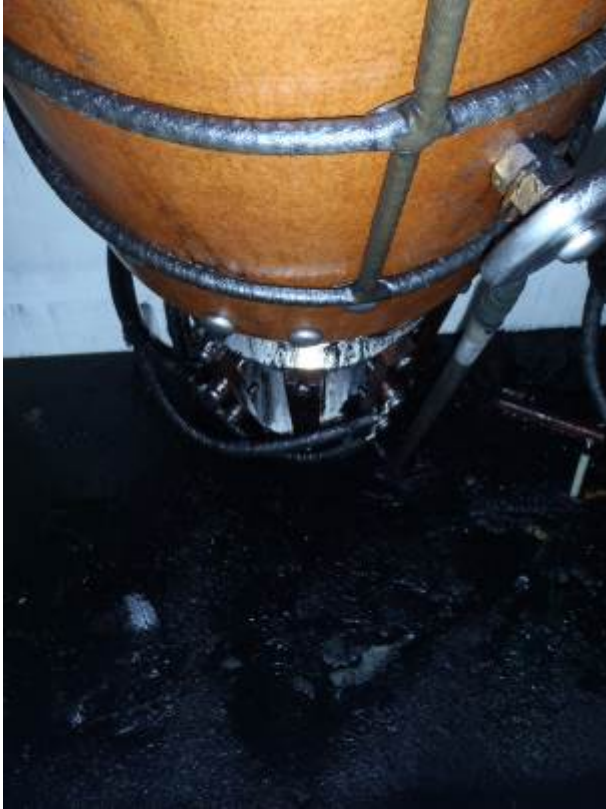
**Photo 11** – LTC Compartment (Phase 3)

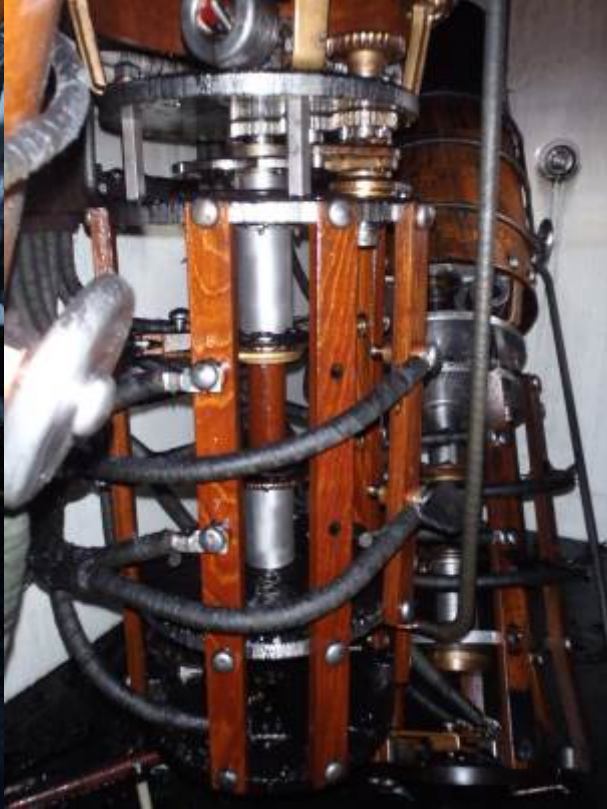
**Photo 12** – LTC Compartment (Phases 2 & 1)

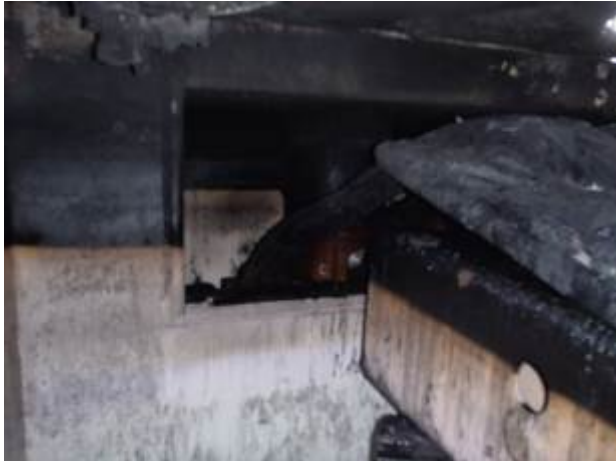
**Photo 13** – Fire Line on Tank Wall & Core Clamp

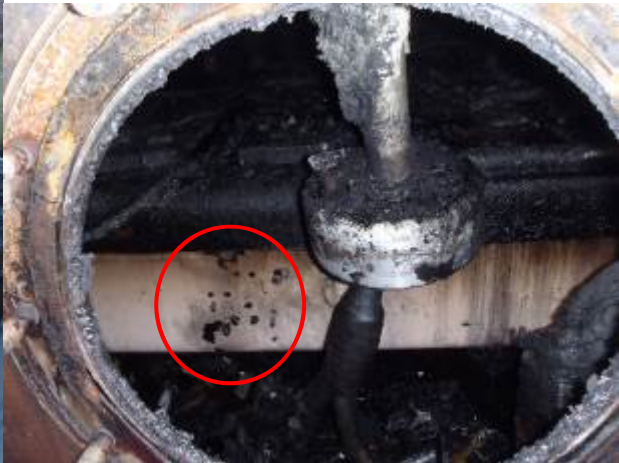
**Photo 16 – LV1 Bushing & Flashover marks**

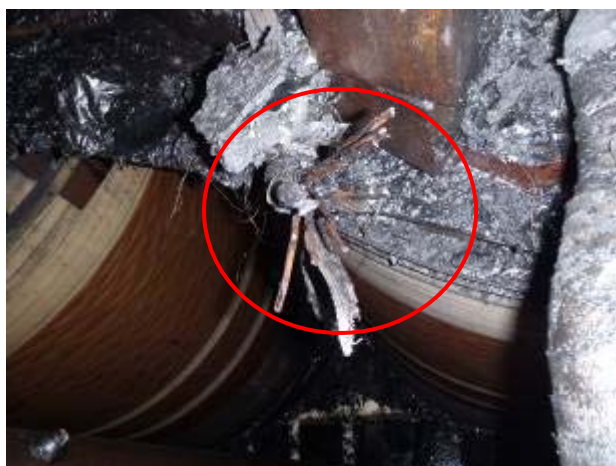
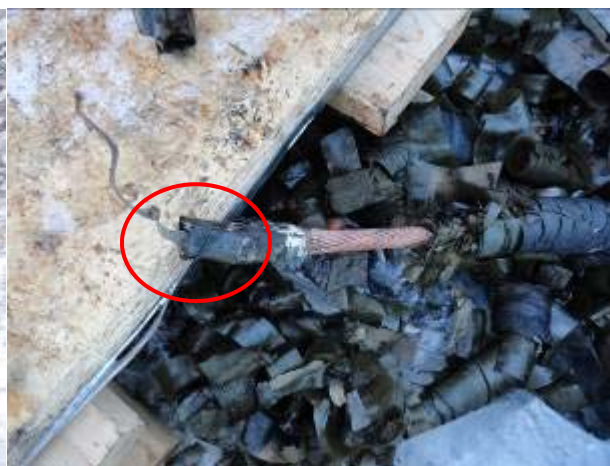
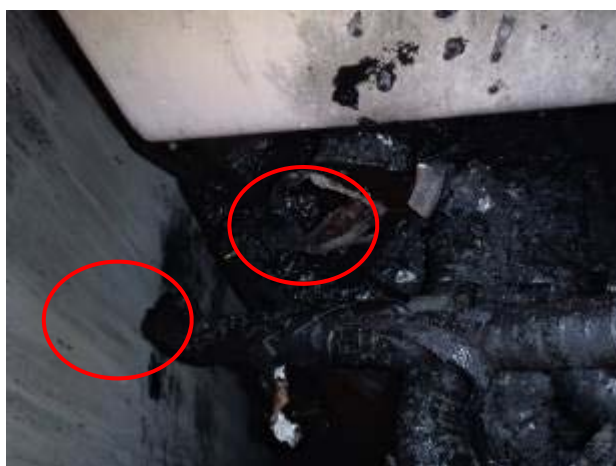
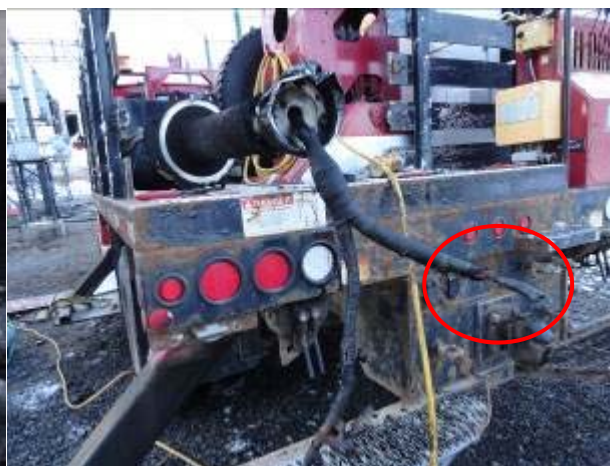
- For Phases 1 and 2 the leads connecting the LV bushings to the windings are disconnected. It seems the two leads were mechanically pulled and cur at the crimp during the fault when the cover opened up. The insulation of the leads looks intact with no signs of failure. **See Photos 19&20&21&22**

**Photo 19** – LV2 Winding Lead Broken

**Photo 20** – LV2 Bushing Lead Broken at the Crimp

**Photo 21** – LV1 Winding Lead Broken

**Photo 22** – LV1 Bushing Lead Broken at the Crimp

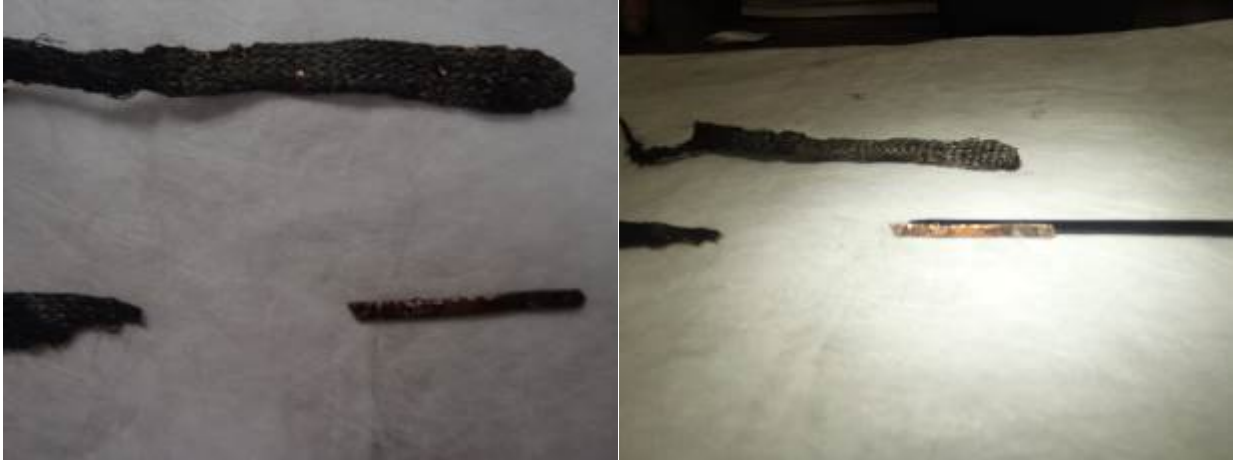
- Spitting and melting cooper were seen on the LV windings conductor copper strands of phase one. **See Photo 23**

**Photo 23** – LV1 Winding Conductor Strand Copper Spitting

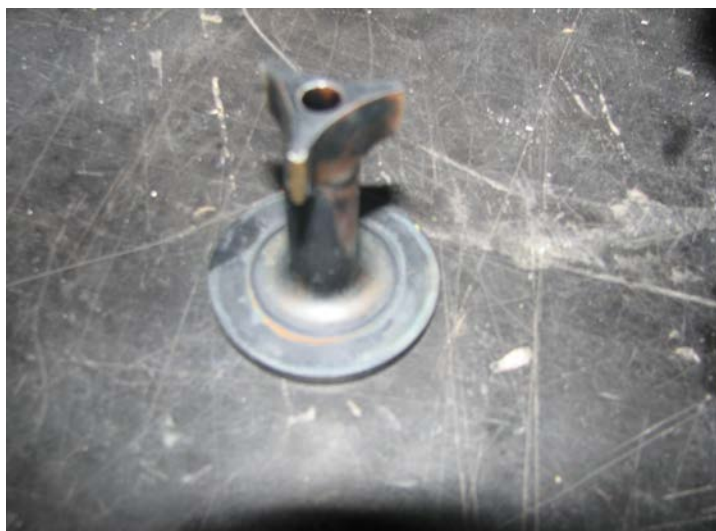
#### Black Trip Piston

1. Lubrication with Dow Corning 55
2. The trip black piston showed signs of corrosion an indication of moisture being present at one time.
3. The housing the black trip piston fit into also showed signs of moisture being present at one time.
4. The linkages and latches for the mechanism were dirty. They did operate freely in the shop environment. In my opinion I felt the latches looked worn and I did not check the mechanism to see if it was properly adjusted. I was not aware of any field checks for the setup of the mechanism being done.
5. Some minor corrosion on parts of the control assembly possibly caused from the salt environment or sulphur from the nearby oil refinery.

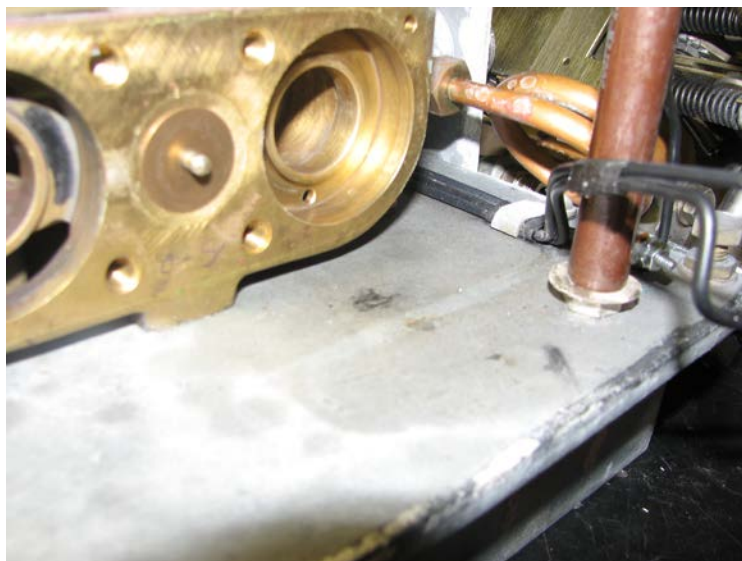
#### Wet Pole Control Box

1. This pole control box was in the same condition as the “B” pole control box with one noticeable difference. There was a wet stain spot on the control box that could not be explained or identified. It had no noticeable smell or taste. It seemed to be some type of solvent or chemical and I found it strange it was still wet. I am not sure if this is of any significance. A picture is below. The right side, a bit darker grey, is wet.

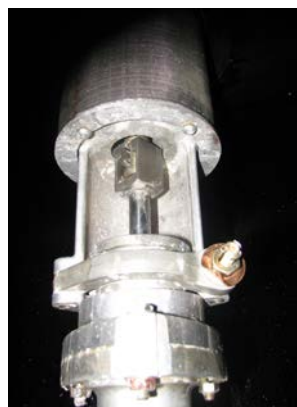
- The inspection cover on the top of the “A” phase air receiver was removed to inspect the breaker control rod drive. The control rod drive bolts were corroded. A picture is below. The control rod drive was not in the position to be expected considering the breaker was suspected of being closed and drained of air. The control rod drive was binding and not able to be moved freely. The bottom of the control rod could not be seen because of the air screen. Not much more could be learned in the tight working space. The control rod and control rod drive needed to be removed for closer inspection.

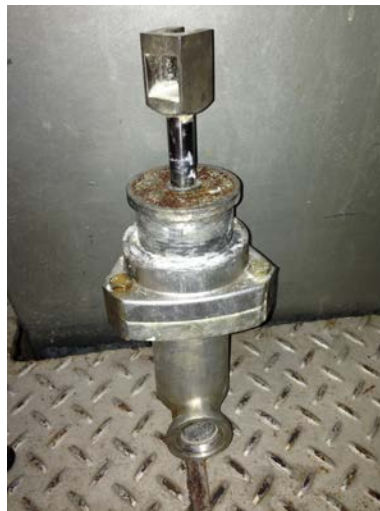
- The control rod drive was found seized to the point that it could not be moved at all. See picture below. When the control rod drive was inverted free water came out. The corrosion of the control rod drive was excessive. The screen was in bad shape. This corrosion would not be visible looking in from the bottom inspection cover of the air receiver when the control rod drive was installed.

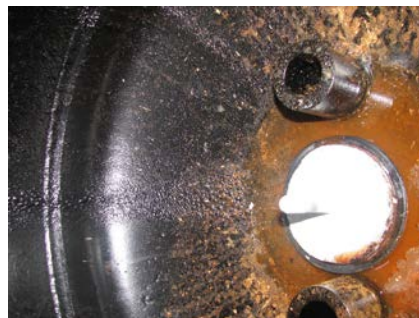
- There is no indication at this time of a power arc occurring in the “A” phase.
- Suspicious of excessive moisture being present in the air receiver the lower air receiver inspection cover on the “A” phase air receiver was removed. An excessive amount of water was found in the bottom of the air receiver. A picture is below.

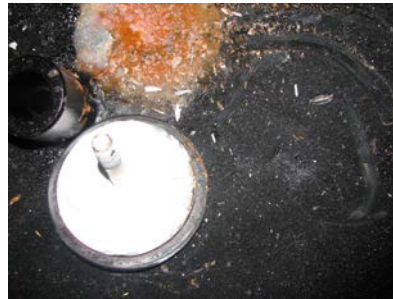
- The other two phases of the B1L17 breaker air receivers were inspected by removing the lower air receiver inspection cover. The "B" phase showed a very small amount of free water. The "C" phase had a moderate amount of water in it. A picture of the "C" phase air receiver is below.

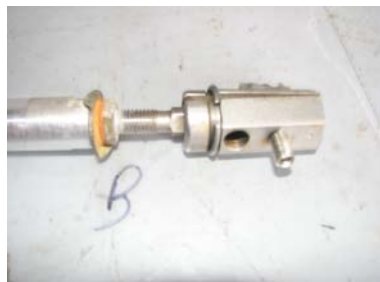
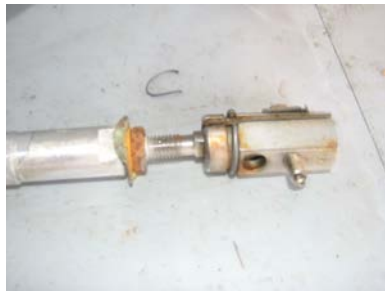
- The "B" and "C" phases of the B1L17 were disassembled for inspection.
- The control rods of the "B" and "C" phases were found to be in the same condition. There were some marks on the rods that appear to be from scraping or wear. The nuts on the top of the control rod showed signs of corrosion. "C" phase showed the more corrosion compared to "B" phase which is supported by the amount of water in the poles. Pictures of each are below.

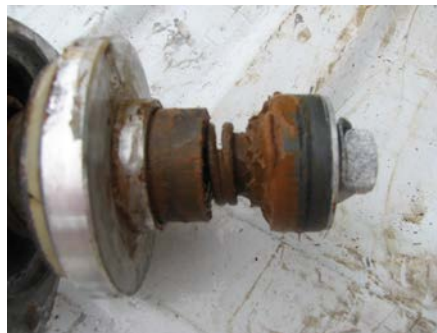
- The control rod drive on the “B” phase was tighter than normal to operate by hand. It was operable and not seized like the “A” phase.
- The control rod drive on the “C” phase was quite a bit tighter to operate than the “B” phase but again not seized like the “A” phase.
- In parallel with the B1L17 inspection two more DLF breakers were inspected for moisture in the air receivers. The breakers inspected were the B3B13 and B3L18. The two breakers had silicone installed on them about the same time. Both breakers showed no signs of free water in the air receivers. The control rod drive of the “B” phase on both breakers were inspected and showed no signs of corrosion.
- The control rod drive from the “A” phase was taken apart for inspection. The valve was very badly corroded and completely seized. It was very difficult to get apart. A couple is below.

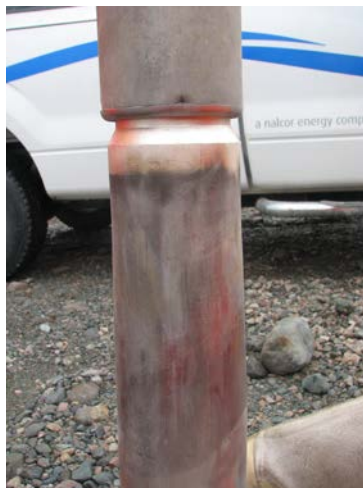
The tube on each of the moving contacts each showed some signs of heating. I do not believe these were from the recent event. These were not fresh and could not be removed. A picture of a moving contact showing the heating is below.
