**A REPORT TO
THE BOARD OF COMMISSIONERS OF PUBLIC UTILITIES**

**Black Tickle Diesel Plant
Fire Restoration Project
Unforeseen Capital Expenditure**

October 2013

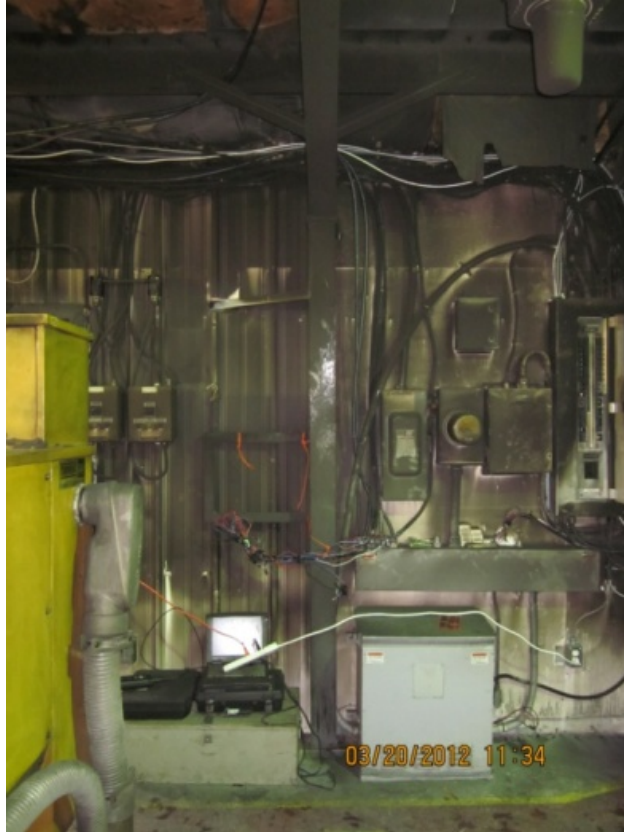
Figure 1: Station Service Equipment after the Fire

- 600 V 3 phase disconnect and associated distribution splitter;
- 600/120/240 V single phase dry type station service transformer;
- 120/240 V circuit breaker and distribution panel complete with circuit breakers;
- Conduit and wire for all electrical lighting and electrical outlets;
- Light fixtures, light switches, electrical outlets boxes, and devices;
- 600 V 3 phase motor starters for radiator fan cooling;
- 600 V 3 phase motor starters for building ventilation;
- Fire protection wiring and sensors followed by system recertification; and
- Rewiring of fuel pump control panel.

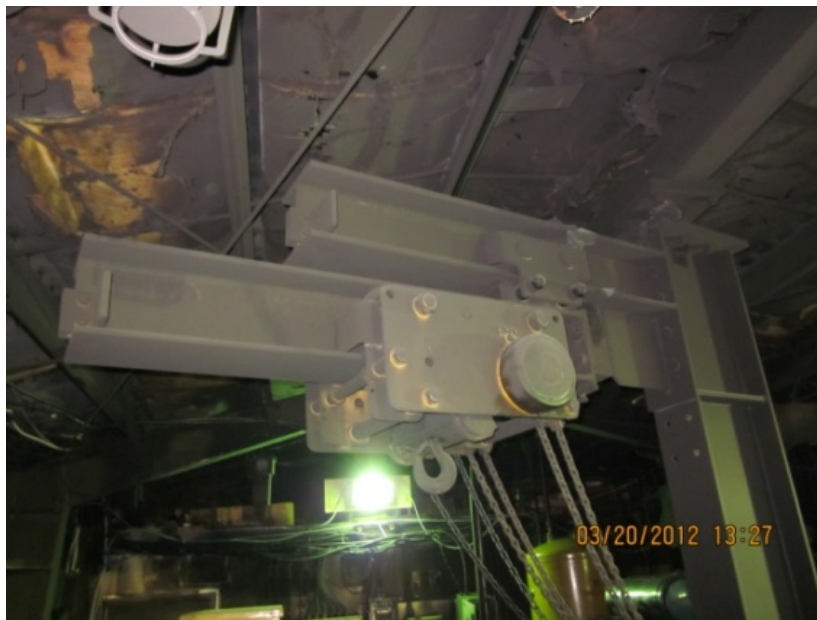
Figure 2: Jib Crane after the Fire

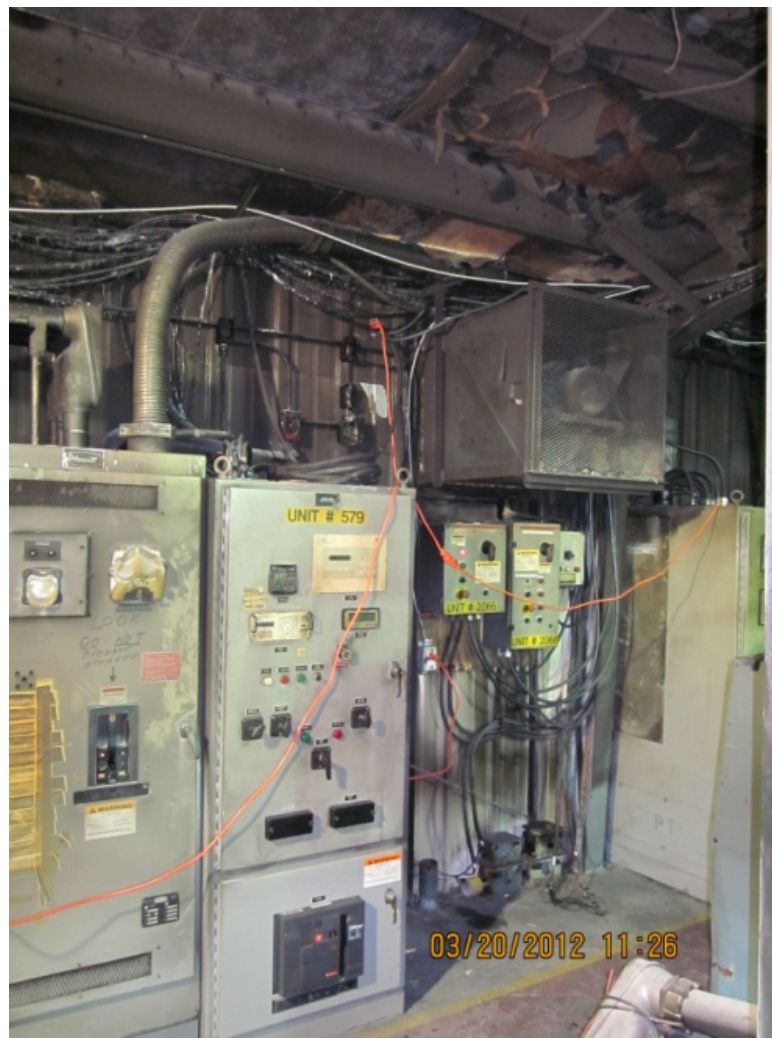
The metal clad switchgear located in the engine hall received extensive heat damage. All control modules mounted on the doors of the switchgear were exposed to high heat.

The interior of the switchgear control cabinets were also extensively damaged by high temperatures. The switchgear itself was salvageable, but the control wiring and several interior protection and control devices required replacement.

Figure 3: Switchgear after the Fire

- Replacement of all power and control cables between generators and switchgear;
- Replacement of all inter-wiring between switchgear units; and
- Installation and commissioning of all new switchgear components.

- A fault study;
- A review of all protection relay settings; and
- An arc flash study.

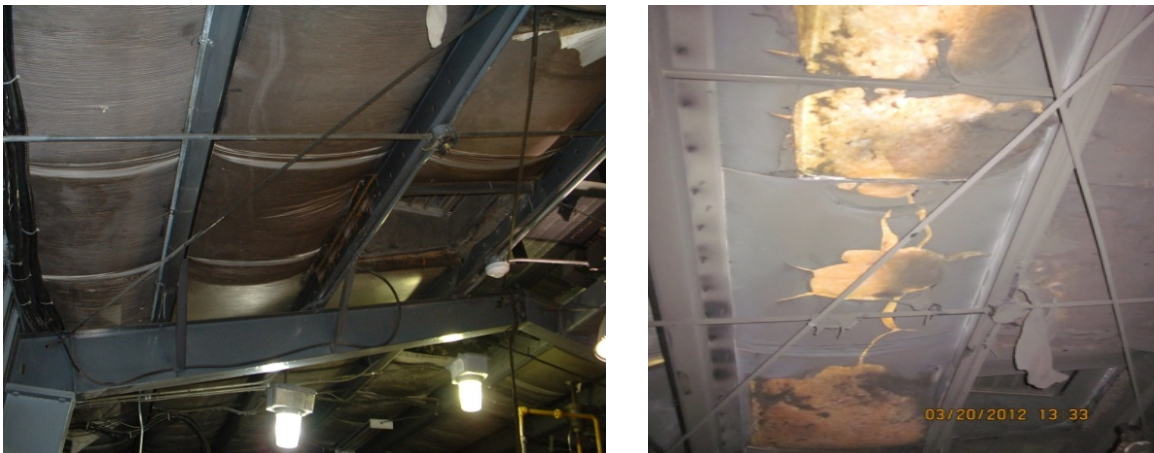
Fire damaged the interior walls and ceiling of the diesel plant engine hall. There was no degradation to the integrity of the structural steel members and the damage was restricted to the metal liner panel and building insulation. As a result, the following refurbishment work was completed:

Figure 4: Building Insulation Before and After the Fire (left to right)

- The interior liner panel and building insulation were replaced;
- Industrial cleaning of the interior of the diesel plant and the repainting of the plant interior and concrete floor; and
- The steel doors and hardware were replaced.

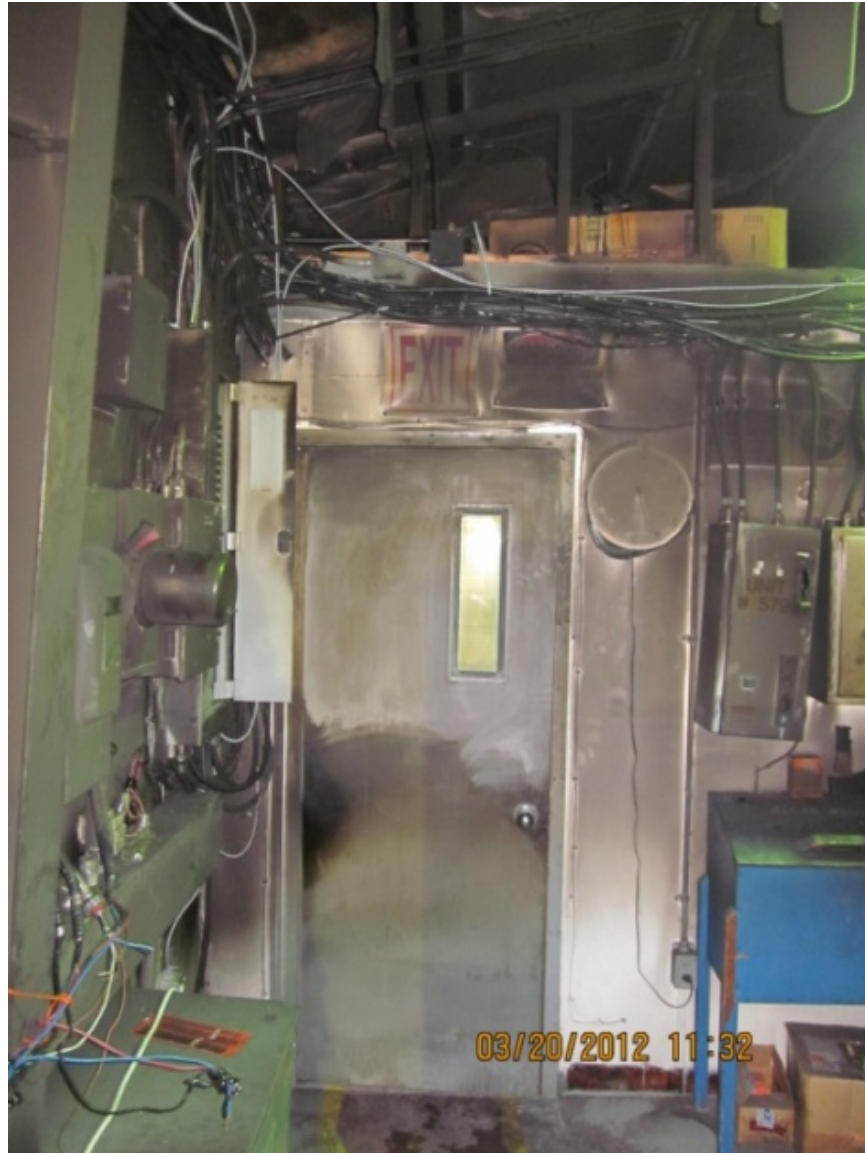
Figure 5: Fire Damage to Door, Wiring, Walls and Ceiling

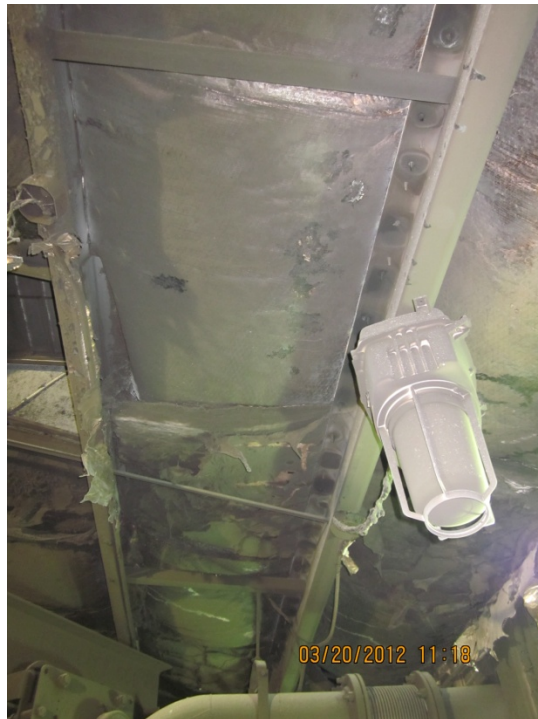
Figure 7: Fire Damage to Engine Hall Ceiling

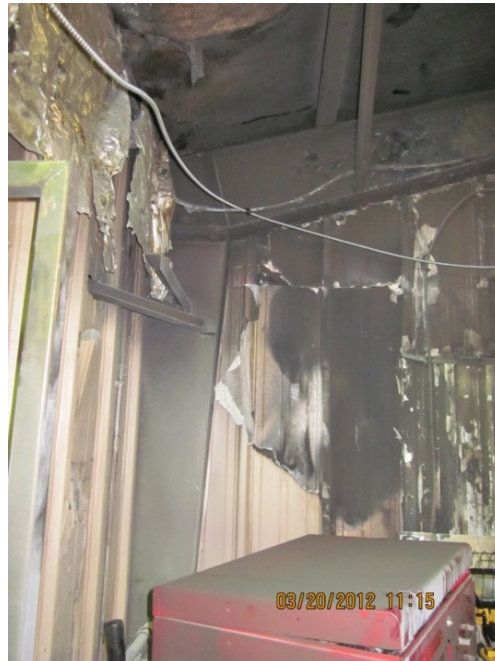
Figure 8: Fire Damage to Interior Panelling

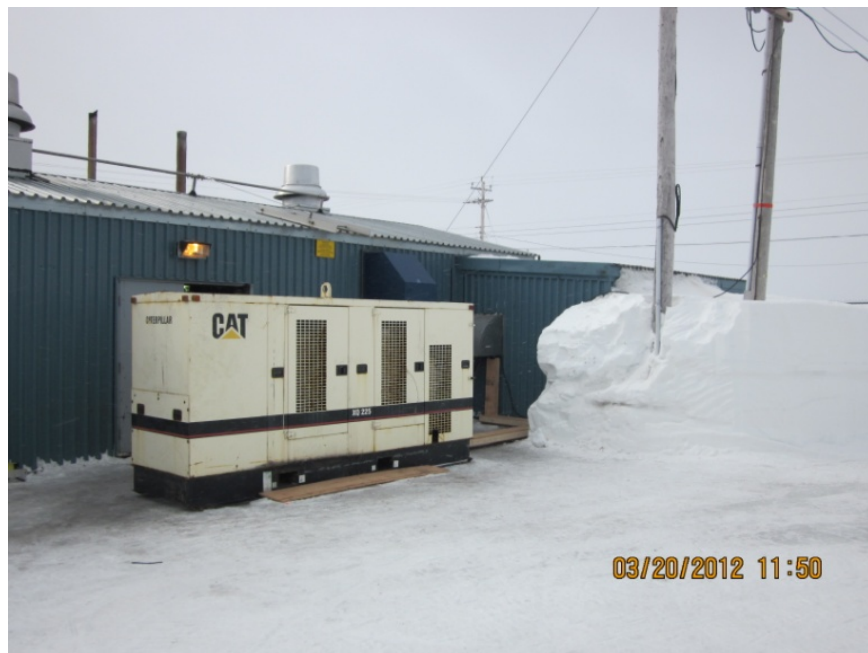
Figure 9: 225 kW Mobile Genset Installation
