1 Q. Provide copies of all opinions, reviews, reports, studies and assessments  
2 commissioned or obtained by Hydro internally, or commissioned or obtained by  
3 Hydro from external sources, which address or discuss, in any respect, Hydro's  
4 capabilities for black starting the Holyrood generating units.  
5  
6

## POWER SYSTEM OUTAGE REPORT

**DEC. 8 TO DEC. 11 1994**

**NEWFOUNDLAND AND LABRADOR HYDRO**

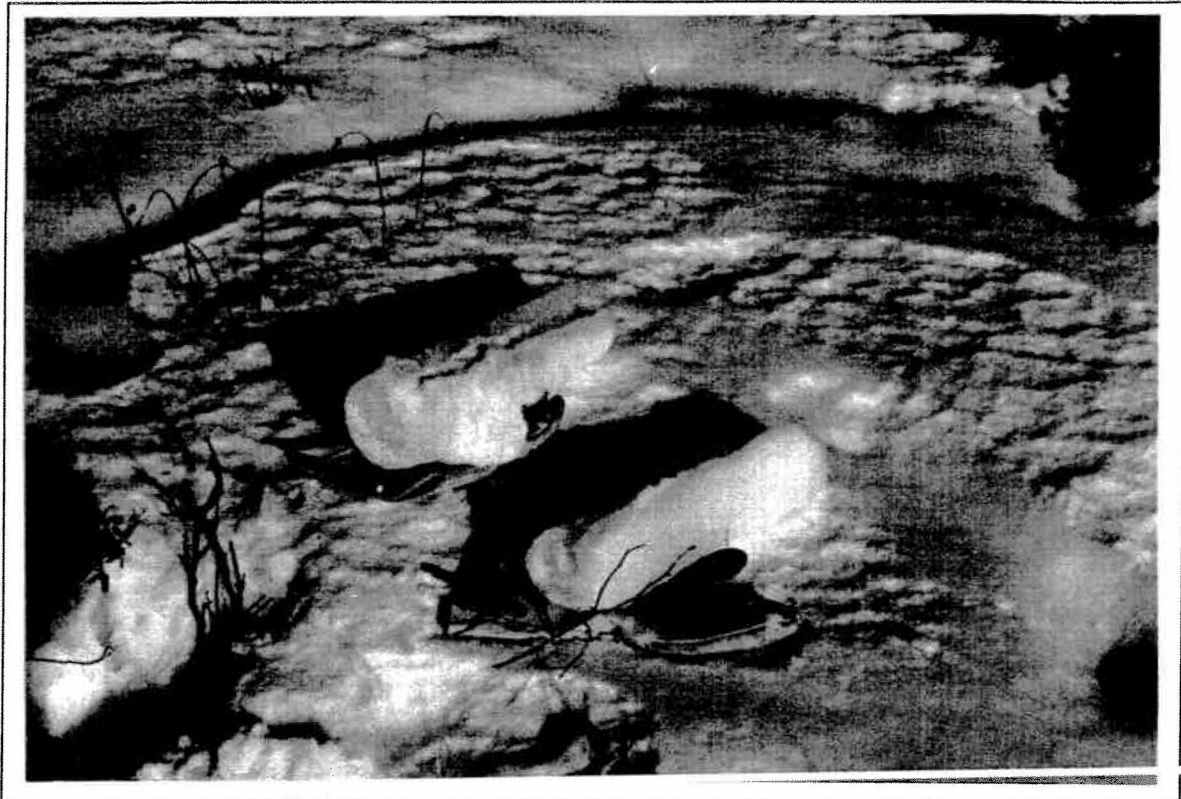
Ice observed between Str.#5 and #6 on TL 201

Location	Conductor Diameter (Inches)	Diameter Ice - Radial (Inches)
TL 201 Str.#3 - #4	1.0	1.5
TL 201 Str.#5 - #6	1.0	1.5 - 2.0

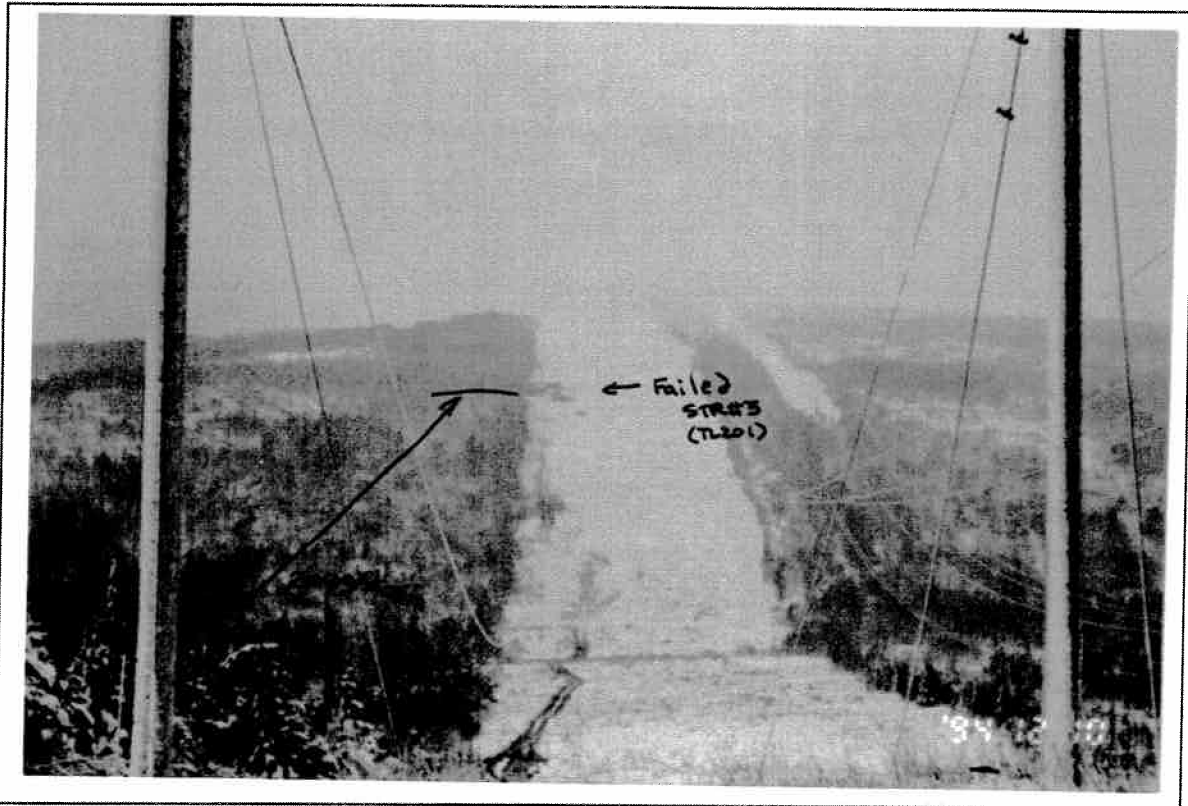
**Photo 1:** TL201 - Str.#2  
*Looking towards Whitbourne*

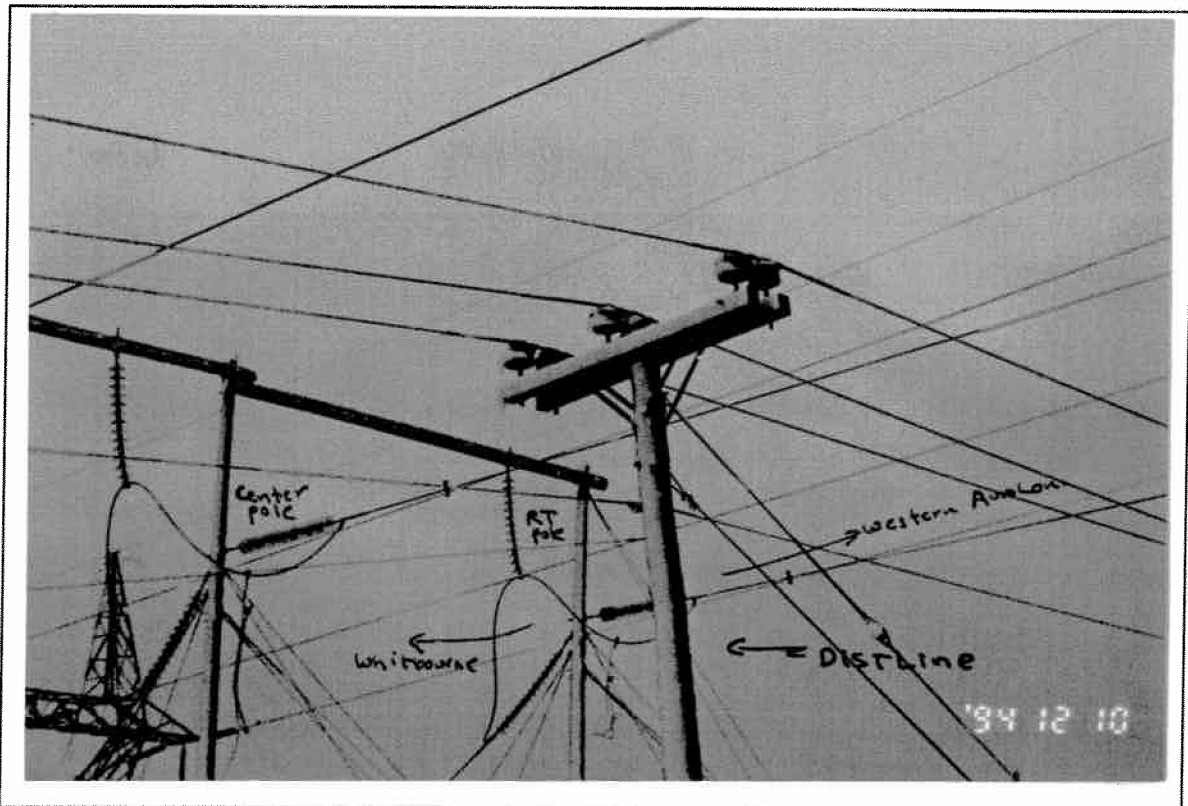
**Photo 2:** TL201 - Str.#2 - Type D  
*Near Chapel Arm Road: Structure shaken but intact.*

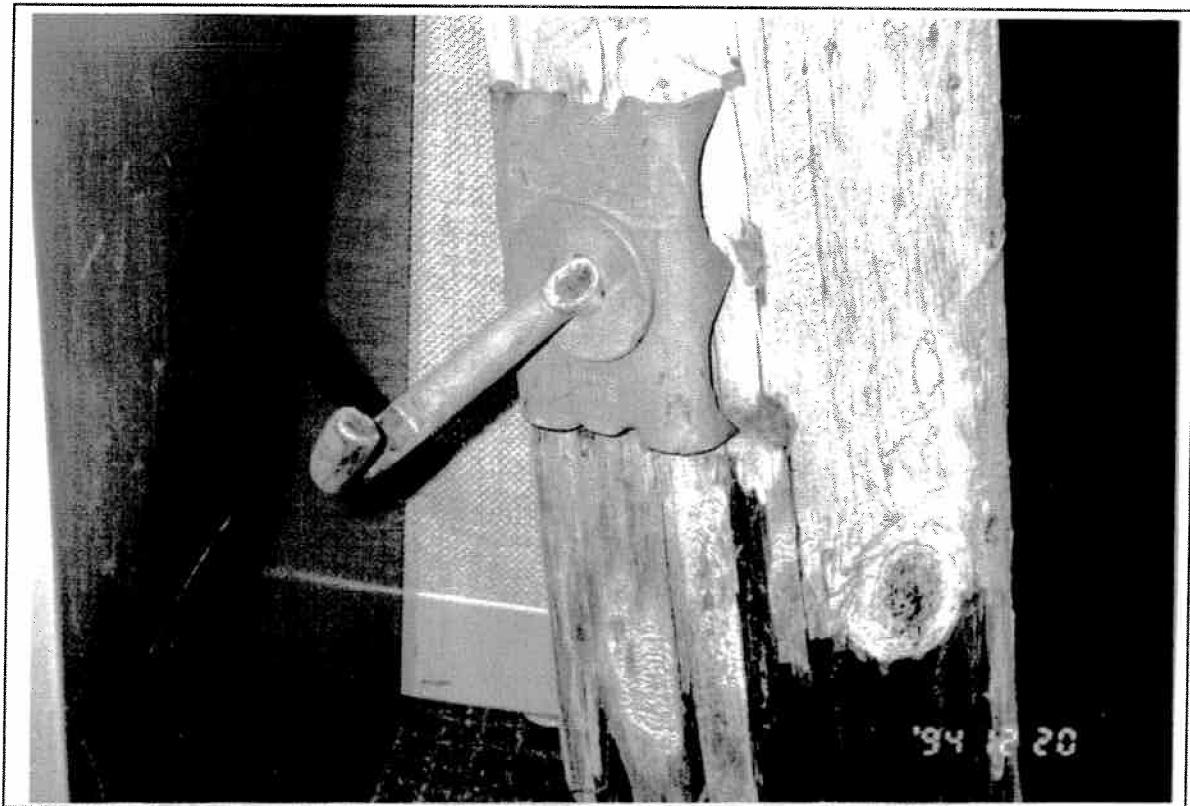
In reviewing the mode of failure of the transmission line TL 201, it is concluded that the use of certain hardware, i.e. welded eyebolts and guying design using a single eyebolt, holding the conductor in the strain position, is inadequate to meet the conditions actually experienced during this storm. Remedial action is recommended to replace this type of welded eyebolt design.

**Photo 4:** TL201 - Str.#3 - Type D.  
*Failed 7/8" Welded Eyebolt.*

- 1) It is concluded that heavy icing of the conductors, in excess of design, initiated the failure of a welded eyebolt at both locations on TL 201. It has been decided to review the use of the "welded eyebolts design" of transmission line hardware on all transmission lines and determine the need for replacement.

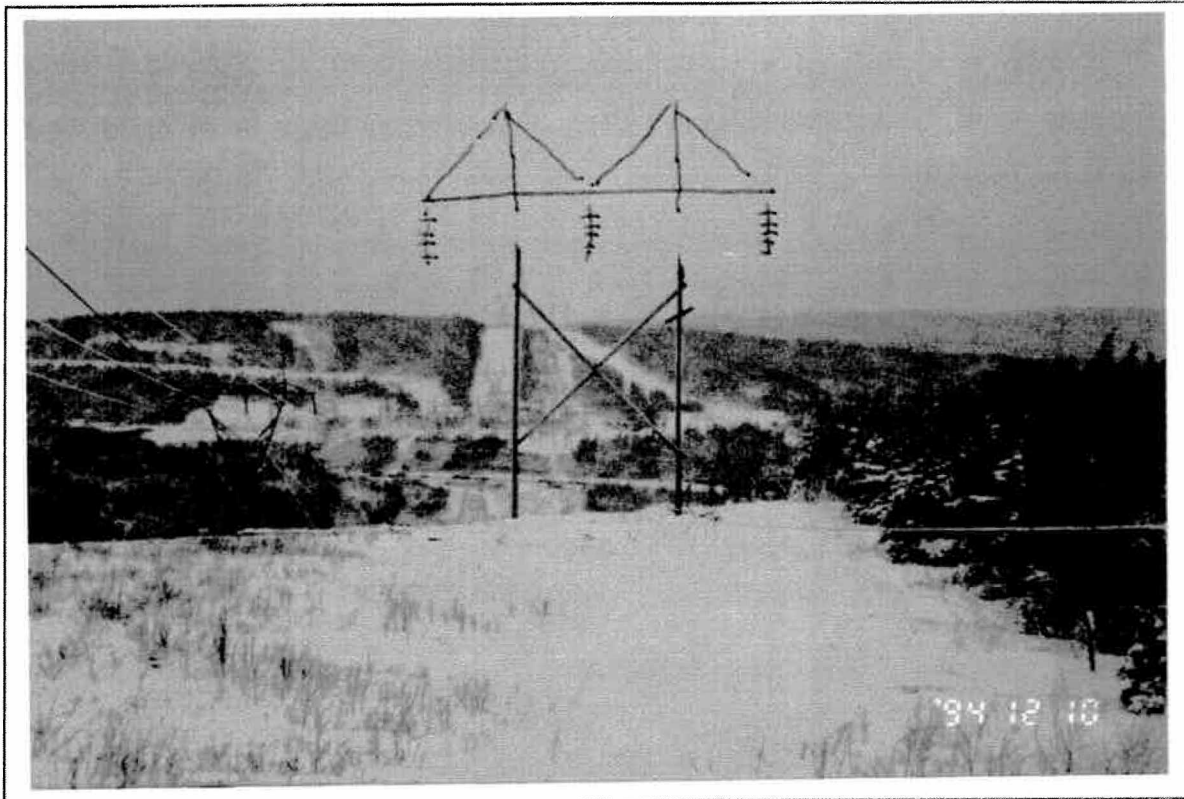
Near Western Avalon Terminal Station, seven (7) wooden structures (structures # 2 to # 9) failed (see photographs #5 to #9, Appendix A). In addition, at structure # 134, near Brigus Junction, an eyebolt supporting the line conductor failed.

It is concluded that the excessive ice accumulation, in excess of design, (2 inch radial) on transmission line conductors combined with high winds (126km/hr or higher) was the major cause of structure and hardware failure during the storm. These lines were originally designed for a load of one (1) inch radial ice on the conductor and a wind speed of 176 km/hr.

**Photo 5:** TL201 - Str.#4 - Type A  
*Pole tops and crossarm on ground.*

Repairs to structure # 2 to # 9 commenced immediately and were completed in fourteen (14) days. The damaged eyebolt at structure # 134 was also replaced.

During the repairs to the damaged sections, the design of these sections of line was upgraded to withstand the climatic loading conditions which were actually experienced.

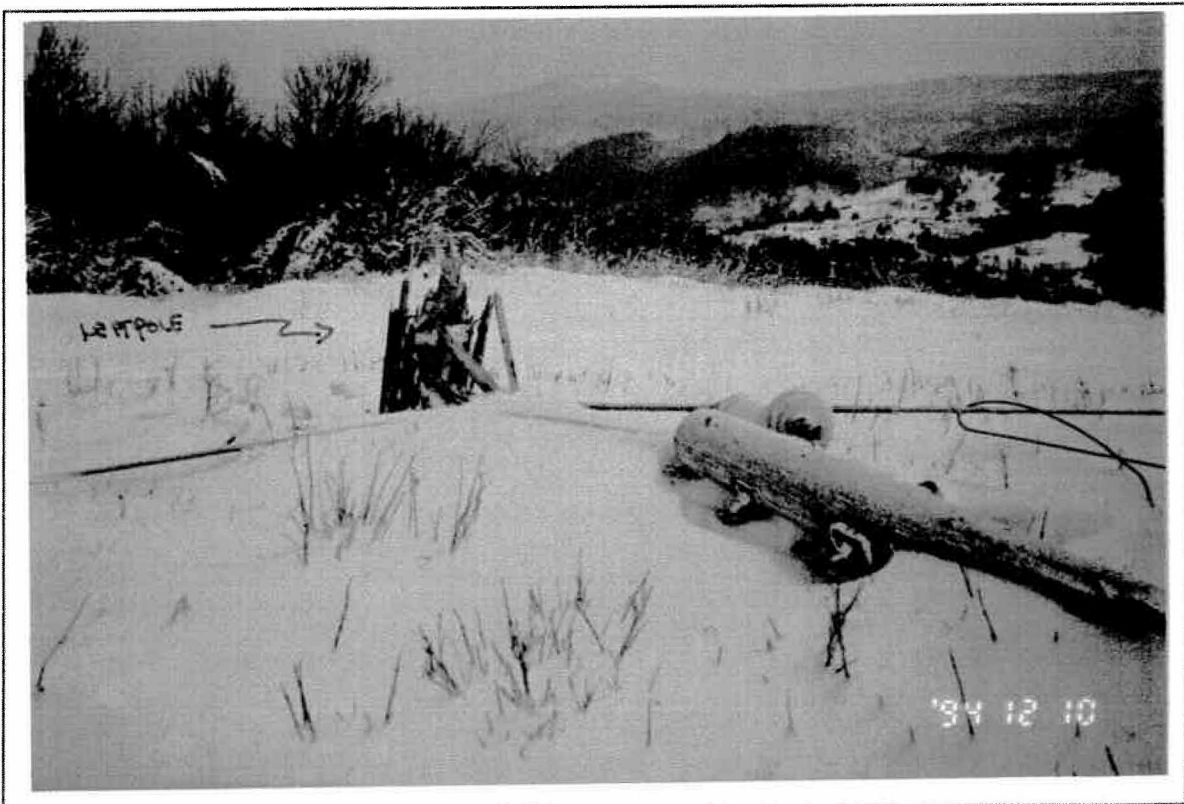
**Photo 6:** TL201 - Str.#5 - Type B  
*Left pole cracked at ground-line.*

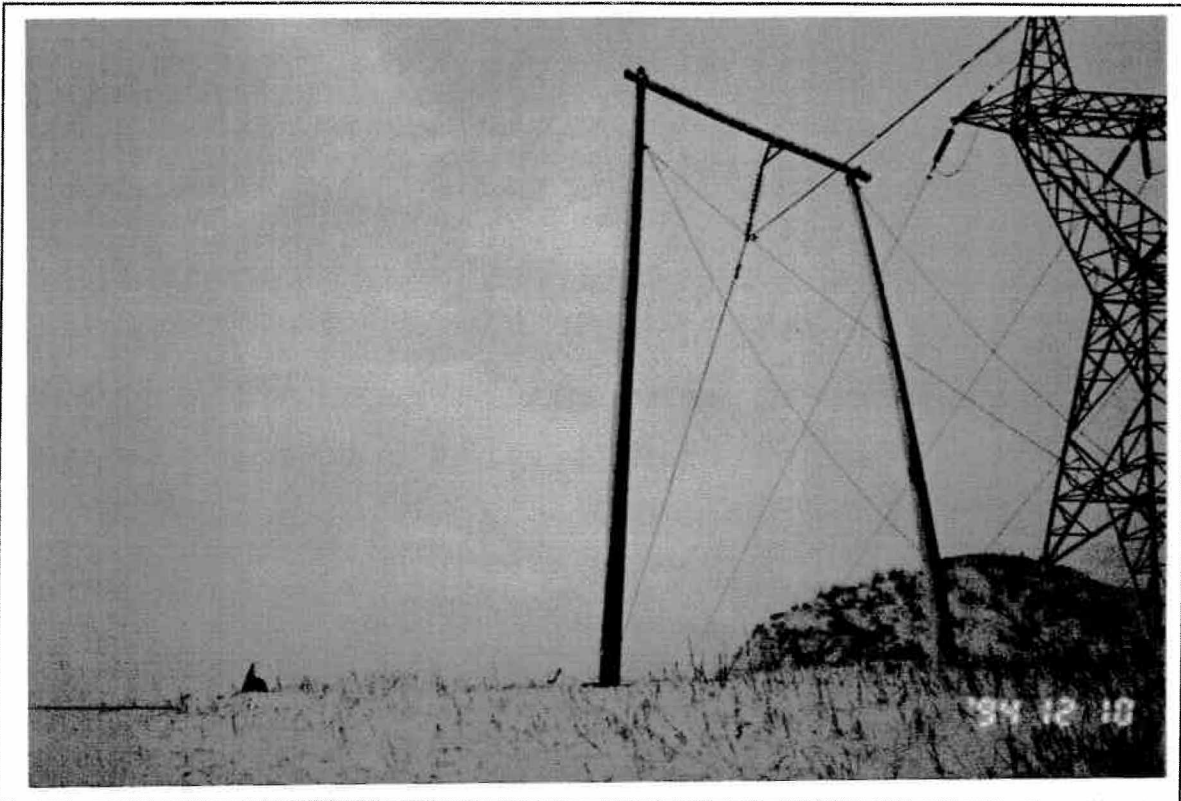
**Photo 7:** TL201 - Str.#5 - Type B  
*Center and right pole leaning heavily towards Whitbourne.*

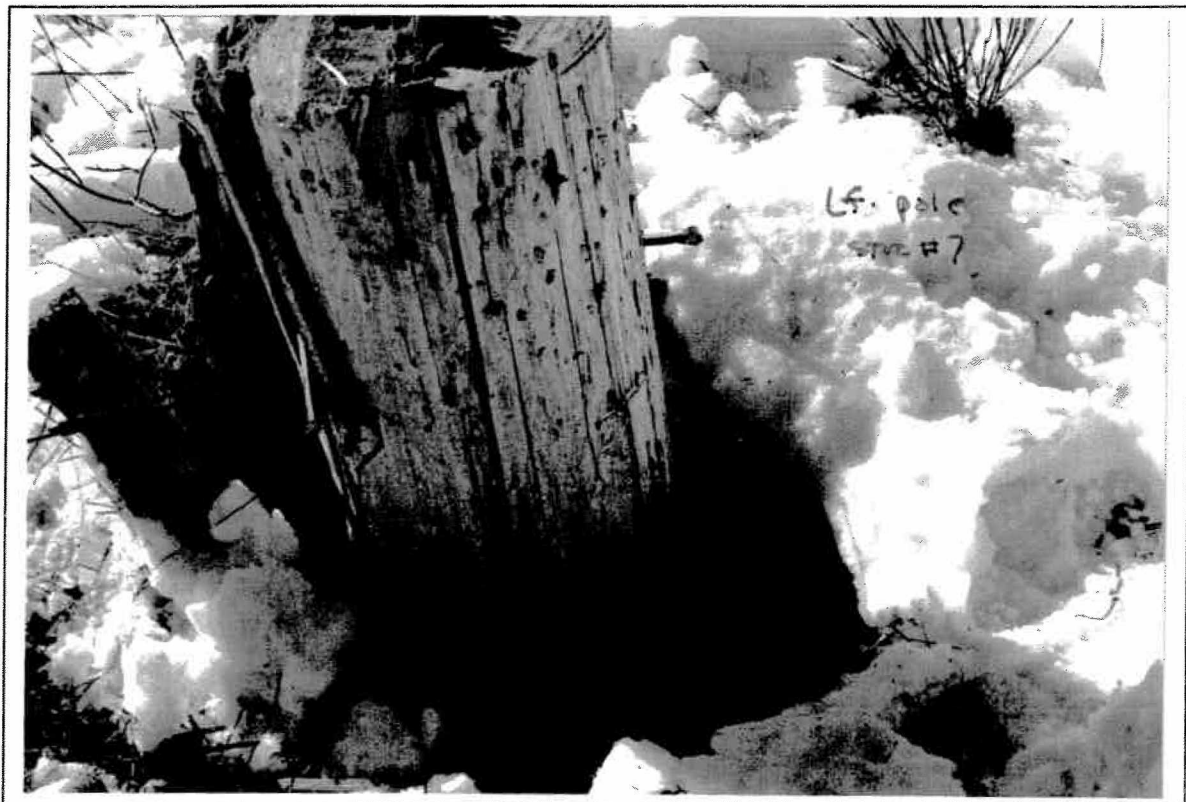
**Photo 8:** TL201 - Str.#7 - Type A  
*Left pole moved through ground.*

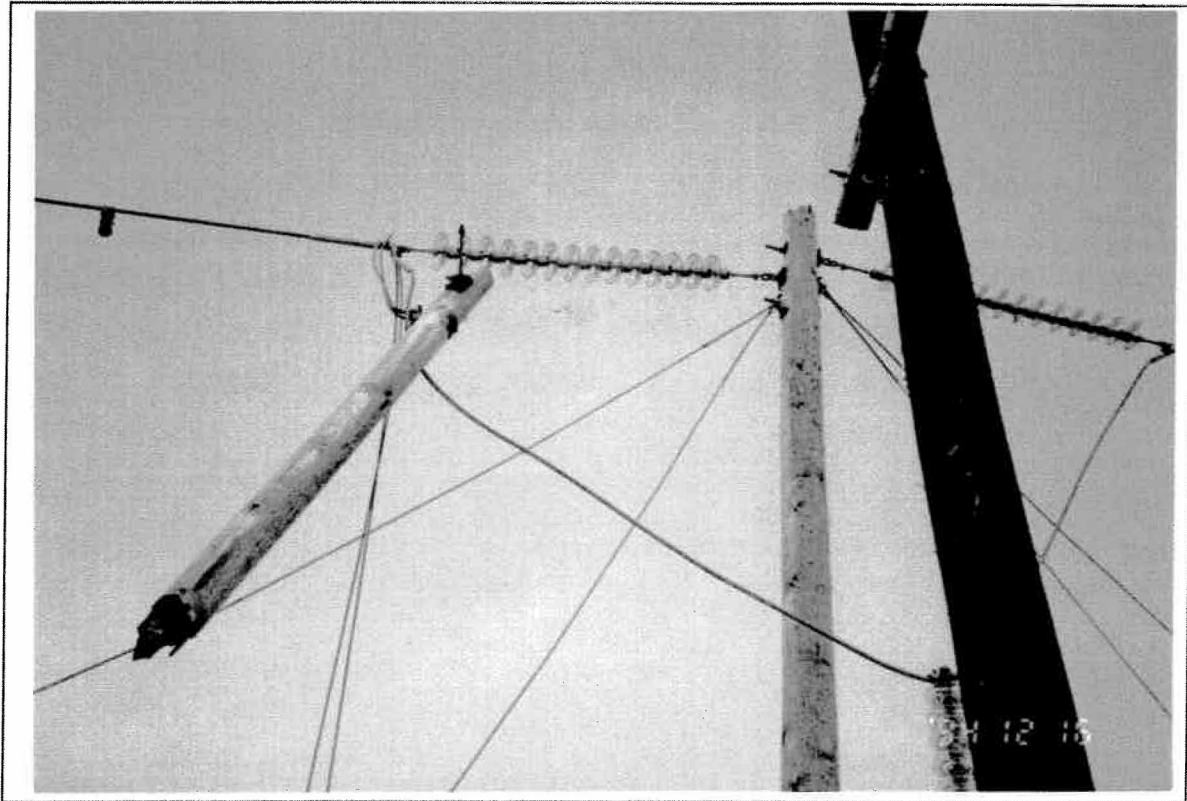
**Photo 9:** TL201 - Str.#3 - Type D  
*Crossarm hanging on jumper.*

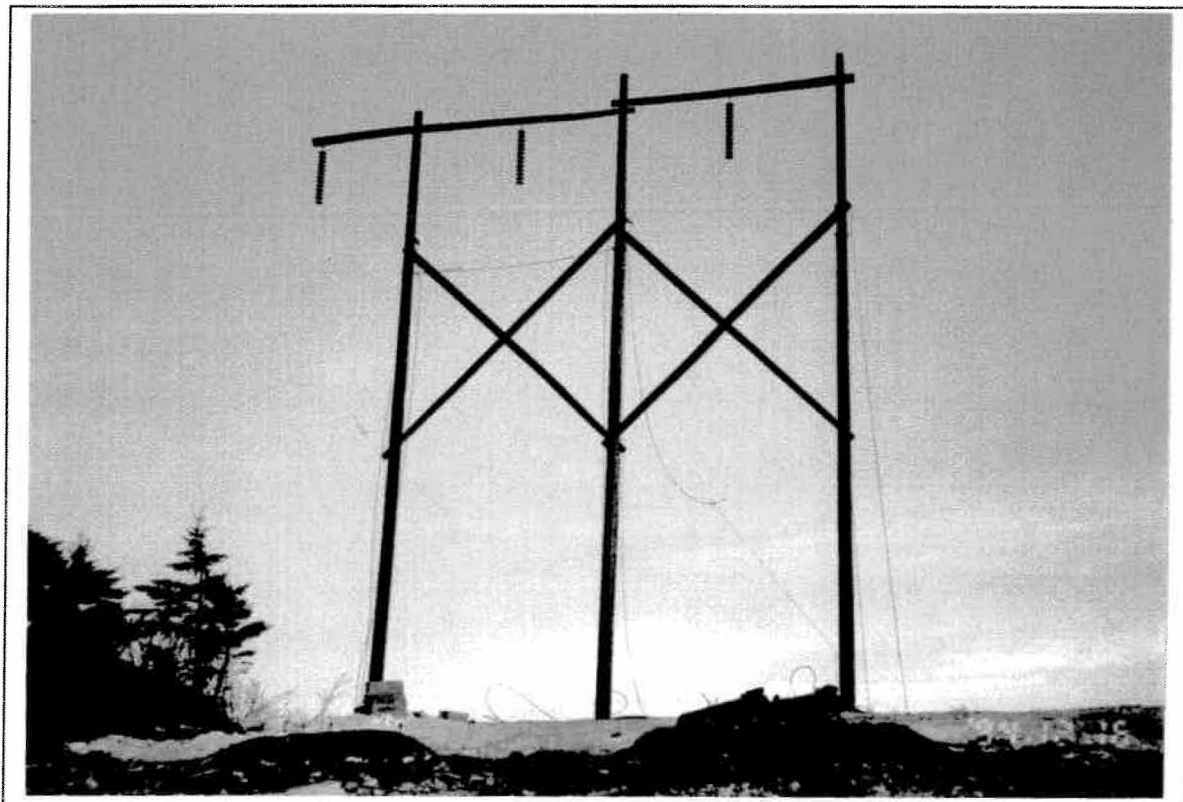
**Photo 10:** TL201 - New Str.#3 - Type G  
*3-Pole - 230 kV - In-line Deadend.*

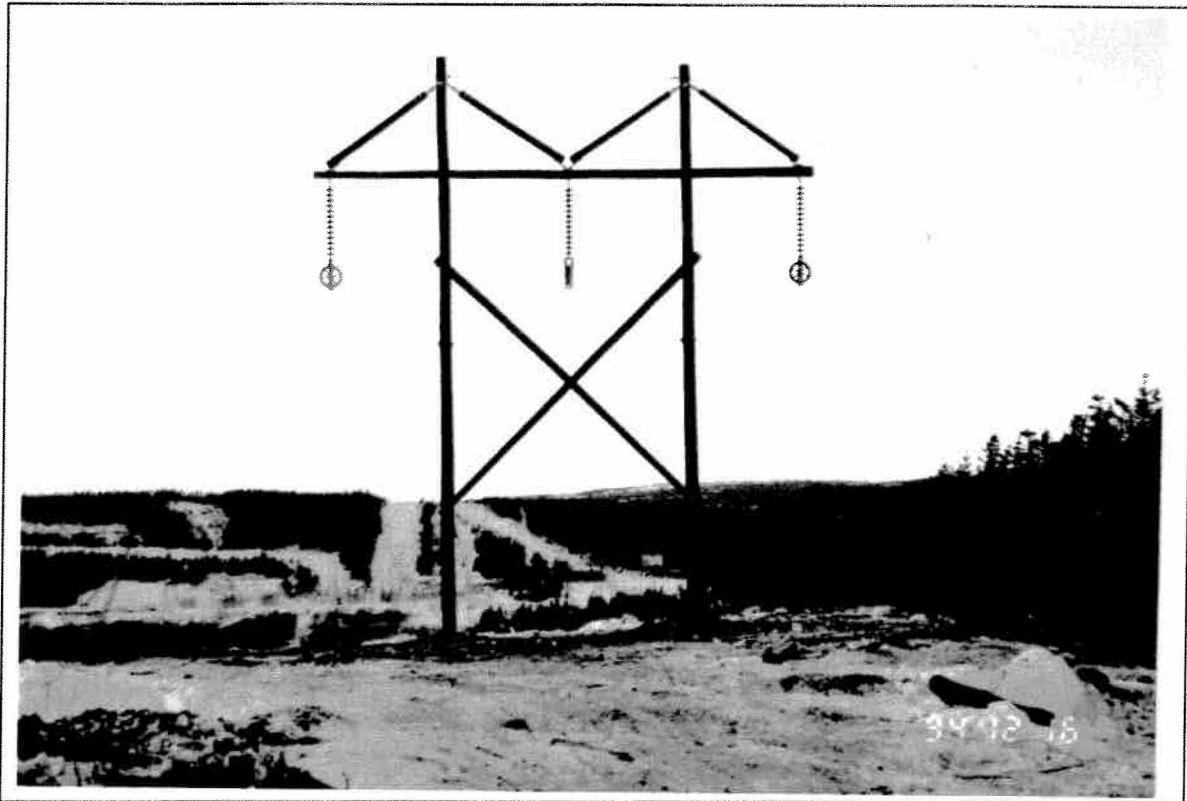
Photo 11: TL201 - New Str.#4 - Type AX  
2-Pole Tangent Structure (0 - 3°)

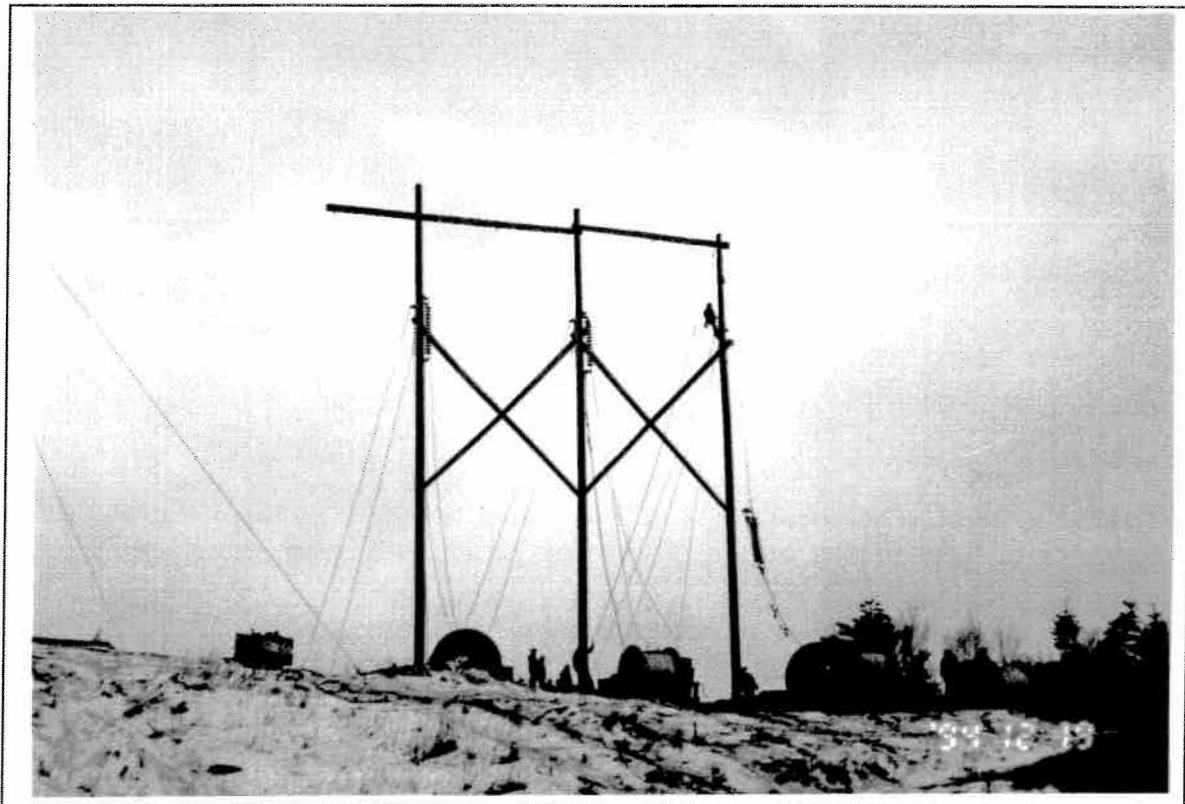
Photo 12: TL201 - New Str.#6 - Type G  
3-Pole - 230 kV - Deadend
