Inspection Report To

Borescope inspection of Avon 37029 1533 70L

Date: June 10 2008

IC-NLH-012, Attachment 1 Page 2 of 14, Holyrood Blackstart

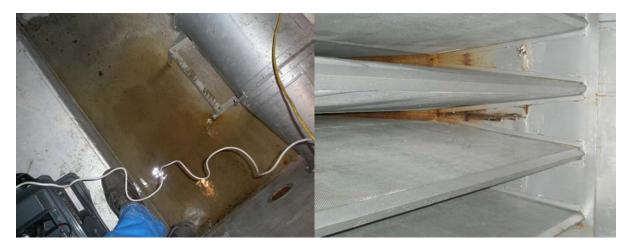
On entering the plenum it was noted that a large amount of water had gathered under the intake, this will have a significant impact on the units condition, corrosion and potential for FOD ingress. In addition 2 large holes where noted in the sidewall as well as a large amount of rust particles on the floor. All of these will have a risk of ingress attached.

Water in plenum

Hole in side wall

The unit showed greater salt ingress and corrosion this year, this would be attributed to the poor condition of the intake plenum, water ingress and flaking corrosion particles. This should be addressed prior to any further running.

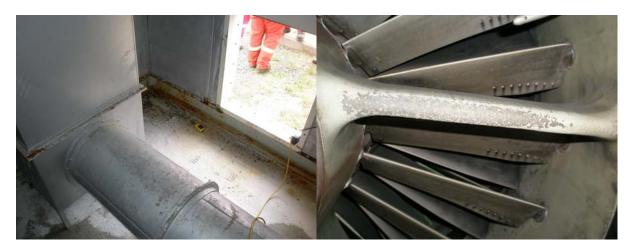
Rust particles

Corrosion on intake

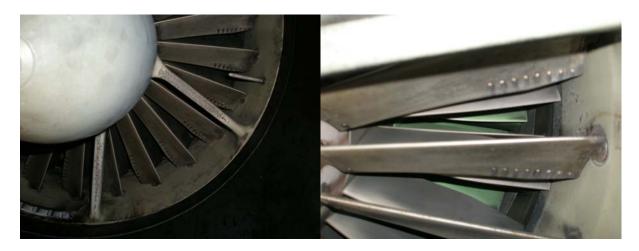
It was noted that the Front bearing housing, Inlet Guide Vanes and Compressor have significant corrosion and coating loss. This has now increased greatly from last year's inspection with the addition of salt ingress and the Front Bearing housing pitting (As shown in above section)

Corrosion pitting on Front Bearing housing struts and outer casing

The unit would ideally be returned to our facility for repair / overhaul due to the coating loss, pitting, corrosion etc. If the unit continues to run in its current condition then overhaul and replacement prices will increase while the parent material decreases in reparability.

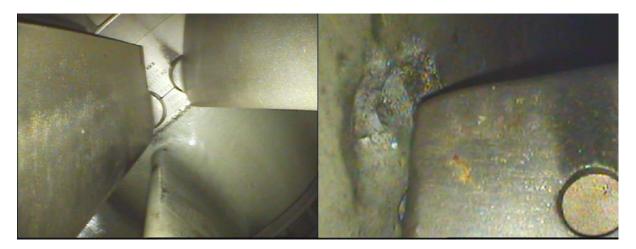
IGV Inner journals

FBH Wear

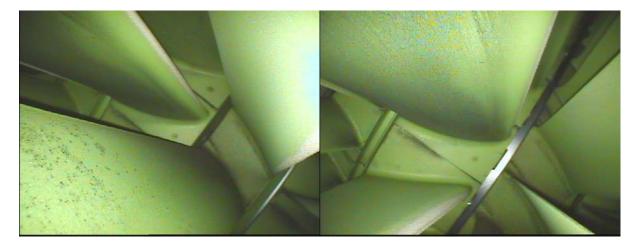
Coating loss and pitting stage 1

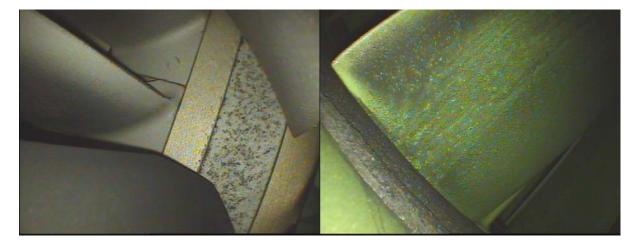
Stage 5 Disc Corrosion

Stage 4 casing and blade condition

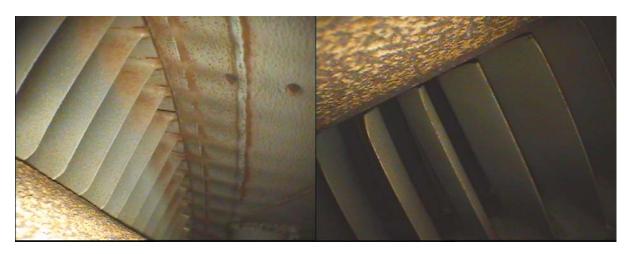
Stage 15 OGV Corrosion

COC Corrosion

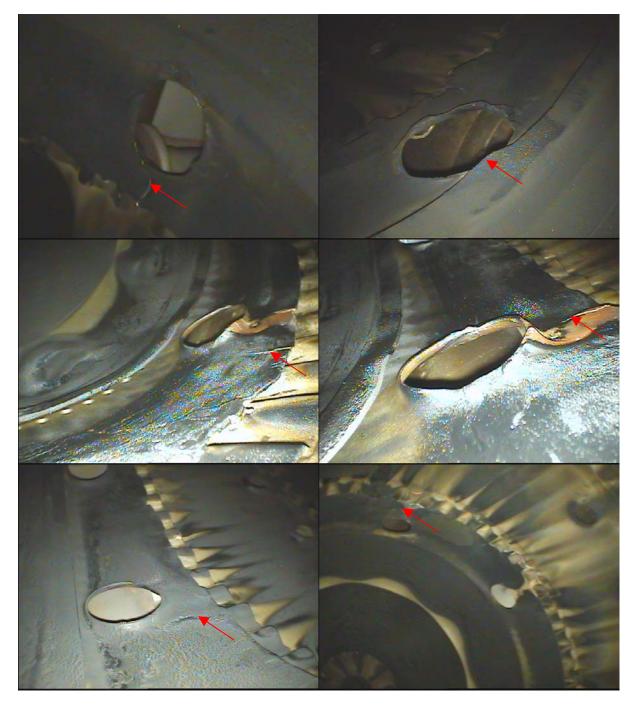
In 2007 the unit showed extreme wear of the Combustion cans with cracks and loss of coating. The unit has operated 26 Hours and 54 Starts since that time which has increased the level of cracking. It may only be a matter of time before this material is released and impacts the turbine.

Access could only be gained through burners 1 and 2 due to rusting bolting in other areas, all borescope ports where removed to gain minimal access in the combustion area.

After the last inspection it was highly recommended that as a minimum the Combustion cans be replaced. Whilst we understand due to budgetary and operational requirements this has not happened it must now be placed as a high priority to ensure the continuous availability of this unit.

In the immediate future the combustion cans should be changed, if a part is ingested into the turbine the unit could suffer a catastrophic failure which would not only damage and increase the Avon overhaul / replacement price, but would do considerable damage to the Power Turbine as well as be a large safety risk.

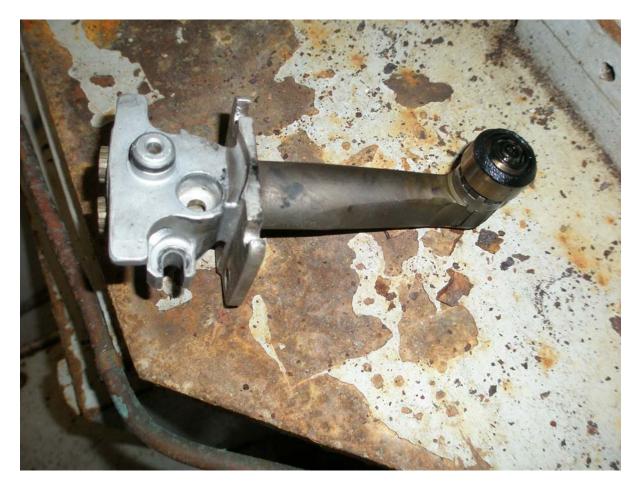
Burner No1 after removal

The unit shows signs of burner leaking, it was highlighted last year that the drains tank fills continuously and the unit has some start issues. These where and continue to be attributed to the failing of the seals in the Fuel control unit, this should be addressed to improve start reliability while reducing poor burn in the combustion area and reducing leaks back through the drains system.

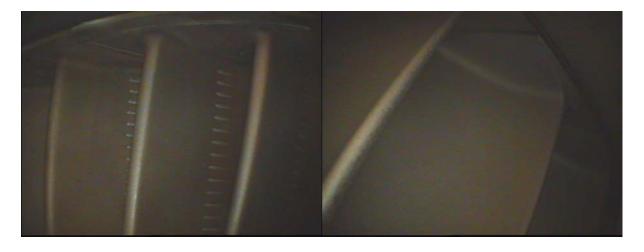
The turbine section showed minor impact damage from either combustion can material or corrosion flakes from the intake. Coating loss was evident throughout with some minor pitting.

HP Nozzle Guide Vane

HP Turbine Blade inner platform

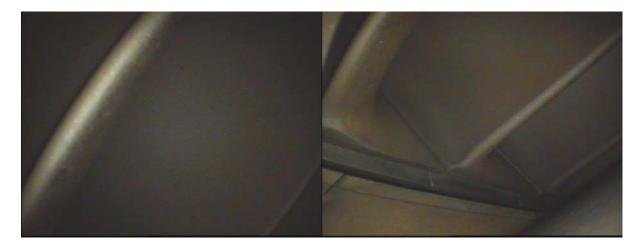
HP Blade leading edge pitting

HP Blade outer platform

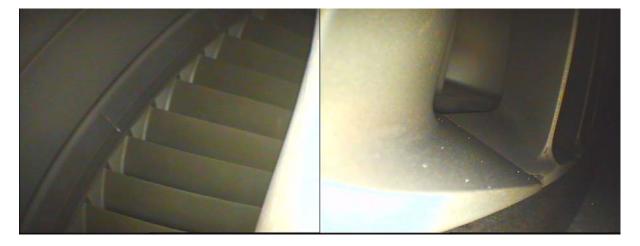
LP Turbine Blades

LP Turbine blade damage and FOD material flakes

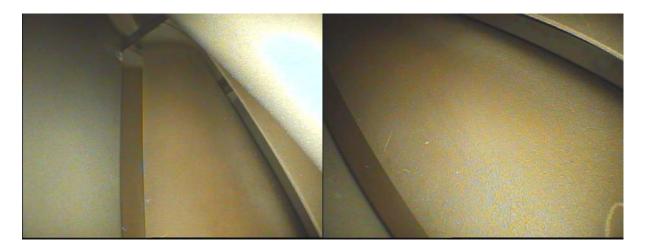
IP Blade and NGV

IP Blade

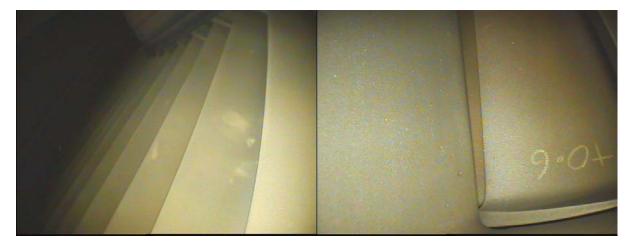
LP Blade coating deterioration

IP Blade outer platform
