Re: Field Investigation for Holyrood Combustion Turbine, March 4, 2015

**Field Investigation for Holyrood Combustion Turbine
Failed Start, March 4, 2015**

July 20, 2015

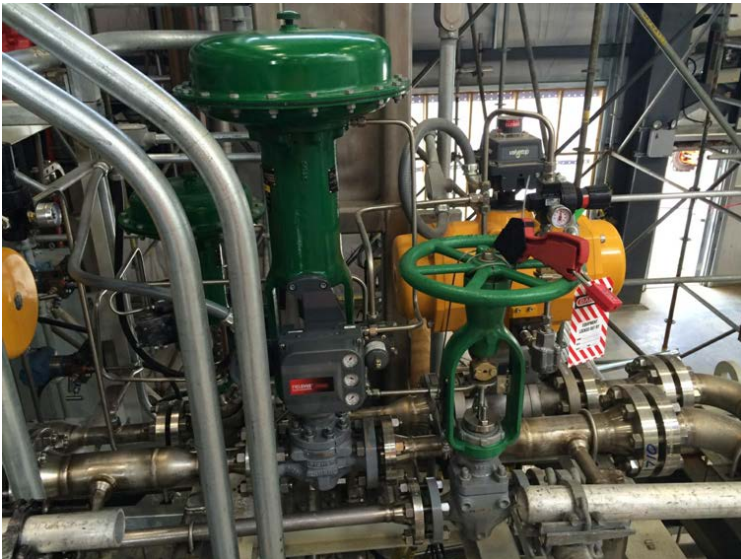
Photo 2: Fuel bypass valve locked and tagged

- The valve set position corresponding to the required flow rate was immediately marked on the valve so that if moved, the valve could be quickly returned to the proper position (Photo 3);
- The valve was locked in position so that it could not be easily moved (Photo 2);
- A pre-start up verification of the valve position was instituted; and
- The valve manufacturer was contacted to determine whether there was an engineered locking mechanism which could be affixed/applied to the valve.

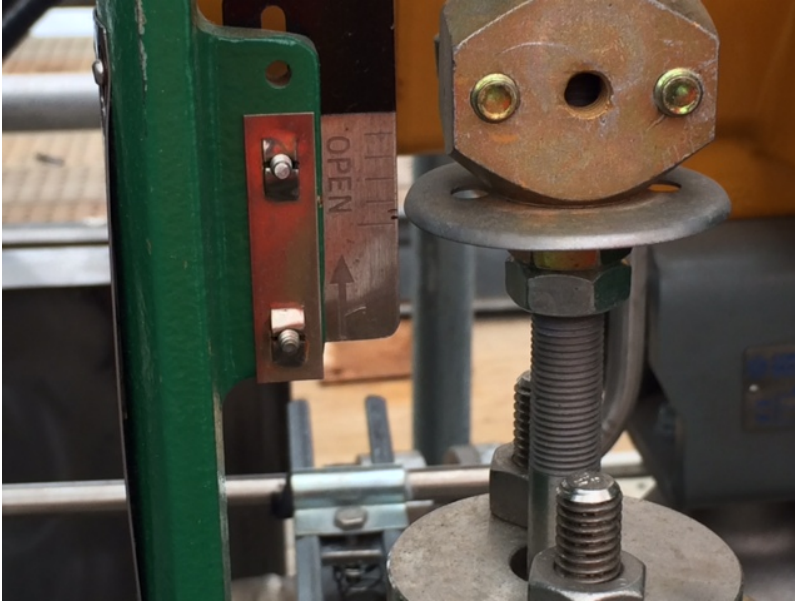
Photo 3: Close up of fuel bypass valve position indicator

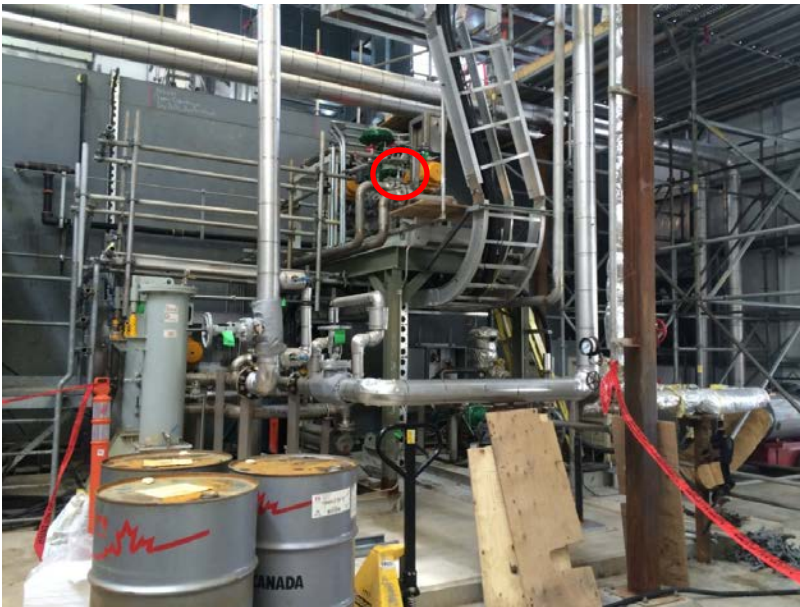
On Wednesday March 4, during start-up of the Holyrood CT, there were a series of failed starts due to an excessive fuel bypass valve flow rate. The bypass valve provides initial flow to the turbine fuel nozzles for starting the unit. The flow rate on this valve had been commissioned following installation to a flow rate in accordance with the original equipment manufacturer (OEM) specifications. This valve is not located on the turbine itself, but is part of the fuel supply system and is located on the fuel, oil, and water injection skid, on an elevated platform within the plant (Photo 4).

Photo 4: Fuel bypass valve location within the plant
