1 Q. Black Start: Please confirm that Hydro lacked black start capability at the Holyrood
2 Plant in the winters 2011-2012, 2012-2013 and 2013-2014.

POWER SYSTEM OUTAGE REPORT

DEC. 8 TO DEC. 11 1994

NEWFOUNDLAND AND LABRADOR HYDRO

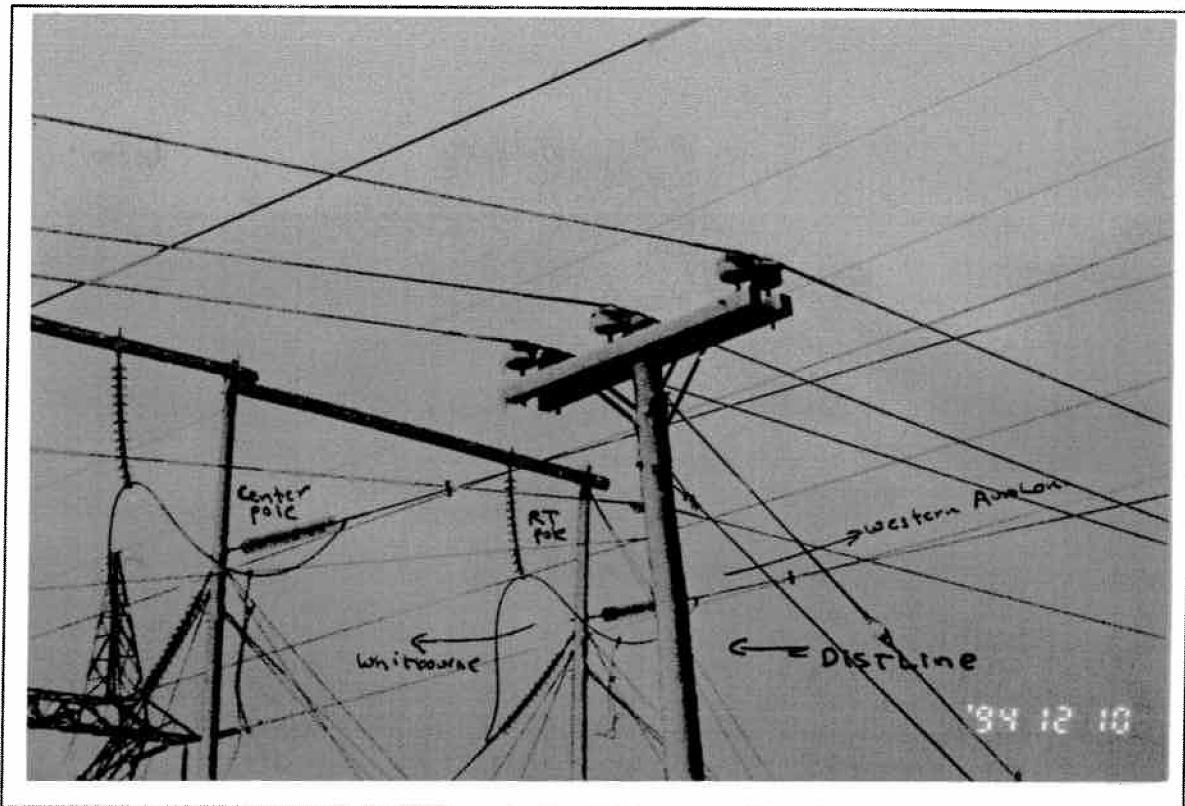
Photo 2: TL201 - Str.#2 - Type D
Near Chapel Arm Road: Structure shaken but intact.

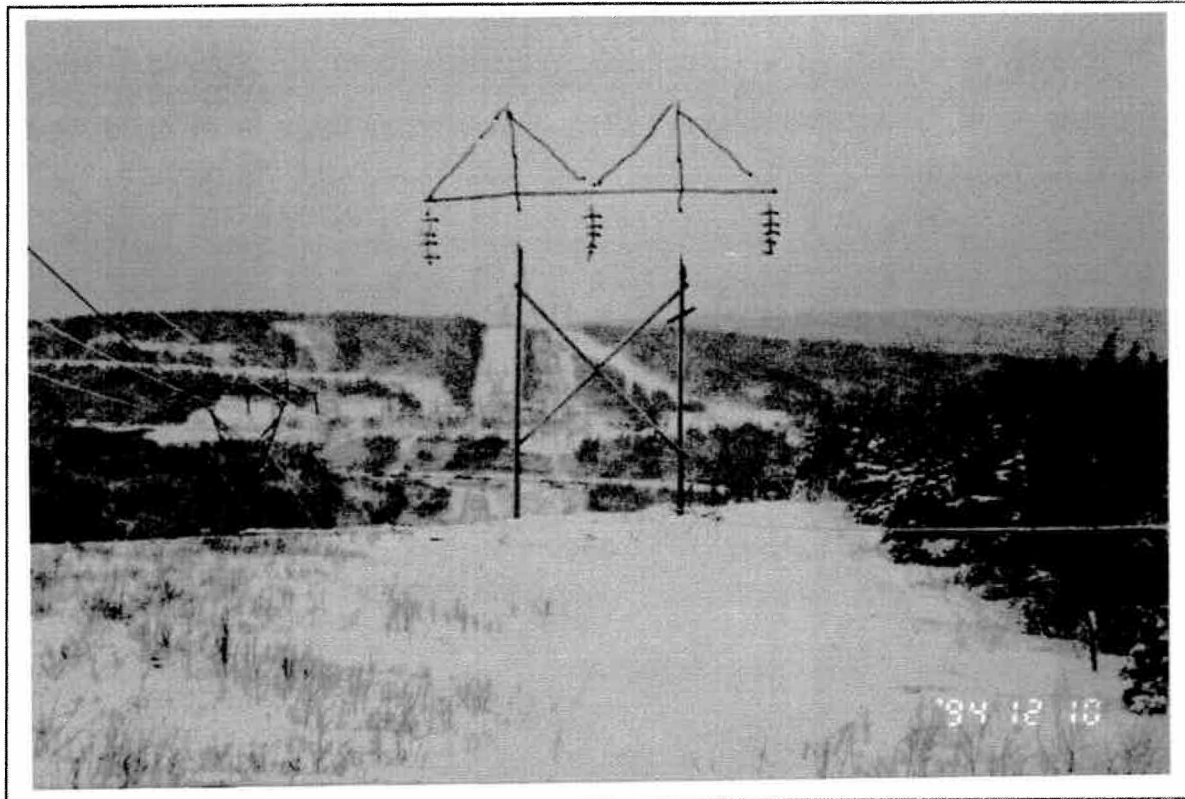
It is concluded that the excessive ice accumulation, in excess of design, (2 inch radial) on transmission line conductors combined with high winds (126km/hr or higher) was the major cause of structure and hardware failure during the storm. These lines were originally designed for a load of one (1) inch radial ice on the conductor and a wind speed of 176 km/hr.

Photo 5: TL201 - Str.#4 - Type A
Pole tops and crossarm on ground.

During the repairs to the damaged sections, the design of these sections of line was upgraded to withstand the climatic loading conditions which were actually experienced.

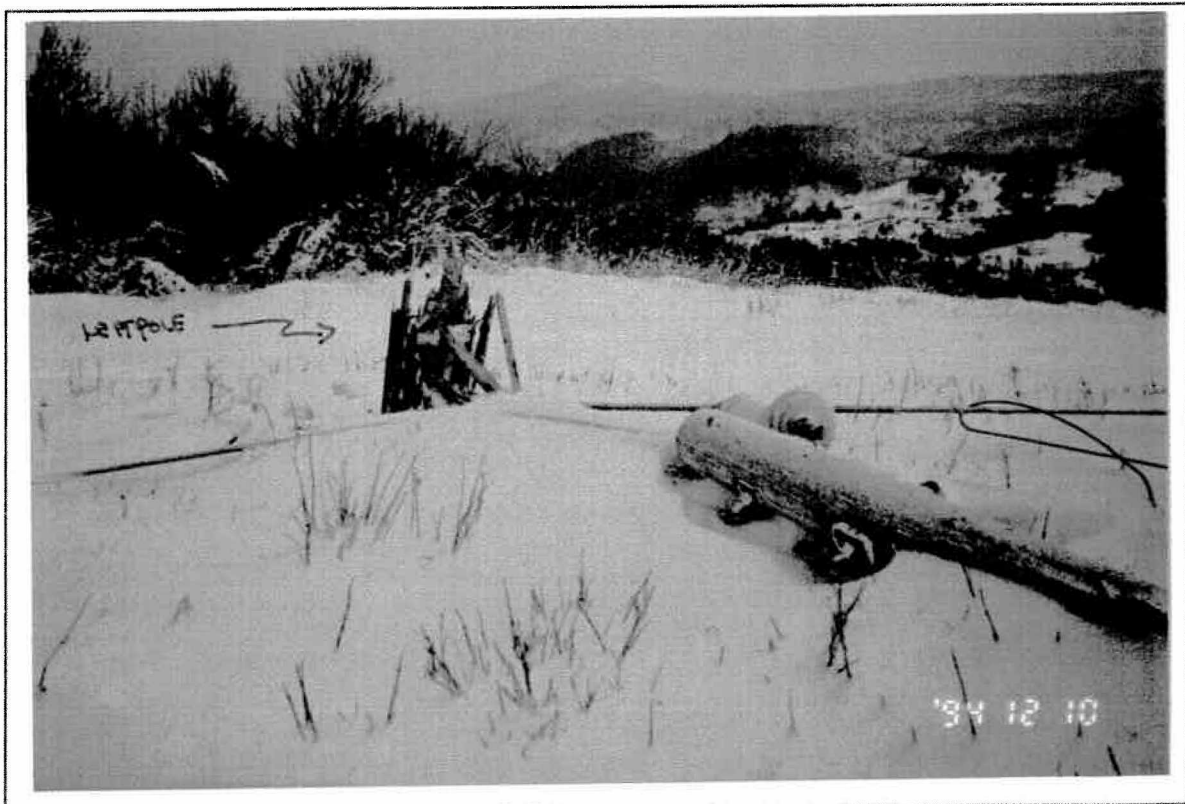
Photo 6: TL201 - Str.#5 - Type B
Left pole cracked at ground-line.

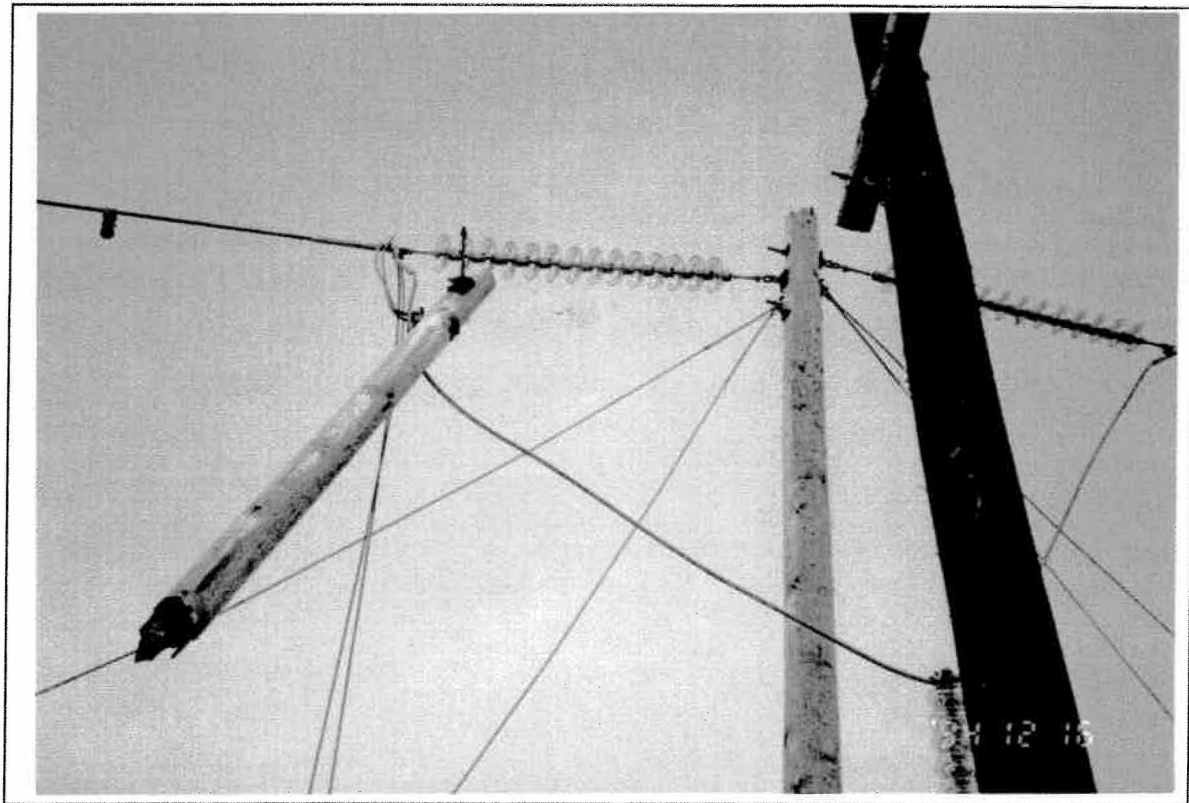
Photo 9: TL201 - Str.#3 - Type D
Crossarm hanging on jumper.

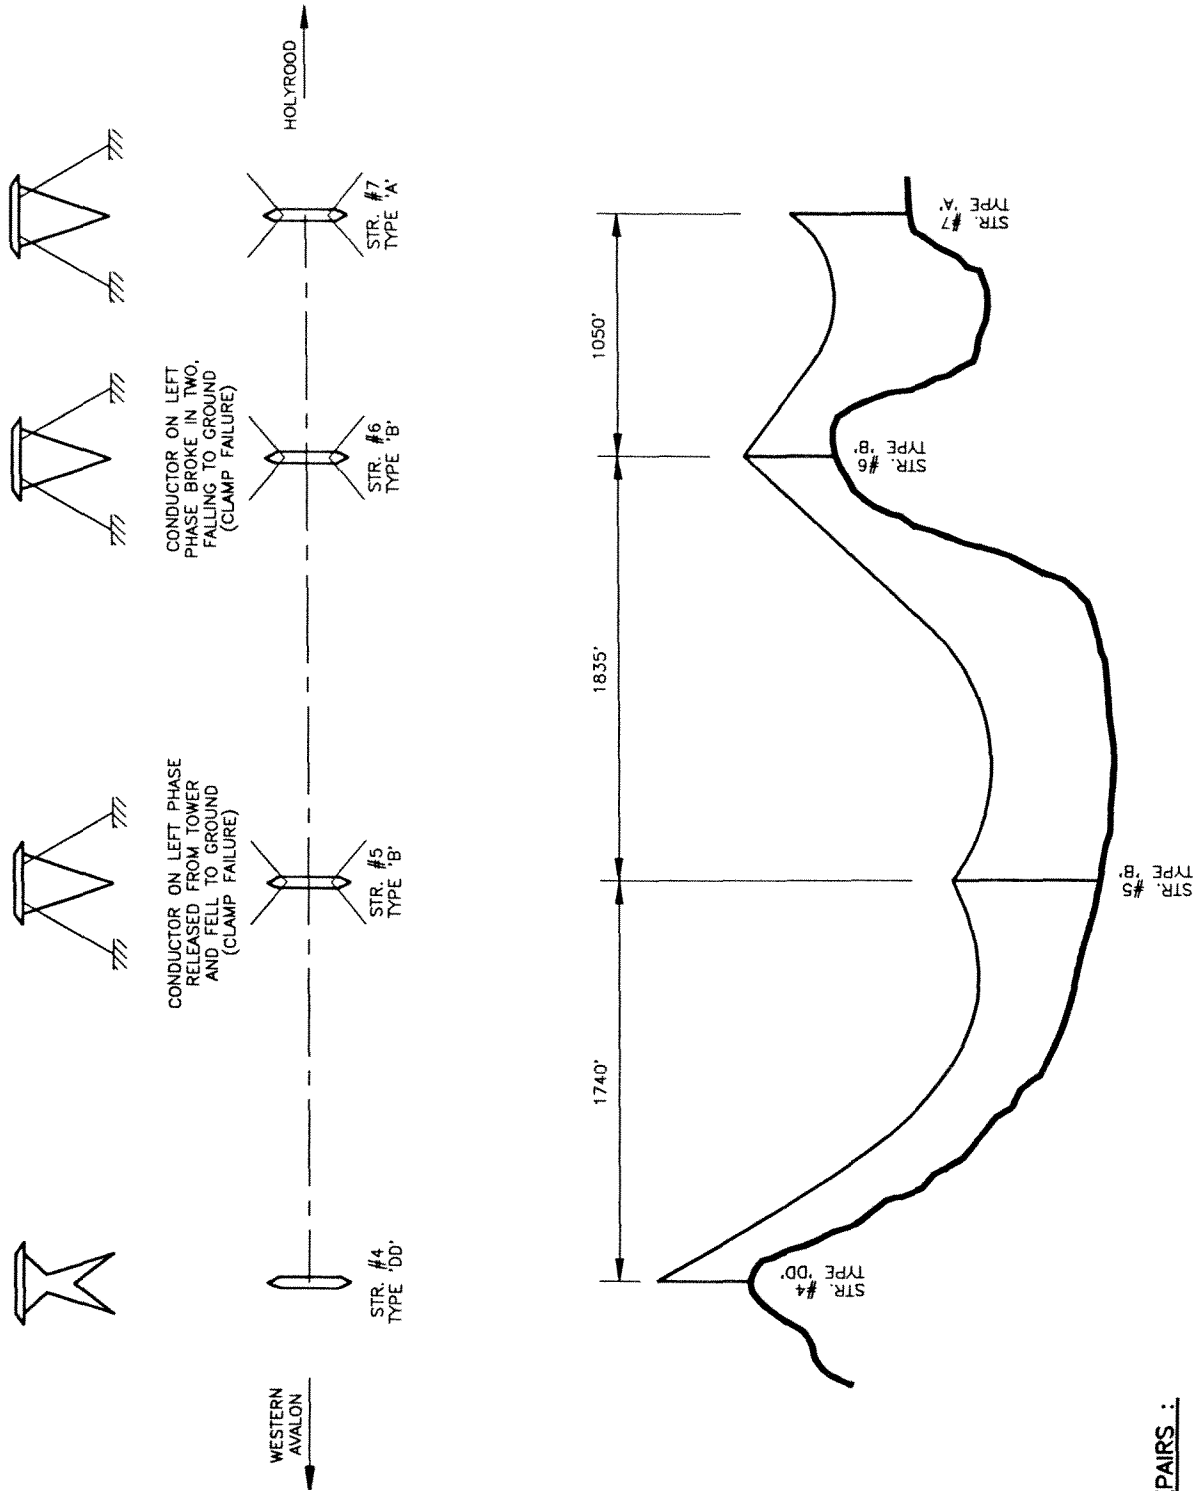
TL.217 LINE FAILURE
 STRUCTURE No.4 TO No.6

Similarly, heavy icing of the conductors initiated the failure of a clamp holding the conductor on TL 217. The investigation showed that perhaps this clamp was also weakened by the aeolian vibrations (conductor galloping caused by certain wind conditions) experienced on this transmission line.

REPAIRS :
 CONDUCTOR WAS SPliced TOGETHER
 AND THE CONDUCTOR RE-ATTACHED
 WITH NEW HARDWARE.
