A REPORT TO THE BOARD OF COMMISSIONERS OF PUBLIC UTILITIES

UNFORESEEN ITEM: Sunnyside B1L03 230 kV Breaker Overhaul

April 2014

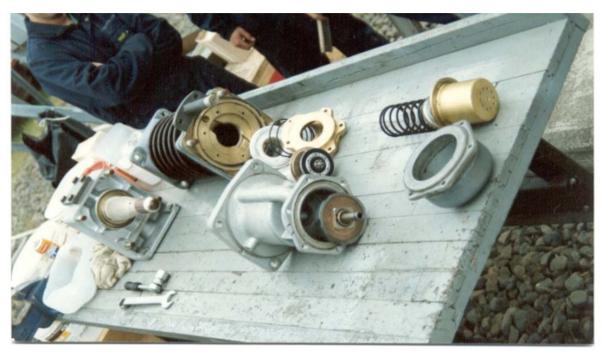
230 kV Breaker – DCVF during overhaul (Internal components)

The project, to overhaul the 230 kV DCVF Asea Brown Broveri (ABB) air blast circuit breaker², was undertaken immediately following the investigation of the breaker components. The project was carried out by Hydro personnel and included removing the existing breaker heads, columns, control blocks, and control valves and replacing them. (See Appendix C for pictures of this breaker and components). Once the parts were replaced, the breaker was subjected to testing to ensure that it operated correctly. Once the testing and checks were completed, the breaker was released to Hydro's Energy Control Center (ECC) and put back into service.

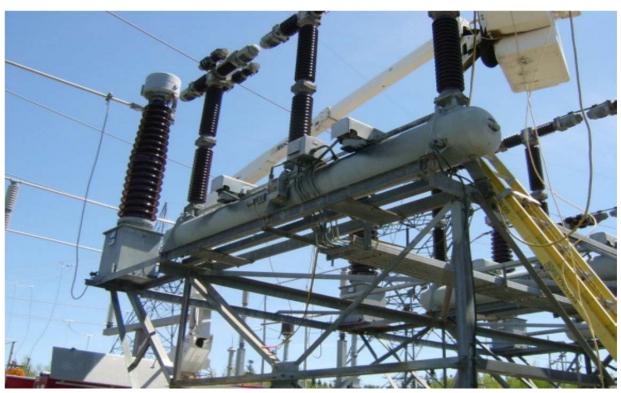
230 kV Breaker – DCVF during overhaul

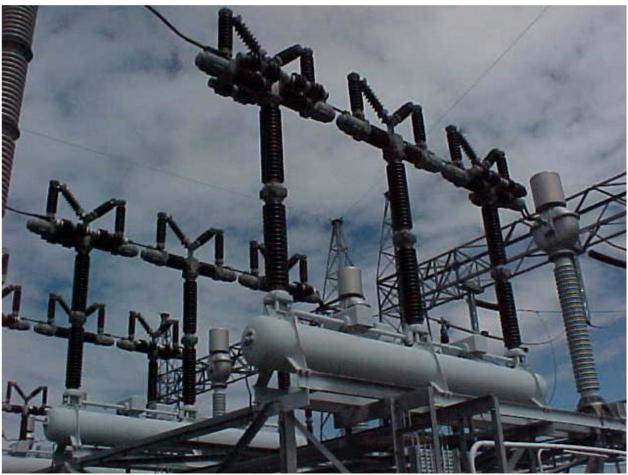
230 kV Breaker – DCVF in terminal station
