1 Q. Further to PR-PUB-NLH-172, despite the conclusion of the technical analysis  
2 referred to, the Newfoundland Power option was found to be inadequate on May  
3 10, 2013. Please describe what actions Hydro took between the time it learned the  
4 Newfoundland Power option was inadequate and November 29, 2013 when the  
5 Board approved new action to be taken to provide black start capability.

14  
15 This report summarizes the sequence of events that occurred on the power system, the  
16 problems experienced, the damage incurred, and identifies remedial actions being taken as a  
17 result of follow up investigations.

**Unit 1 Failure – Holyrood  
Life Safety Review  
SWOP # 2013000599  
January 11, 2013**

# **Nalcor Holyrood Unit 1 Turbine and Generator Inspection Report January 15, 2013**

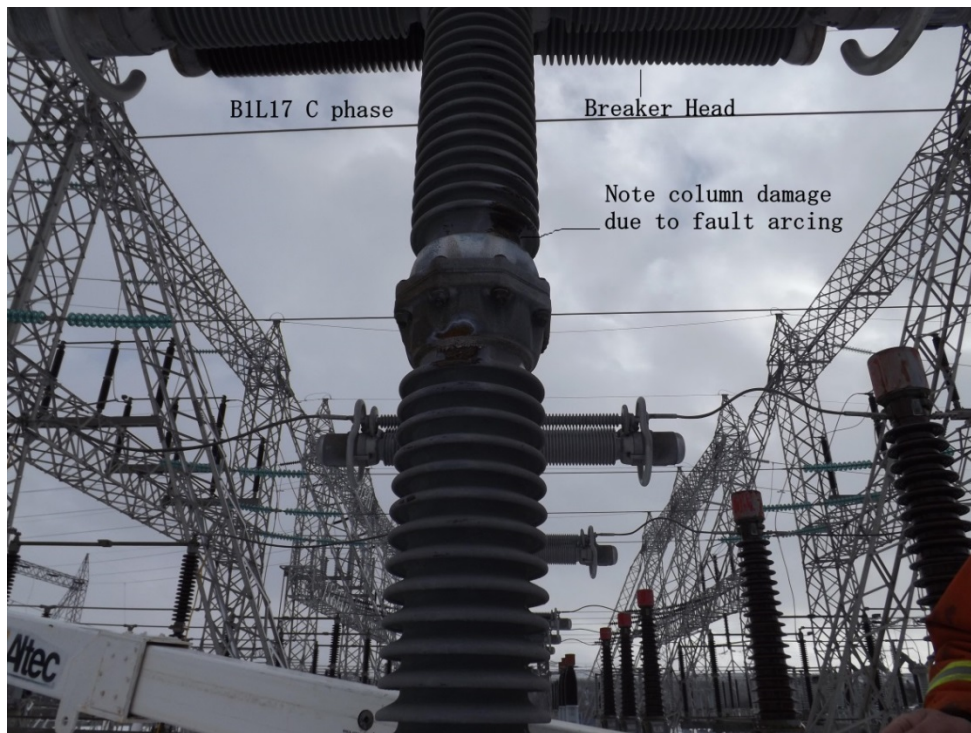
At 06:42, while Holyrood plant personnel were in the process of restoring Unit 3, there were trips of Units 1 and 2 and transmission line TL 217 at the Western Avalon end. Both units were loaded to 110 MW. Newfoundland Power's 138 kV line, 39L, also tripped at this time. This resulted in a significant customer impact with nearly 250 MW of Newfoundland Power load loss, primarily on the Avalon Peninsula. This was caused by a fault on Unit 1 230 kV breaker B1L17, which was a result of salt contamination.

Figure 2-5d: B1L17 Vertical Column Arcing Damage
