1 **Q. Re: Tab 1.1 - 2013 Facility Rehabilitation – Soldiers Pond Outlet**

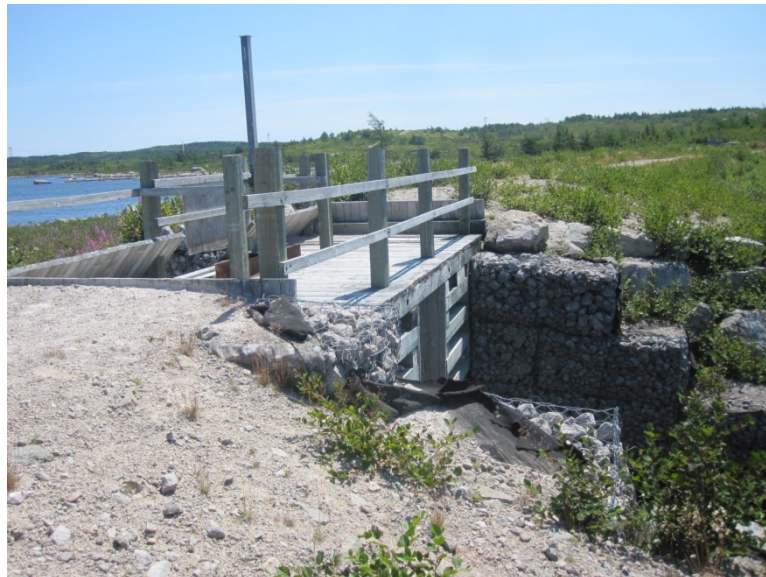
2
3 **At p. 5 of the report at Tab 1.1, it states that “The wing walls do not have safety**
4 **railings as they cannot be accommodated with the existing design. A more robust**
5 **wing wall design that incorporates appropriate safety measures is required.” Figure**
6 **12 shows that access to the wing walls is already blocked off by fencing at the top of**
7 **the structure. Is there a safety code provision or other legislative or regulatory**
8 **provision that would require further railings along the wing walls?**
9

- 14 • *Where there is a risk of a vertical fall of three metres.¹*

15
16 The vertical drop from the wing walls upstream and downstream of the Soldiers Pond
17 structure ranges from 2 to 4 metres. As shown by the photograph in Figure 1 below, the
18 existing fence at the top of the structure does not provide any fall protection along the
19 length of the wing walls and is inadequate from the perspective of public and employee
20 safety.²
21
22

¹ The requirement for fall protection for vertical drops in excess of 3 metres for the general public is consistent with fall protection for employees under section 141 of the Occupational Health and Safety Regulations.
