NEWFOUNDLAND POWER
DIESEL POWER PLANT REVIEW

JULY, 1997

# Diesel Generator Review

March 1997

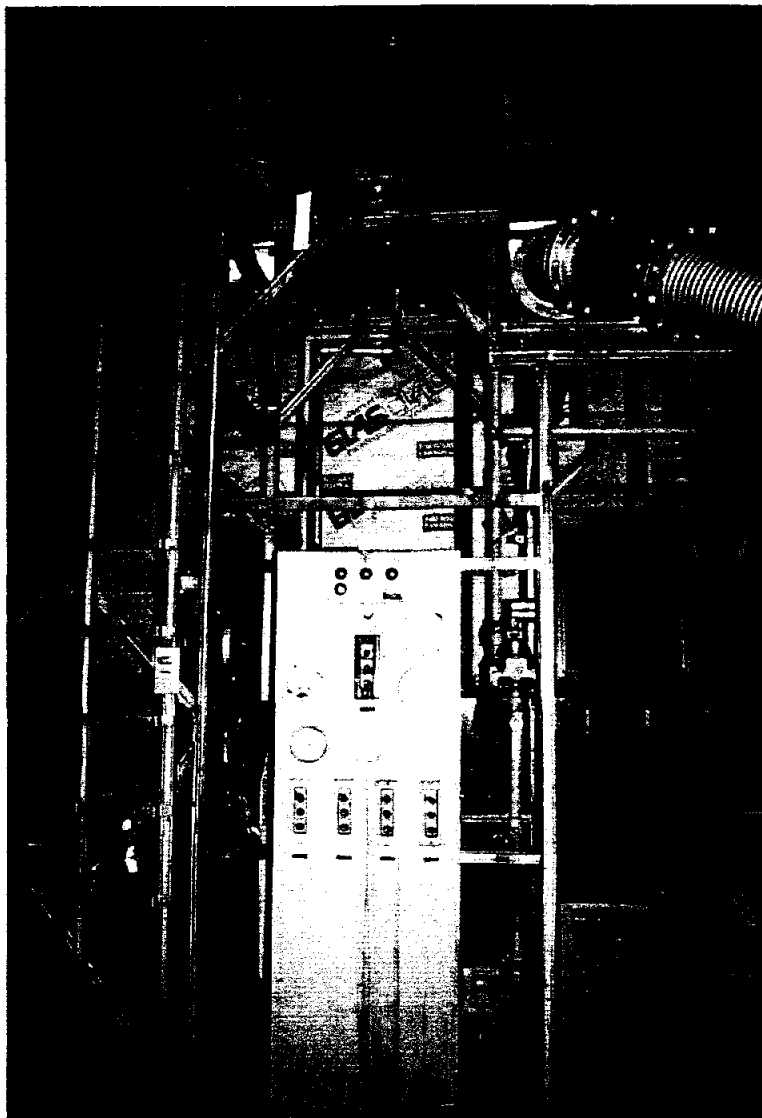
**Photo 9**

Consultant's Comments - Engines have operated beyond the usual manufacturer's recommended major overhaul period. Three day tanks in the building are vented in the building and do not have high level alarms or shut off devices. Floor trenches contain pools of oil. Unit # 3 should not be operated due to the possibility of crankshaft failure. Instrumentation inadequate. Some parts may be available but would be expensive and have long delivery times. Major components likely not available.

Salt Pond - Fuel tank and exhaust in close proximity

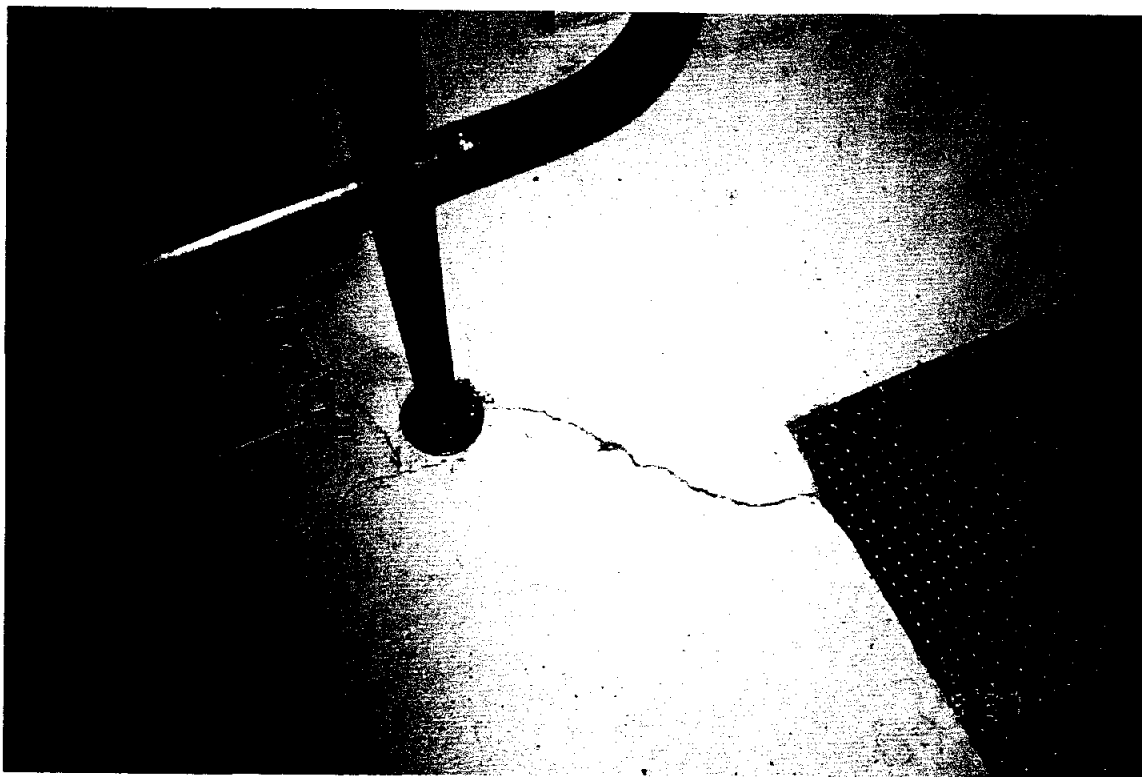
**Photo 26**

The plant is in fair condition. All engines suffer from oil leaks. The stack on Unit # 2 has oil deposits on the exterior. The engine foundations are cracked with the most severe being on Unit #3. The unit coolers are undersized and restrict unit load to approximately 75 to 80% of the machine rating. Switchgear and controls are obsolete. Ground water is continuously running into the plant sumps. These sumps and the sump outfall area require continuous attention. The building aesthetics are extremely poor.

Gander - Unit No.3 showing cracked foundations

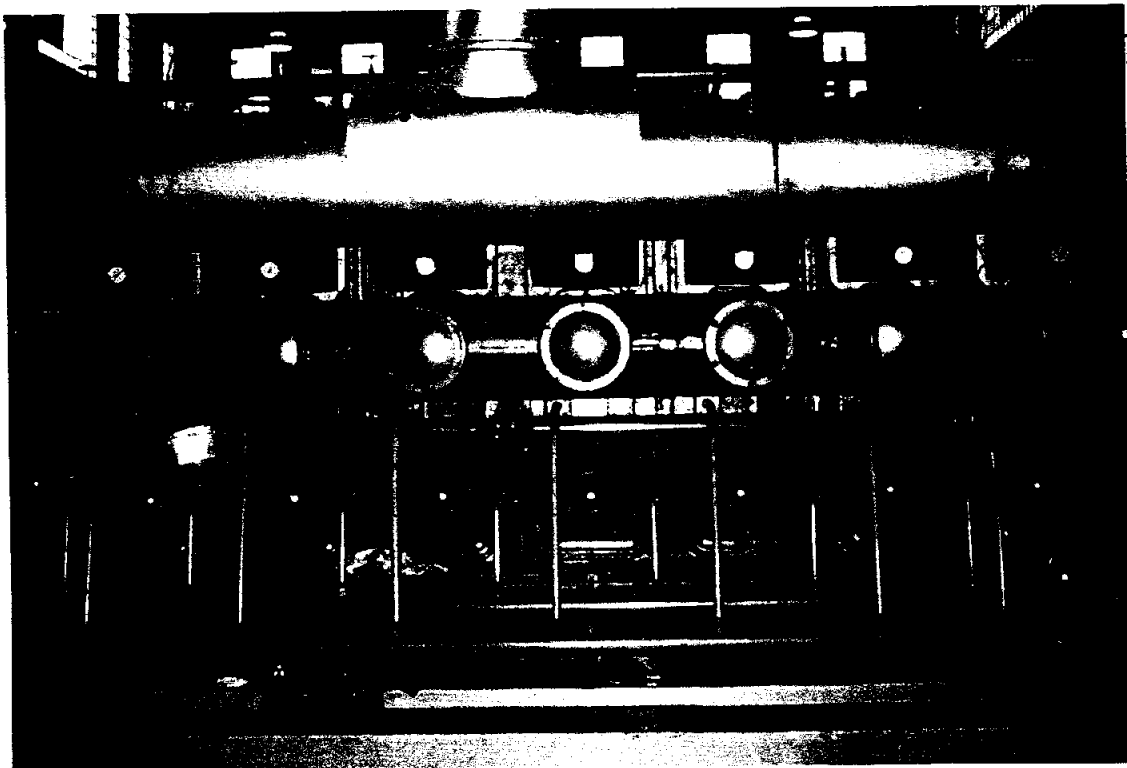
**Photo 28**

Consultant's Comments - Engines and auxiliary systems are in need of substantial repair. Unit # 2 had large amounts of oil leak from the hot exhaust manifold resulting in a dangerous condition. Foundation on Unit # 3 requires major repair work as does the drive mechanism on the scavenger blower. Units have accumulated about 100,000 hours each and are overdue for major overhauls.

Gander - Unit No.2 showing excessive exhaust oil drips onto air manifold

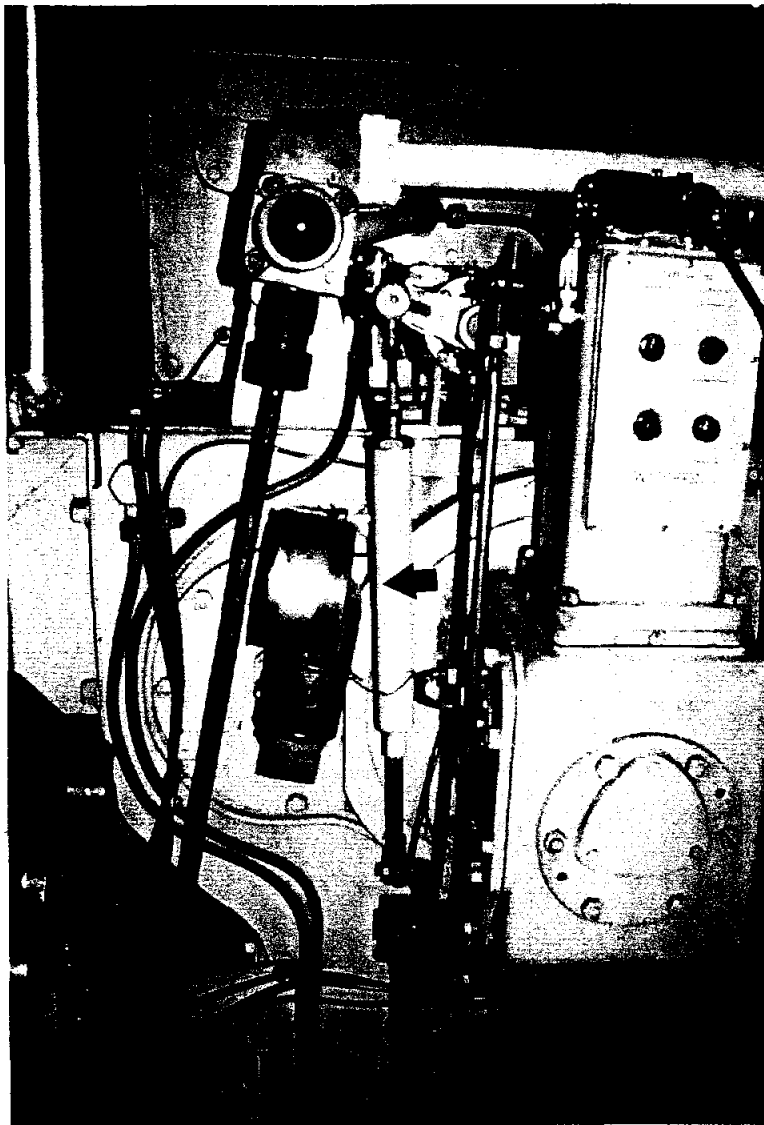
**Photo 35**

Consultant's Comments - Numerous minor water and oil leaks. Asbestos wrap on exhaust in bad condition. Collapsible link on governor safety system seized resulting in the overspeed shutdown system being inactive. Engine due for a major overhaul. Piston blow-by creates a health and fire hazard. The disabled overspeed mechanism creates a serious danger. Instrumentation inadequate. The manufacturer no longer makes diesel engines and parts are no longer available.

Aguathuna - Governor linkage with collapsible link shown

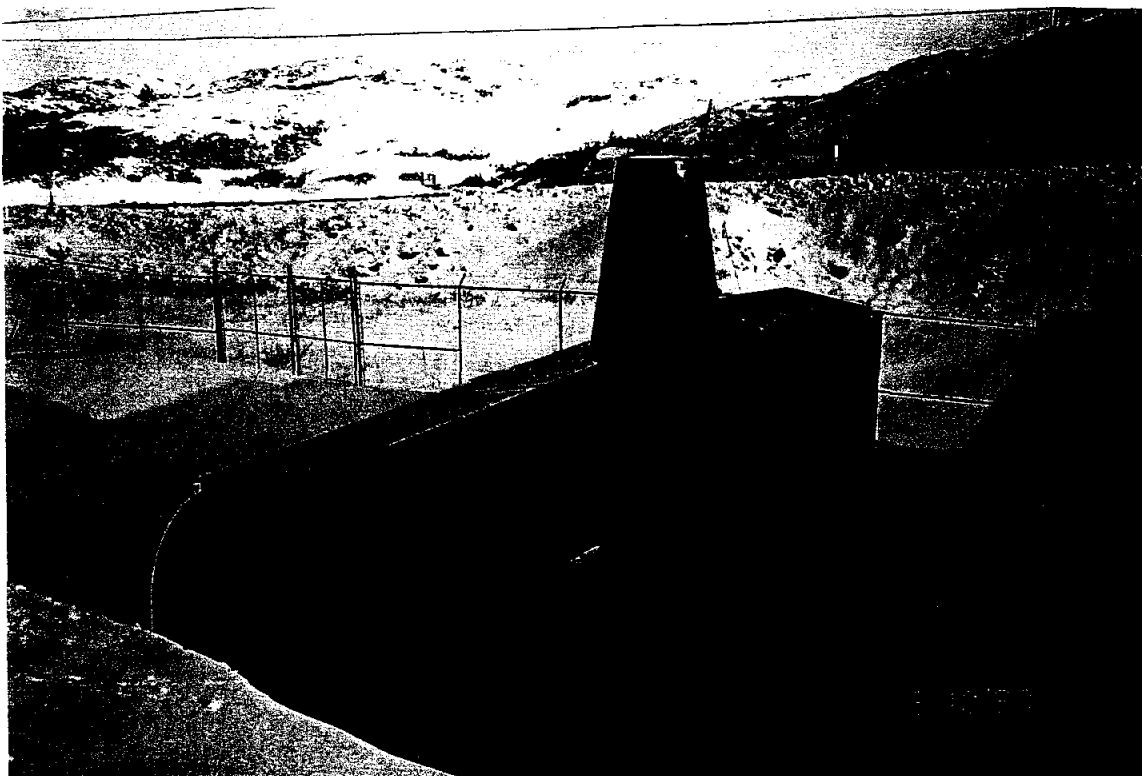
**Photo 43**

Unit # 10 - Enclosure is corroded. Overall unit in good condition and operates well. Unit is still manufactured and is supported with both maintenance and service spares.

Port-aux-Basques - EMD unit enclosure, open to weather at radiator end, top and side

Unit # 10 - Consideration should be given to moving the unit indoors due to the condition of the enclosure.

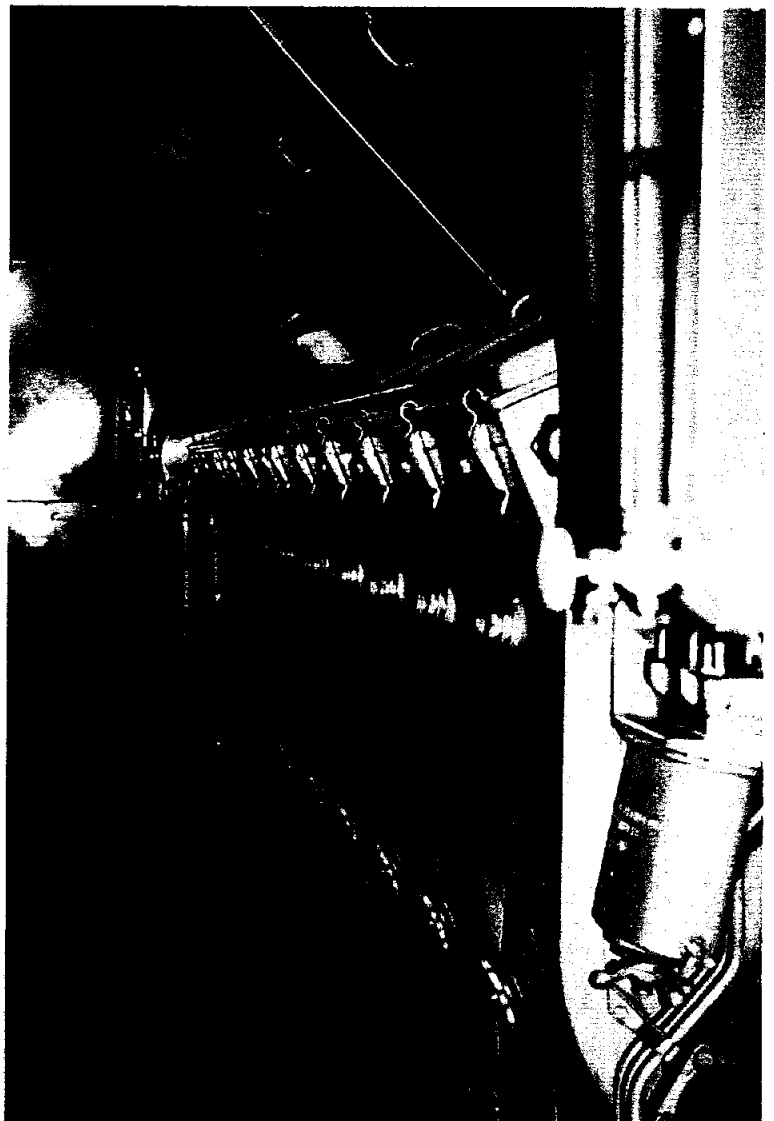
**Photo 46**

Port-aux-Basques - General view of EMD enclosure showing limited maintenance space between engine and container wall

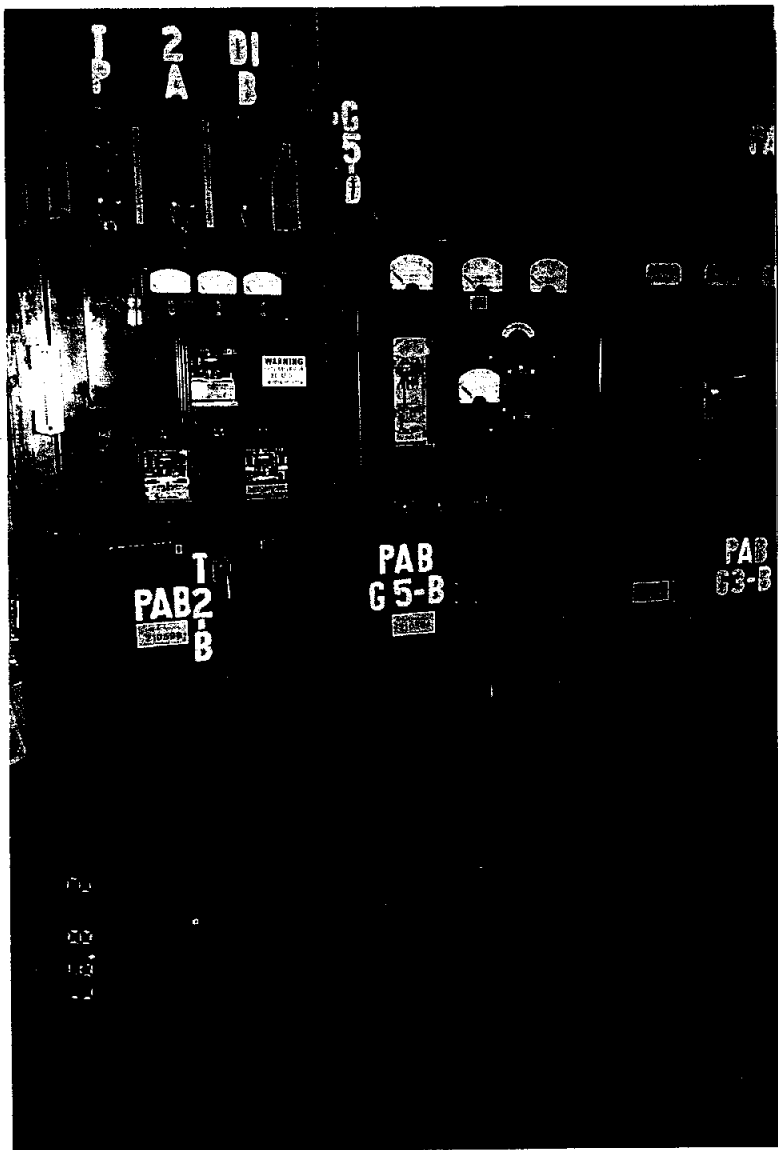
Overall, the units are in fair to good operating condition. Unit #2 generator is faulted and has yet to be repaired. Some mufflers require rebuild. All generators require cleaning. The main plant switchgear was manufactured in 1937 and is obsolete with the only plant protection being overcurrent on the main breaker. The fuel tank system is in excellent condition as it was replaced in 1995. Of note is that \$4800 per year is paid to the Town of Port Aux Basques for cooling water used at the main plant.

In March 1997, a further review was undertaken by NP personnel into the condition of the switchgear in the main plant(memo - B. Nickerson to J. Simmons - Appendix E). The maximum fault levels were determined for the main plant under both parallel and isolated operating conditions. This revealed that all four generator breakers on the T2 bus are exposed to fault levels in excess of their ratings. The operating practices of the plant were changed immediately to limit the fault levels. This results in the main plant capacity when operating in parallel to the system being reduced to 575 Kw from 1635 Kw. The main plant capacity in isolation to the system was reduced to 925 Kw. The cost of replacing the switchgear and providing adequate electrical instrumentation and controls was reassessed in early 1997 (Appendix E) and determined to be approximately \$460,000.

**Photo 51**  
Port-aux-Basques - Outdated switchgear
