**Q. [Account 355.3] – As it relates to Account 355.3 - Insulators, please provide the number and size of insulators; period during which each different type of insulator was installed, the reason for changing the type of insulator, and the number of each type of insulator retired by year for the past 10 years.**

**Distribution Insulator Replacement Program**  
**Newfoundland Power Inc.**  
**June 2003**

# **Distribution Insulator Replacement Program**

Newfoundland Power Inc.  
June 2003

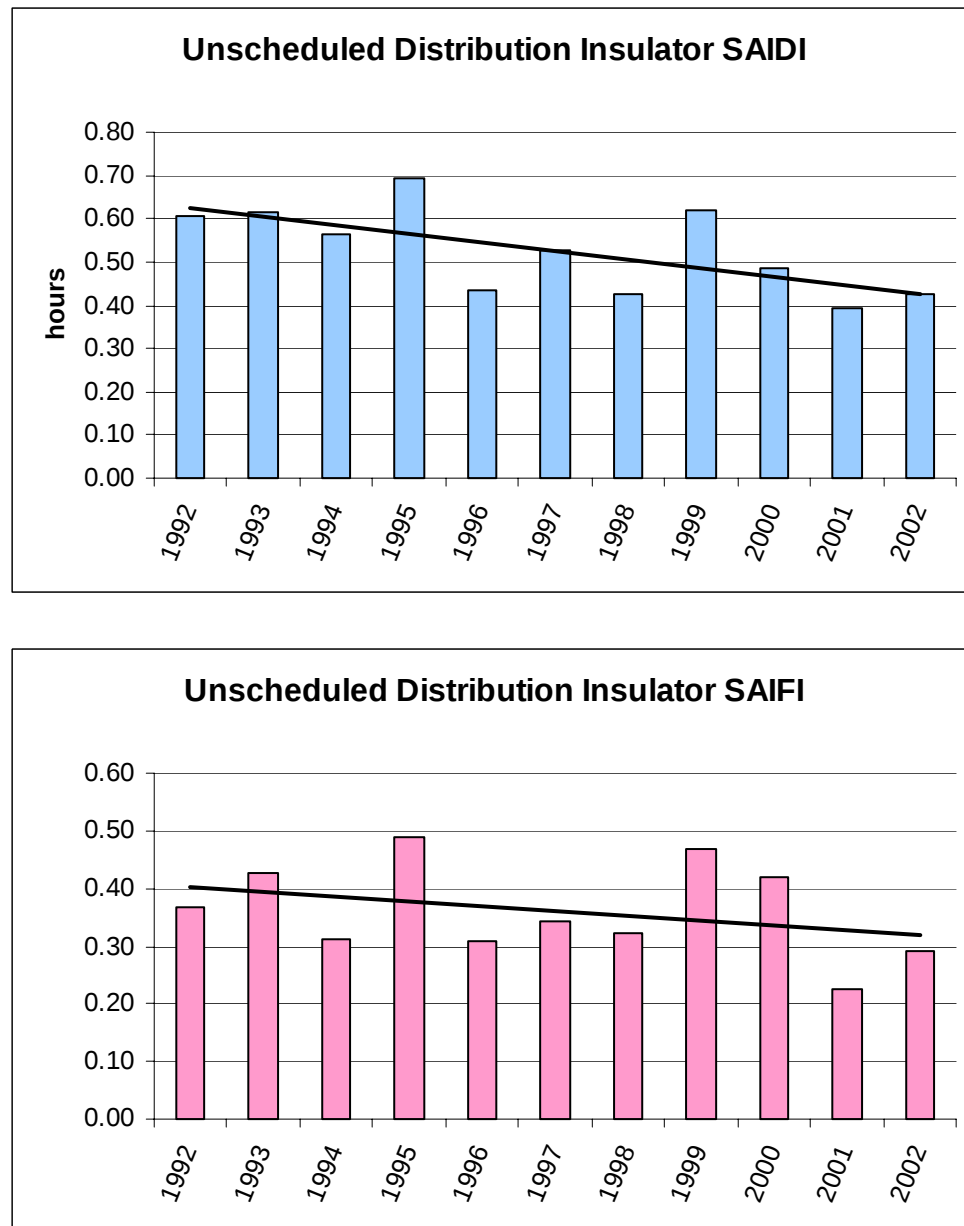
**Figure 1: Insulator Related SAIFI & SAIDI**

Since the late 1980s the Company has replaced a significant number of defective insulators. The impact on reliability to the end of 2002 has been positive. The SAIFI and SAIDI statistics for 2002 for insulator-related outages were 0.29 and 0.43 respectively. This compares with a 10-year Company average of 0.37 and 0.54 respectively.

Shown in Figure 1. The SAIFI and SAIDI statistics for 2002 for insulator-related outages were 0.29 and 0.43 respectively. This compares with a 10-year Company average of 0.37 and 0.54 respectively.

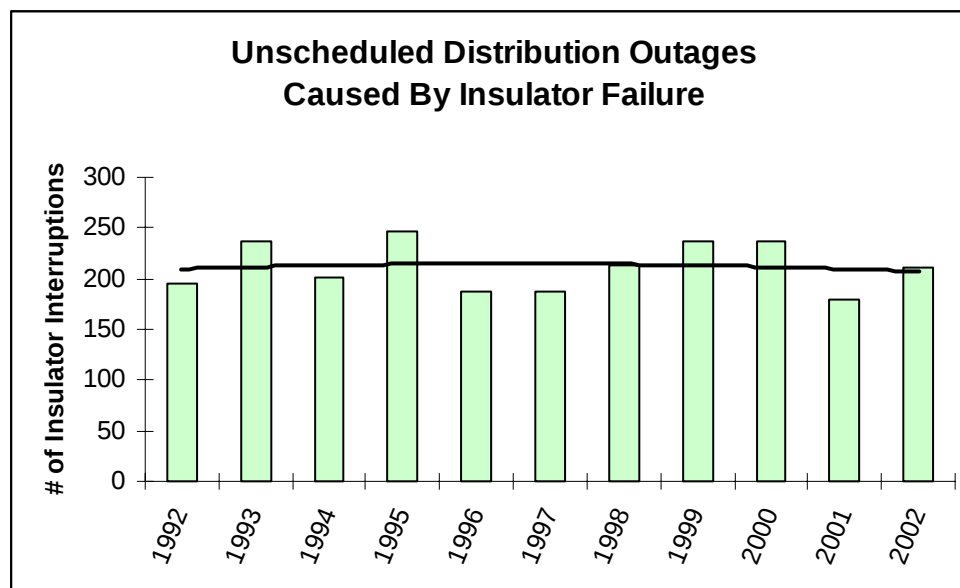
**Figure 2: Number of Insulator Interruptions**

Considering the number of insulators changed out over the last five years and the overall improvement in SAIDI and SAIFI statistics related to distribution, a decreasing trend in the number of insulator related outages might be expected. Unfortunately this is not the case. As demonstrated in Figure 2, since 1992 there has not been any decrease in the number of insulator related outages. It seems likely that this is related to the fact that there are still a large number of CP8080 and 2-Piece insulators in the system on tap off lines. These are now five years older than they were when the Distribution Insulator Replacement Program started. As insulators age their failure rate goes up. Therefore, we have fewer insulators in

the system but with a higher failure rate resulting in approximately the same number of outages in a year.

The apparent inconsistency between the number of insulator outages and the SAIFI and SAIDI trends can be attributed to the focus the Company has been placing on replacing insulators on critical feeders and feeder trunks. An insulator failure on these sections of the distribution system impact more customers than do outages on feeder taps. As a result, while the number of insulator-related outages has remained the same, fewer customers are being impacted by the failures. This in turn results in a reduction in the average number of times a customer is impacted by an insulator outage as evidenced by the declining SAIFI statistic.

As part of the annual distribution feeder inspection program, identify all 2-piece and CP8080 insulator for replacement and replace them in the following year.
